Assessment of the USAF Aircraft Accident  
Investigation Board (AIB) Report on the F-22A Mishap  
of November 16, 2010

**F-22A, T/N 06-4125**

**3<sup>RD</sup> WING**

**DATE OF ACCIDENT: 16 NOVEMBER 2010**

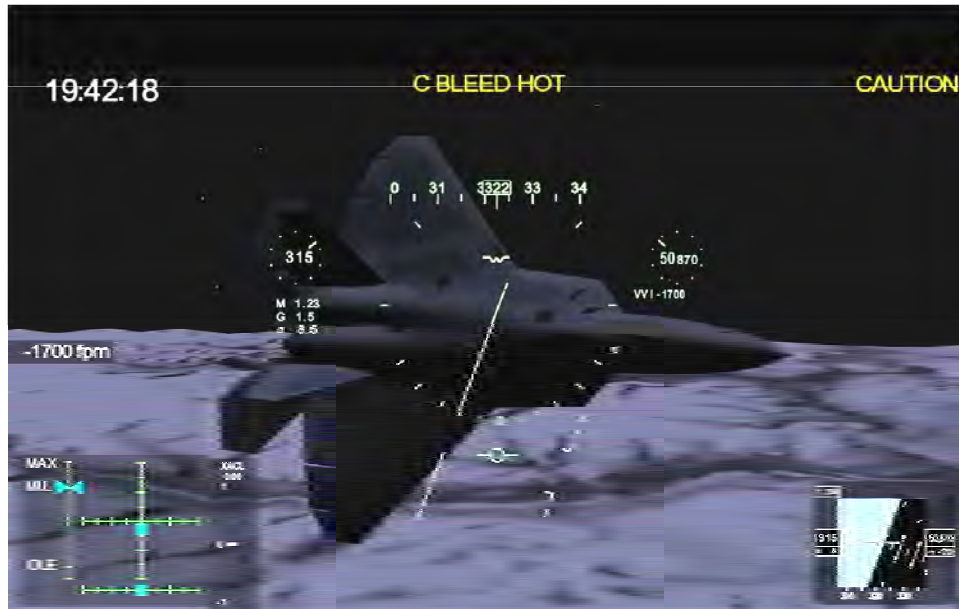
**Figure 2 19:42:18 -- MA parameters at assertion of C BLEED HOT caution ICAW. (Tab EE) See Tab Z-10 for a diagram explaining the symbology in the Figures.**

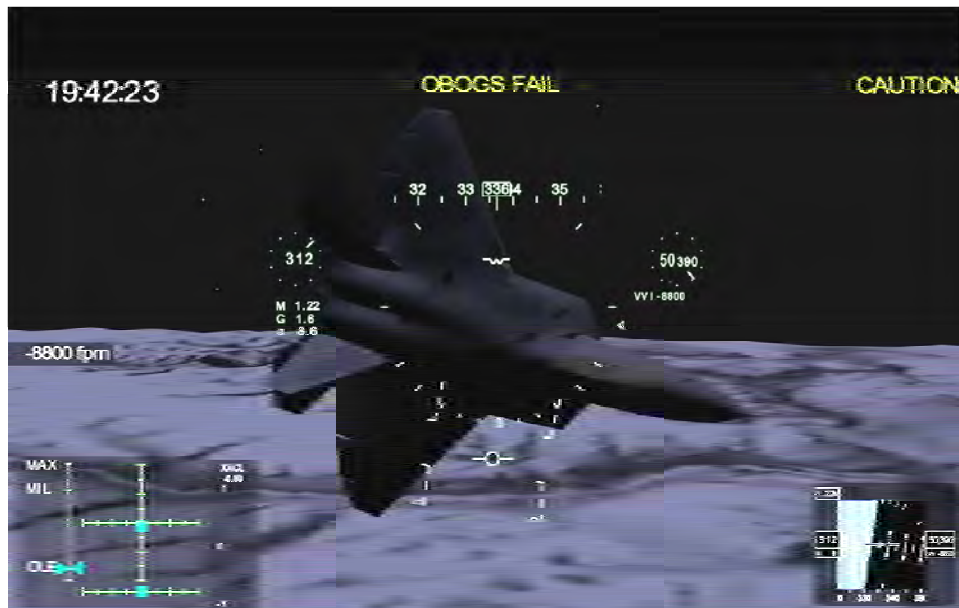
**Figure 3 19:42:23 – MA parameters at assertion of OBOGS FAIL caution ICAW. (Tab EE)**

At the assertion of this ICAW until 19:42:45L, the MP retarded the throttles to IDLE power and deliberately continued a controlled, descending right hand turn to descend to a lower altitude IAW the checklist. (Tab BB-29) At this time the MA was at 41,460 ft MSL, 390 KCAS, 1.29M, 30 degrees ND, 44 degrees RWD, 1.7 g, and with a VVI of -33,700 fpm. (Tab EE)

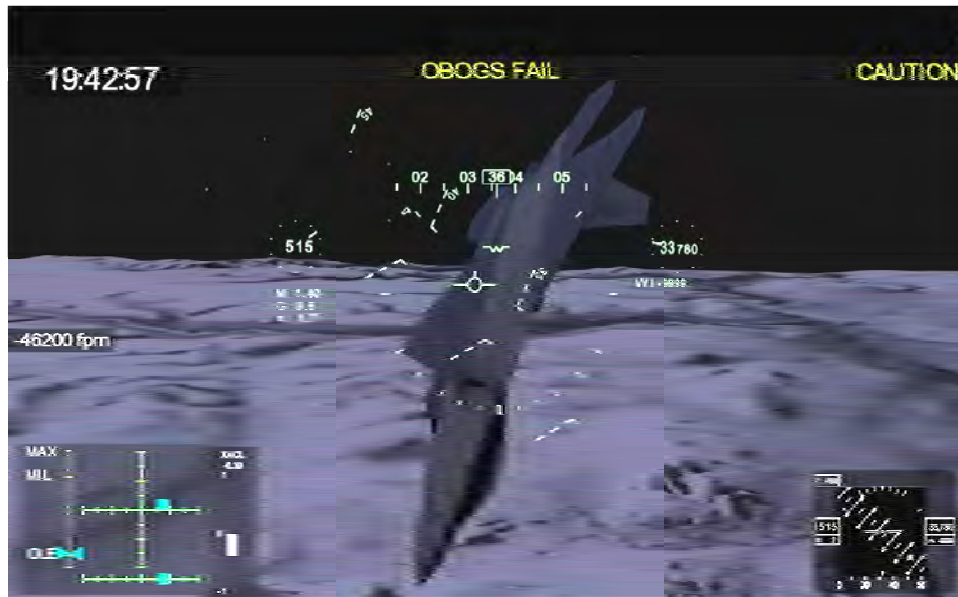
Figure 6 19:42:57 – MA parameters during MA 240 degree roll to the right resulting from stick and pedal inputs. (Tab EE)

At the completion of these stick and pedal inputs at 19:43:08L, the MA had rolled through inverted, experienced less than 1 g of gravitational force, and went from a RWD to Left Wing Down (LWD) attitude, and the descent rate of the aircraft significantly increased. The parameters at this time were 24,070 ft MSL, 627 KCAS, 1.39M, 44 degrees ND, 81 degrees LWD, 0.8 g, with a VVI of -57,800 fpm. (Tab EE)

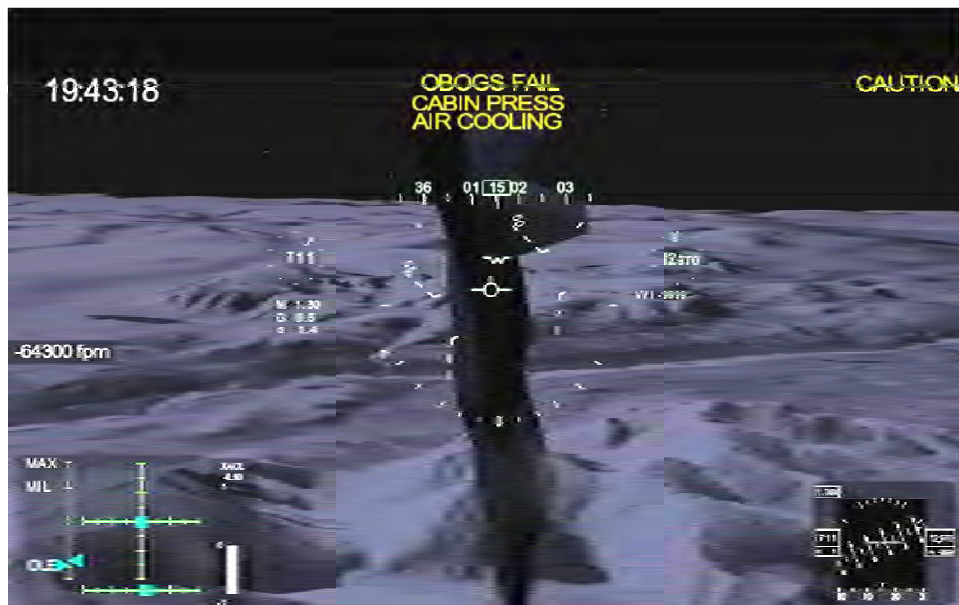
Figure 9 19:42:18 – MA parameters at assertion of AIR COOLING caution ICAW. No stick or pedal inputs. (Tab EE)

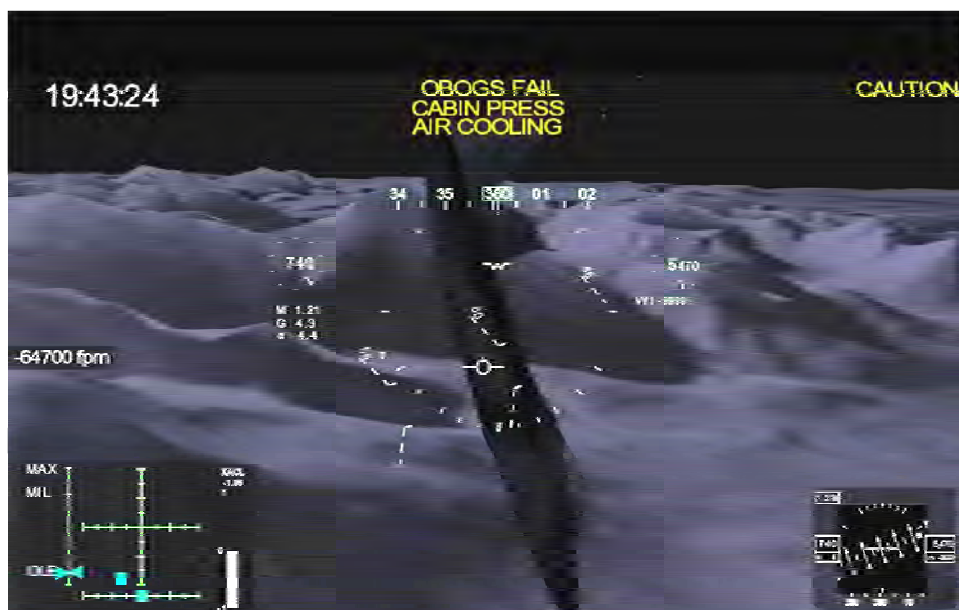
Figure 10 19:43:24 – MP initiates full aft stick pull to start dive recovery at 5,470 ft MSL. (Tab EE)

At 19:43:27L, the MA impacted the ground at 735 KCAS, 1.17M, 48 degrees ND, 47 degrees LWD, 7.4 g, with a VVI of -57,900 fpm. The impact site is approximately 120 NM north of JBER, AK, in the Talkeetna Mountain range. The site is approximately 3,100 ft MSL near the edge of a south-west to north-east running valley. The impact crater is located at the valley floor where it begins to slope upwards towards the southeast. The valley floor is approximately one-half mile wide at this point and has a stream running through it approximately 60 yards west of the impact point. (Tabs J-4 through J-6)

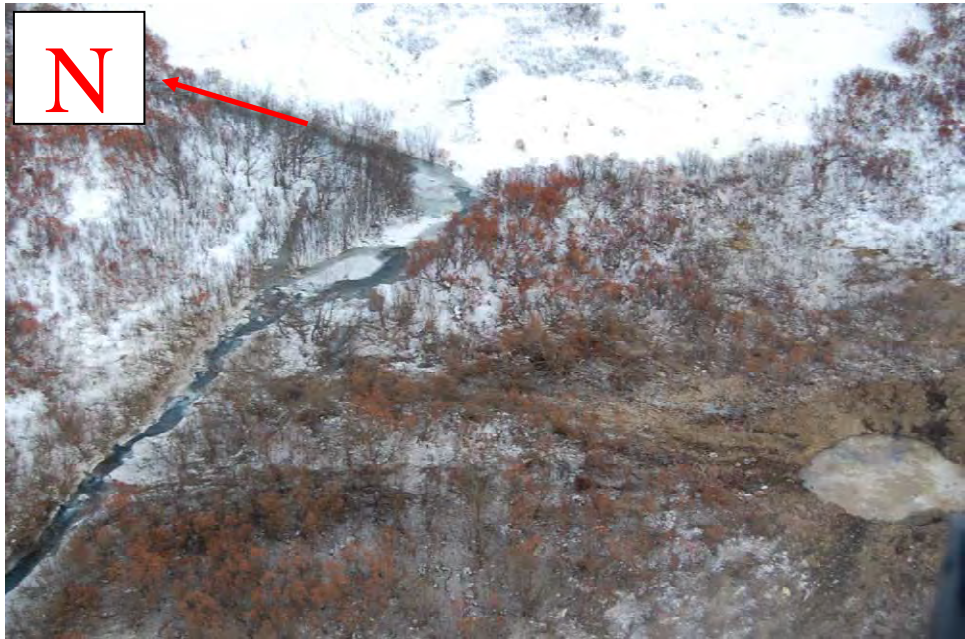
**Figure 12 Impact Site. 17 Nov 2010 (Tab S-7)**

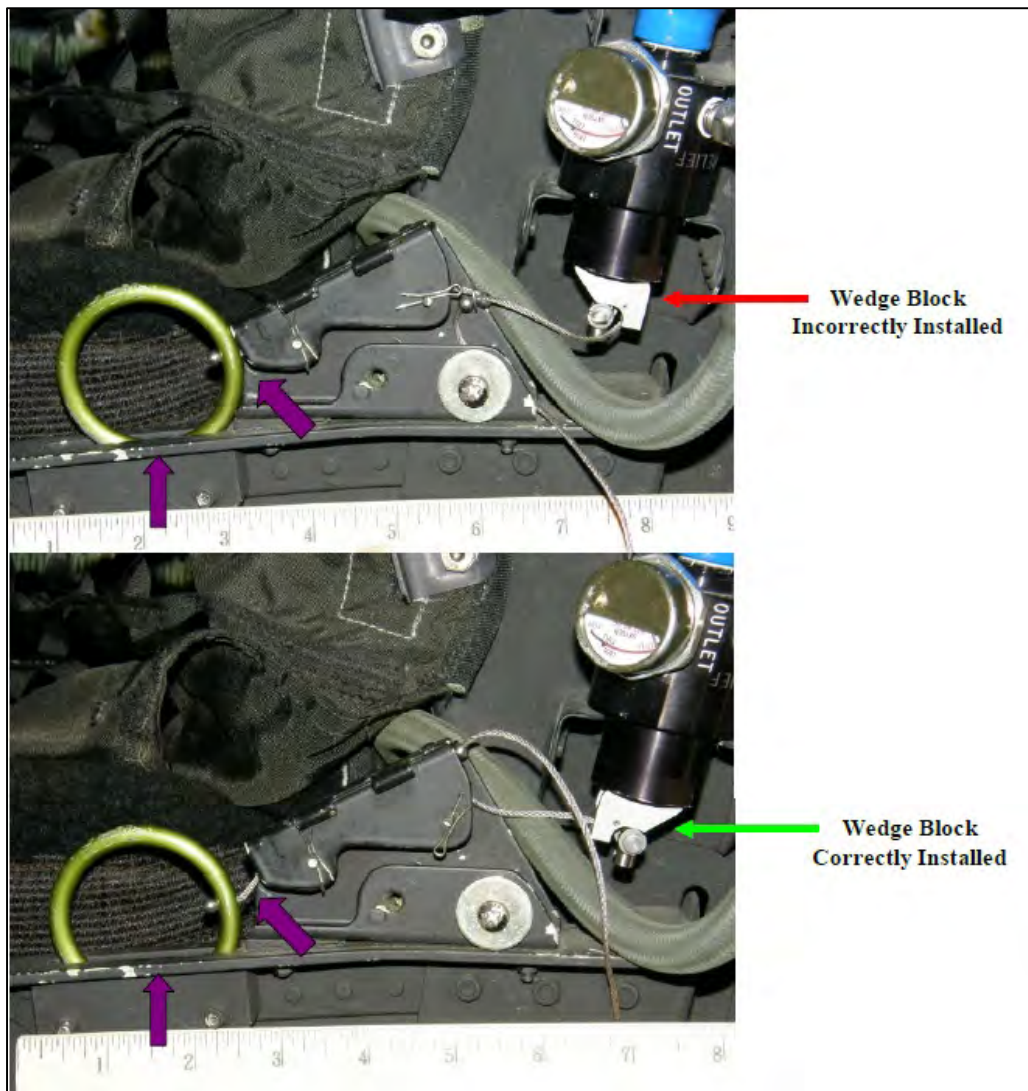
The AFRL report identified that if the EOS wedge block had been incorrectly installed, the wedge block would be unable to move or rotate during manual EOS ring activation. However, during ground simulation the board members were able to initiate the EOS in the incorrectly installed position. (Tab U-4)

**Figure 14- The wedge block installed incorrectly (red arrow) and correctly (green arrow). Notice the position of the ring within the seat (purple arrows) based on wedge block position. (Tab Z-6)**

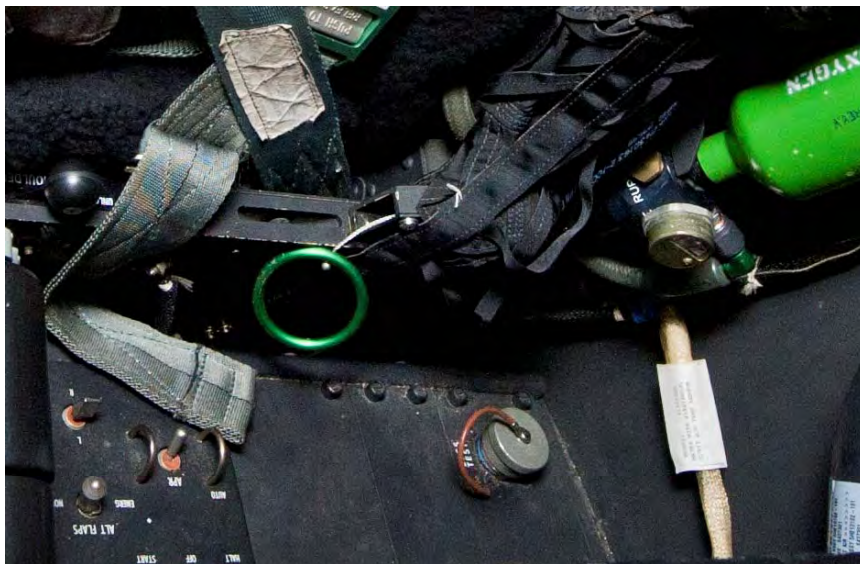
During ground simulation, the manual EOS activation ring was unseated and dropped between the seat and console prior to EOS activation. This was done to simulate a failed initial pull,

**Figure 16- Manual EOS activation ring fallen below lip of seat. (Tab CC-5 and Tab Z-8)**

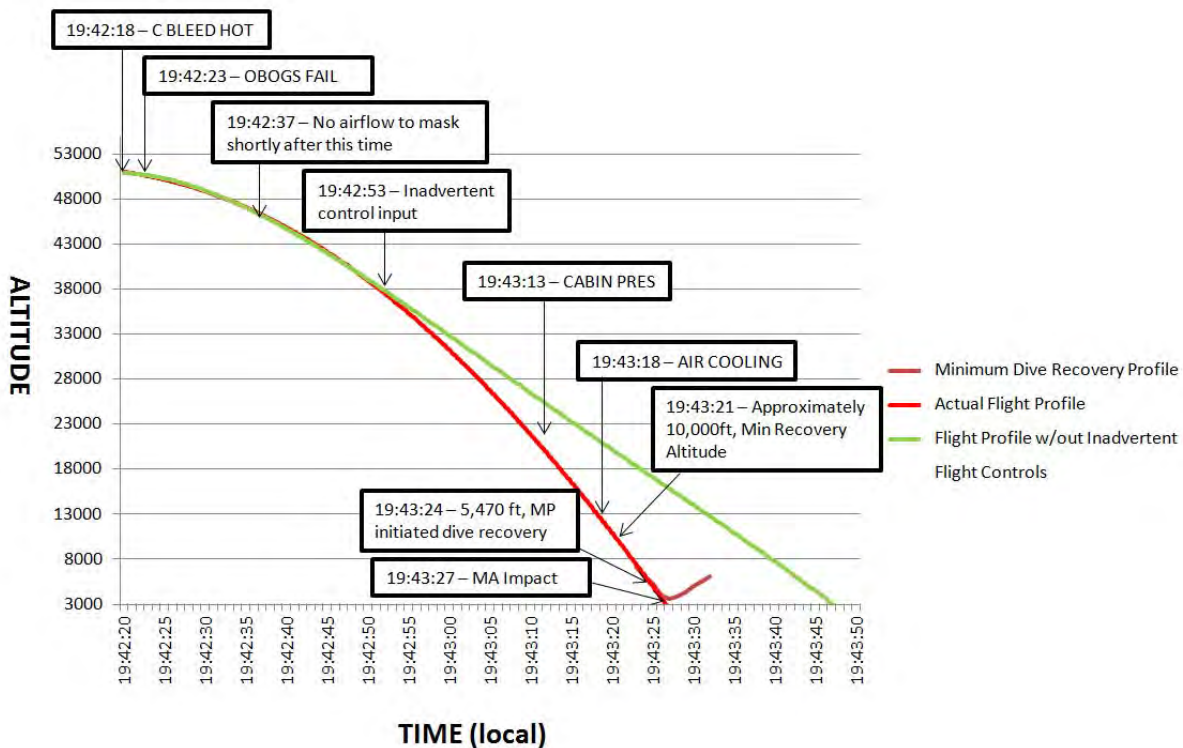
Fifth, the MP was late to recognize the necessity for a dive recovery. At 19:43:27L, the MP impacted the ground because his channelized attention and breakdown in visual scan resulted in unrecognized spatial disorientation. When the MP recognized the MA attitude and altitude, he was below minimum recovery altitude. Figure 17 shows the actual initiation of the attempted dive recovery altitude along with the 1F-22A-1 minimum recovery altitude.

**Figure 17 Flight profiles for MS. Actual flight profile (red), flight profile without inadvertent flight control inputs (green), and minimum altitude dive recovery profile (maroon) shown.**
