### Low Dissolved Oxygen Levels in Summer Powerplant Discharges from Fort Randall Dam, South Dakota

**Report Number: CENWO-ED-HA/SSR/Fort Randall Tailwaters/2010**

**October 2010**

**Prepared by:  
Water Control and Water Quality Section  
Hydrologic Engineering Branch  
Engineering Division  
Omaha District  
U.S. Army Corps of Engineers**

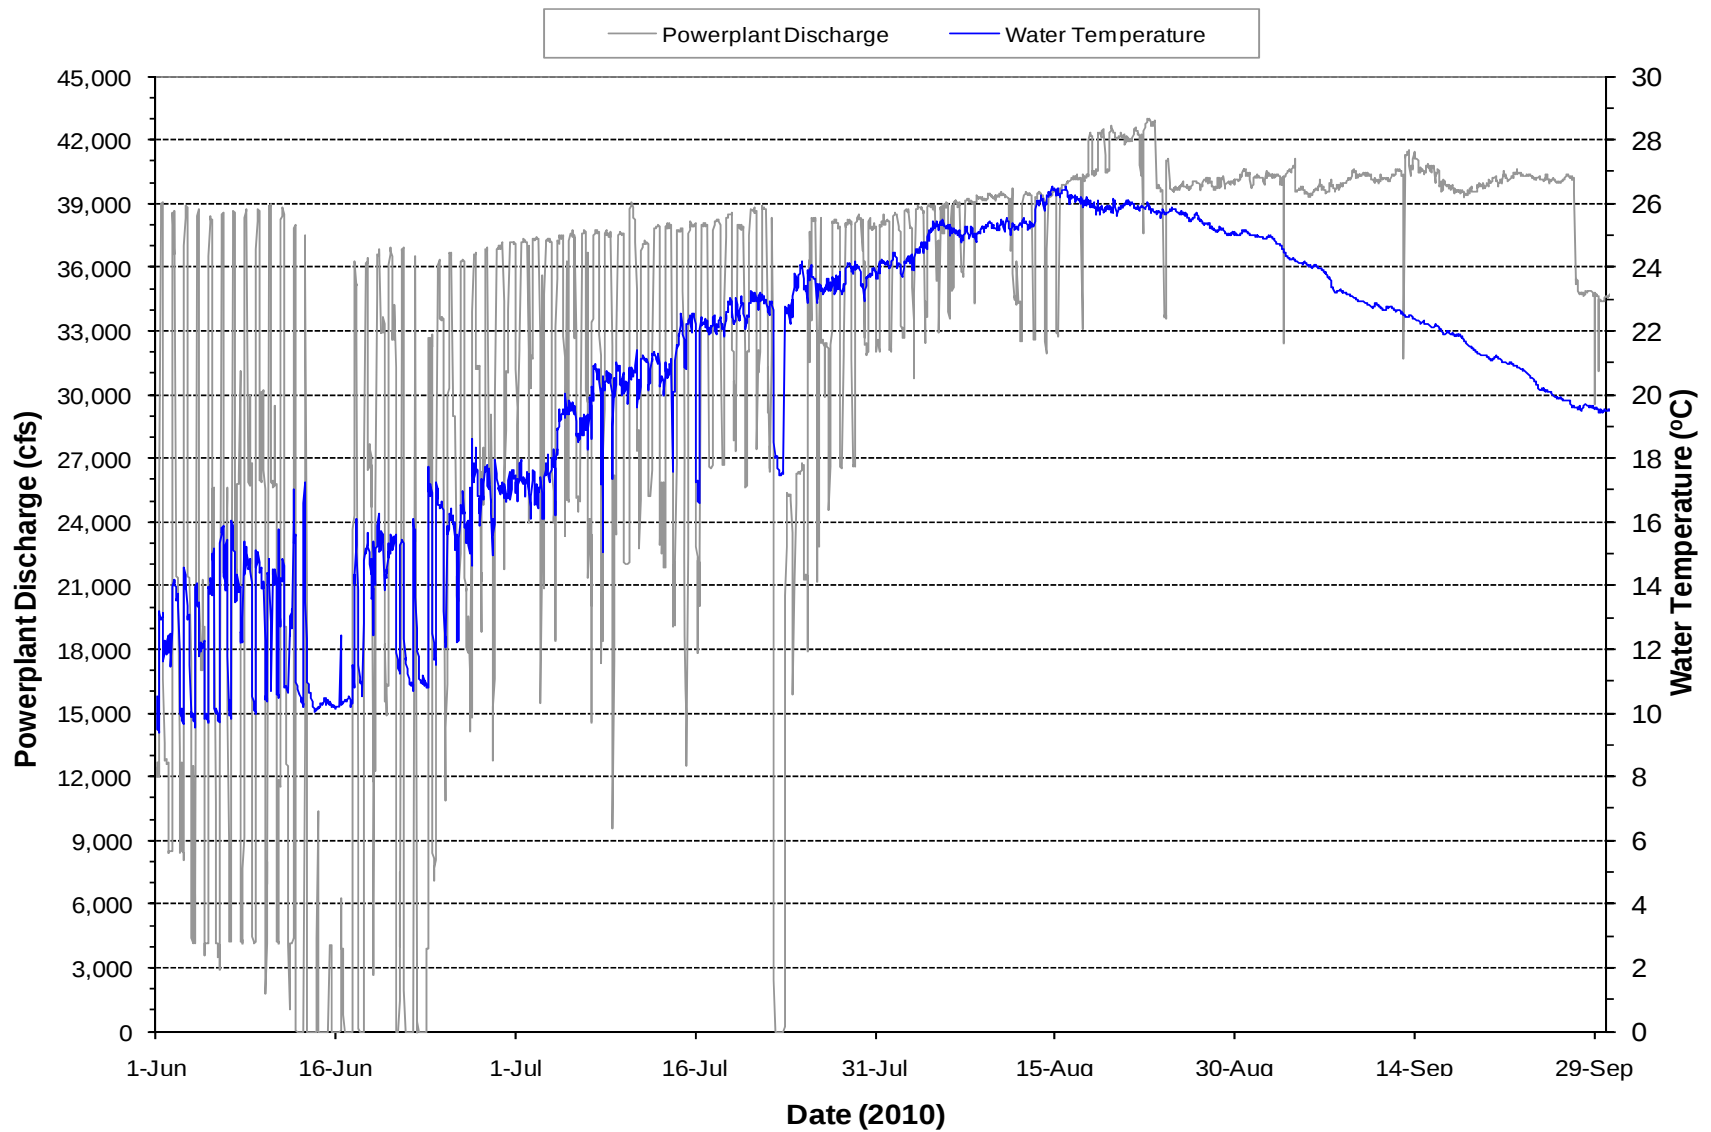
Water quality conditions monitored at the Fort Randall powerplant in 2010 were reviewed. Figures 2 and 3 show hourly water temperature and dissolved oxygen levels monitored from June 1 through September 30, 2010. Figure 4 shows hourly dissolved oxygen and powerplant discharge for the period July 1 through August 30, 2010. As seen in Figures 2 - 4, the monitored water temperature and dissolved oxygen were more dependent on dam discharge in June and July. Dissolved oxygen levels continually decreased during June, and first went below South Dakota's 5 mg/l dissolved oxygen water quality standard minimum criterion on July 8. The lowest dissolved oxygen occurrences tend to be associated with lower dam discharges.

**Figure 2.** Hourly powerplant discharge and water temperature monitored in the Fort Randall powerplant “raw water” supply line during the period June 1 through September 30, 2010.

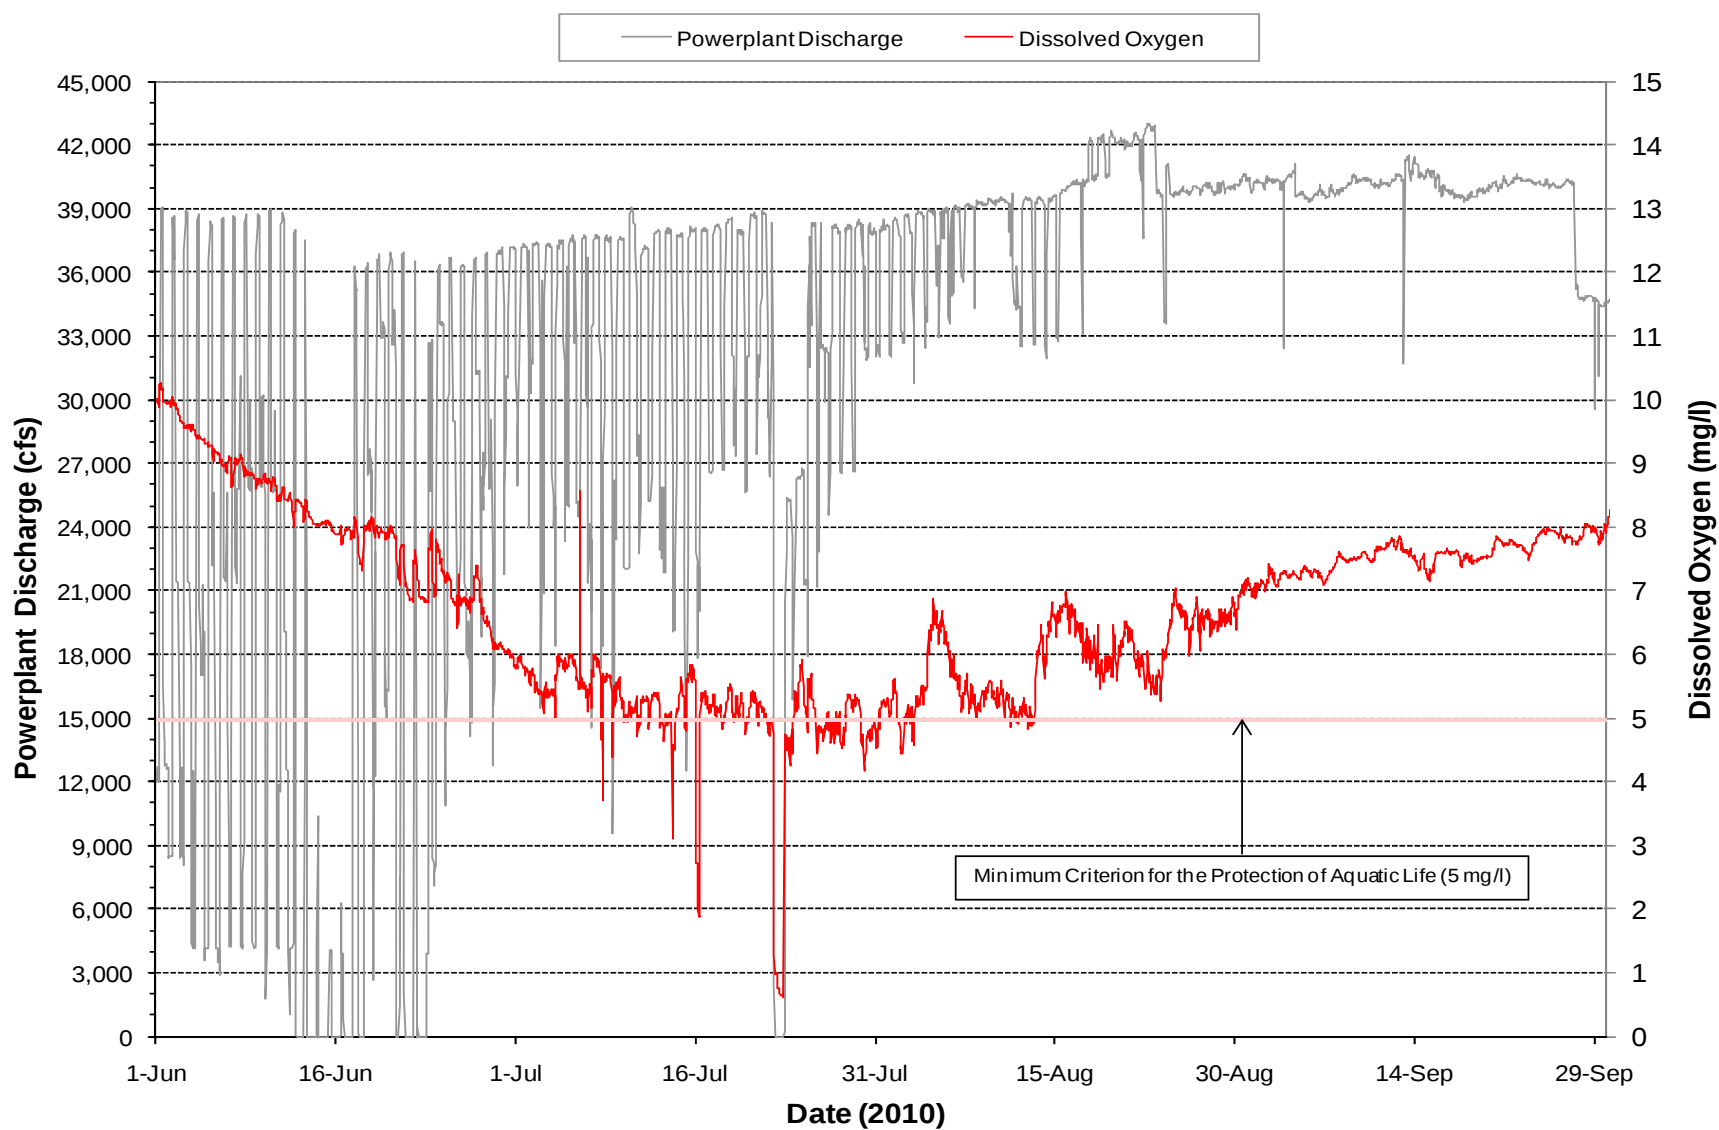
**Figure 3.** Hourly powerplant discharge and dissolved oxygen monitored in the Fort Randall powerplant “raw water” supply line during the period June 1 through September 30, 2010.

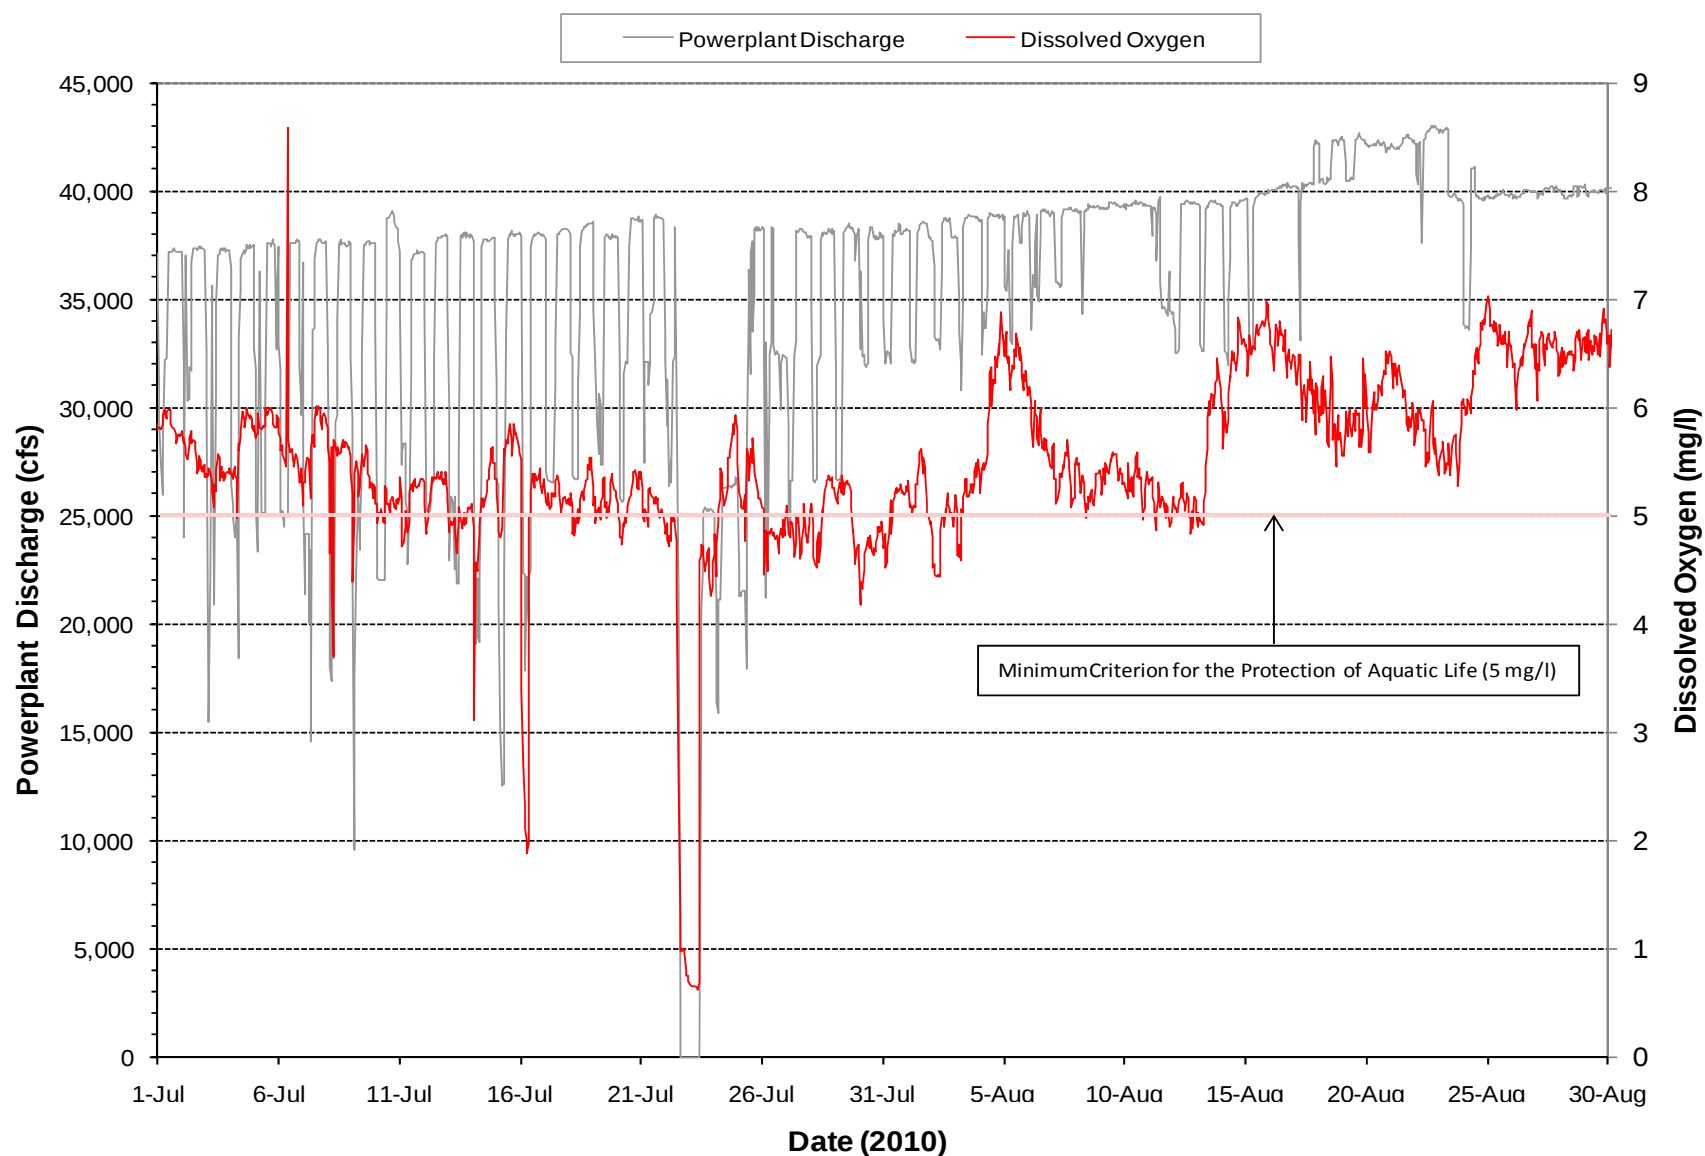
**Figure 4.** Hourly powerplant discharge and dissolved oxygen monitored in the Fort Randall powerplant “raw water” supply line during the period July 1 through August 30, 2010.

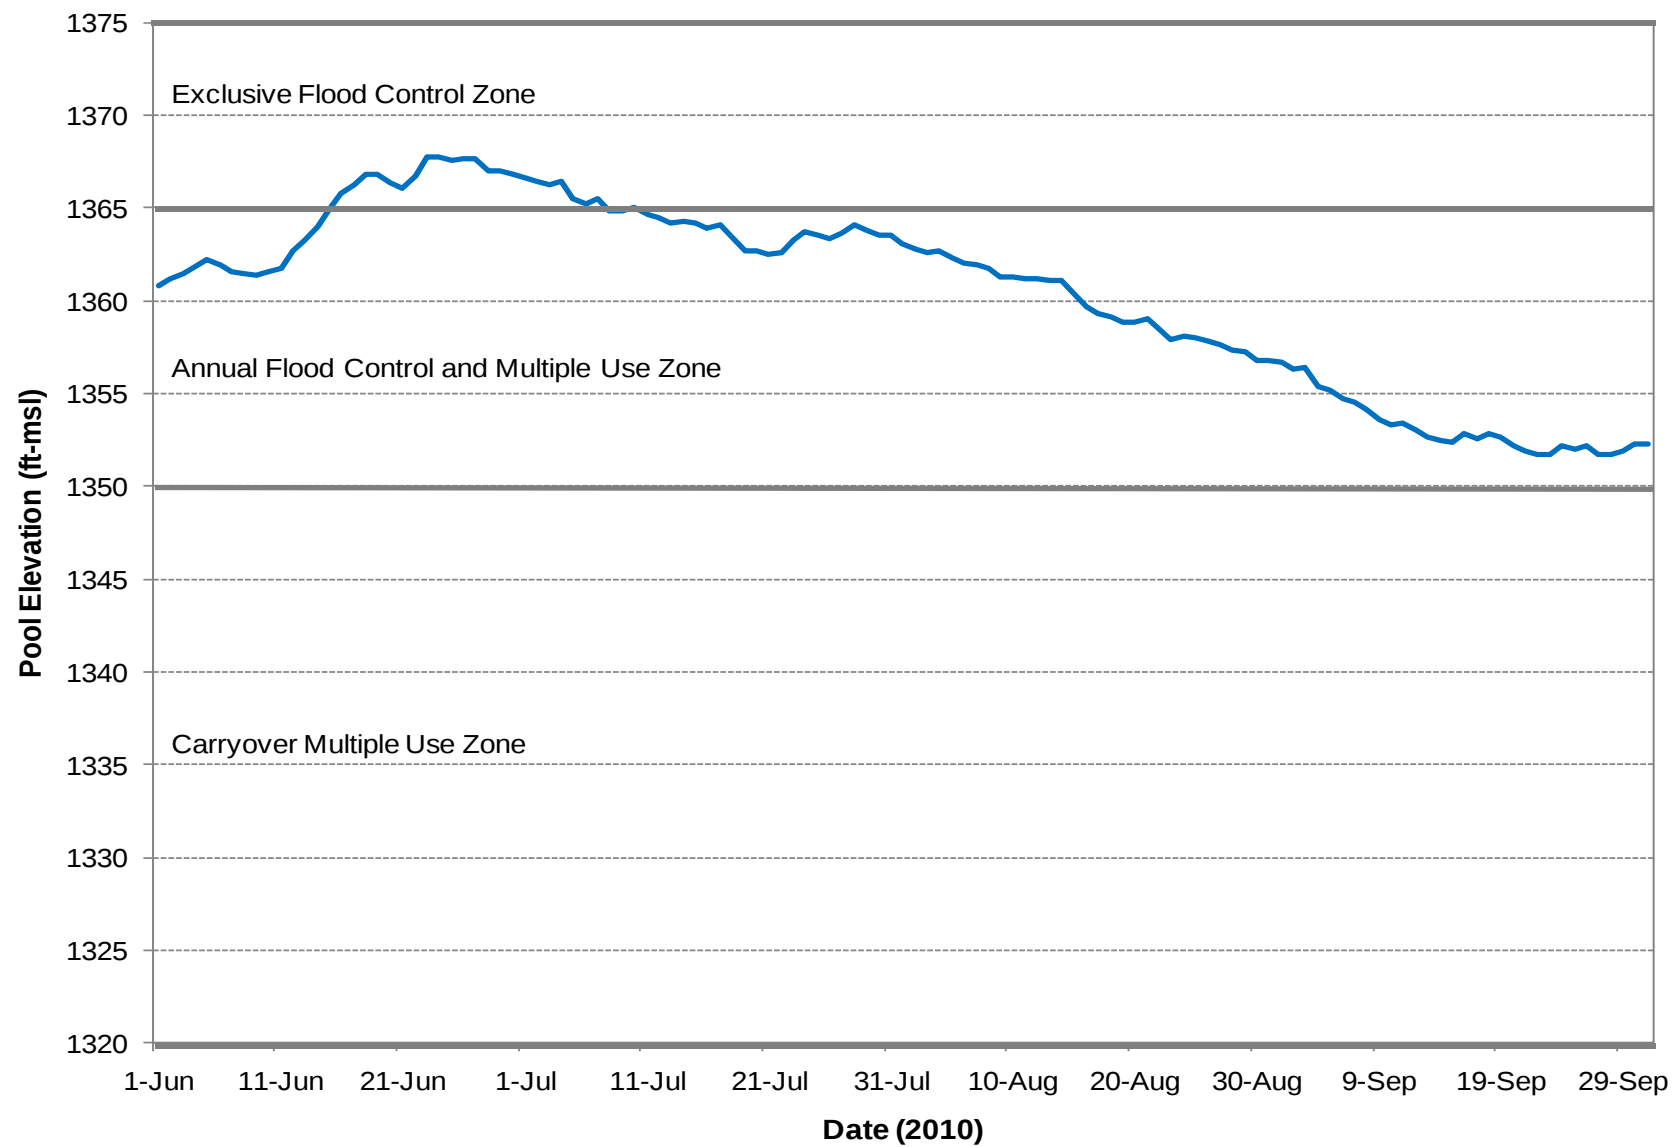
Figure 5 plots the midnight pool elevations for Lake Francis Case from 1-June-2010 through 1-October-2010. Pool levels in Lake Francis Case peaked in late-June (Figure 5). Higher pool levels in Lake Francis Case enforce summer thermal stratification of the reservoir and an increased hypolimnetic volume. Decreasing pool levels will enhance mixing of the reservoir. Mixing of the reservoir will lead to the breakdown of thermal stratification and eventual "re-aeration" of the lower depths of the reservoir.

**Figure 5.** Lake Francis Case midnight pool levels June 1 through October 1, 2010.

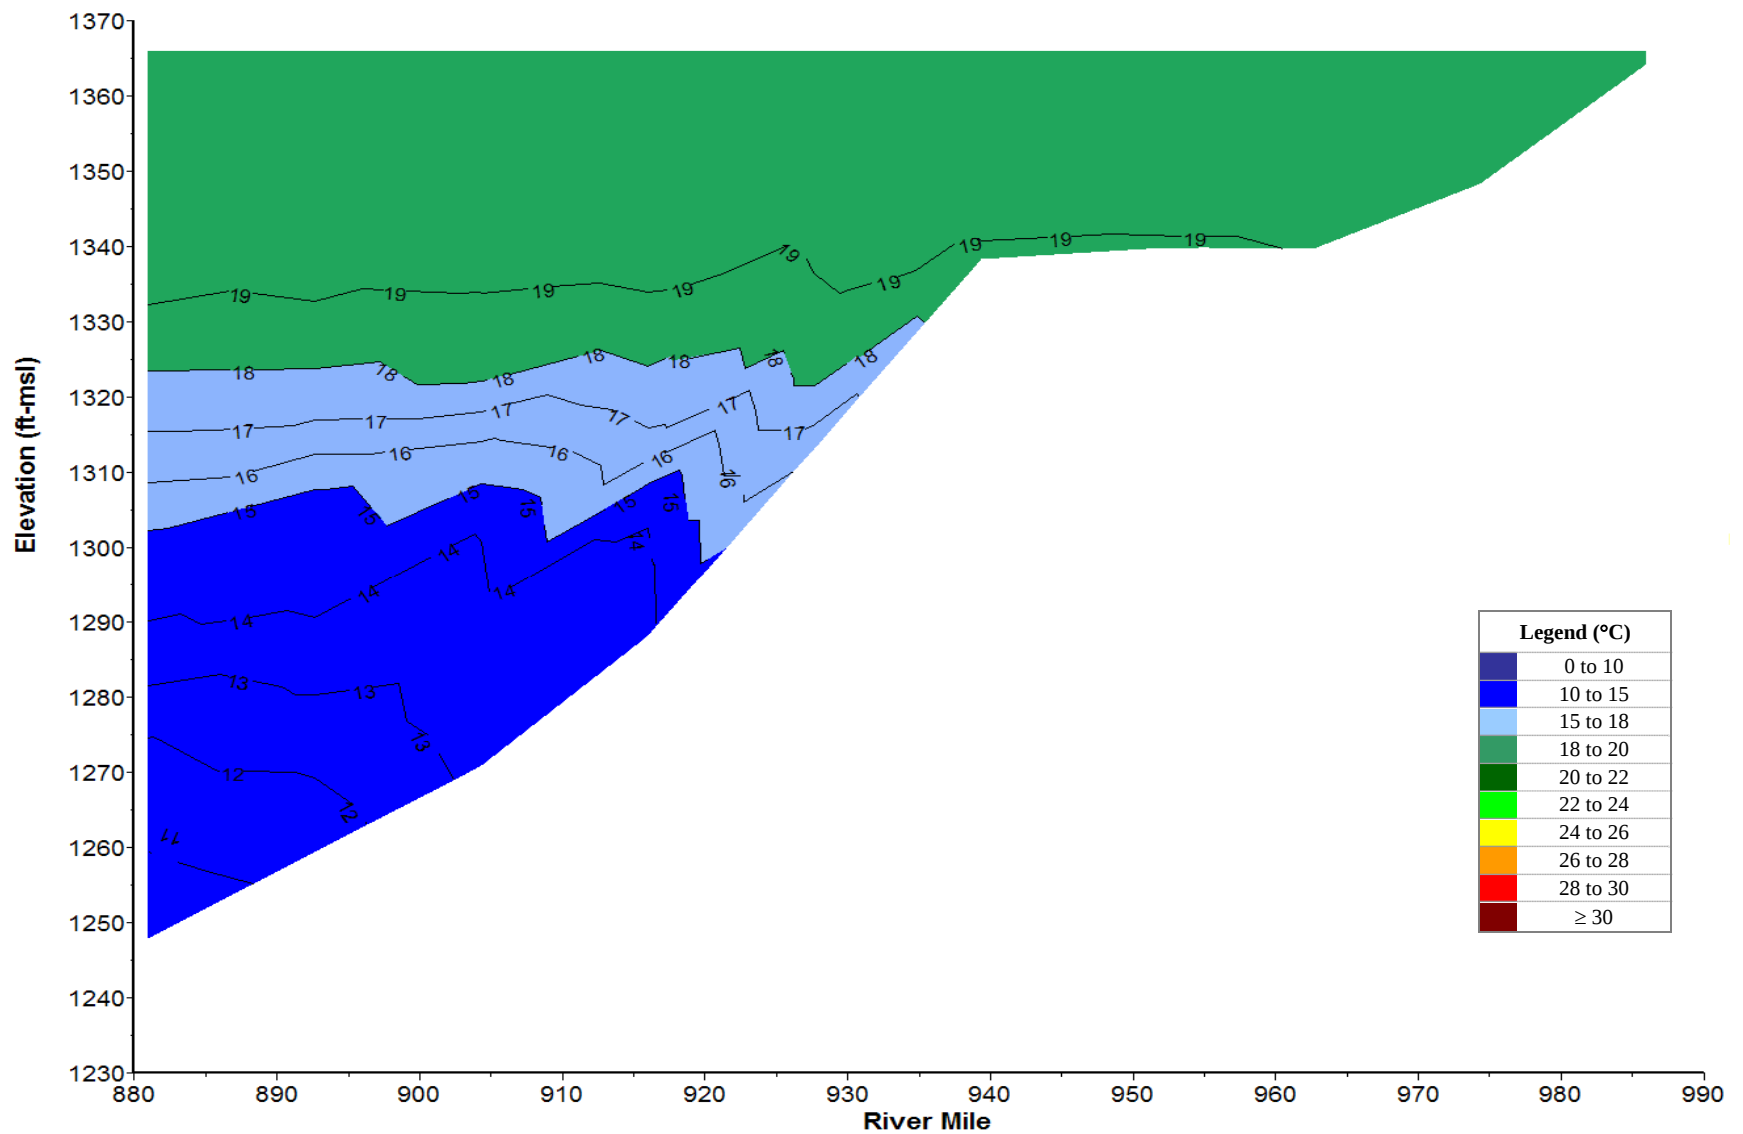
formed. The thermocline was located at about elevation 1300 ft-msl at a depth of about 20 meters (Figure 7).

Monitoring of Lake Francis Case on June 17, July 15, and August 12, indicated significant thermal stratification of the reservoir (Figures 7, 9, and 11). Monitoring on September 16 indicated that “fall turnover” had occurred and thermal stratification of the reservoir had broken down (Figure 13). The differences in surface and bottom water temperatures measured on June 17, July 15, and August 12, were, respectively, 9° C, 9° C, and 5° C. The depth of the thermocline on June 17, July 15, and August 12, was, respectively, 20, 25, and 30 meters.

**Figure 7.** Longitudinal water temperature contour plot of Lake Francis Case based on depth-profile water temperatures measured at RM880, RM911, RM 940, and RM968 on June 17, 2010.

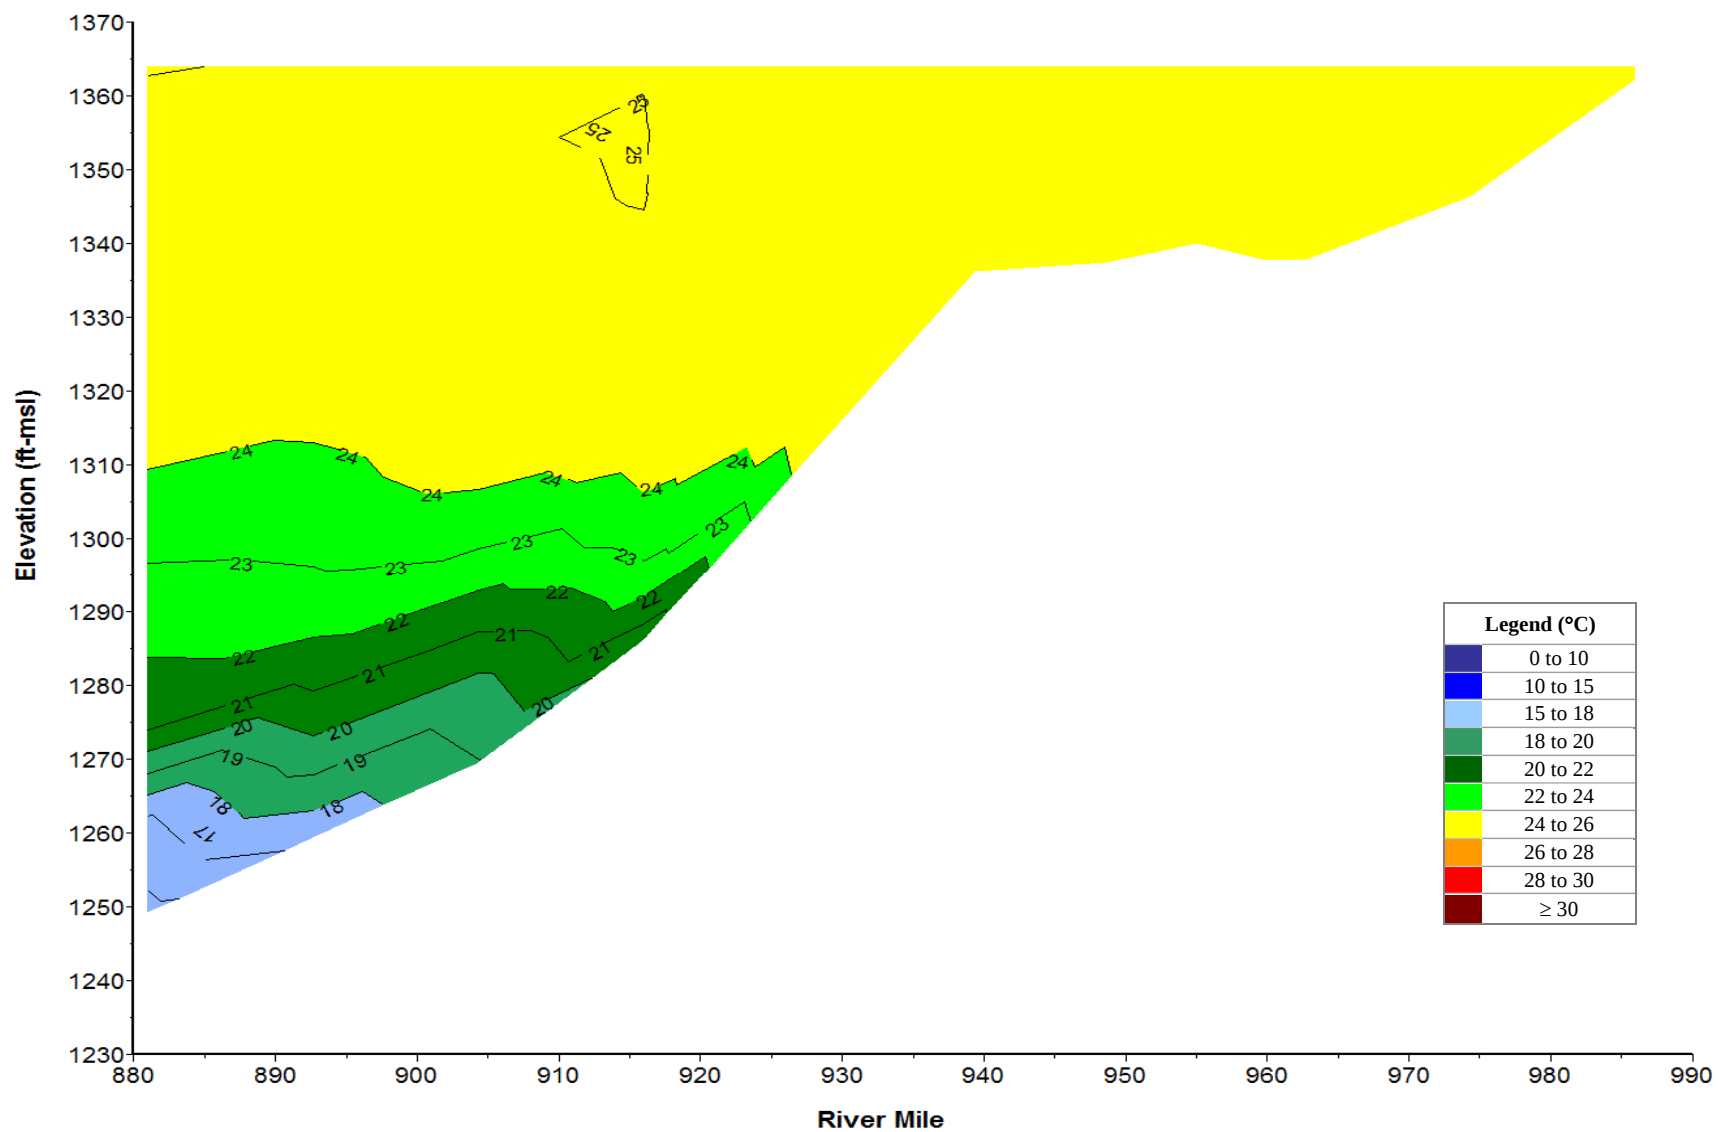
Water quality monitoring of the ambient monitoring sites on Lake Francis Case occurred on July 15, 2010. Longitudinal contour plots of water temperature and dissolved oxygen were constructed from depth-profile data collected at RM880, RM911, RM940, and RM968. Figures 9 and 10, respectively, show the longitudinal contour plots for water temperature and dissolved oxygen. On July 15, Lake Francis Case was thermally stratified and the thermocline was located at about elevation 1285 ft-msl at a depth of about 25 meters (Figure 9).

**Figure 9.** Longitudinal water temperature contour plot of Lake Francis Case based on depth-profile water temperatures measured at RM880, RM911, RM 940, and RM968 on July 15, 2010.

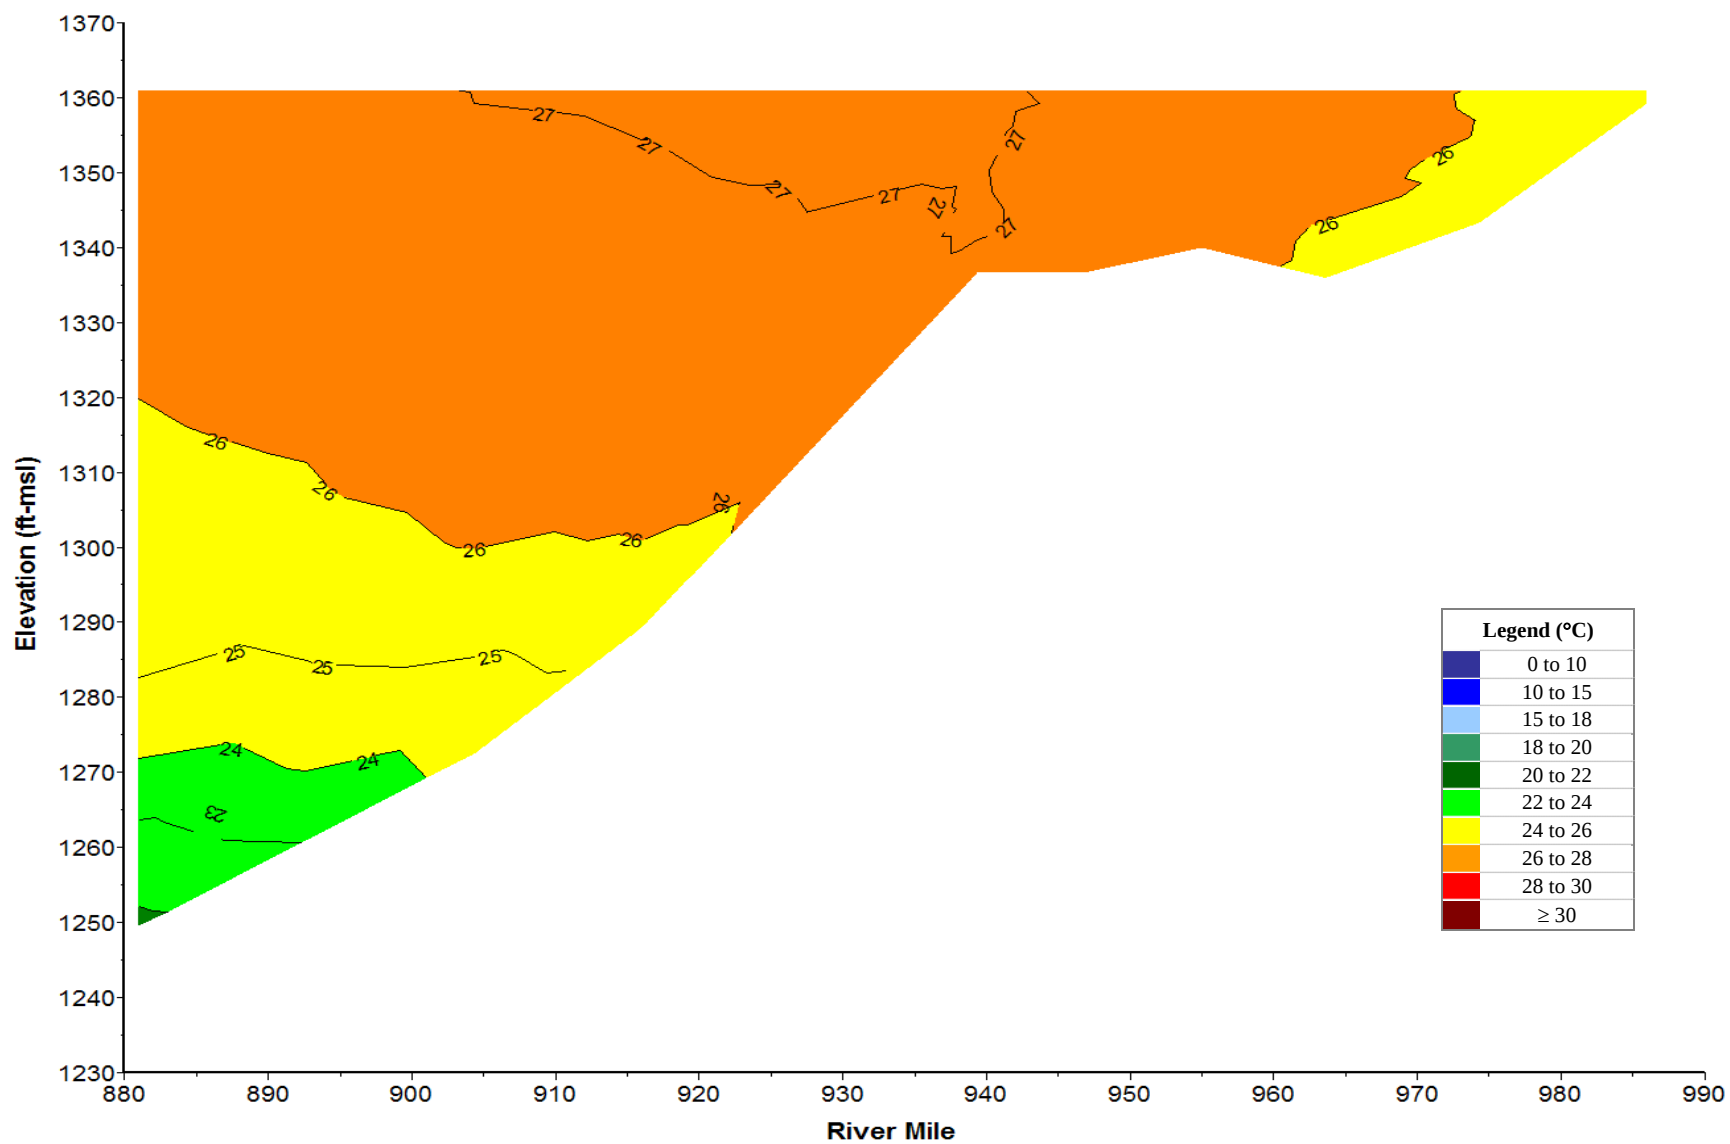
Water quality monitoring of the ambient monitoring sites on Lake Francis Case occurred on August 12, 2010. Longitudinal contour plots of water temperature and dissolved oxygen were constructed from depth-profile data collected at RM880, RM911, RM940, and RM968 on August 12. Figures 11 and 12, respectively, show the longitudinal contour plots for water temperature and dissolved oxygen. On August 12, Lake Francis Case remained thermally stratified and the thermocline was located at about elevation 1260 ft-msl at a depth of about 30 meters (Figure 11).

**Figure 11.** Longitudinal water temperature contour plot of Lake Francis Case based on depth-profile water temperatures measured at RM880, RM911, RM 940, and RM968 on August 12, 2010.

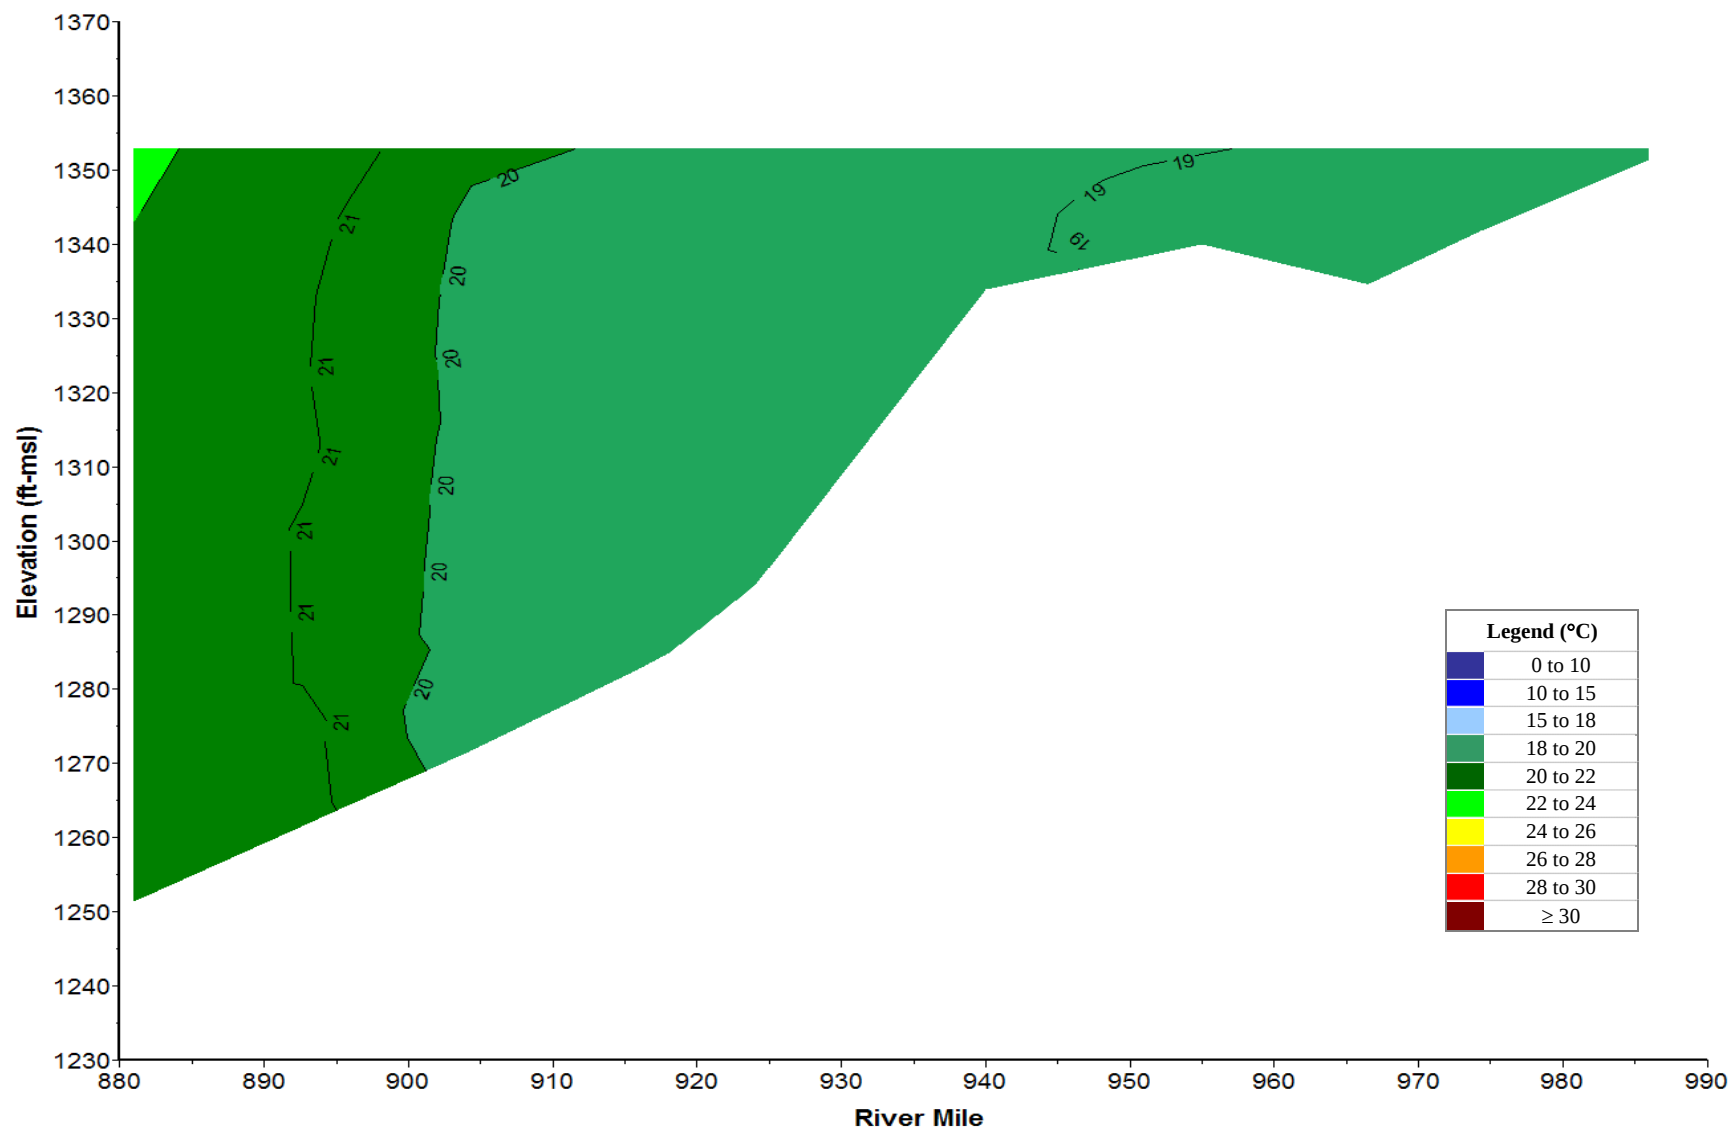
Water quality monitoring of the ambient monitoring sites on Lake Francis Case occurred on September 16, 2010. Longitudinal contour plots of water temperature and dissolved oxygen were constructed from depth-profile data collected at RM880, RM911, and RM968 on September 16. Monitoring at RM940 was not conducted because of an unusable boat ramp due to siltation and low water conditions. Figures 13 and 14, respectively, show the longitudinal contour plots for water temperature and dissolved oxygen. On September 16, Lake Francis Case was no longer thermally stratified (Figure 13).

**Figure 13.** Longitudinal water temperature contour plot of Lake Francis Case based on depth-profile water temperatures measured at RM880, RM911, and RM968 on September 16, 2010.

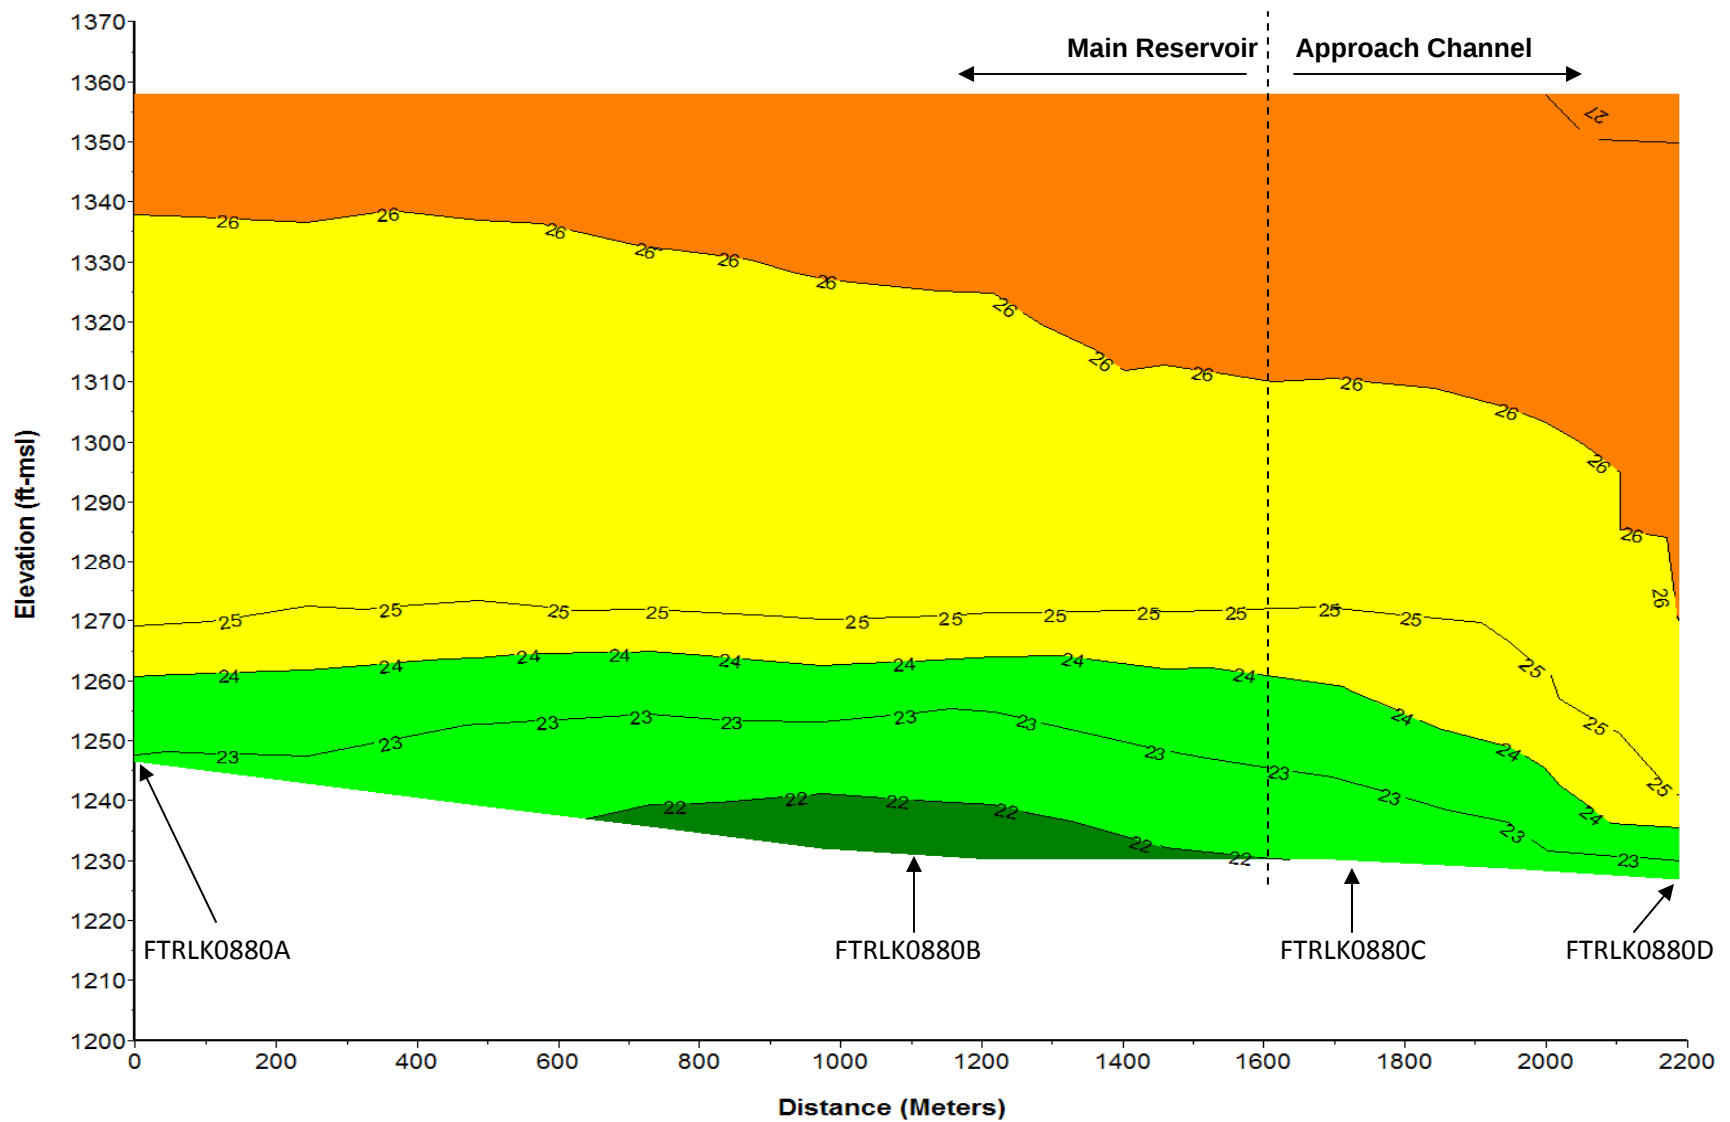
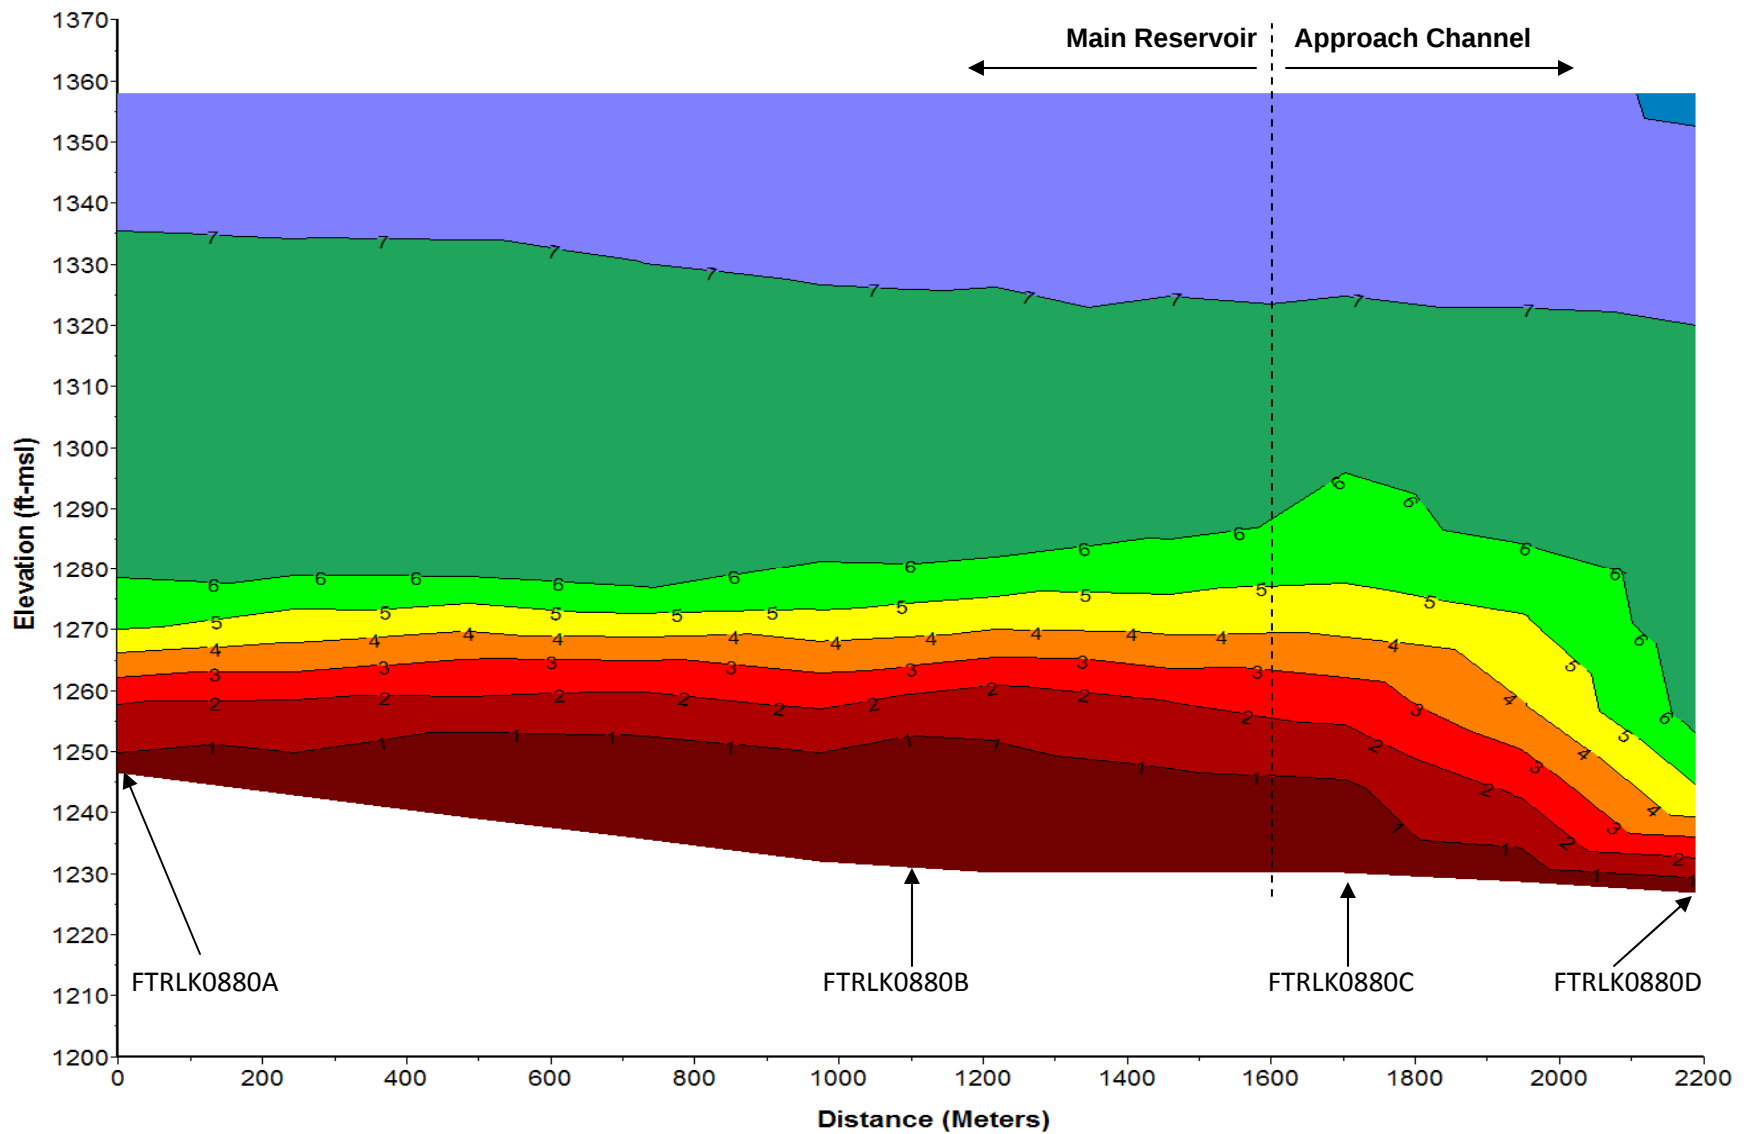
Additional water quality monitoring was conducted on August 19, 2010 to evaluate the variation in thermal stratification and dissolved oxygen levels in Lake Francis Case along Fort Randall Dam. Four sites were monitored in the deepwater region of the reservoir along the dam and submerged approach channel to the intake structure (Figure 15). At each for the four sites a depth-profile, in 1-meter increments, was measured for water temperature and dissolved oxygen. This information was used to construct a contour plot for water temperature and dissolved oxygen along the line through each of the four sites from site FTRLK0880A to site FTRLK0880D (Figures 16 and 17).

Figures 16 and 17 depict the thermal stratification and dissolved oxygen conditions that were monitored along Fort Randall Dam on August 19, 2010. The depicted area runs from the deepwater area of the submerged Missouri River channel (i.e., west side of the reservoir) to the east through the approach channel to the dam intake structure. Significant thermal stratification and hypoxic conditions occurred through this area (Figures 16 and 17). In the approach channel, warmer water with higher dissolved oxygen levels is seemingly drawn down from higher elevations in the area nearer the intake structure. This is attributed to “turbulence” created near the intake structure by the bottom withdrawal of water from the reservoir during higher inflows to the powerplant. The turbulence ostensibly allows warmer, less dense water higher in dissolved oxygen to be drawn down towards the reservoir bottom at the intake structure.

**Figure 16.** Contour plot of water temperature measured along Fort Randall Dam from monitoring site FTRLK0880A to site FTRLK0880D on August 19, 2010.

**Figure 17.** Contour plot of dissolved oxygen levels measured along Fort Randall Dam from monitoring site FTRLK0880A to site FTRLK0880D on August 19, 2010.
