# **Laboratory and Field Evaluation of In-Place Asphalt Recycling Technologies for Small Airfield Repair**

Mariely Mejías-Santiago, William D. Carruth,  
Jeffrey C. Petermann, and Dean H. Hitzelberger

June 2013

Final report

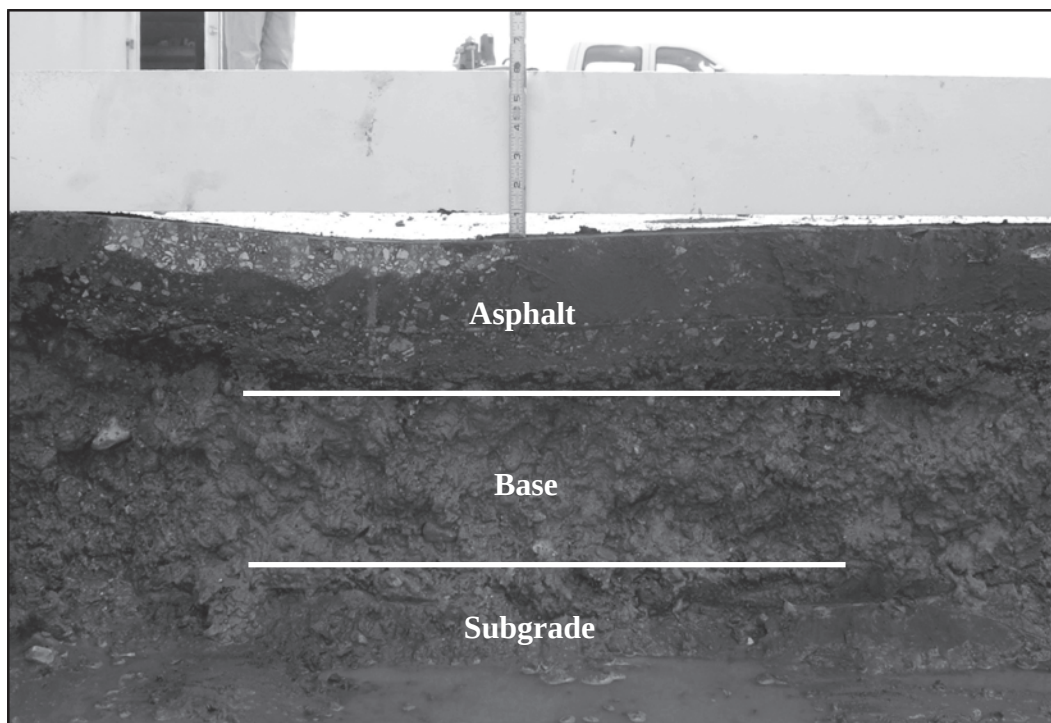
Figure 72. Repair FD-2 trenched cross-section view after failure.

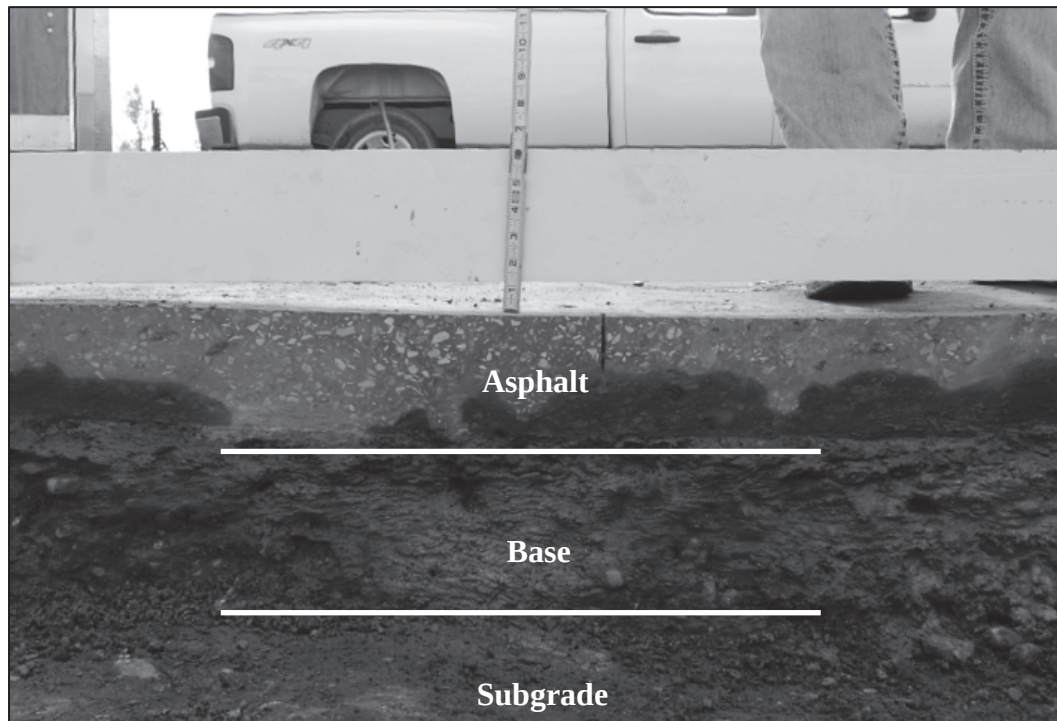
Figure 73. Repair FD-5 trenched cross-section view after failure.

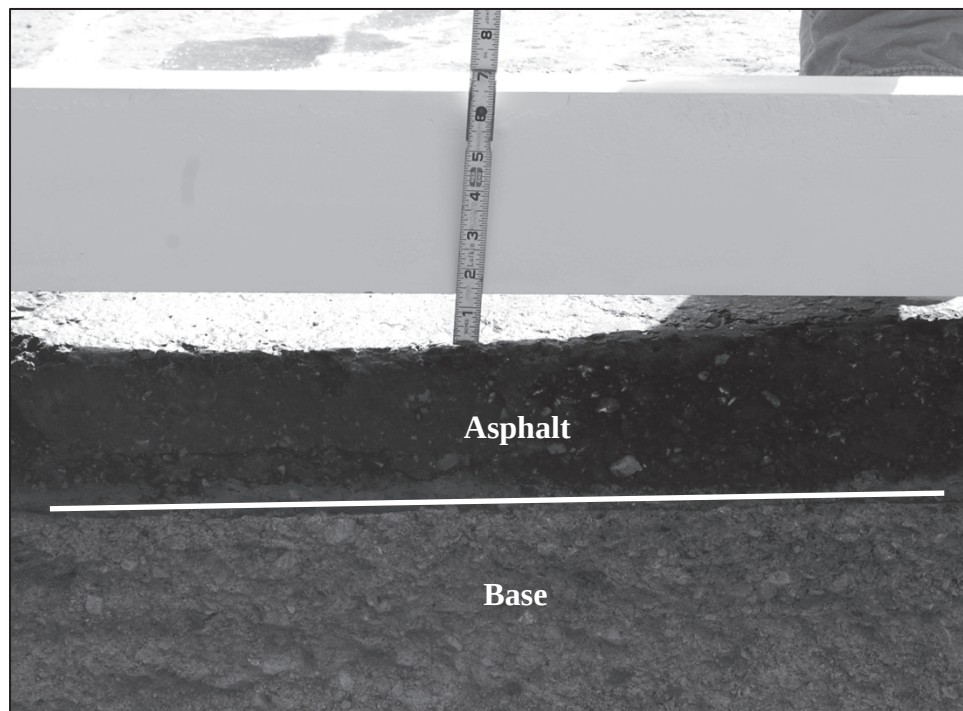
Figure 78. Repair PHP-4 trenched cross-section view post traffic.

PHP-4 exhibited the greatest rut depth of all four repairs conducted at Test Site 2. Trenching revealed loose material close to one edge (which could be expected for repair edges), but uncoated aggregate was also observed as
