# **Thule Air Base Airfield White Painting and Permafrost Investigation**

Phases I–IV

June 2013

Final report

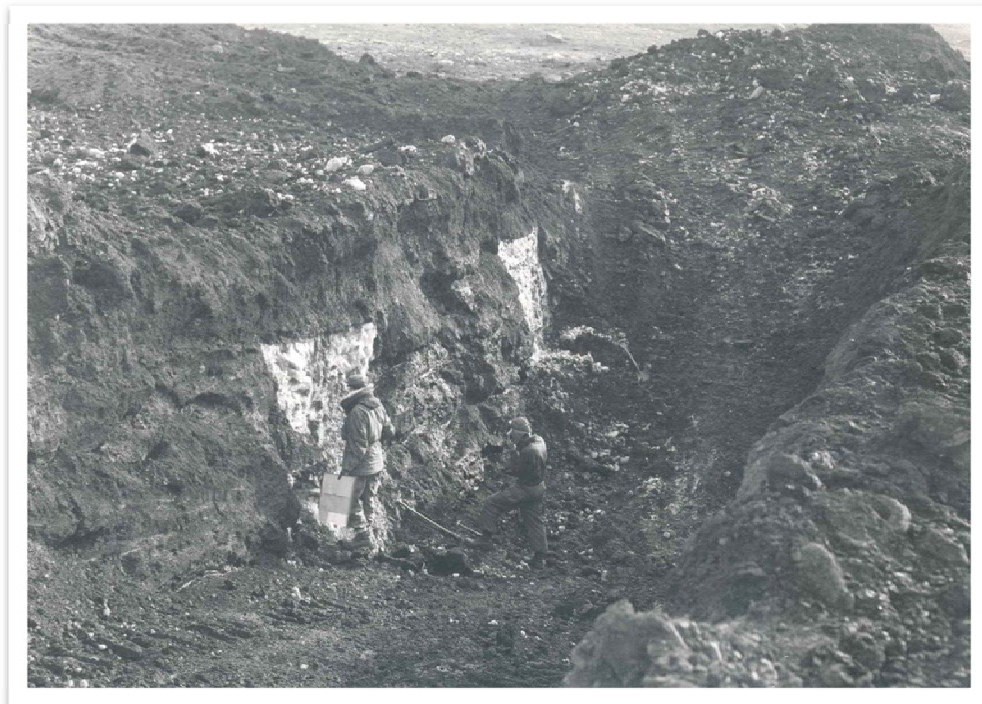
Figure 5. Ice wedges excavated at Thule in the 1960s (CRREL photo). Ice wedges such as these, located under the runway, are the cause of many previous localized depressions on the runway. Depressions that currently exist at 62+00 and 70+00 were drilled in 2009 and wedge ice was found at the 6 ft depth.

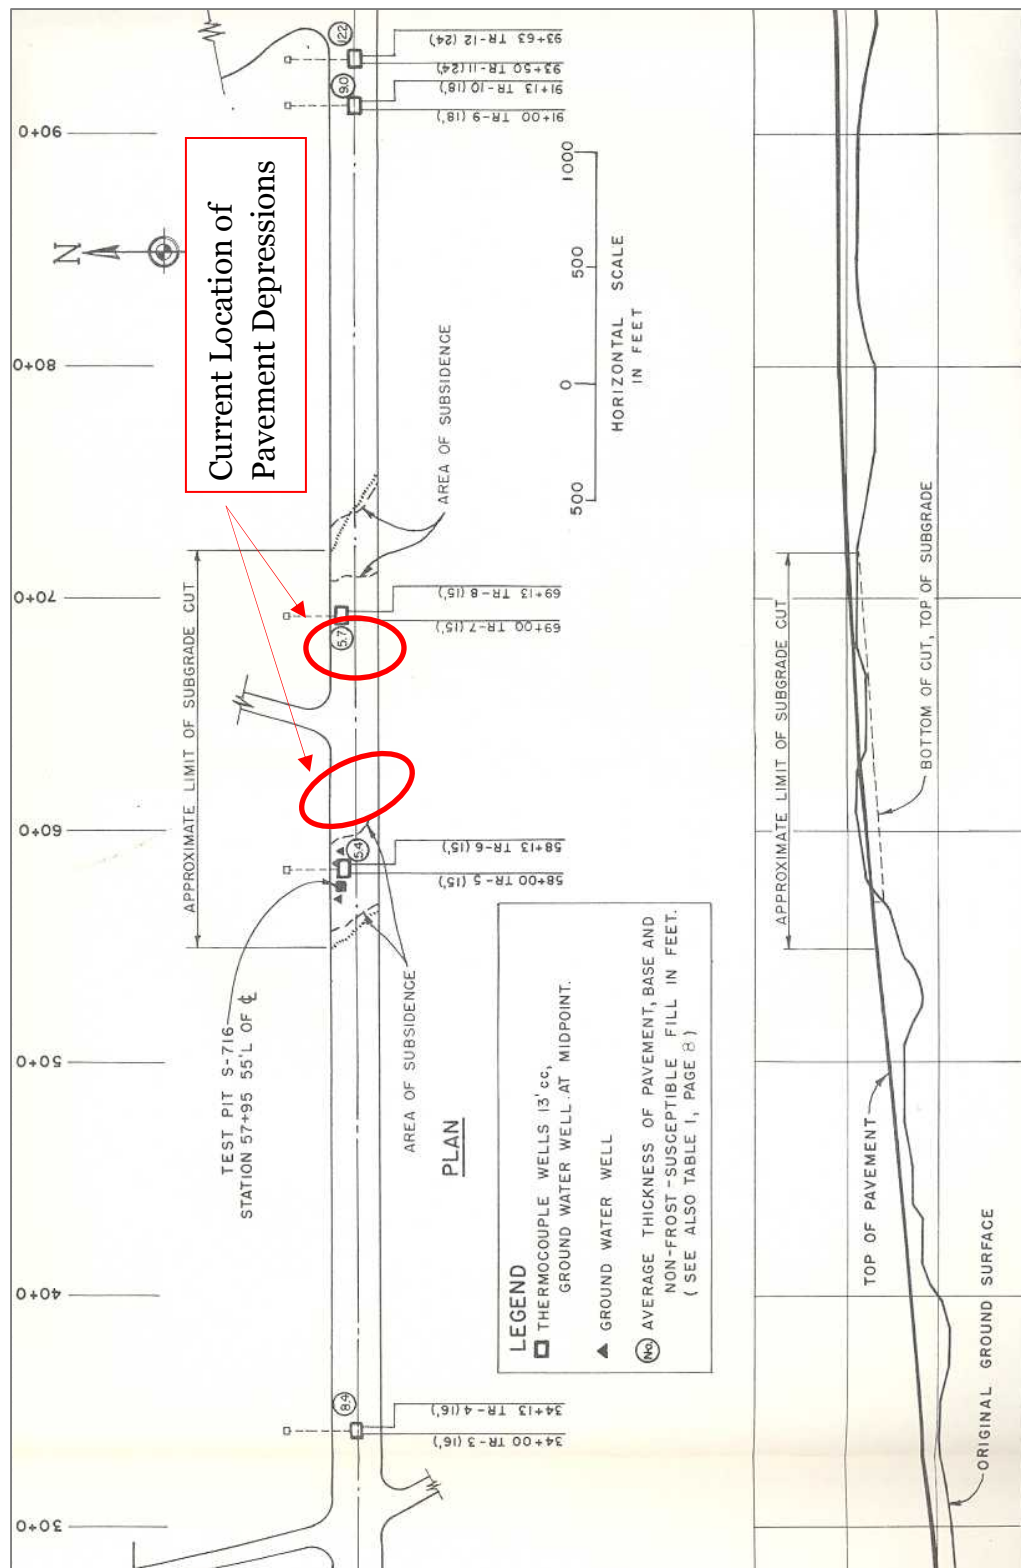
Figure 8. Plan view of depressions and test pits from ACFEL 1955 investigation (ACFEL 1955). Current depression areas are noted.

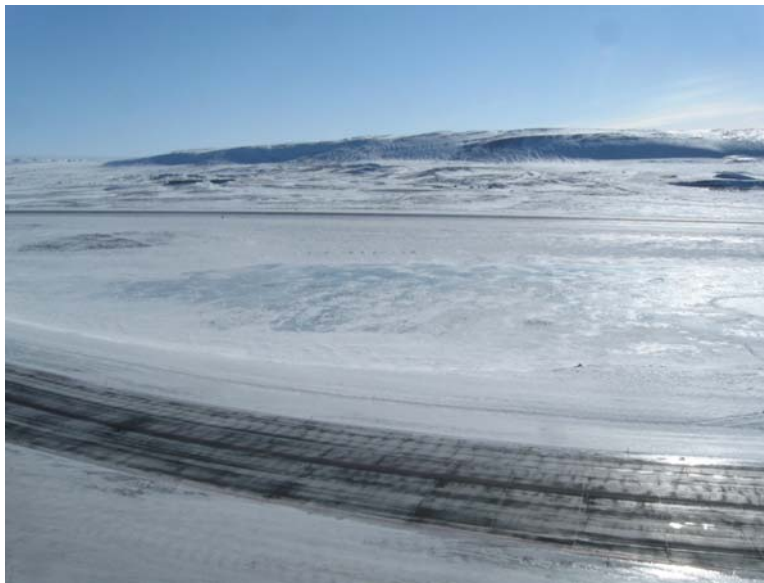
Figure 16. View from the tower in April 2011, looking directly south over Lake Eddy. The dark colored runway and taxiway are visible.

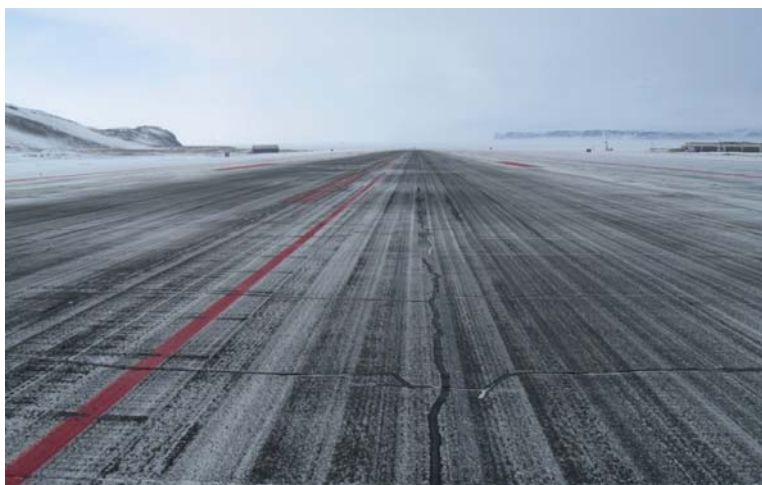
wash is reapplied (Fig. 18). Therefore, since summer 2009, the runway has had virtually no white paint along this 100-ft-wide keel during the crucial solar heating months of June, July, and early August. No thaw depressions have been created during this time, and the existing thaw depressions (namely at 62+00) have not increased in size or depth. This is especially enlightening because the summers of 2008, 2009, and 2011 were the fifth, third, and fourth warmest summers, respectively, on record since 1951 (Table 1).

Figure 18. View of the 26 end of the runway April 2011. The winter maintenance has removed the white wash coating applied the previous summer. This state persists through the warm period of June, July and early August before repainting.

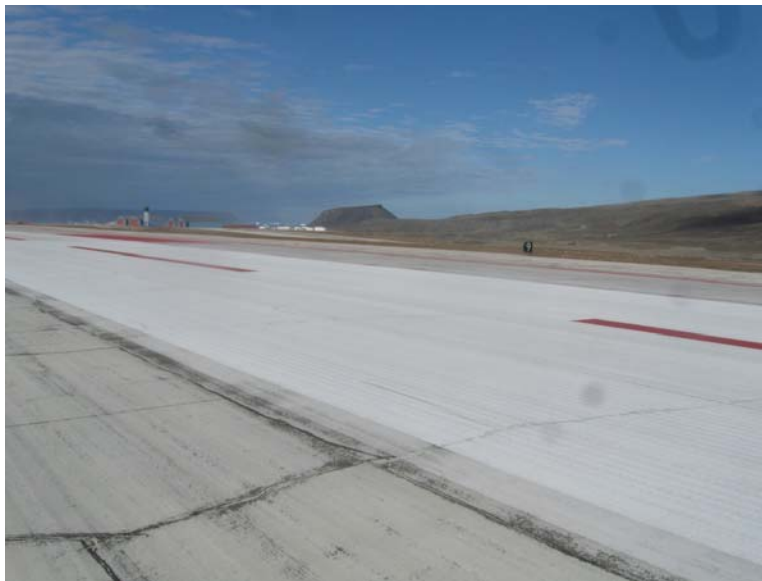
Figure 20. Bright white runway at 91+00. Albedo measured at 0.58 and the thaw depth measured at 3.9 ft.

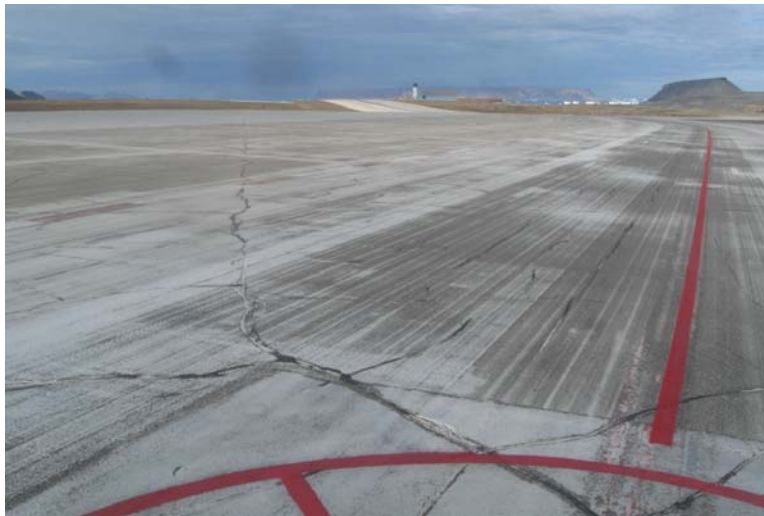
Figure 21. Brushed and faded milled surface on Txwy A at Vortac Calibration. Albedo measured at 0.26 and thaw depth measured at 5.3 ft.

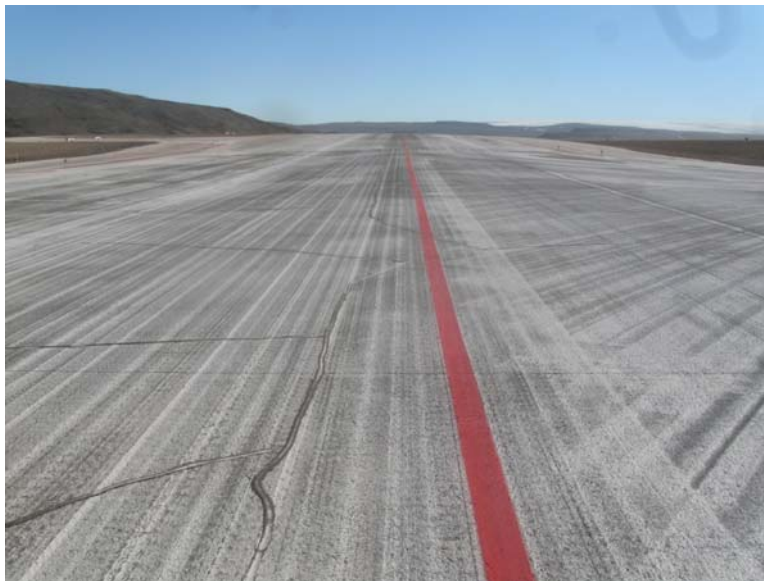
Figure 22. View east along Txwy A at Txwy Charlie. Albedo measured at 0.32. The measured thaw depth is 5.3 ft.

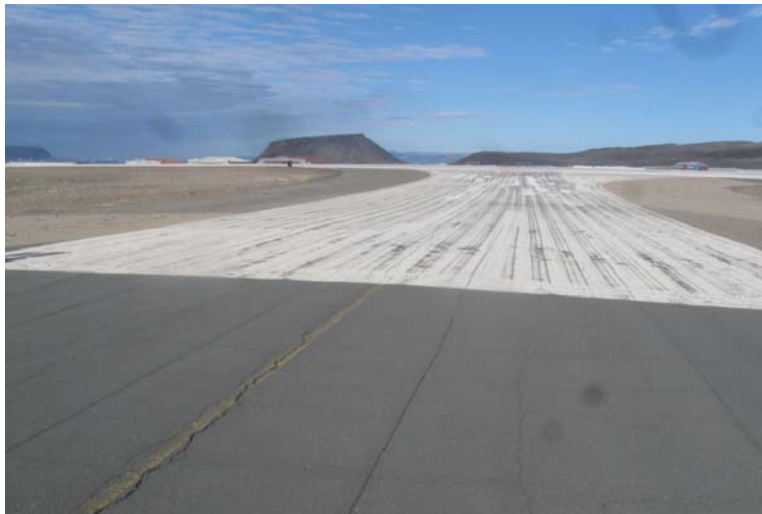
Figure 23. Old white paint transitioning to never painted surface at Txyw Bravo Extension. The white albedo measured 0.44 and the thaw depth measured 5.1 ft, while the black surface measured 0.15 and the thaw depth measured 6.5 ft.

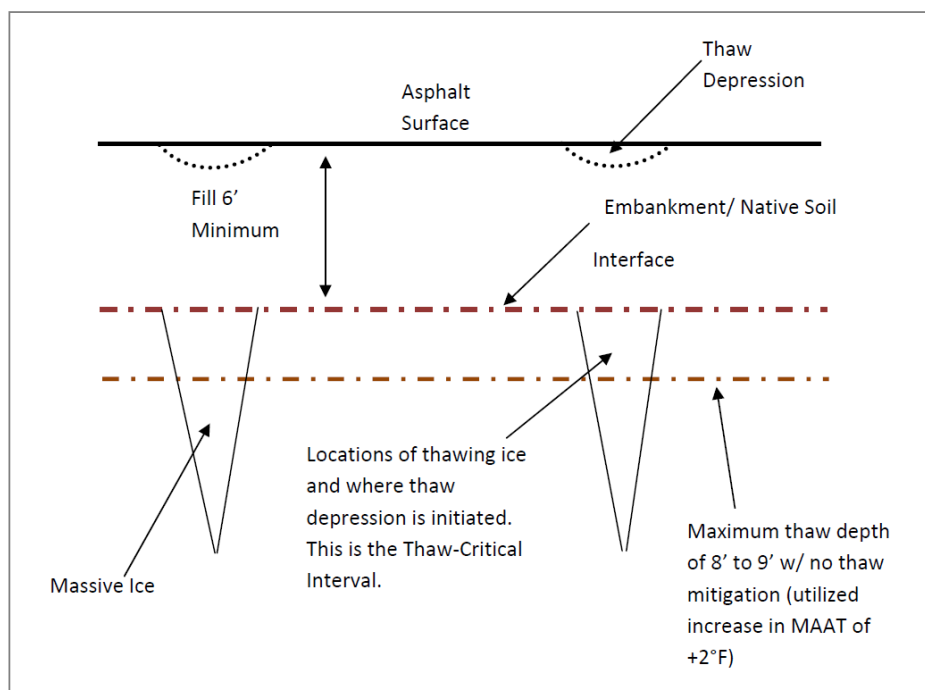
The engineering design specified in 1951 was to place a minimum of 6 ft of fill over the native surface to act as insulation against thawing of the massive ice. We now know that the 6 ft of fill was inadequate (Fig. 32). The *thaw-critical interval* is defined as the space below the surface that is between the current thaw depth at approximately 6 ft and the possible thaw depth attainable without thaw mitigation. It includes an increase in average mean annual air temperature (MAAT) of +2°F, or a maximum thaw depth of 9 ft.

Figure 32. Simplified physical situation causing thaw depression on and around the airfield. The fill section is inadequate to prevent summer heat energy from reaching the depth of massive ice. The thawing ice creates a void that is filled with adjoining soil and a surface depression is the end result.

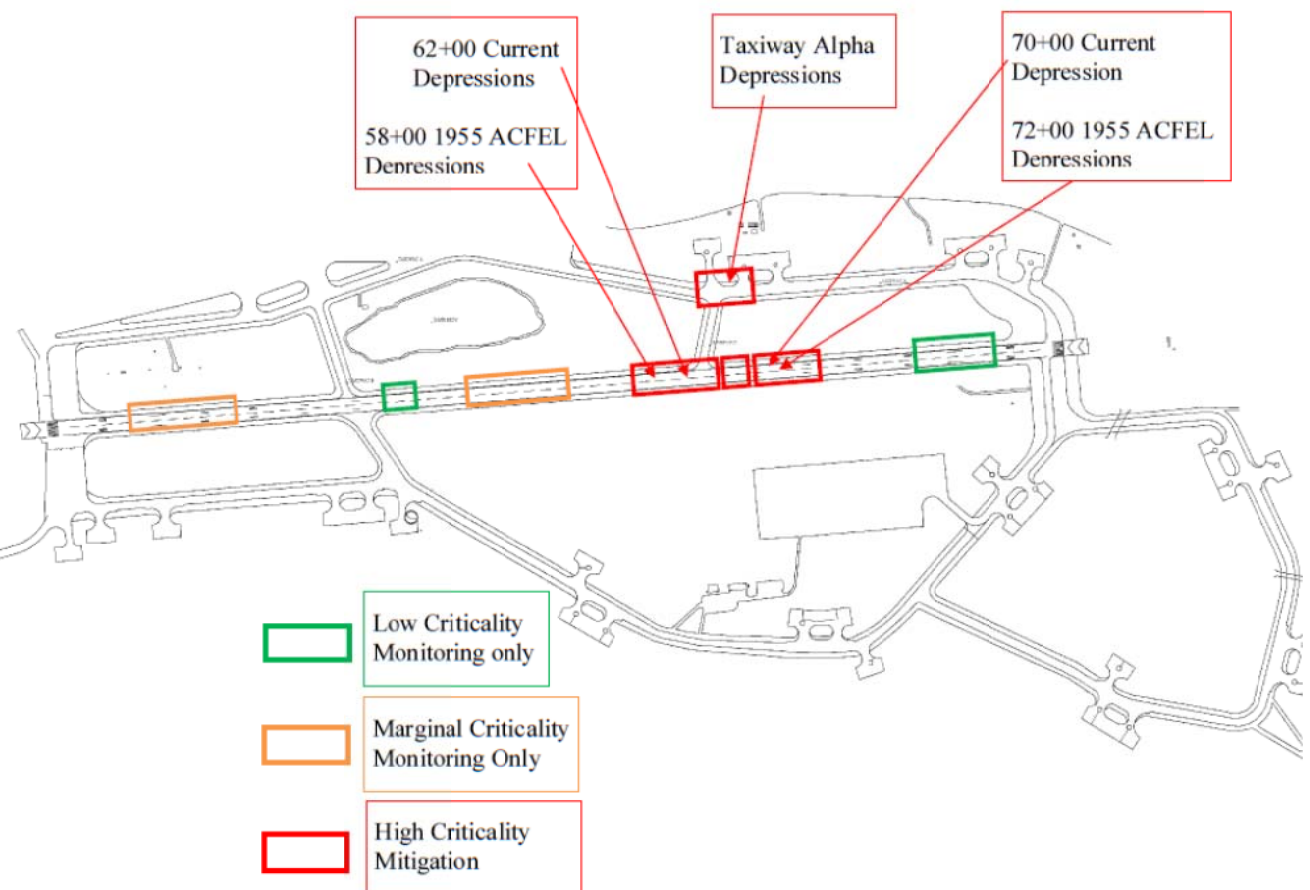
Figure 37. Plan view of the areas absolutely requiring and possibly requiring thaw mitigation.

and has had in the past; mitigation is required. The mitigation technique should be applied across the full width of the runway at the selected locations, and beyond the runway edge lighting where applicable.

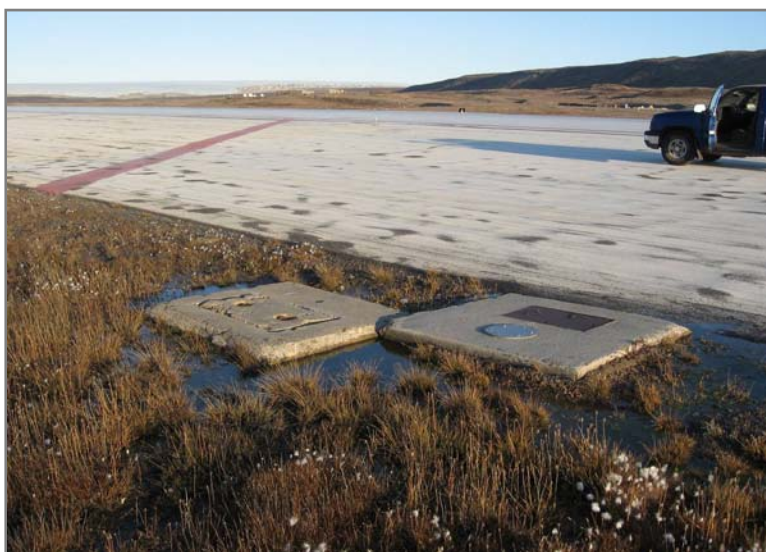
Figure 41. North shoulder of runway at 38+00. Seepage water is flowing from the electric vaults, and the visible splotchy asphalt of the shoulder is coincident with this area suggesting fatigue due to weakening of the base course or freeze–thaw problems. Water flows from the locations of the runway lighting early in the thawing season, slowly diminishing over the summer.
