# INSPECTOR GENERAL

JULY 18, 2013

## Compliance with Electrical and Fire Protection Standards of U.S. Controlled and Occupied Facilities in Afghanistan

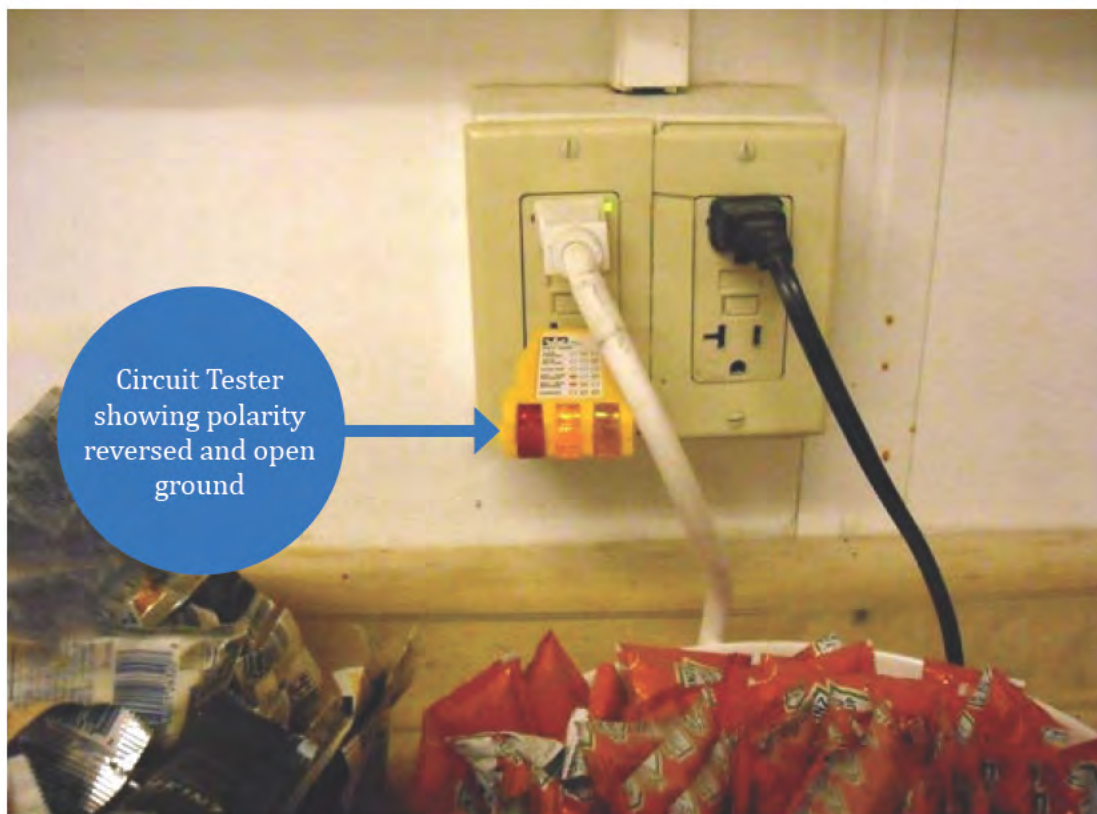
KAF-EL-120426-026

- In Building 518, reverse polarity and no grounding of kitchen receptacles: (Finding KAF-EL-120426-026)
- In Building 518, main electrical panel wires are not color-coded to any standard: (Finding KAF-EL-120426-025)
- In Building 156 “Old Kandahar Hotel,” live power cables placed directly on roof top: (Finding KAF-EL-120426-084)
- In Building 156 “Old Kandahar Hotel,” there are unprotected wires used throughout the living quarters: (Finding KAF-EL-120426-047)
- In Building RLB7B, living quarters are unsafe for occupancy due to severe wiring issues: (Finding KAF-EL-120426-097)

Figure 1. Reverse Polarity and No Grounding - Chaplain's Office Building Kitchen Area

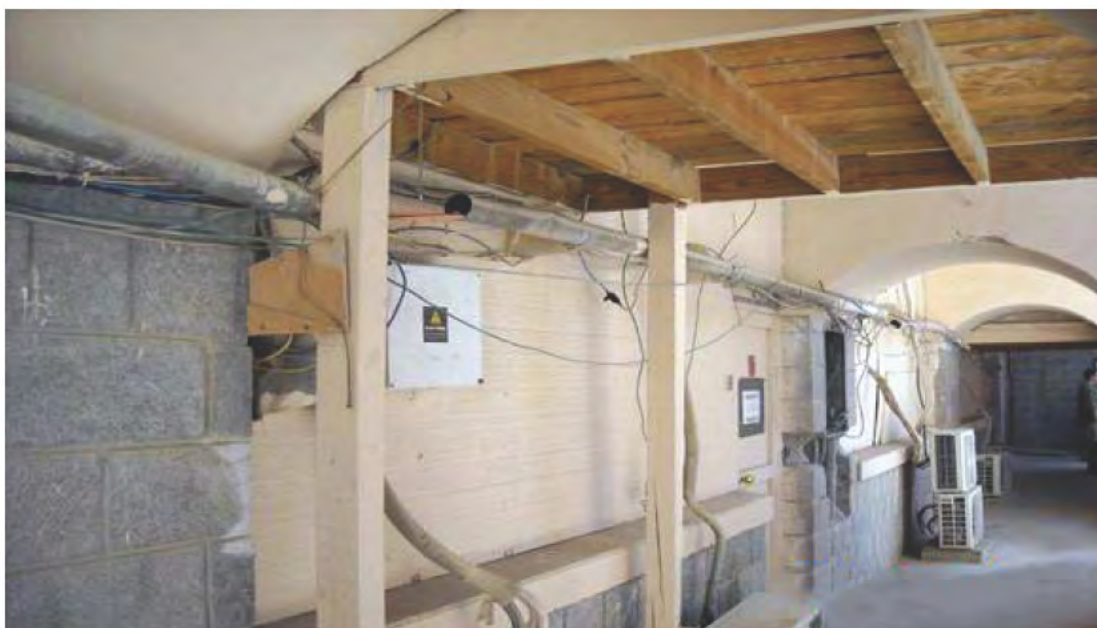
KAF-EL-120426-055

2. **Misuse of plastic-sheathed cables:** Multiple cases of indoor-rated, plastic-sheathed cables used in damp outdoor locations, unsupported and unprotected by conduit and raceways (Figures 2, 3, and 4). Improperly mounted cables and breaks in raceways increases the risk of abrasion and breaks in conductors, which could cause fire, electrical shock, and/or electrocution.

Figure 2. Noncontiguous Raceway in Outdoor Location

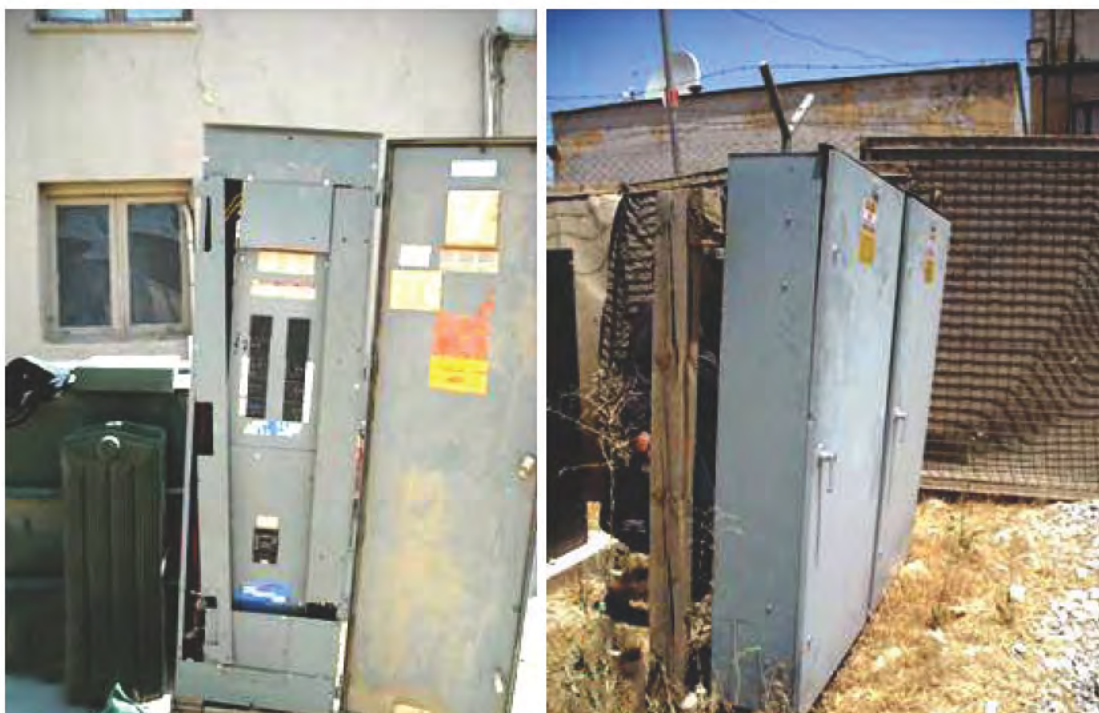
4. **Hazardous electrical service to facilities:** Electrical wires supported by rooftops, many cases of incomplete or damaged electrical panels, and electrical panels that are missing front covers and other covers for openings (Figures 6, 7, 8 and 9). Power lines draped over the top of buildings and structures present a high risk for fire and electrocution. Energized panel enclosures with front covers that do not fit properly expose energized wires, increasing the risk of electrocution to personnel accessing the circuit breakers. Also, damaged electrical panels present the possibility of other unseen internal damage and could result in ground faults/arc flash and potential fire, electrical shock, and/or electrocution.

BAF-EL-120709-017 (left)    BAF-EL-120709-063 (right)  
Figure 7. Damaged and Hazardous Electrical Panels

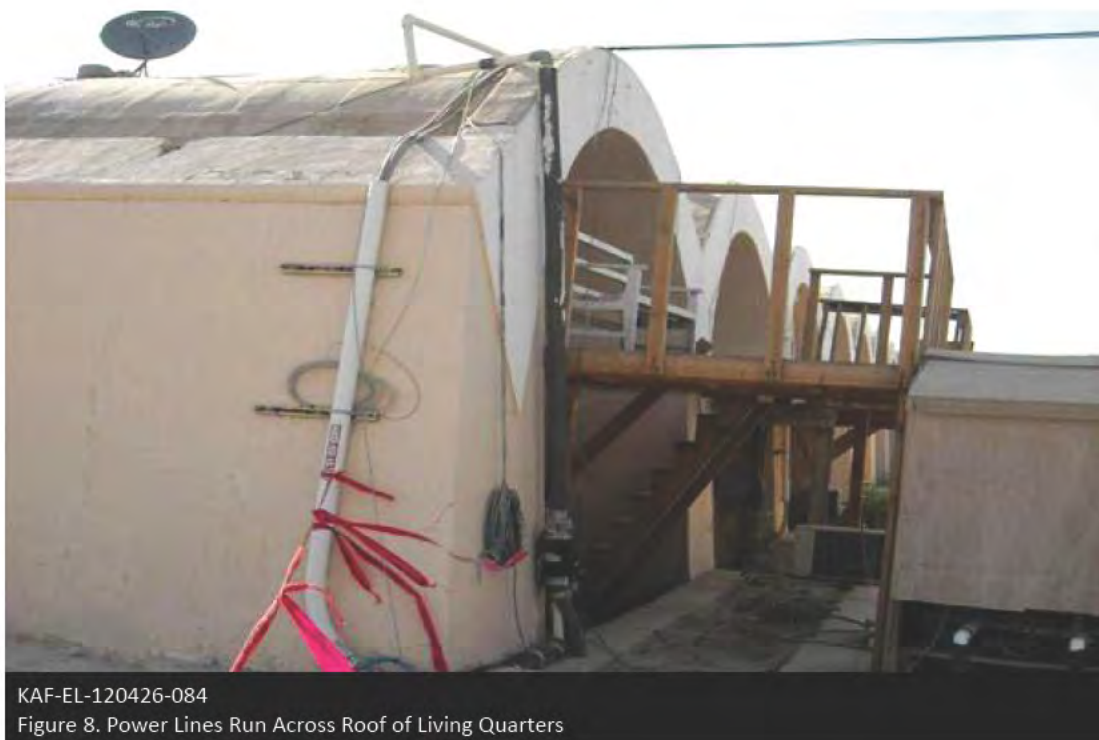
KAF-EL-120426-084  
Figure 8. Power Lines Run Across Roof of Living Quarters

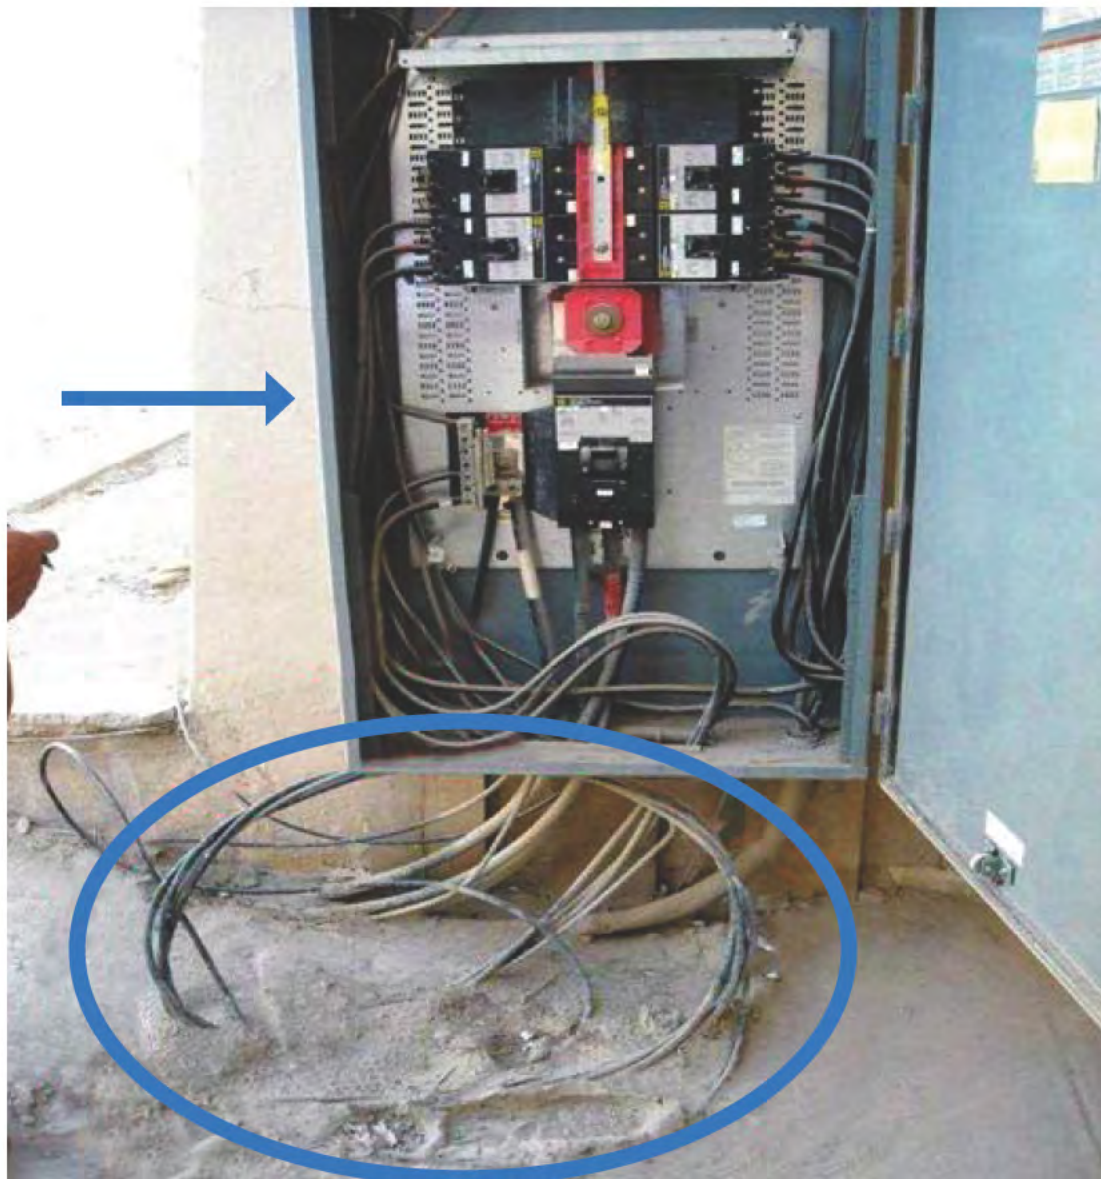
KAF-EL-120426-057

Figure 9. Unprotected Cables Buried in Concrete (Circled) and Missing Front Panel Covers

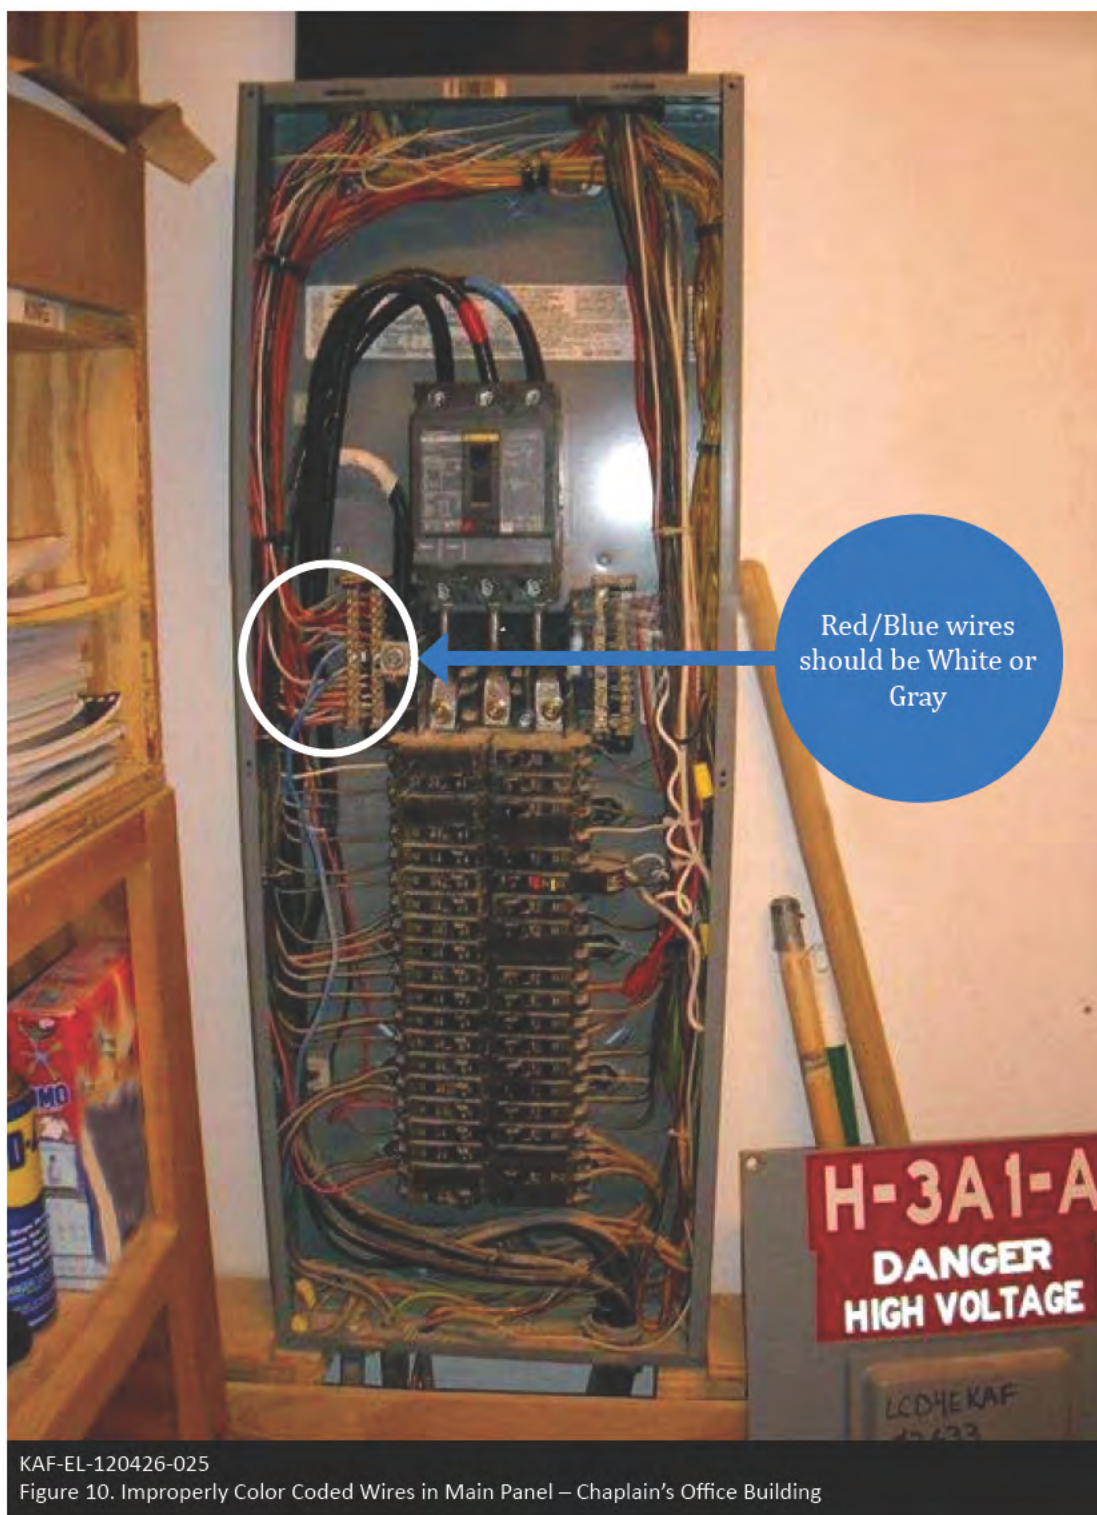
KAF-EL-120426-025

6. **Other:** Non-systemic issues include the lack of an automatic charging system for the fire pump house water pump engines, nonoperational hospital standby/backup power system, improper color coding of electrical wires (Figure 10), and electrical receptacles filled with paint.

Figure 10. Improperly Color Coded Wires in Main Panel – Chaplain's Office Building

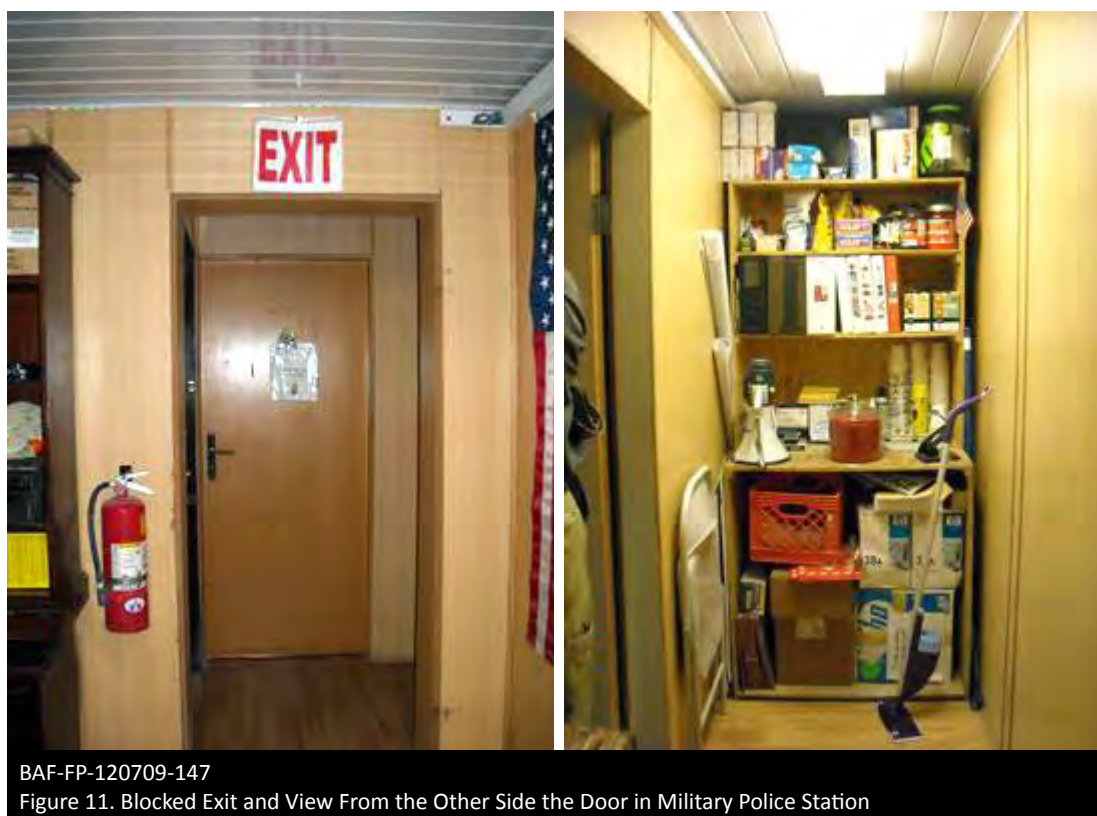
1. **Means of egress:** Locked and obstructed exits and inadequate exit configurations, signage, and emergency lighting. Many cases where the exits are locked, obstructed (Figure 11) or not clearly identified in all lighting levels; occupants may become confused or even trapped by not being able to readily locate the exit during an emergency.
