## **Evaluation of Precast Panels for Airfield Pavement Repair**

Phase II: Results of Accelerated Pavement Testing

September 2013

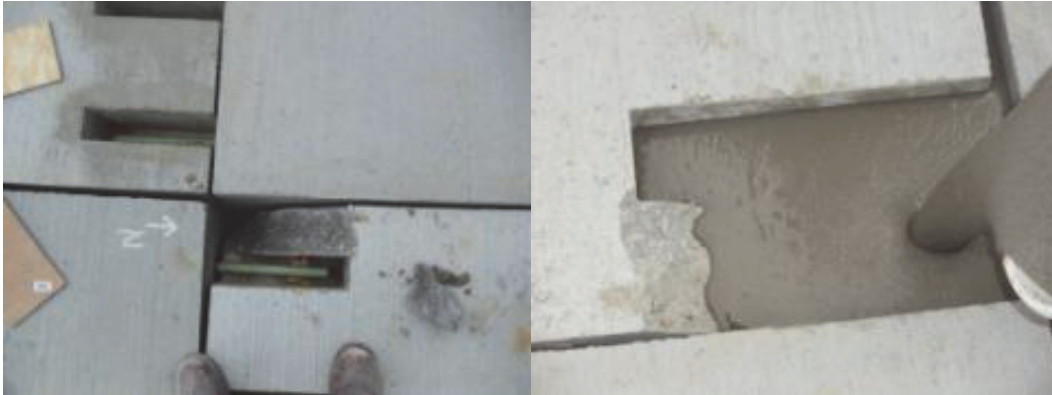
Figure 11. Damaged and repaired dowel bar receptacle on panel 4.

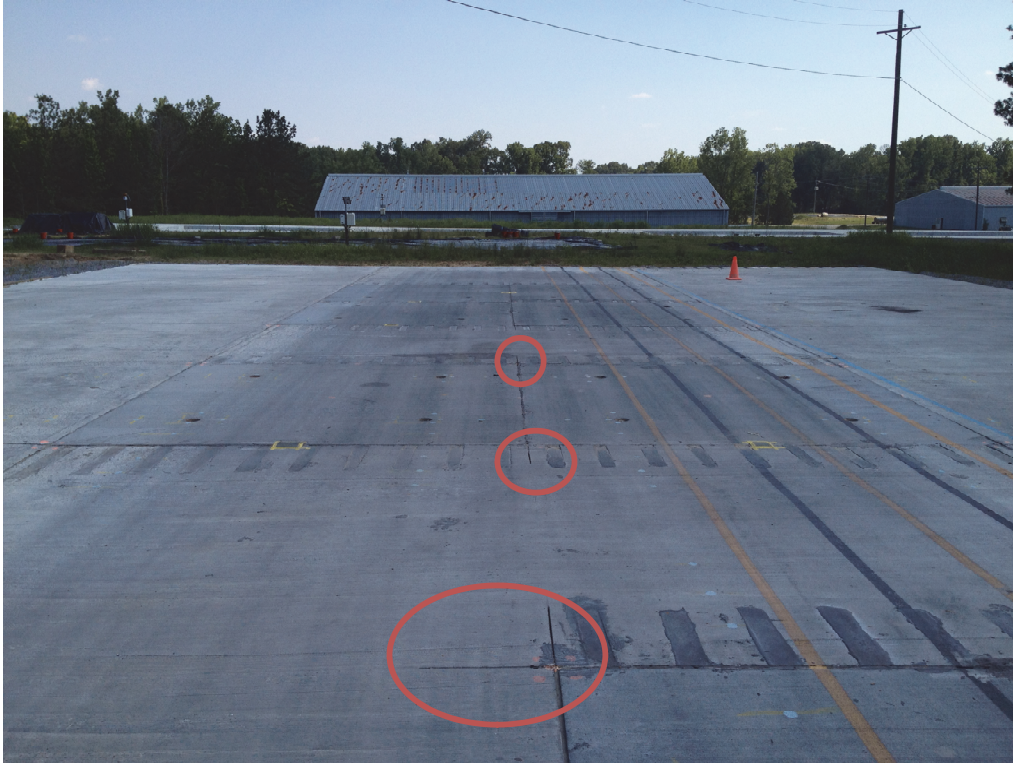
Additionally, when the test section was saw cut to generate the repair areas, overcuts (kerfs) from the corners of the repairs extended approximately 12 to 15 in. into the parent PCC (Figure 12). This overcutting was necessary to provide the full depth cut using a round saw blade to fully free the demolished concrete. During trafficking, cracks extended from these overcuts.

Figure 12. Saw cuts at corners of panels.

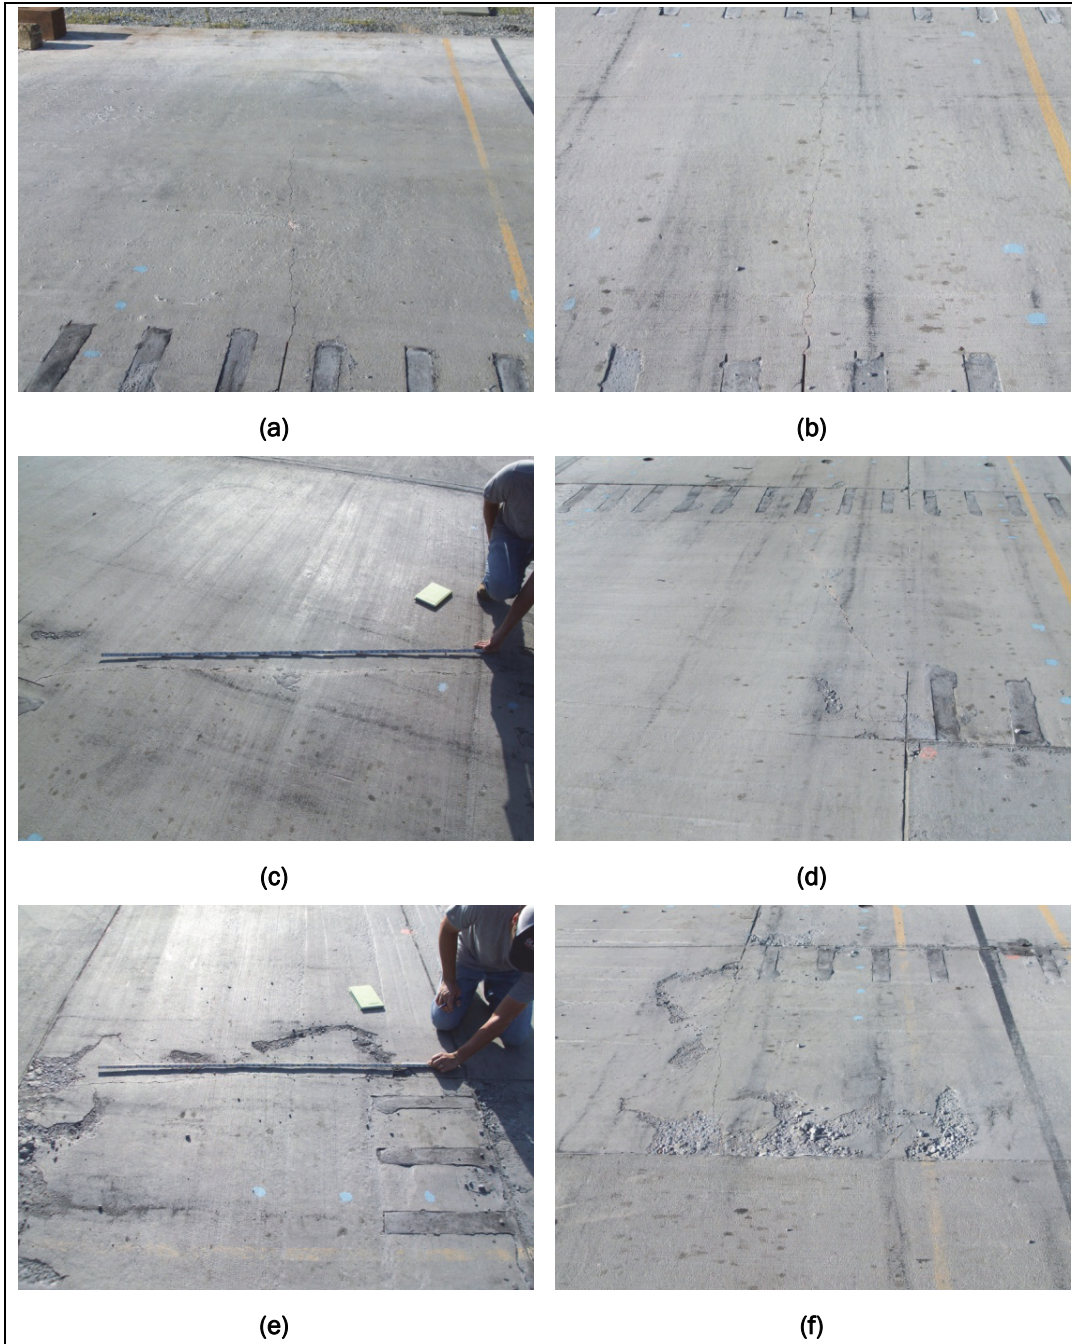
Figure 13. Parent slab distresses after 2,800 passes: (a) longitudinal crack in parent slab south of Repair 2 extending from saw undercut; (b) longitudinal crack in parent slab between Repairs 2 and 3 extending from saw undercut; (c) diagonal crack in parent slab extending from NE edge of Repair 1 extending from saw undercut; (d) diagonal crack in parent slab from SE edge of Repair 1 to Repair 2 extending from saw undercut and spalling and cracking between saw overcuts on SE corner of Repair 1; (e-f) spalling and cracking in parent slab north of Repair 1 near construction cold joint.

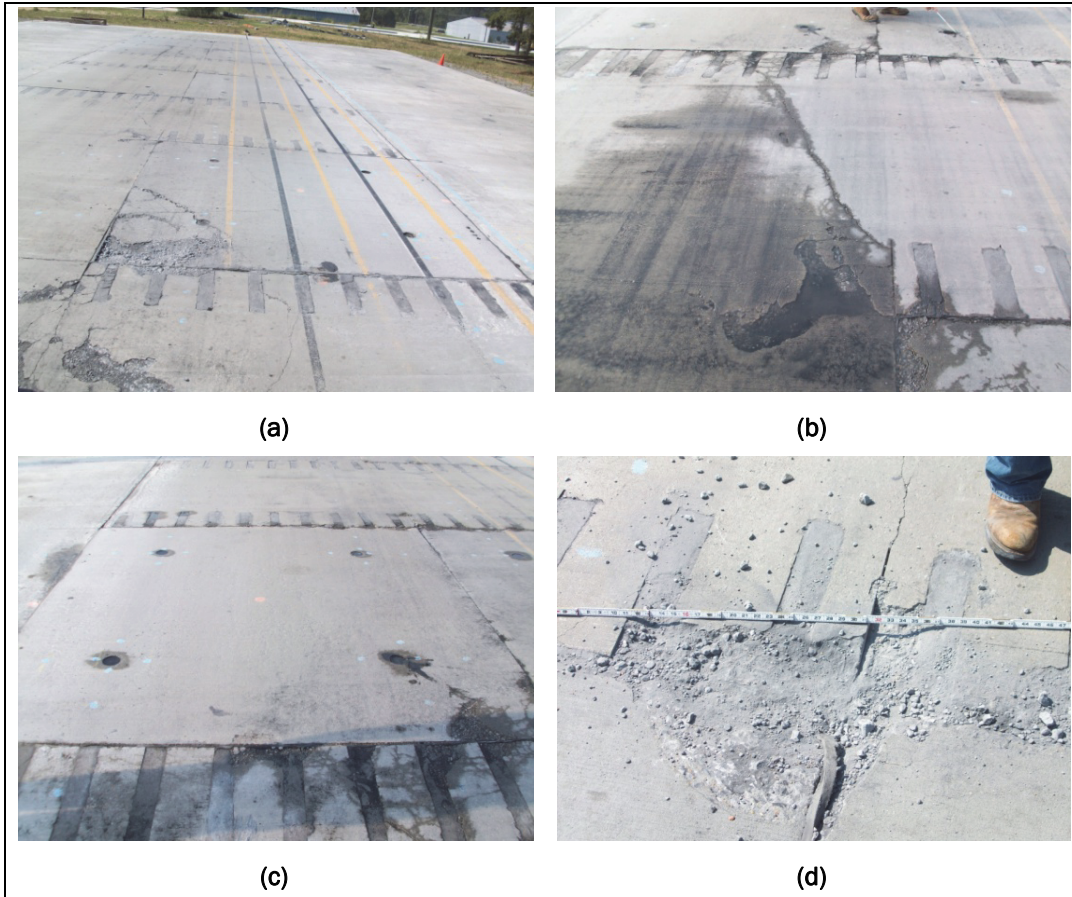
Figure 14. Repair failure details: (a) Repair 1-Panel 1: high-severity corner break/spall and shattered parent slab; (b) Repair 2: diagonal cracking in parent slab between Repairs 1 and 2 and cracking and spalling of Panel 2 due to the parent slab deterioration; (c) close-up of the cracking and deterioration in the parent slab and dowel slots and corner of Panel 2; (d) Repair 3 Panels 6 and 7: high-severity spalling in corner of Panels 6, 7, and the parent slabs south of the repair.

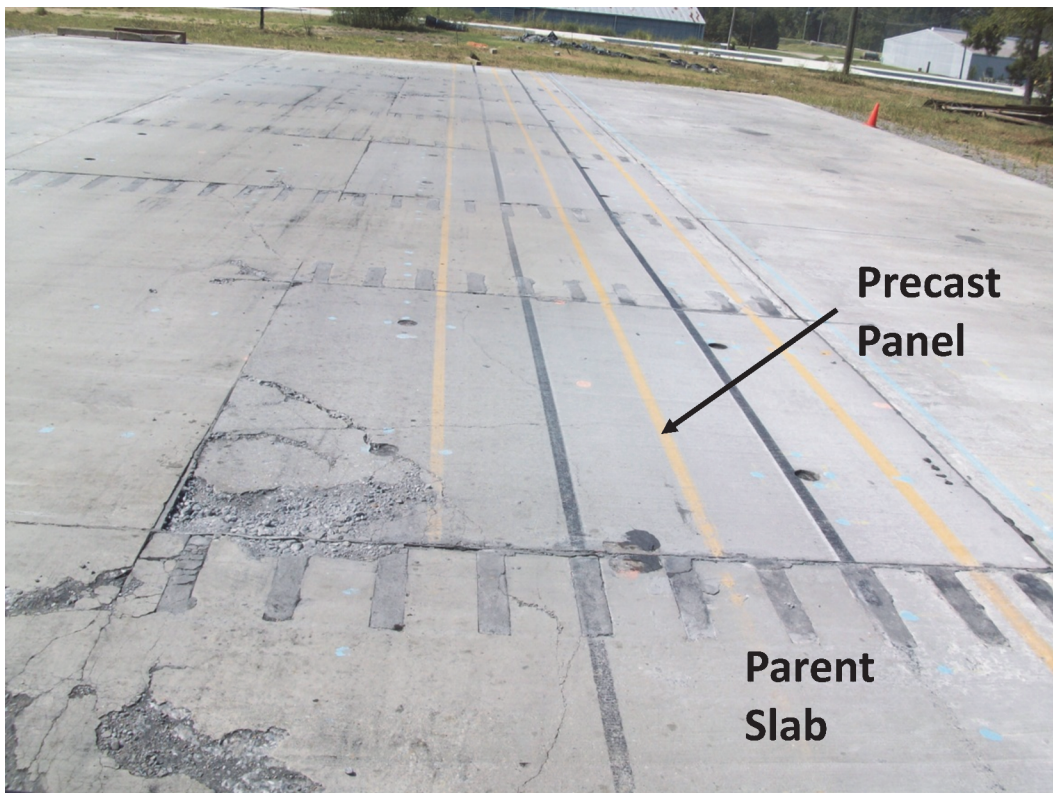
Figure 47. Repair 1 at failure condition.

joints, the initial LTE was approximately 88 percent, but this reduced to 20 percent for the E joint and 78 percent for the W joint after 5,600 passes. For the transverse joints, the LTE met the general PCC guidance of at least

70 percent, indicating that the dowel preparation was acceptable as meeting the requirements for general PCC requiring load transfer.

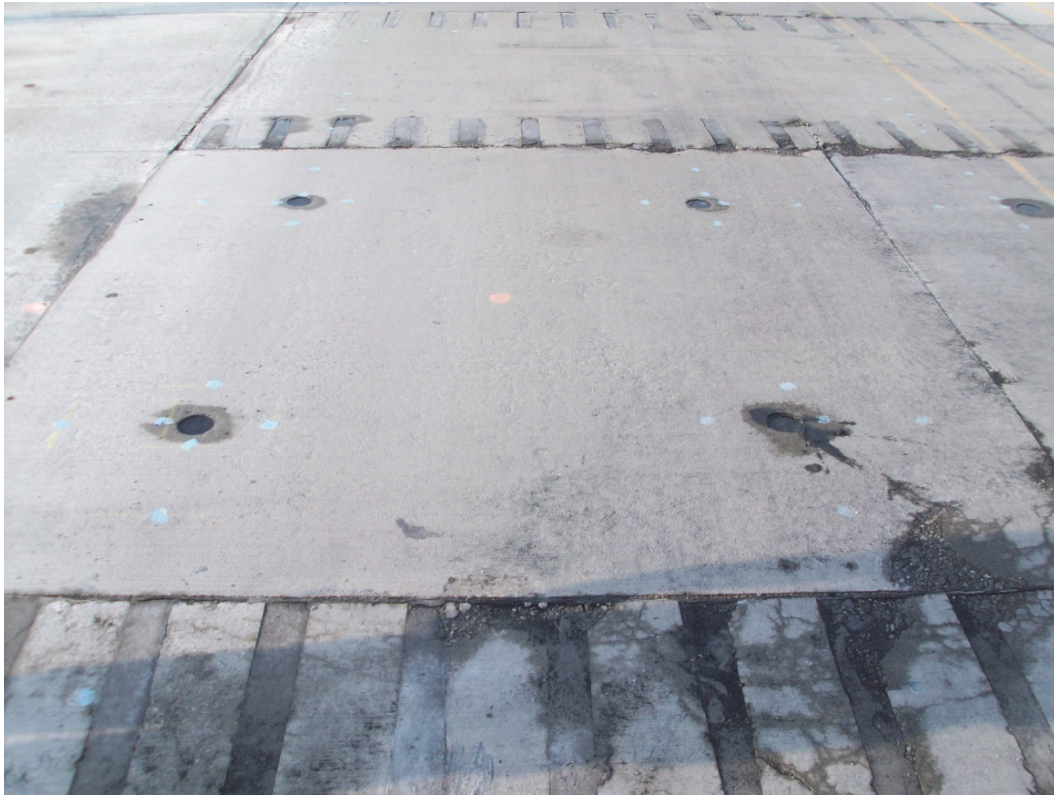
Figure 48. Repair 2-Panel 2 at failure condition.

80 percent. The LTE increased from 54 percent to 85 percent for the E joint of Panel 2, indicating that the joint had better LTE possibly due to expansion or movement of a panel. The E and W joints of Panel 3 also increased in LTE from the initial measurement, most likely also due to expansion or movement of the panels causing closer contact of the panel to the parent PCC leading to increased LTE. For the transverse joints, the LTE prior to traffic met the general PCC guidance of at least 70 percent, indicating that the dowel preparation was acceptable as meeting the minimum requirements for general PCC requiring load transfer. After 10,000 passes, the S joint of Panel 2 and the N joint of Panel 3 had LTE values less than the minimum requirement.

The maximum panel center deflection measured following 10,000 passes was 17.41 mils for Panel 2 and 17.44 mils for Panel 3, which were small increases from the initial deflection measurements of 12.21 and 12.34 mils, respectively. The corner deflections of Panel 2 showed an increase from 19.5 to 52.93 mils at failure. The initial peak center deflections from these panels were similar to the other panels with a range of 12 to 15 mils.

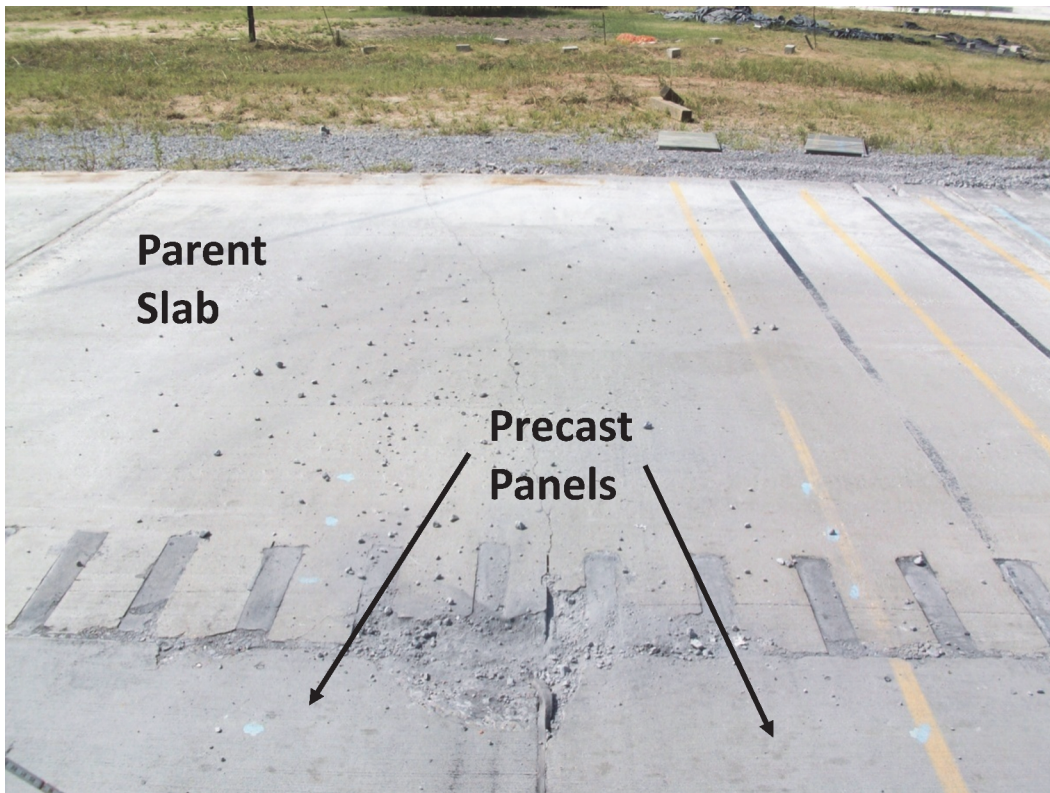
Figure 49. Repair 3 South edge at failure condition and cracking extending from overcut in parent slab.

The roughness criteria were not exceeded for this repair with a maximum recorded elevation difference of 0.375 in. from the installation elevation. The maximum elevation measurement was 0.625 in. along the NE corner of Panel 4.
