# Characterizing PCB contamination in Painted Concrete and Substrates: The “Painted History” at Army Industrial Sites

ERDC-EL Environmental Engineering

# Site Investigation at IAAAP

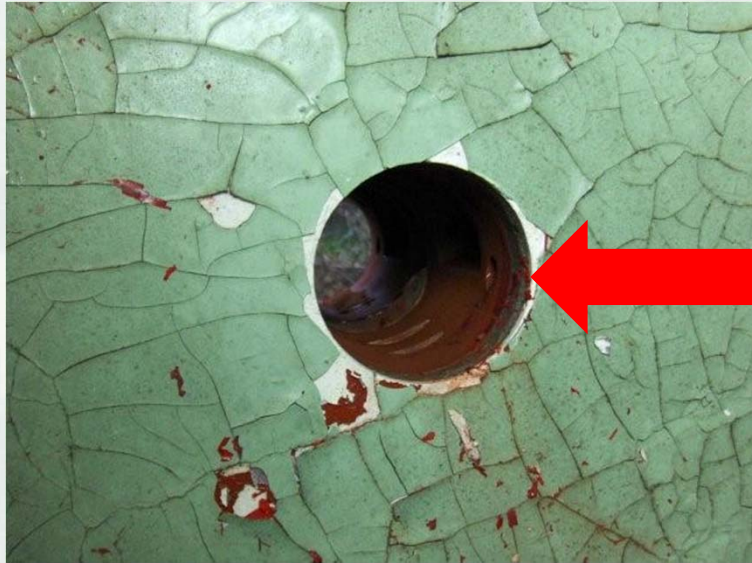
Some of these building materials were over 1 foot thick.

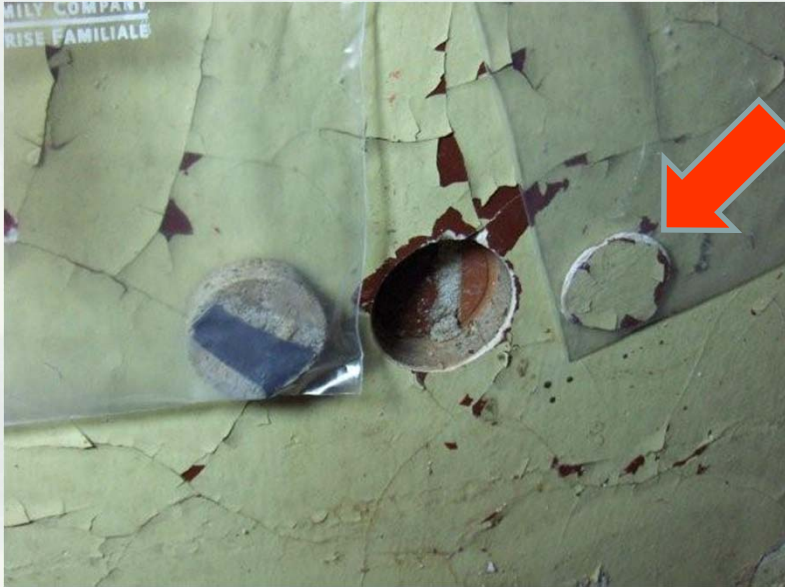
Where surface paint concentrations of 290 mg/kg were observed, only 2 mg/Kg was present in the plaster directly beneath the paint.

gradients in concentration with depth were not observed in the data
