# Technical Report ARAEW-TR-06012

## Analysis of HEMCL Railgun Insulator Damage

**JUNE 2006**

ARMAMENT RESEARCH, DEVELOPMENT AND ENGINEERING CENTER  
Armaments Engineering & Technology Center  
Weapon Systems & Technology

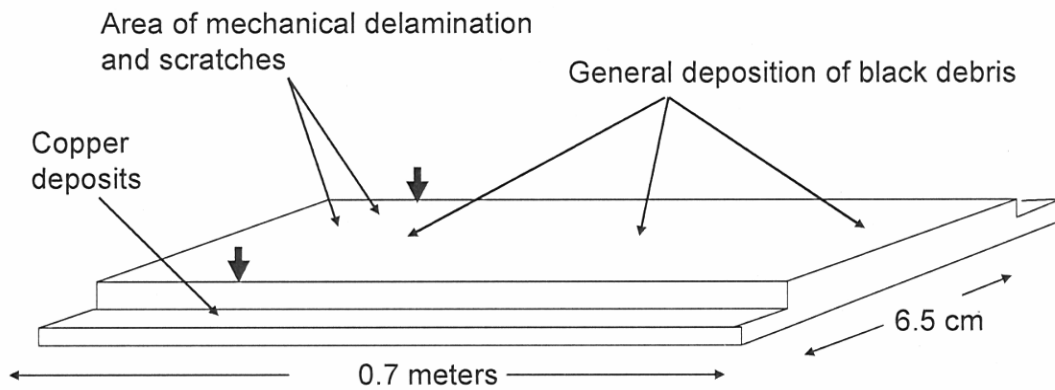
Figure 1. Schematic of G10 insulator specimen.

Regarding mechanical damage to the insulator from firing of the three shots, delamination of approximately 20 cm<sup>2</sup> of the top layer of the 0.7 meter G10 specimen is observed near the edge closest to the breech (Figure 1). There are several deep scratches adjacent to the delaminated area. There is also general damage that is similar that described in Gee and Persad [1] in the transition region: epoxy degradation and subsequent fiber removal, possibly by gas wash behind the high velocity projectile. There is no other indication of uniform mechanical damage to the insulator surface that would be expected from general mechanical contact with the moving projectile.

The most severe thermal damage to the insulator is localized at the two edges of the insulator that are immediately adjacent the two Glidcop/steel junctions. These locations are indicated by the arrows in Figure 1. Approximately 2 to 3mm of insulator material is removed all along a 4 to 5 cm length at the insulator corners at these two locations. Again, the damage is clearly thermal as indicated by numerous observations of fiber softening (fiber deformations) and large quantities of epoxy and glass fiber removal. There is a relatively large amount of copper around these sites. The location of this copper (Figure 1) indicates that it originates from melting of the copper rails that back the Glidcop and steel liners.

Dark arrows indicate locations of Glidcop/steel junction at 12 cm from left edge. Projectile motion is from left to right.

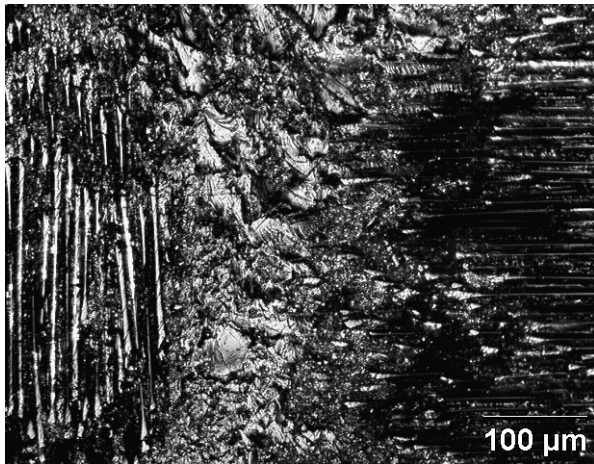
LSCM images were recorded for the damaged G10 surface. The entire surface is blackened. Images from the reverse side (unexposed side) of the G10 sample were also recorded for comparison. Figure 2 is an image from the unexposed side of the G10 sample. It shows a typical junction between the raised bundles and the submerged cross bundles. The original surfaces were ground smooth during manufacture so that most of the top surface glass fibers are short fiber segments held together with epoxy binder. Most of the glass fiber segments show some flattened portions from the grinding process before firing. The junction in this image is filled with a large volume of epoxy matrix material. This surface was gently cleaned with an alcohol soaked cotton swab and, unlike the exposed surfaces, no detectable effects of this cleaning were seen in the microscope images.

Figure 2. Micrograph of epoxy morphology and fiber bundles of G10 in the as-fabricated condition. Surface was cleaned with alcohol moistened cotton swab.

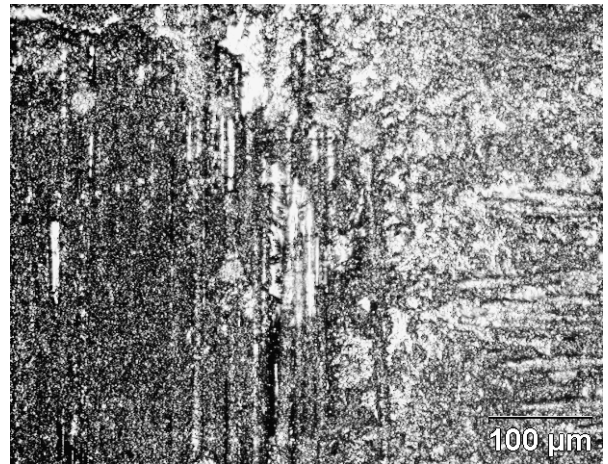
Figure 3 is an LSCM image of the exposed face of the G10 at approximately the center of the 0.7 meter sample. The sample surface appears roughened which probably accounts for some of the darkened appearance. This image is representative of the entire 0.7 m G10 sample. Figure 4 is an image from an area immediately adjacent to that in Figure 3 after gentle cleaning with an alcohol moistened cotton swab. The polished appearance of the epoxy region between the fiber weave bundles is in stark contrast to that of Figure 3 and to that of the similarly polished area on the unexposed side (Figure 2). The ease with which a high polish is obtained indicates that a major softening of the epoxy has occurred. The entire 0.7 meter sample exhibited this softened feature.

It is known that pyrolysis of glass reinforced composites produces epoxy decomposition products in the form of gases, oils, waxes and chars solid (heavily cross-linked residues) [4]. The nature of the soft, readily

polished surface in 3b is consistent with a wax decomposition product, so we will describe it in those terms in the remainder of this report.

Figure 3. Micrograph of G10 surface exposed to firing conditions (three shots).

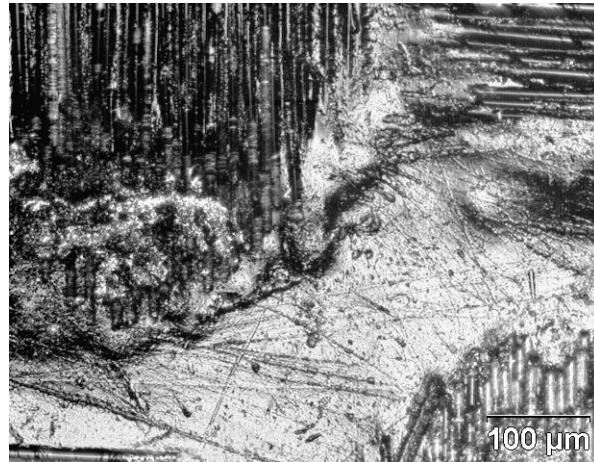
Figure 4. Micrograph of exposed G10 surface after gentle cleaning with an alcohol moistened cotton swab.

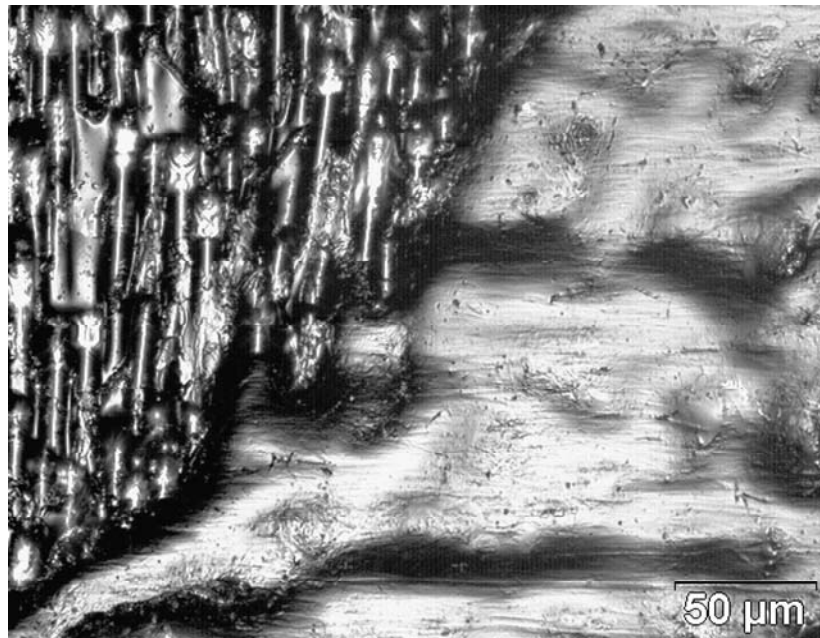
Figure 5 is an LSCM image of a G10 sample that was exposed to laser pulse heating. As in the image in Figure 4, gentle cleaning with an alcohol moistened cotton swab produces a high polish on the epoxy regions between the fiber bundles indicating the formation of the same pyrolytic decomposition product (wax) of the epoxy as in the fired specimens.

Figure 5. Micrograph of G10 after laser pulsing and cleaning with a cotton swab.

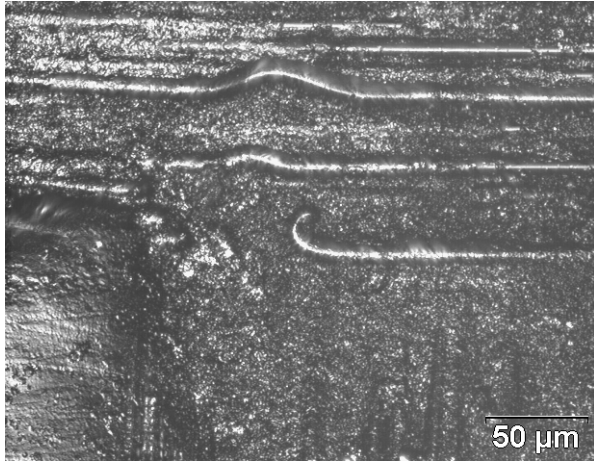
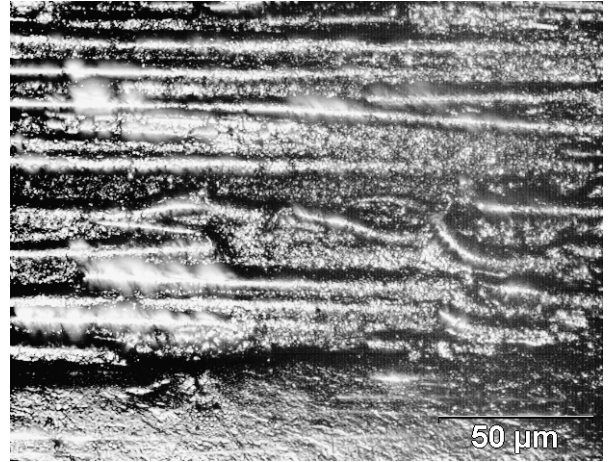
Figures 6 and 7 are typical examples of glass fiber softening and deformation found within pits that occasionally form at all locations on the surface of the 0.7 meter insulator specimen. The twisting and stretching of the glass fibers and the rounding of fiber tips show that the fibers were heated above the glass transition temperature,  $T_g$ , (approximately 700C for E-glass). The tips generally accumulate adherent coating of debris including aluminum and copper.

Figure 6. Micrograph showing glass fiber damage in a pit on the G10 surface exposed to firing of three shots.

Figure 7. Another micrograph showing glass fiber damage in a pit on the G10 surface exposed to firing of three shots.

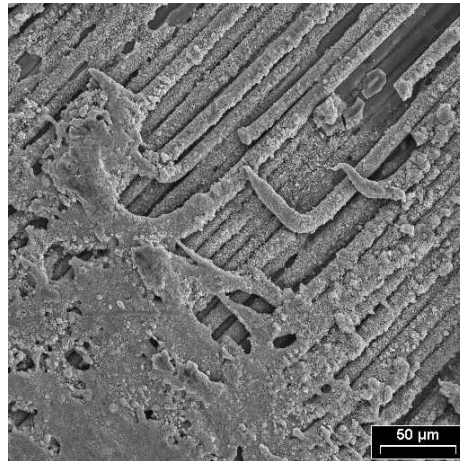
Figure 8 is an SEM image from the exposed top surface of a fired specimen showing glass softening with the tendency of the glass tips to bend in the direction of projectile motion. Also shown in the lower left corner are layers of liquefied glass that appear to result from a dragging of liquefied glass in the direction of projectile motion over the underlying fibers. This is probably a result of high velocity air flow behind the projectile. All surfaces are covered in debris, including aluminum and copper.

Figure 8. Scanning electron microscope image of glass fibers on the top surface of the G10 exposed to three shots. EDAX shows all surfaces are uniformly coated with a thin layer of debris containing aluminum and copper.

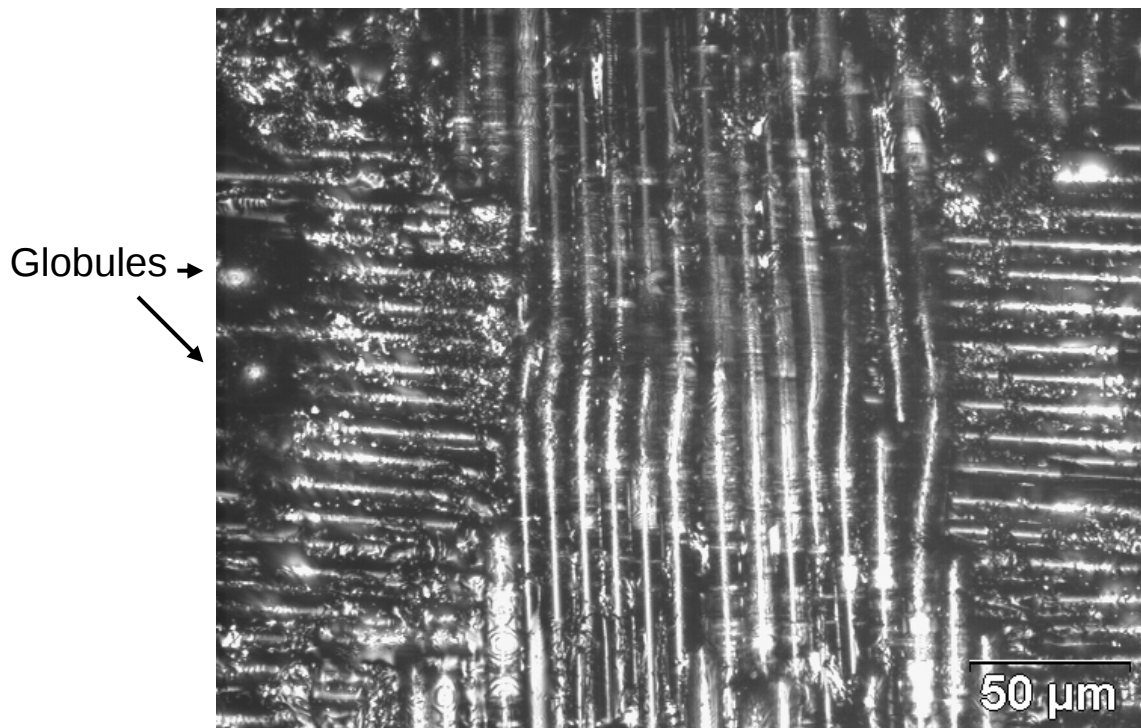
Laser pulsing also produces softening, deformation of fibers, and preferential melting of the glass fiber tips as observed in the fired specimens. See Figure 9. The softened tips exhibit rounding; at incident

laser energies of  $0.3\text{J}/\text{mm}^2$  and higher, there is obvious heating well above  $T_g$ , as indicated by the formation of glass globules (liquification) at the fiber tips. These glass globules are not observed in the fired specimen (Figure 8); the absence of globules in the fired specimen is likely due to the presence of high rate air flow in a railgun.

Figure 9. Micrograph of G10 insulator surface exposed to laser pulse heating of  $0.3 \text{ J/mm}^2$ . Note softening and deformation of glass fibers and the formation of glass globules as a result of liquification of the fiber tips.

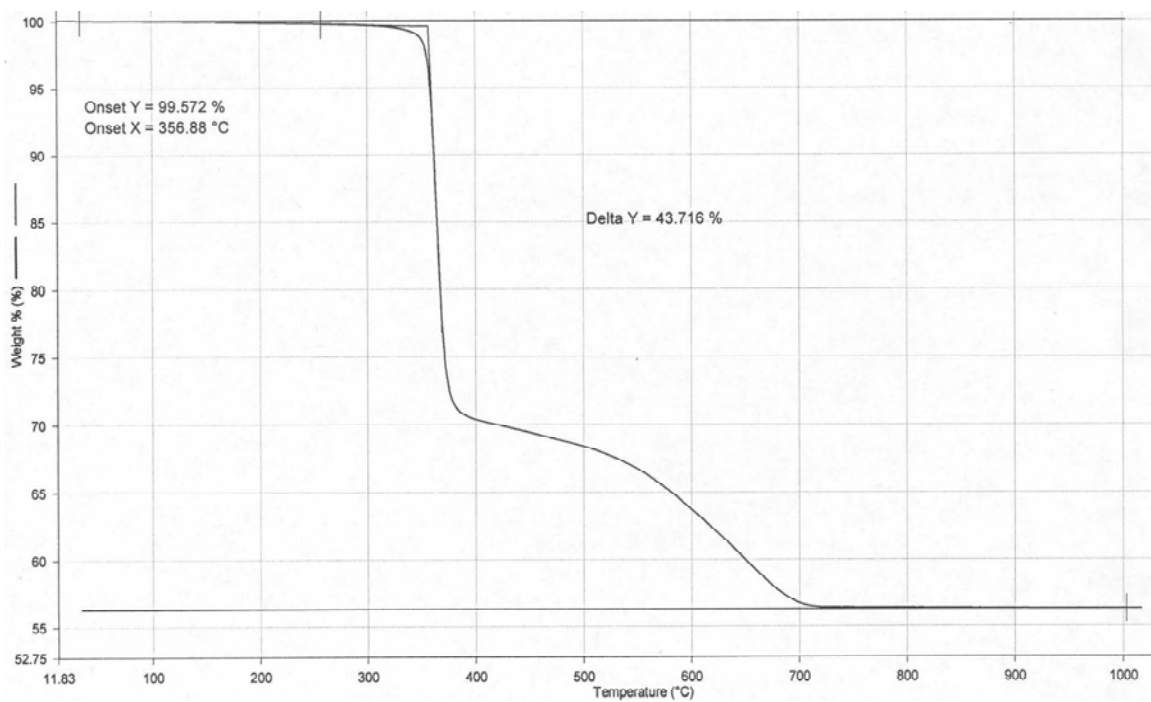
Thermographic analysis results are shown in Figure 10. The heating rate during these tests is 10C/min. The onset of the degradation process occurs at  $\sim 380\text{C}$  where rapid weight loss reflects the evolution of volatile degradation products. Thus, the general degradation of epoxy observed over the entire surface indicates that the surface temperature exceeded 380C everywhere.

Figure 10. TGA results illustrating the onset of epoxy degradation at approximately 360C.

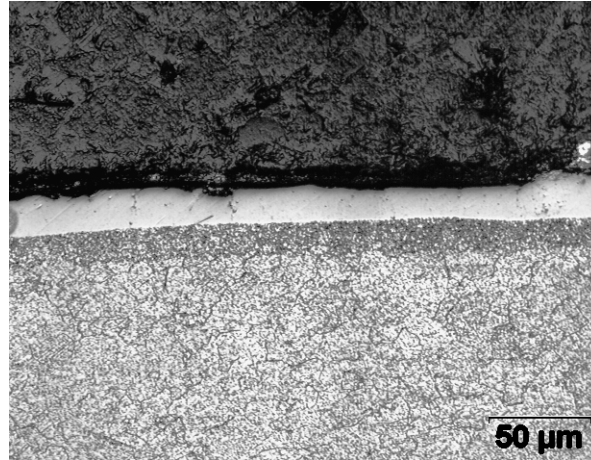
Figure 11 is a micrograph showing the cross section of the steel liner at the 122 cm location which is approximately 30 cm downbore from the Glidcop/steel joint. So it is located at roughly the center of the 0.7 meter insulator specimen in this study. It shows a steel melt layer of approximately 20 microns thickness with an associated heat affected zone (HAZ) of approximately the same thickness. This damage was produced with a single shot and is typical of the entire steel surface. No edge groove is detectable, presumably because only a single shot was fired. This uniform heating cannot be attributed to joule heating from current flow through the rails and armature because that current is known to be localized at the top and bottom edges of the conductors [2].

Figure 11. Micrograph showing typical severe thermal damage to the surface of the steel liner adjacent to the 0.7 meter insulator specimen. This damage resulted from a single shot of the HEMCL railgun.
