## **Demonstration of Corrosion-Resistant Fire Hydrant Retrofits For Military Installations**

Final Report on Project F09-AR12

Edgar Dean Smith, Mark D. Ginsberg, and Clint Wilson

October 2013

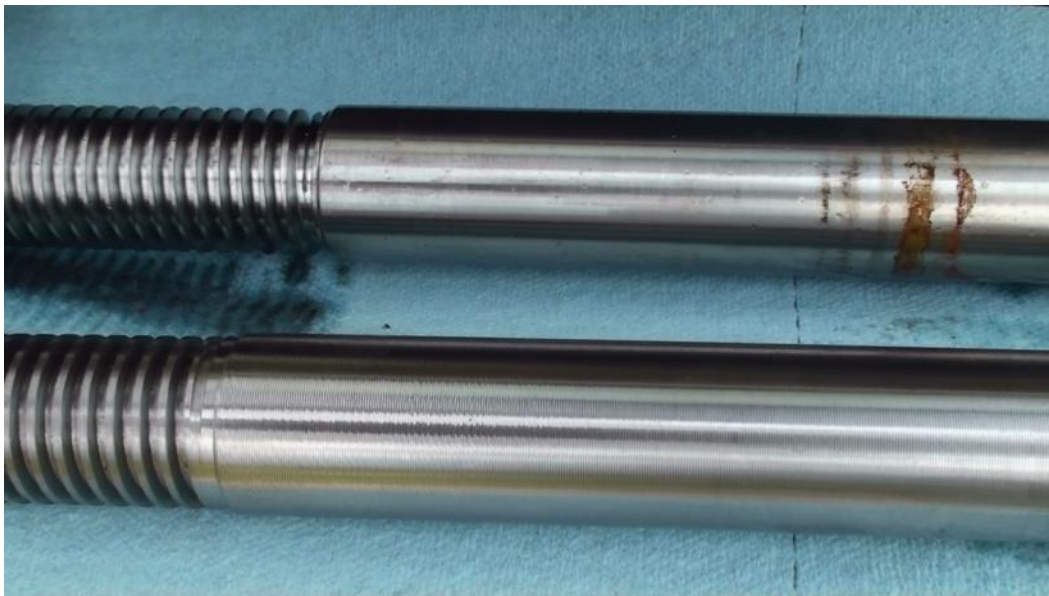
Figure 18. DATV 304 stainless steel stem designed by DATV for a Mueller Standard hydrant after 12 months of exposure (top) and no exposure (bottom).

After 12 months of exposure, none of the inspected stainless steel stems showed any signs of corrosion. Ferrous oxide residue from the lower stem and the bonnet had discolored the stainless steel stem in two places (Figure 18). The cold-rolled stem was severely corroded at the bottom of

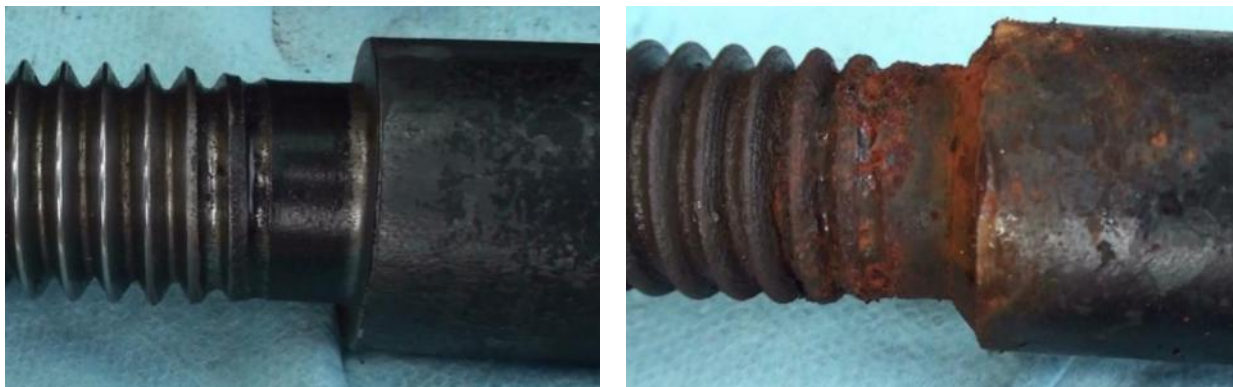
Figure 19. Cold-rolled stem design as supplied by manufacturer (Mueller Standard) with zero days of use (left) and 12 months exposure (right).

the threaded area and the bottom of the stem (Figure 19). The top of the threaded area was protected inside the oil reservoir. The remainder of the stem is protected by the phosphate coating from the manufacturer, but the coating has begun to fail at the thread transition to the solid surface. As a result, lateral undercutting corrosion and blistering has caused the loss of adhesion between the paint and the metal substrate. Further corrosion of the cold rolled stem is expected over time.

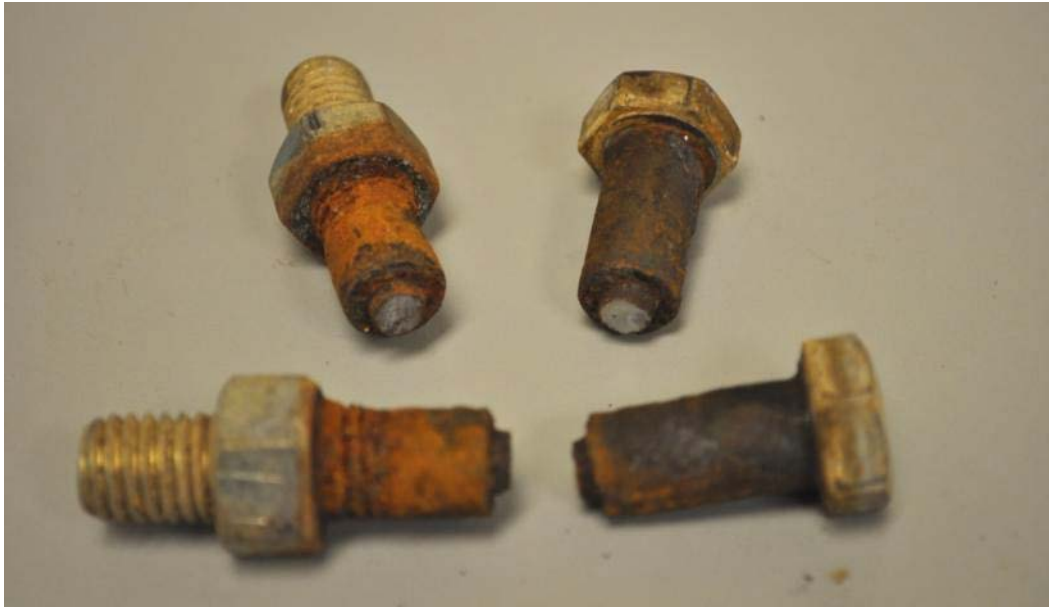
Figure 20. Corrosion on breakaway bolts 12 months after installation.

Most of the inspected DATV parts were in excellent condition after 12 months of use. However, severe corrosion was found on many bolts that hold the upper barrel to the lower barrel. Such corrosion is normal with the breakaway bolts supplied by a hydrant's manufacturer and is unrelated

to the DATV kit. Figure 20 shows two examples of corrosion on breakaway bolts that were removed from service after 12 months of operation.

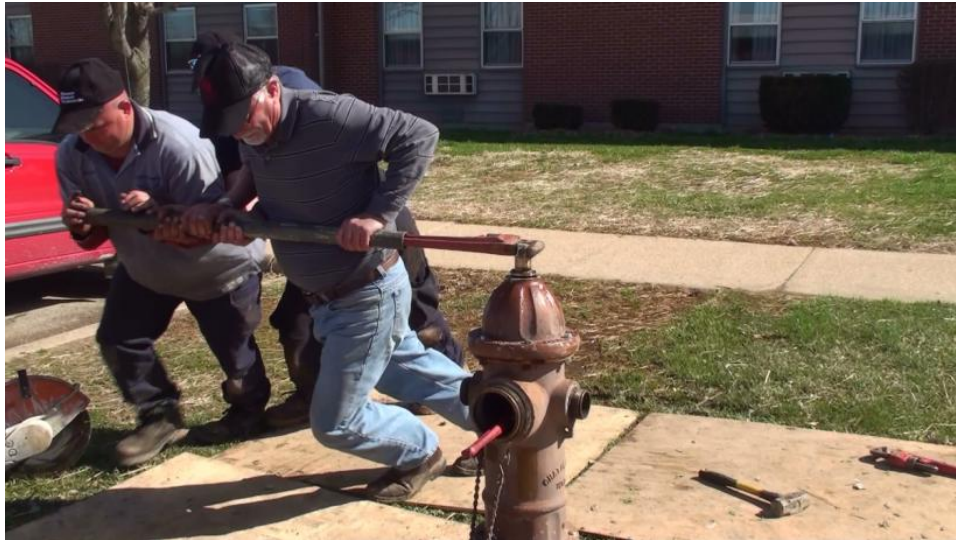
The DATV kits can be installed by a qualified crew in 30–40 minutes. However, if the hydrant is inoperable due to damage or corrosion, installation and maintenance time can increase to 2 hours. Figure 21 and Figure 22 depict the additional efforts required to service a inoperable hydrants in the course of this demonstration.

Figure 21. Three men using a 3 foot cheater bar and a pipe wrench to open inoperable fire hydrant.

It is imperative that installers be trained and certified for DATV retrofit installation for all types of hydrant in place on the installation. Trained installers will be able to avoid errors during installation and will recognize corrosion problems developing in the hydrant soon enough for remedial

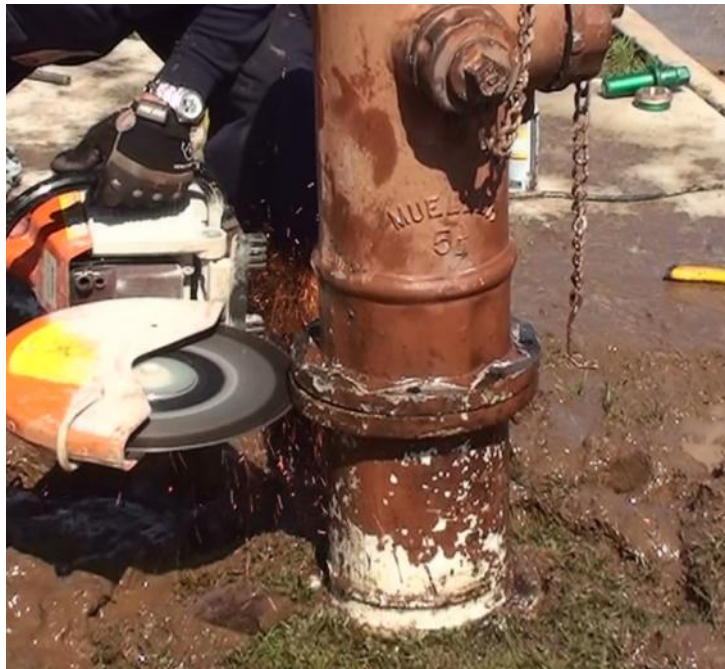
Figure 22. Fire hydrant bolts being cut off due to seizing from corrosion.

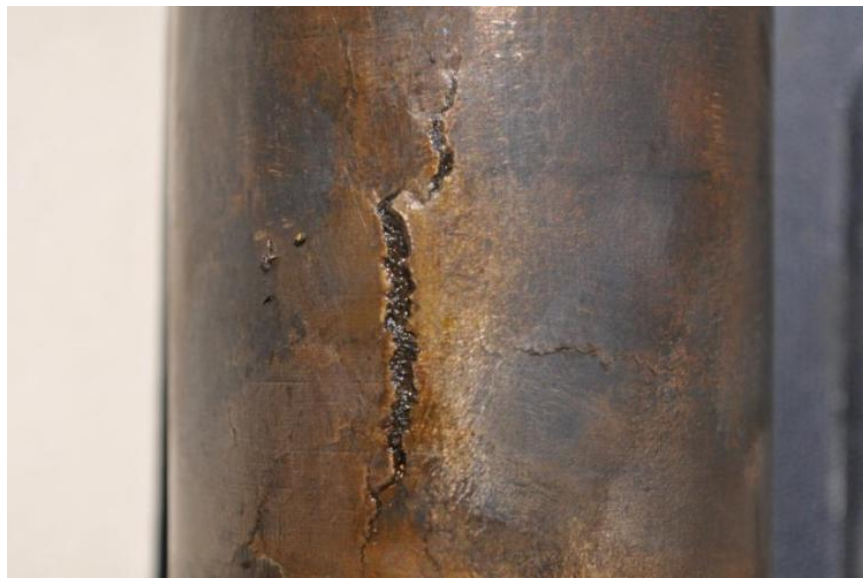
During installation of the DATV kits, several hydrants were found with standing water in the barrel. This was caused by clogging of the weep/drain holes included in the lower barrel of the original hydrant. The weep holes allow water to drain from the barrel after the hydrant is closed.

Water trapped in a barrel can freeze and damage hydrant components. Figure 23 and Figure 24 show cracking and bulging of a brass operating nut caused by water freezing (see Appendix D for analysis). This kind of damage can interfere with hydrant operation. The barrel sleeve included in the DATV kits has a check valve to allow water to drain from the upper barrel, but if the weep holes are clogged, the barrel will not drain.

**Figure 23. Operating nut sleeve\* showing cracks due to freezing water trapped inside the barrel.**

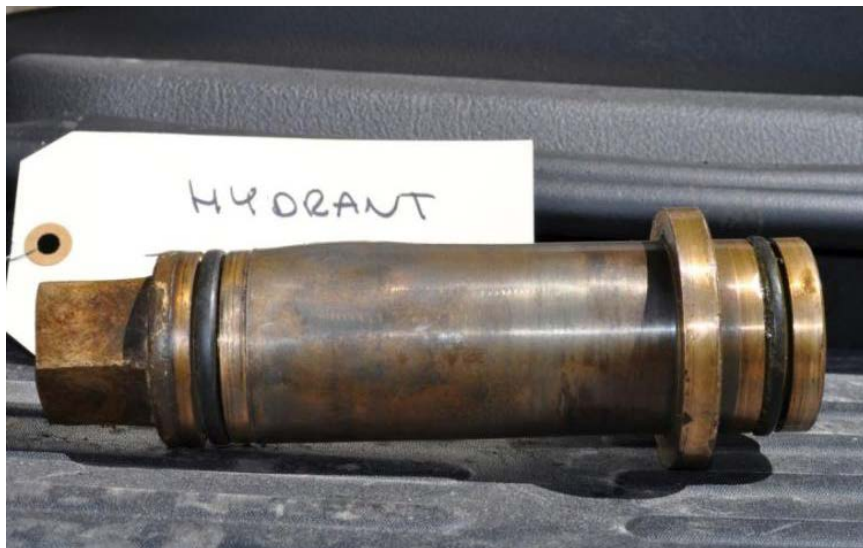
**Figure 24. Bulge in operating nut sleeve.**

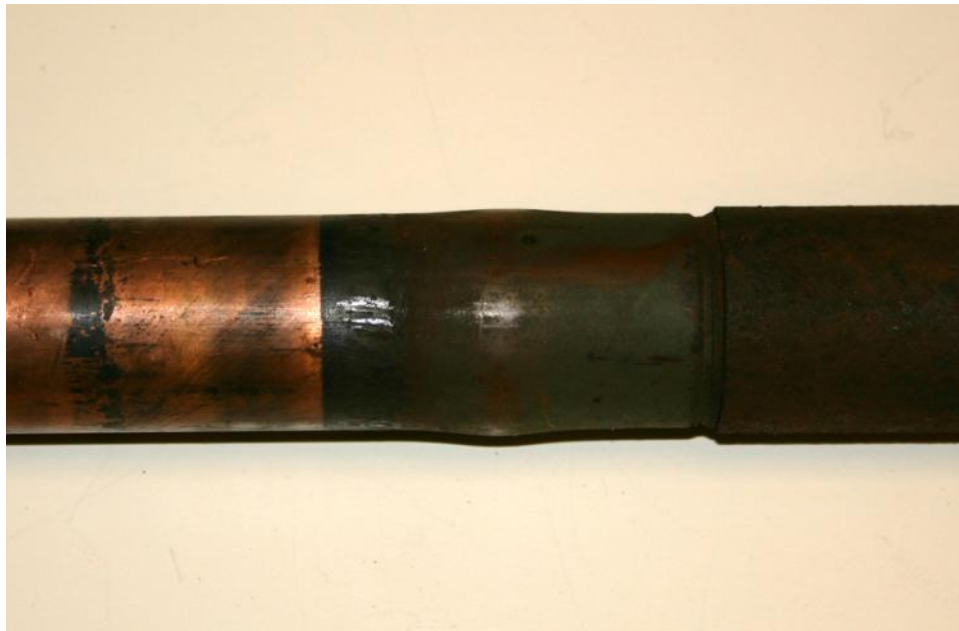
ilar metals caused localized corrosion in the affected area. The increase in volume of the corrosion product caused the copper sleeve to bulge in places where corrosion products accumulated on the steel shaft. In order to stop this type of corrosion in a valve stem of this design, the assembly must be sealed against intrusion of moisture between the copper sleeve and steel stem. If freezing contributed to the bulge, the solution to that problem also would require keeping moisture out of the affected area.

Figure D1. Fire hydrant valve stem showing bulge in copper sleeve.

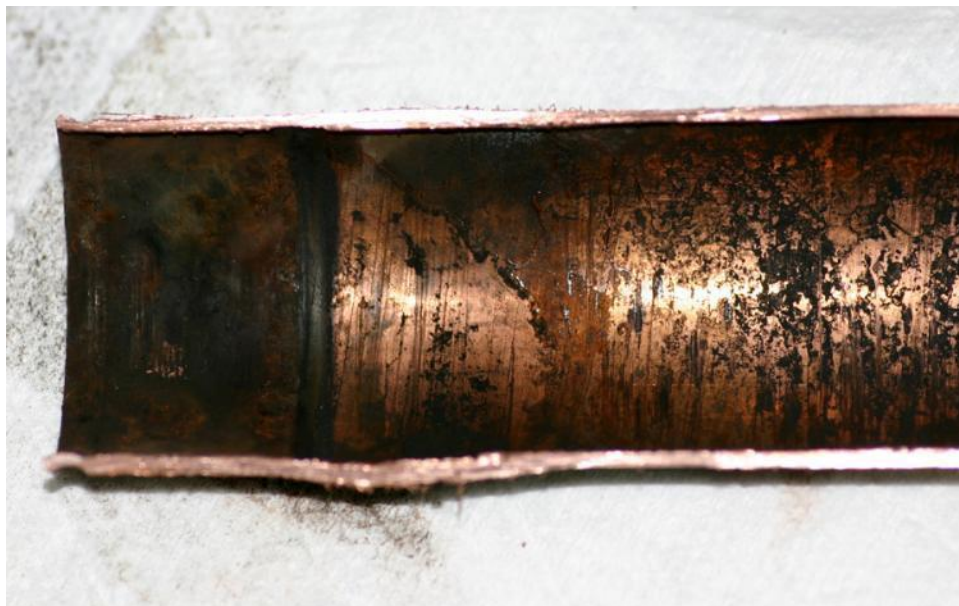
Figure 2. Interior of copper sleeve showing marks from interior o-ring and some residue of iron oxide.

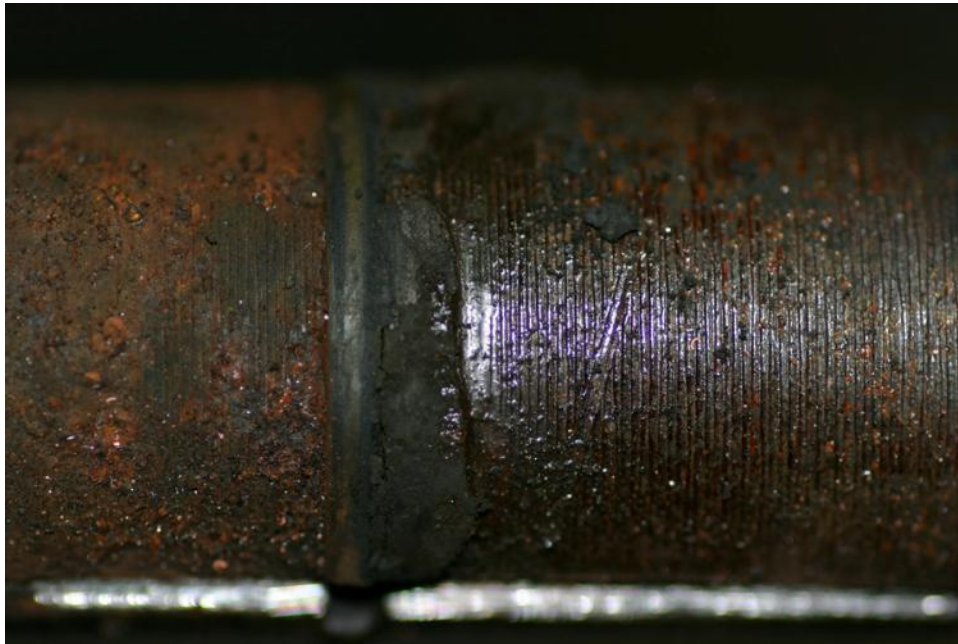
Figure 3. Surface of the valve stem showing buildup of black powder on right side of o-ring.

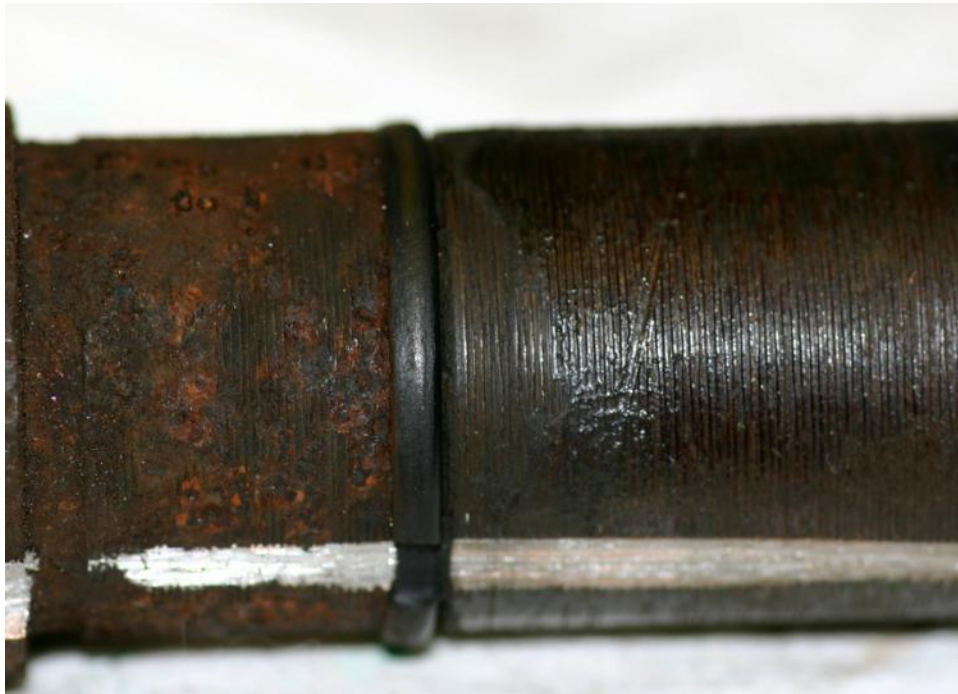
Figure D4. Valve stem after removal of black powder showing area of corrosion attack.

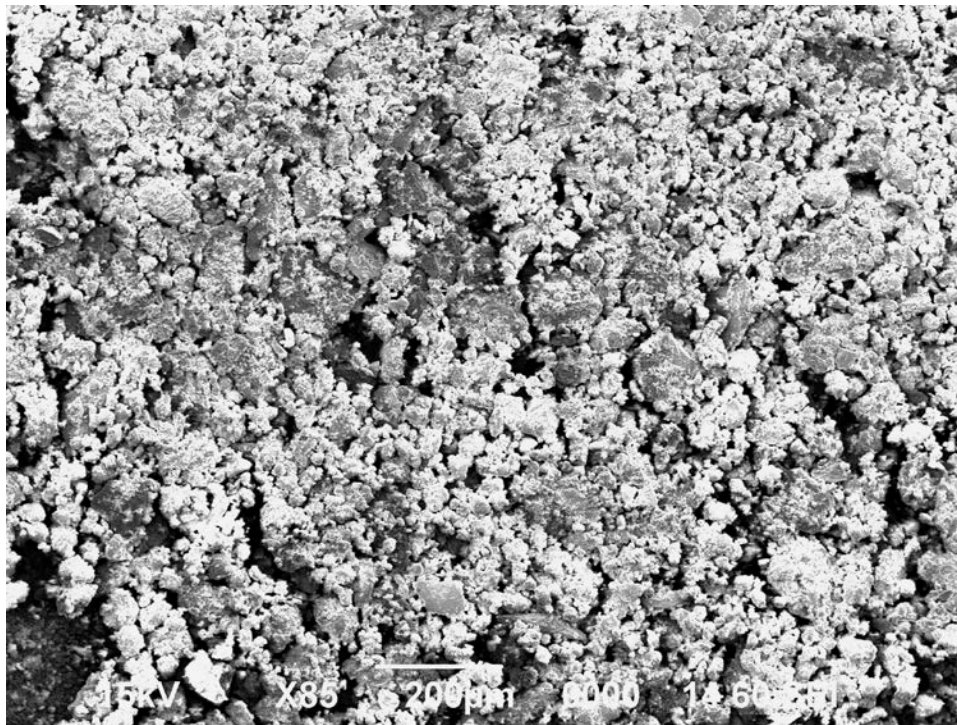
Figure D5. SEM photomicrograph of black powder (85x magnification).
