**Examination of Spray-Applied Oxsilan 9810/2 Steel  
Pretreatment on a Mine Resistant Ambush Protected  
(MRAP) Vehicle**

**ARL-TN-578**

**October 2013**

**Jack Kelley and Tom Braswell**  
**Weapons and Materials Research Directorate, ARL**

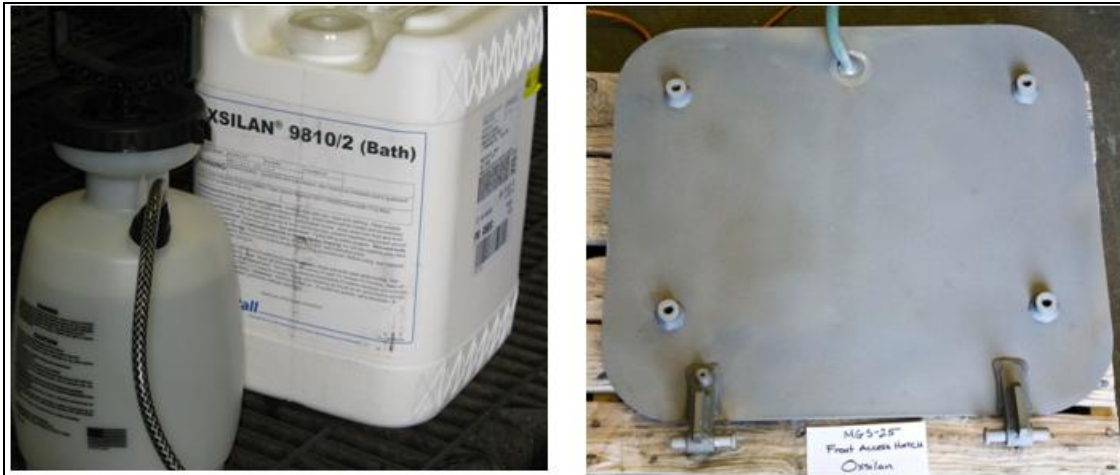
Figure 2. Container of Oxsilan 9810/2 and sprayer used to apply the pretreatments at ANAD (left), Stryker hatch treated with Oxsilan 9810/2 after 19 hours (h) (right).

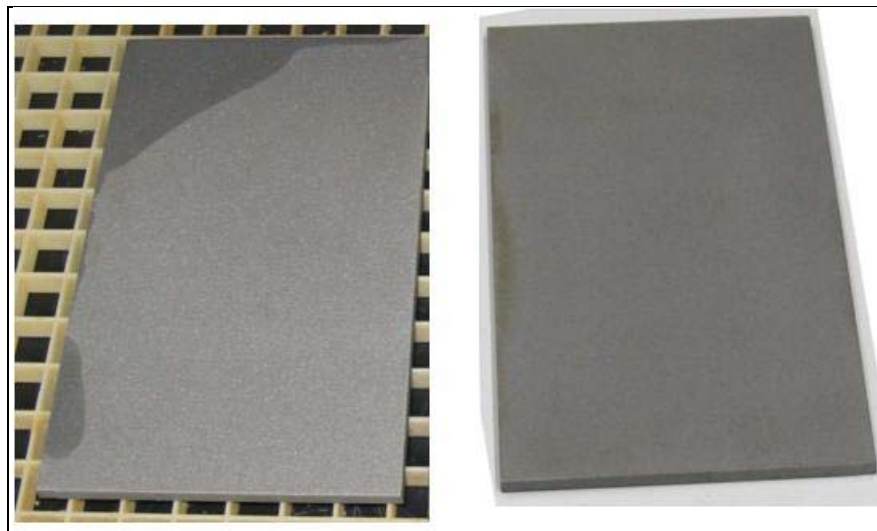
Figure 3. A panel treated with the same batch of Oxsilan 9810/2 from the ANAD demonstration of Stryker (left), shown during drying (right), fully dried 24 h.

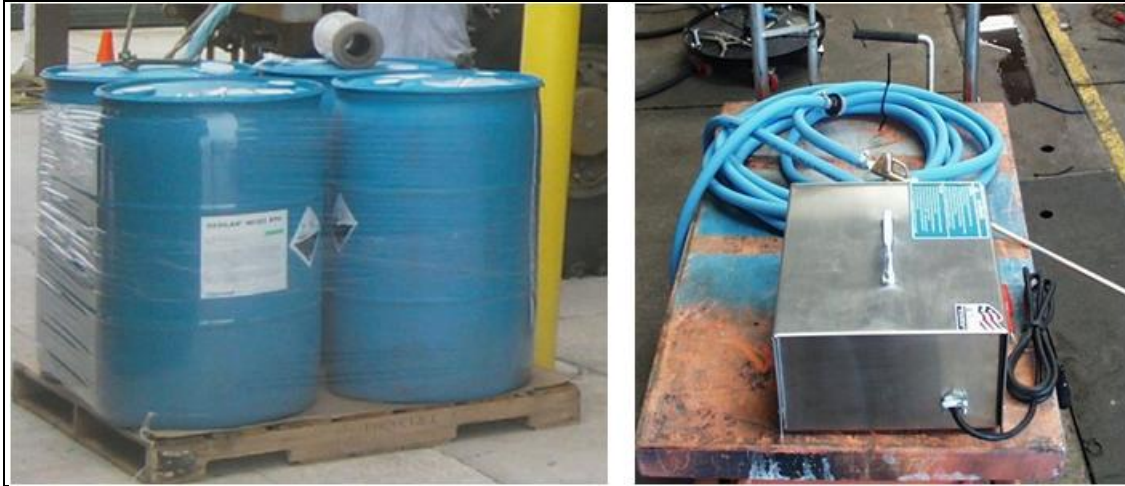
Figure 4. Camp Lejeune demonstration. Drums of Oxasilan 9810/2 RTU (left), and pump sprayer used for applying the pretreatment (right).
