## F-111 Adhesive Bonded Repairs Assessment Program - Progress Report 1: Analysis of FM300 Repairs

*Eudora S. Y. Yeo and Andrew N. Rider*

DSTO-TR-2849

# F-111 Adhesive Bonded Repairs Assessment Program - Progress Report 1: Analysis of FM300 Repairs

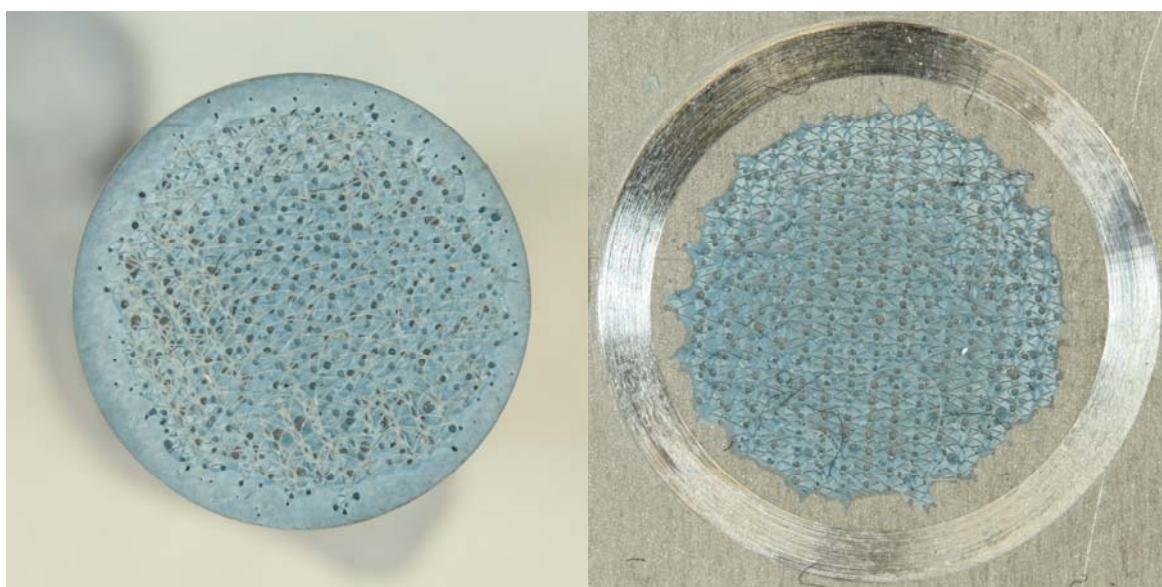
Figure 5 shows the failure surfaces from a 0° test from the second set. This type of failure was not uncommon, with what appears to be adhesion failure in a ring around the edge of the stub. As the test specimens were carefully manufactured and tested in controlled laboratory conditions, the adhesive having been cured and tested within 24 hours and not exposed to any degrading environment, adhesion failure is unlikely. It is possible that this failure surface shows the effect of peel, where the adhesive tends to remain bonded to the stiffer stub and peels away from the more flexible substrate due to the highest strain in the adhesive occurring at the edge of the adhesive layer, close to the flexible substrate.

The failure surfaces of stubs prepared with unstaged adhesive (Figure 5) showed high levels of bondline porosity. General observation of a large number of stubs from tested repairs indicated that bondline porosity was prevalent and could be quite high. The porosity is expected given most repairs were conducted using vacuum bag pressurisation. The results in Figure 4 indicate that porosity may not have any effect on the strength of an

Figure 5 Failure surfaces from a 0° test from the second set with the stub on the left and the substrate on the right. The apparent adhesion failure may actually be the effect of peel in the test configuration. Note that this failure surface shows quite a lot of small voids, which is typical of unstaged adhesive.

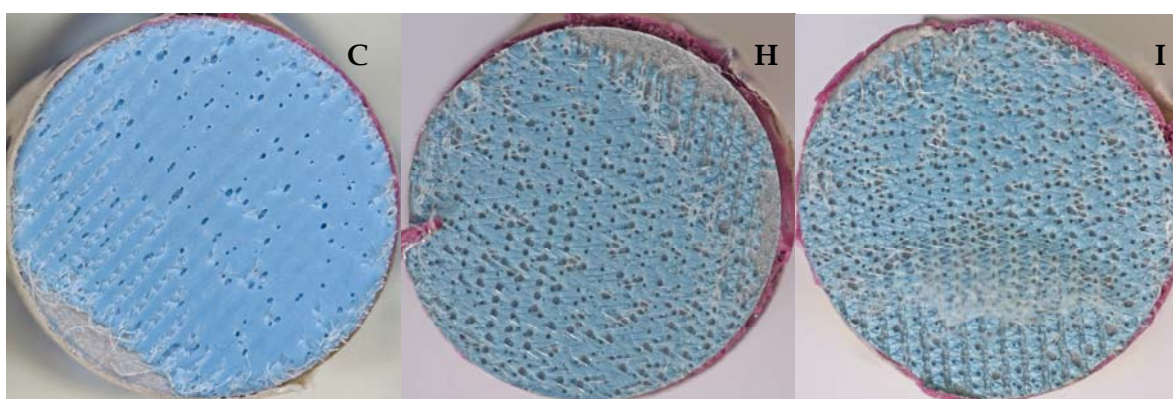
Specifically, repair number five from A8-143 had 10 pull stub tests carried out and 9 of the 10 tests from this repair had strengths below 10 MPa. The low strength repair location on panel 3208 was identified in Figure 9. Table 3 shows a detailed analysis of each of the pull-stub tests from repair 5 on A8-143. It was noted that most stubs exhibited higher levels of voiding than were previously observed on average strength stubs and that some evidence of adhesion failure was noted, shown in Figure 14. The strength below 10 MPa is believed to represent a reduction in strength from the typically applied repair, with high voiding levels suggesting deficiency in the application process, whereby either high humidity

levels may have existed during application or inadequate drying procedures were employed. It is believed that the adhesion failure observed is a direct result of the high voiding levels. As only the stubs were available for detailed examination, it is difficult to tell whether moisture induced degradation was also present.

Note, this repair and many others that were later identified as having heavy voiding, had previously been cleared by non-destructive inspections (NDI) as being of acceptable quality. This illustrates how difficult it is to identify voiding in adhesive bondlines by tap testing and Bondmaster inspections, and even when more sensitive techniques such as ultrasonic scanning is used, there are limitations in transferring laboratory techniques to inspections in the field. A recent review of NDI techniques for composite materials covers some of the limitations of current and emerging technology [7].

*Figure 14 Test stubs C, H and I from repair A8-143-05. "C" shows the smooth surface typical of adhesion failure, while H and I show heavy voiding.*

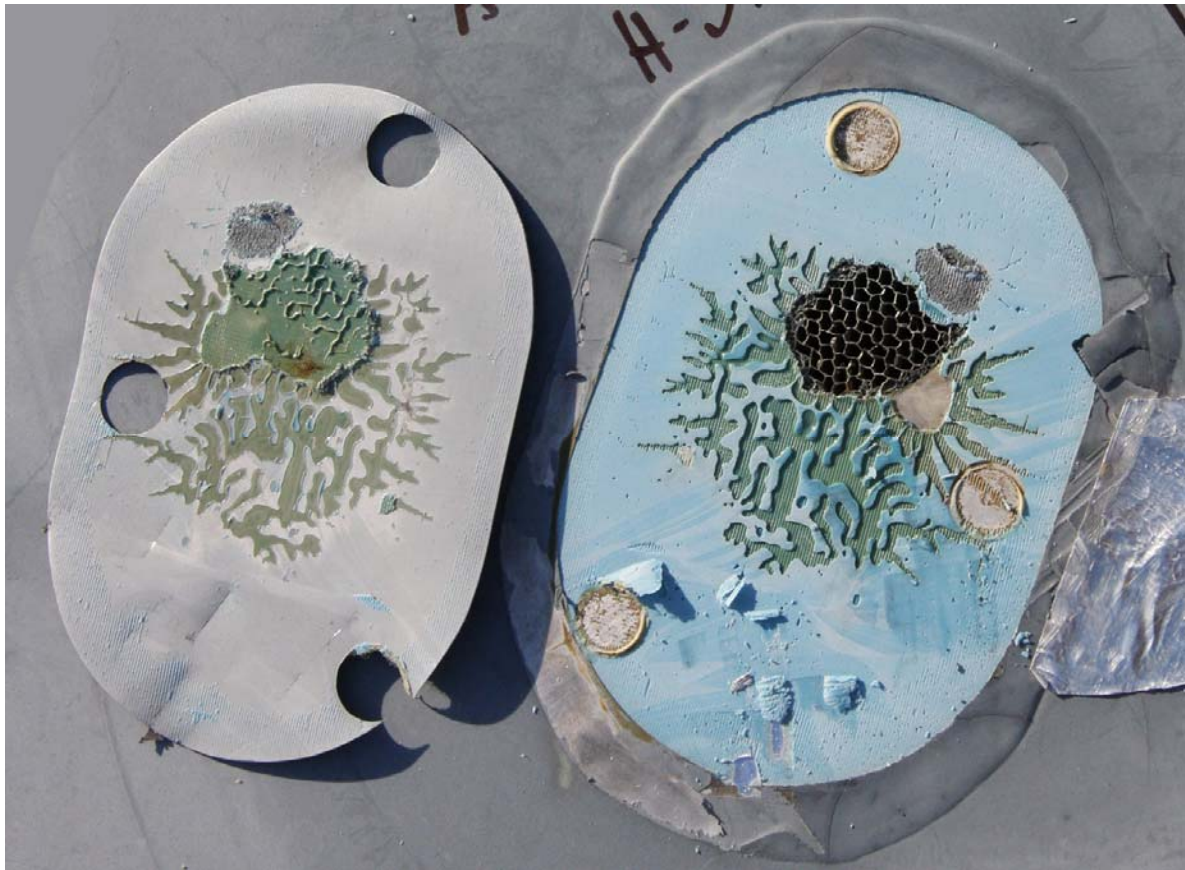
A total of 21 stubs showed heavy voiding associated with lines or tracks that had emanated from the central core region. These indications are highlighted in green in Table 3 and Table 4. A core repair requires cleaning by solvent flushing, followed by drying to remove the solvent. The heavy void tracks, an example of which is shown in Figure 17, are indicative that inadequate drying of the core had occurred prior to the elevated temperature cure of the FM300.

*Figure 17 Repair 514-28 shows heavy voiding emanating from the repaired core, indicative of inadequate drying following cleaning.*

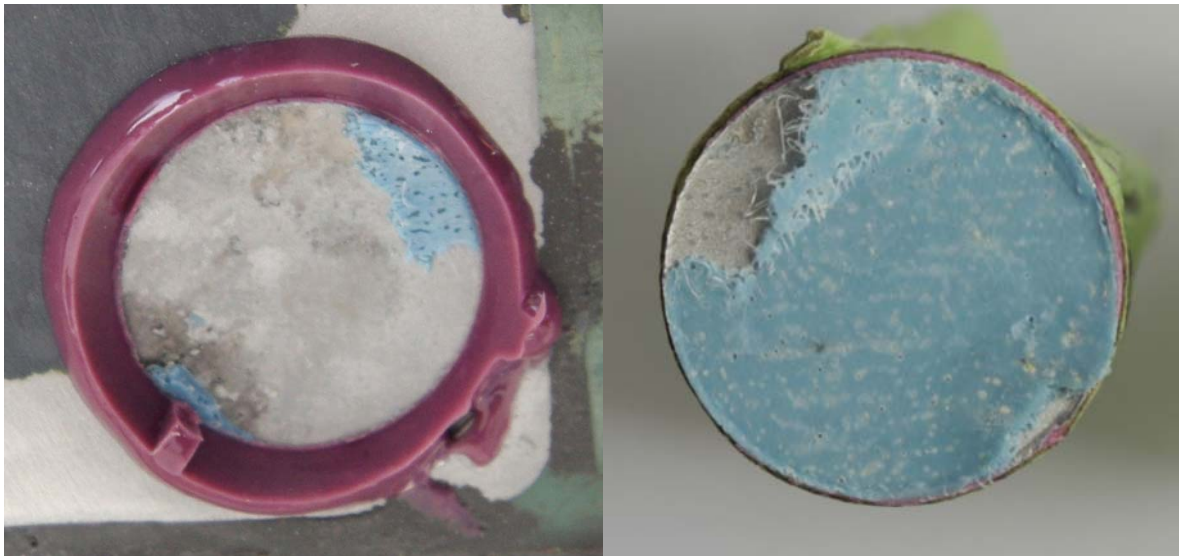
There were 6 stubs which indicated localised corrosion had occurred, including the lowest stub strength recorded for the filtered dataset, which was stub 11D on A8-514. Photographs of the test stub are shown in Figure 18. Inspection of this repair indicated that corrosion was in a very localised area where the low strength stub was pulled, whereas the stub pulled in an area representative of the unaffected region had a strength over 20 MPa. This indicates that the overall repair strength was satisfactory, but localised corrosion had led to significant bond strength reduction. Potentially, the long term storage of the aircraft in an outdoor location, and a long period without maintenance prior to the repair inspection (records indicate that the aircraft had been taken out of service seven years prior to inspection), had led to the corrosion of the repair due to deterioration of the protective paint layer and sealant. Nevertheless, the localised corrosion has clearly developed at a very slow rate and would be identified readily during normal maintenance of the aircraft.

*Figure 18 Test area exhibiting corrosion (stub 11D on A8-514). The aircraft side is shown on the left, and the test stub (removed doubler) on the right.*
