# **Technical Solution for Mitigating Radio-Frequency (RF) Interference to Air Traffic Control Communications**

**ARL-TR-6596**

**September 2013**

**Robert L. Atkinson**  
**Sensors and Electron Devices Directorate, ARL**

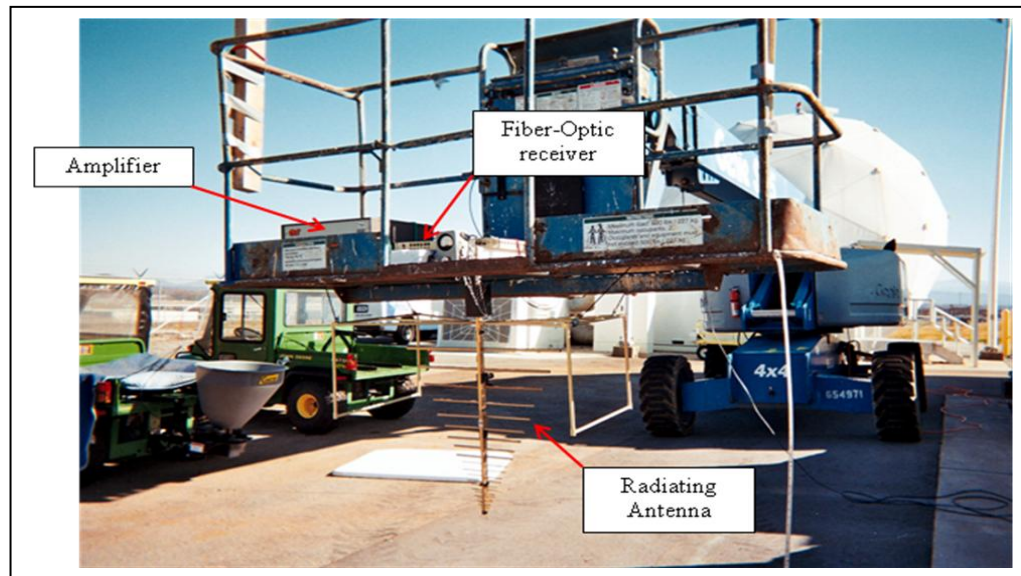
Figure 2. Fiber-optic receiver and amplifier in lift-bucket.

Typically, the network analyzer and fiber-optic transmitter are co-located. If a RF shielded room is available, both instruments would reside inside the shielded area. The fiber-optic receiver and amplifier are also co-located. More often than not, they reside outside of the shielded area and relatively close to the radiating antenna. As an example, figure 2 shows a typical setup configuration for the transmit portion of the test setup.
