**Special Inspector General for
Afghanistan Reconstruction**

SIGAR 14-13 Inspection Report

Forward Operating Base Sharana: Poor Planning
and Construction Resulted in \$5.4 Million Spent
for Inoperable Incinerators and Continued Use of
Open-Air Burn Pits

DECEMBER
2013

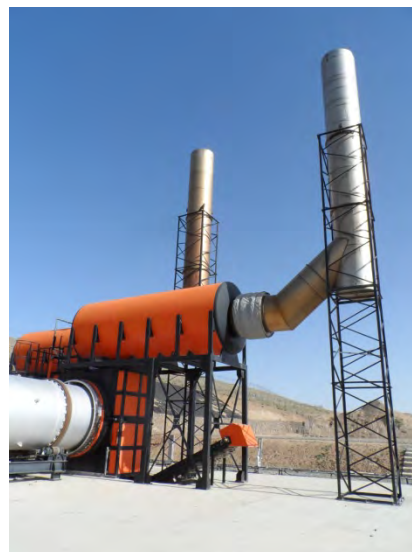
Our site inspection on May 20, 2013, found that the two incinerators installed at the site were not in operation. As a result, we could not fully assess the extent to which the facility met technical specifications. However, we were able to determine that (1) the project experienced significant construction delays; (2) the facility had electrical supply problems that could pose safety hazards; and (3) the incinerators, if made operational, could only be used by manually loading and unloading waste and would be limited to about 80 percent of the capacity called for under the original contract. Photo 1 shows the two incinerators at FOB Sharana.

Photo 1 - Two 40-Ton Capacity Incinerators at FOB Sharana

Our inspection also found that even if the electrical deficiencies were corrected, the incinerators could not be fully used. Although the contract required installing an incinerator facility with the capacity to process 24 tons of solid waste per day, two 40-ton capacity incinerators were actually installed at the facility.⁷ Based on our observations and discussions with base personnel, we determined that the physical layout of the incinerators, as constructed, would allow them to process only 20 tons of solid

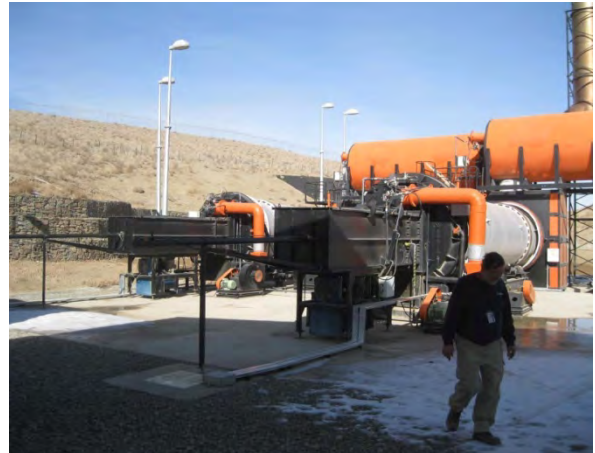
waste daily, which is about 80 percent of the capacity called for under the contract. As constructed, the incinerators also share a common loading area, which is too narrow to allow equipment, such as trash haulers and forklifts, to load the units with solid waste. As a result, solid waste would need to be manually loaded into the incinerators. In addition, the ramps to access the ash ejected from the incinerators are inaccessible to the equipment needed to load and transport the ash to a nearby pit. This design flaw means that workers would need to load wheel barrels and manually transport the ash. Photo 2 shows the narrow loading area for the two 40-ton incinerators.

Photo 2 - Loading Area for Incinerators

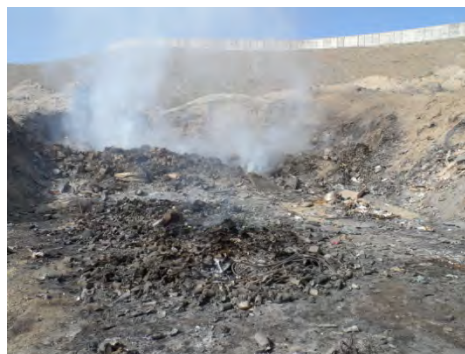
burn pits. Since the regulation's establishment in 2011, FOB Sharana had been using open-air burn pits in violation of the CENTCOM regulation. Photo 3 shows the open air burn pits and emissions at FOB Sharana.

Photo 3 - Open-Air Burn Pit Emissions
