AL IQITADAR SCHOOL
UNDER THE COMMANDER'S EMERGENCY RESPONSE PROGRAM
ANBAR PROVINCE, IRAQ

SUSTAINMENT ASSESSMENT

SIGIR PA-08-141
JANUARY 26, 2009

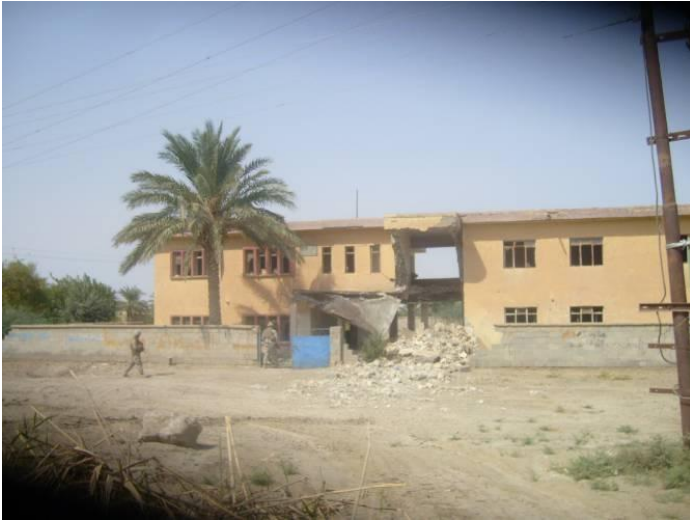
The school is located in the Saqlawiyah neighborhood in Anbar province, Iraq, (Figure 1 and Site Photo 1). Site Photos 2 and 3, courtesy of MNC-I, document the destruction the school experienced during the fighting.

**Site Photo 2. Al Iqitadar School destruction
(Courtesy MNC-I)**

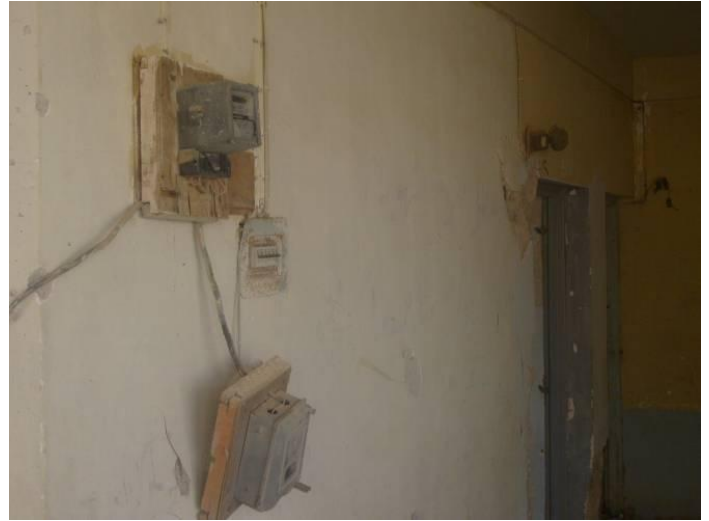
**Site Photo 3. Electric panel destruction
(Courtesy MNC-I)**

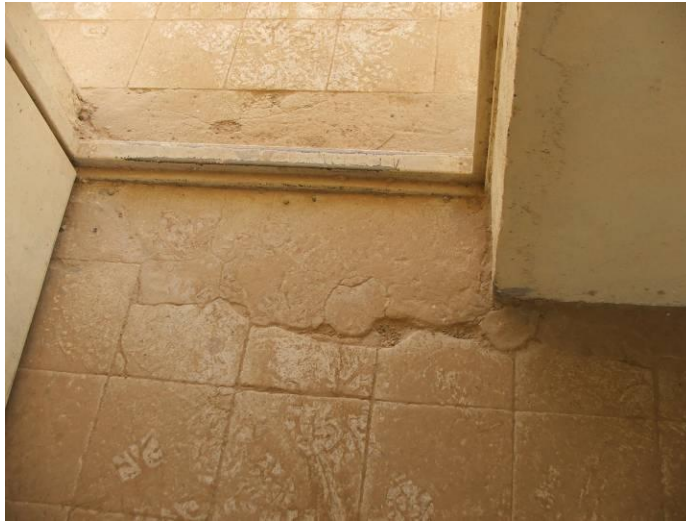
During the site visit, SIGIR observed the construction of the new classroom buildings. The roof tiles appeared to be in good condition throughout the expanse of the roof. There were drainage holes at the roof's edges, which will allow water to drain from the roof. The exterior and interior walls appeared to be adequately repaired/replaced. The majority of the interior tile and concrete floor work was good; however, there were areas of broken tiles and uneven floors (Site Photo 7).

Site Photo 7. Uneven floors

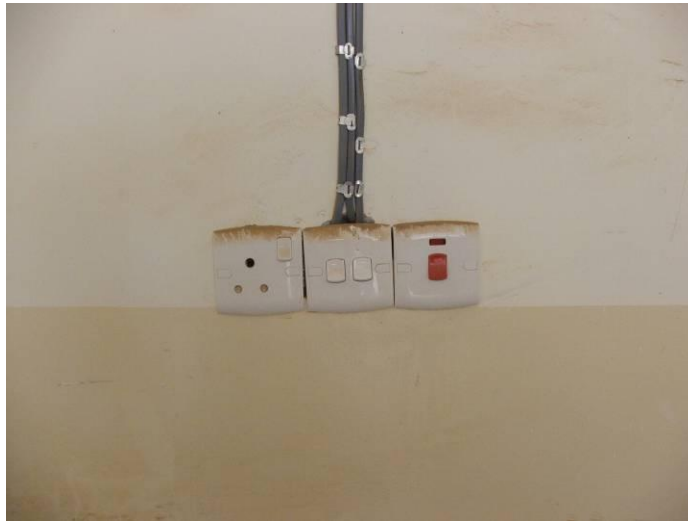
SIGIR verified the existence of the replaced wiring system by testing the newly installed switches, lighting fixtures, and ceiling fans (Site Photo 8). While going through the classrooms, SIGIR periodically tested the lights and ceiling fans, which were found to be functioning properly. According to the contract's SOW, the contractor was required to "install AC units." It did not appear that the A/C units or mounts for the A/C units were ever installed.

Site Photo 8. Switches

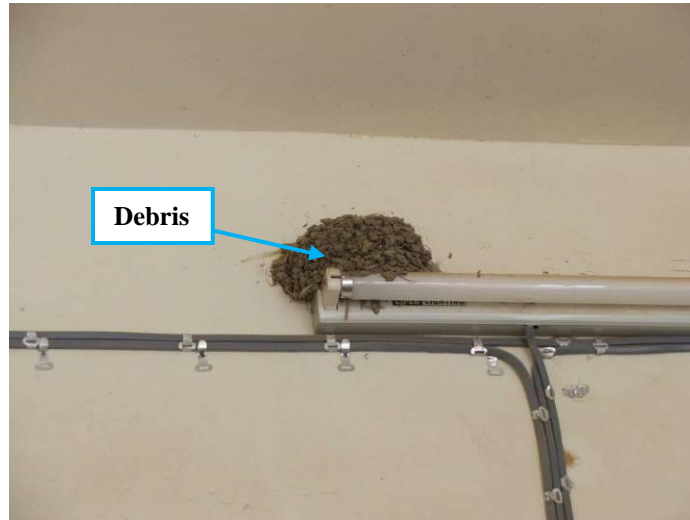
During the site visit, SIGIR did not detect any instances of potentially harmful electrical system tampering. However, some of the light fixtures housed debris from a lack of routine maintenance (Site Photo 9).

Site Photo 9. Debris on light fixture
