AL SHURHABIL SCHOOL
UNDER THE COMMANDER'S EMERGENCY RESPONSE PROGRAM
ANBAR PROVINCE, IRAQ

SUSTAINMENT ASSESSMENT

SIGIR PA-08-142
JANUARY 21, 2009

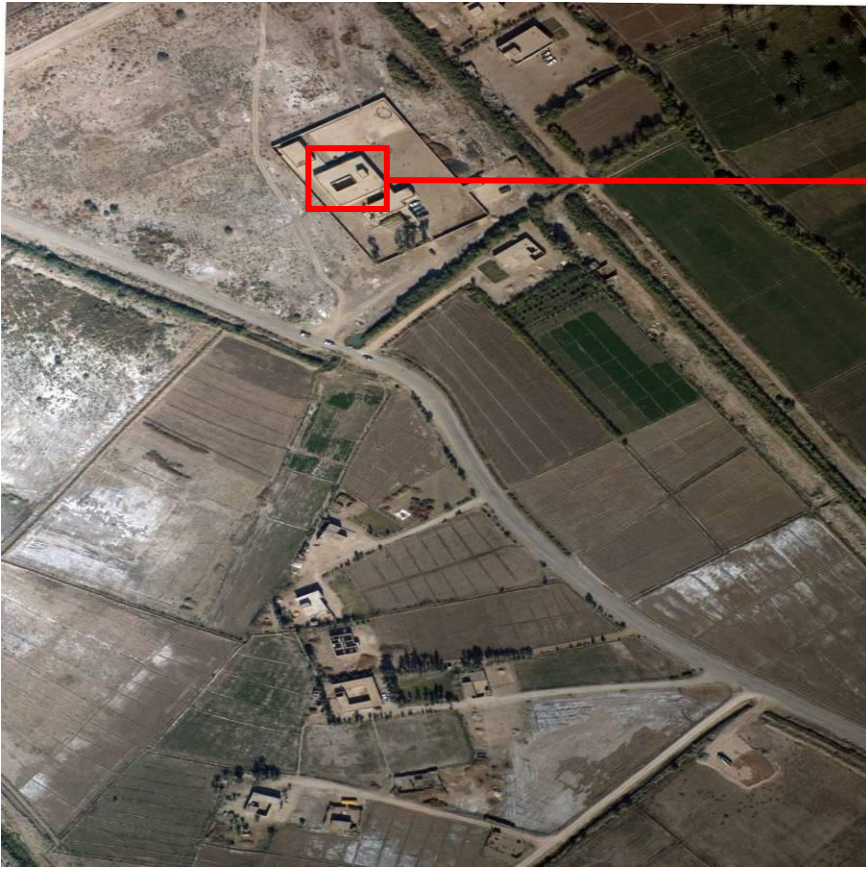
Site Photo 1. Entrance to the Al Shurhabil School

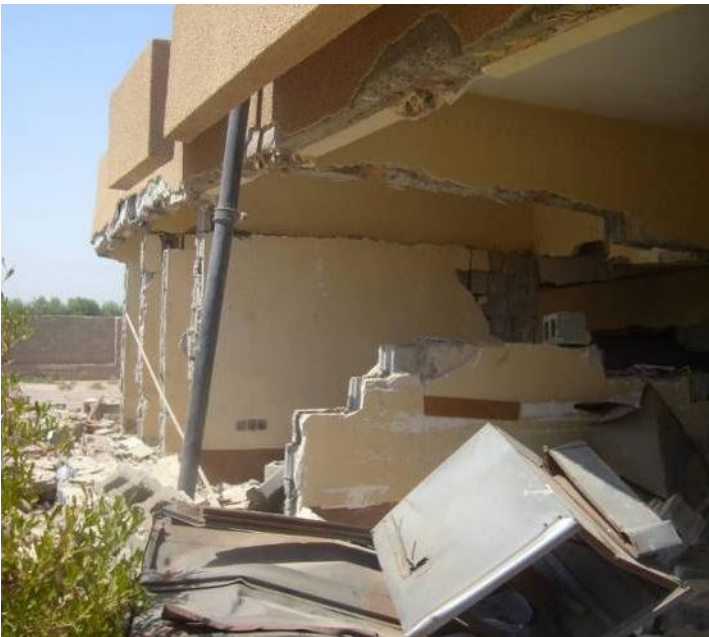
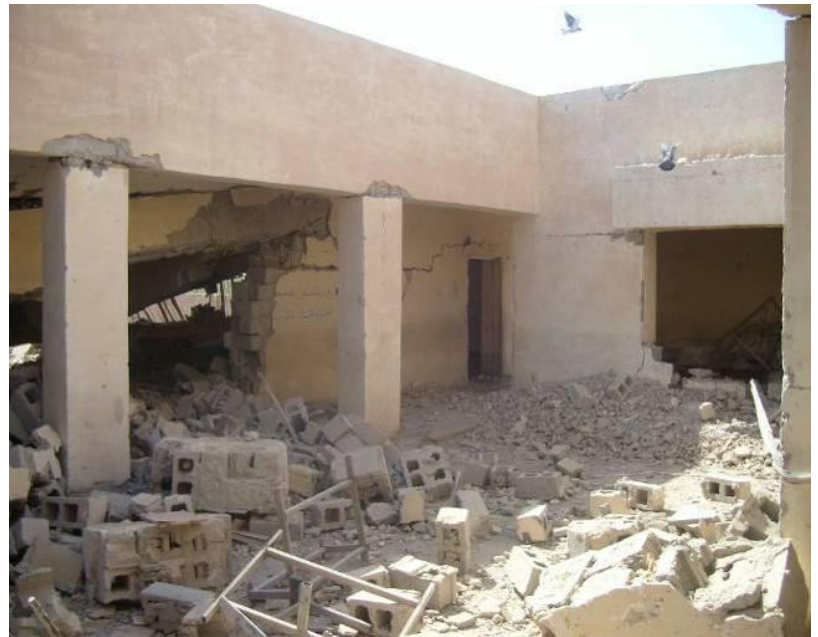
Site Photos 2 and 3. Condition of the Al Shurhabil School prior to refurbishment
(Photos courtesy of MNF-I)

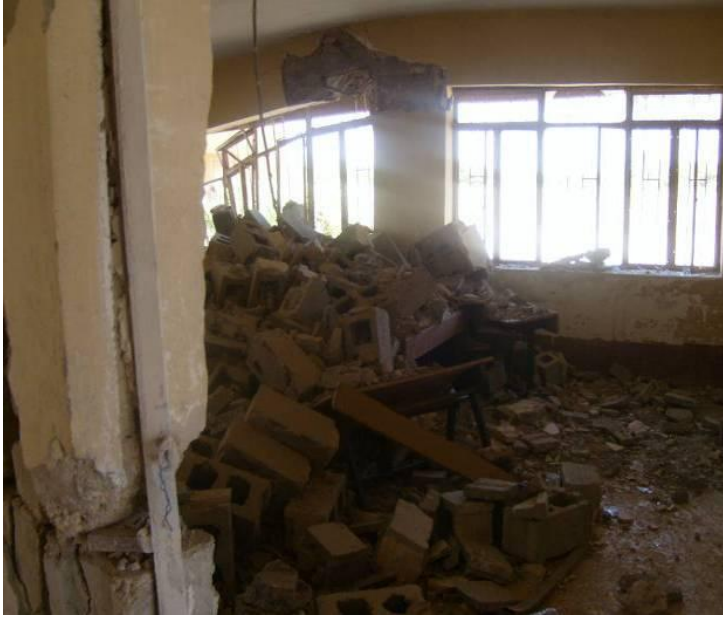
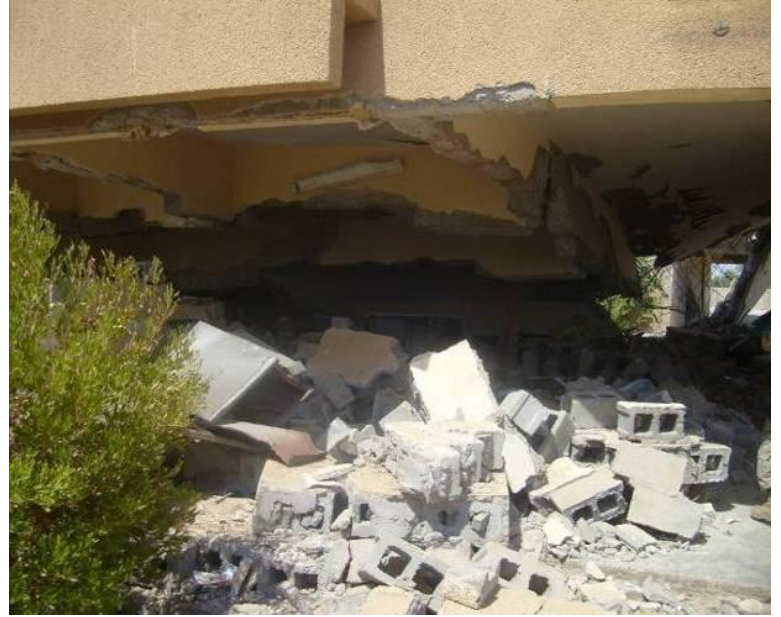
**Site Photos 4 and 5. Condition of the Al Shurhabil School prior to refurbishment
(Photos courtesy of MNF-I)**

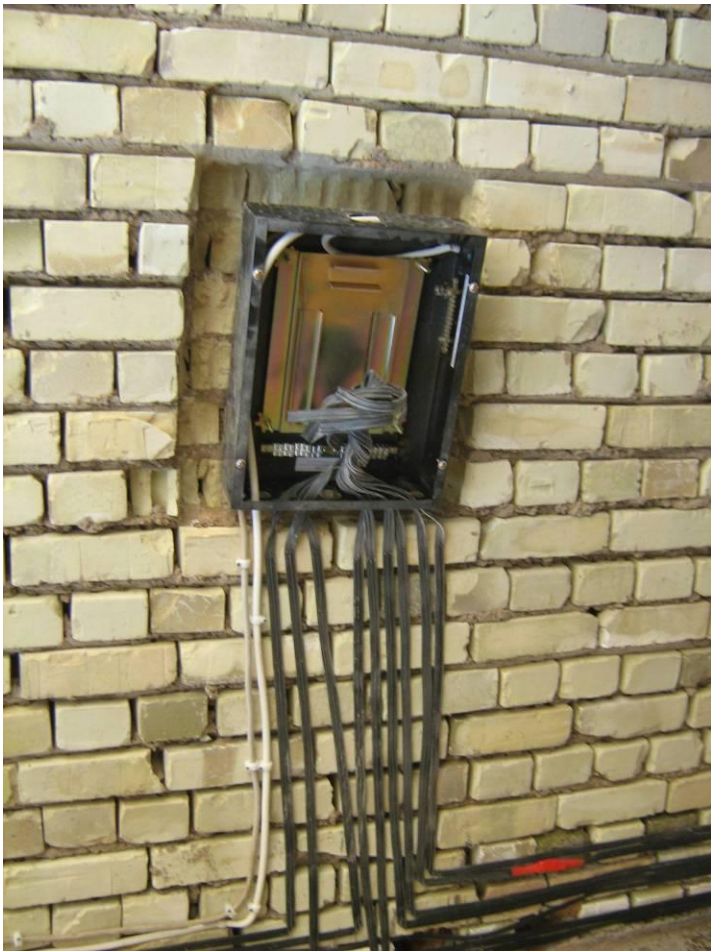
Site Photo 6. Installation of electrical wiring
(Photo courtesy of MNF-I)

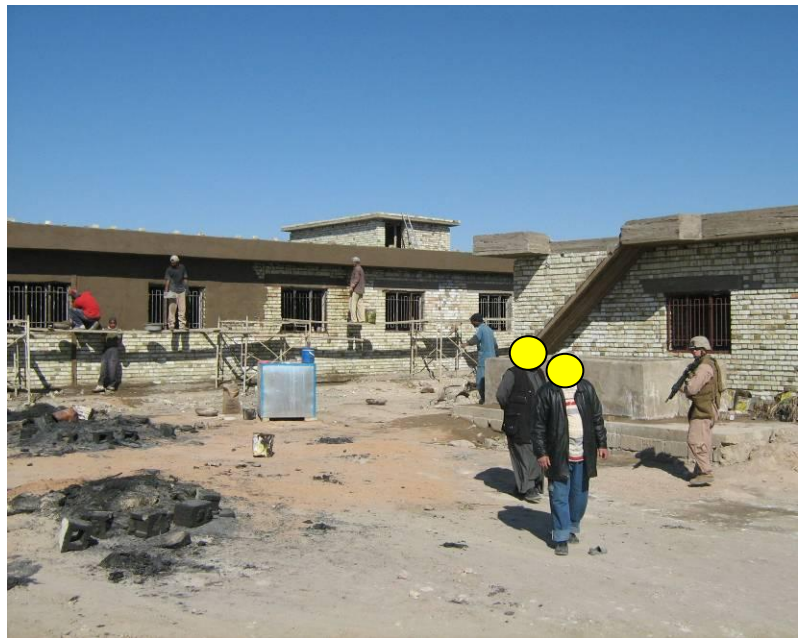
Site Photo 7. Ongoing general construction
(Photo courtesy of MNF-I)

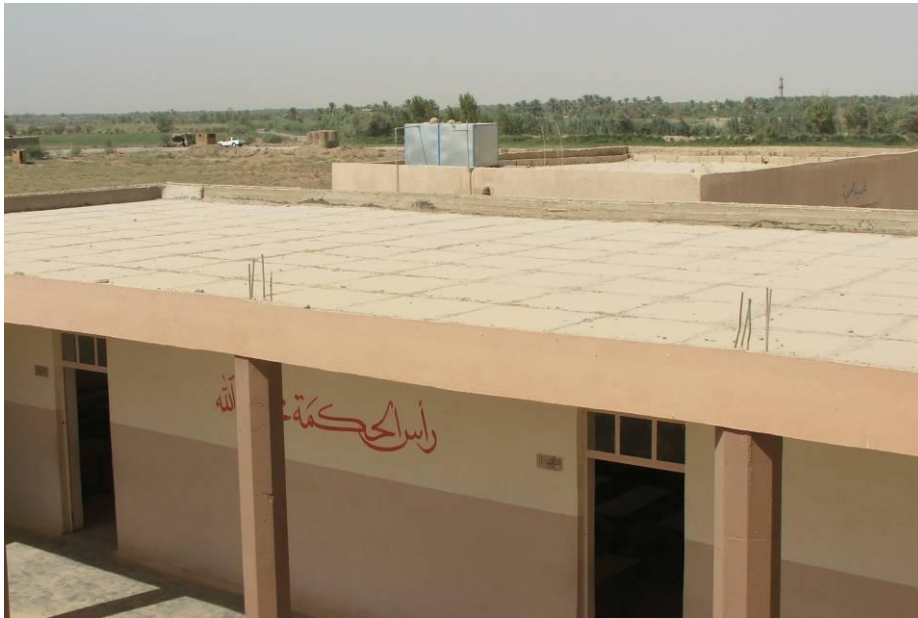
During the site visit, SIGIR observed the construction of the new classroom buildings. The roof tiles appeared to be in good condition throughout the expanse of the roof (Site Photo 8). There were drainage holes at the roof's edges, which will allow water to drain from the roof. The exterior and interior walls appeared to be adequately repaired/replaced (Site Photos 9 and 10). The majority of the interior tile and concrete floor work was good; however, there were areas of missing and broken tiles, as well as, uneven floors (Site Photo 11).

Site Photo 8. Condition of the roof tiles after renovation

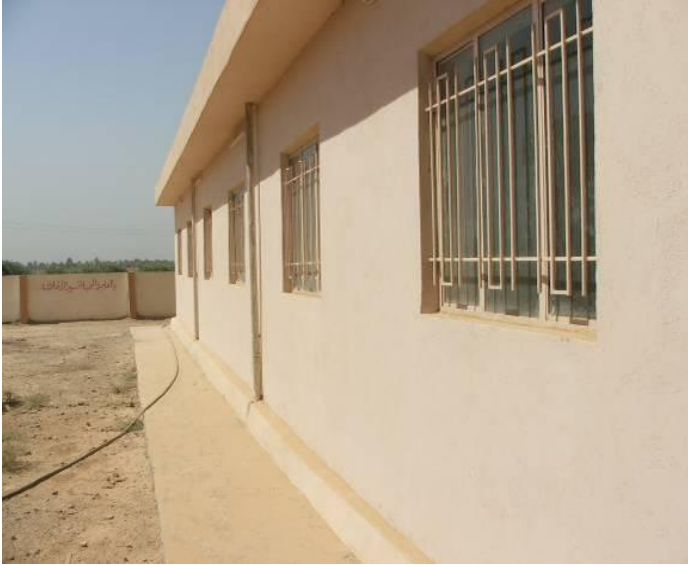
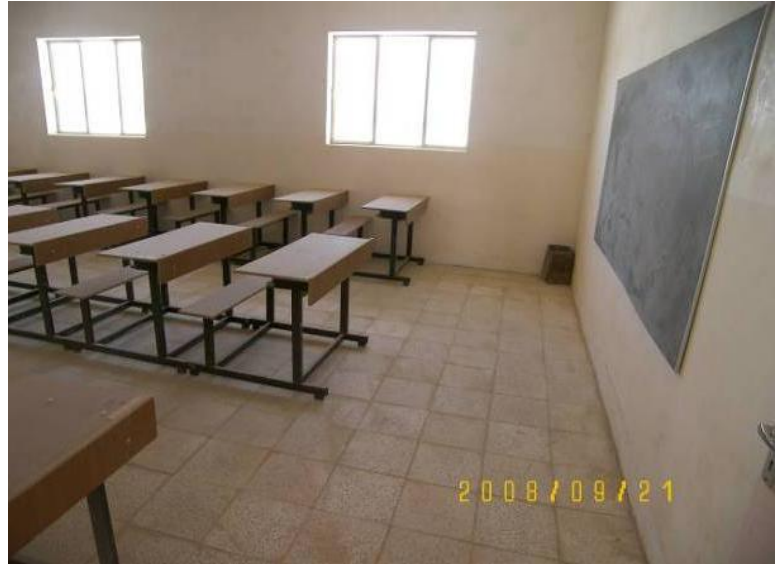
Site Photos 9 and 10. Adequately repaired exterior and interior school building walls

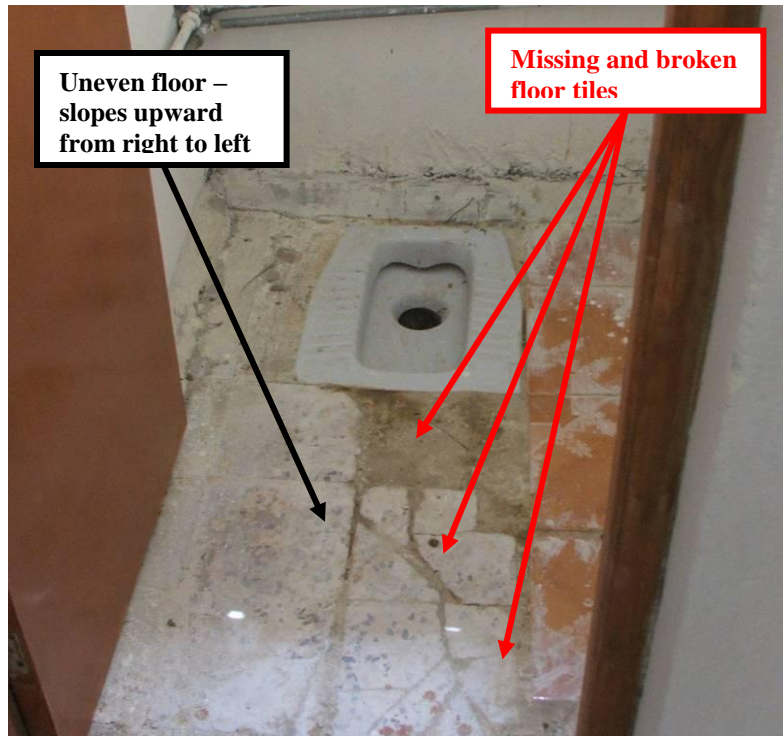
Site Photo 11. Example of uneven and broken floor tiles

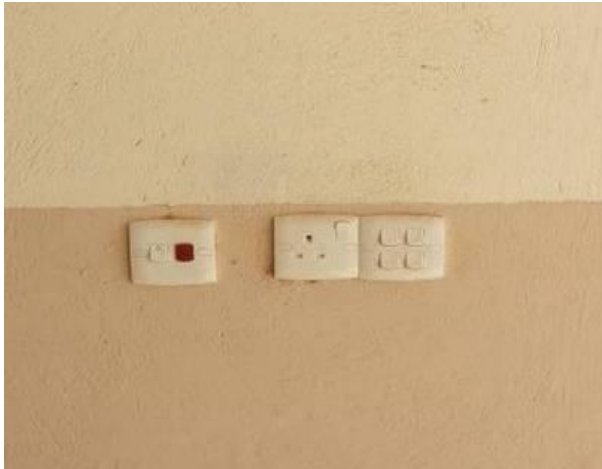
SIGIR verified the existence of the replaced wiring system by testing the newly installed switches, lighting fixtures, and ceiling fans (Site Photos 12 and 13). While going through the classrooms, SIGIR periodically tested the lights and ceiling fans and found them functioning properly. Although the mounts were constructed to hold A/C units, the actual A/C units were missing (Site Photo 14). It did not appear that the A/C units were ever installed. SIGIR asked the school's Headmaster about the A/C units; he responded

Site Photo 12. Installed light switches

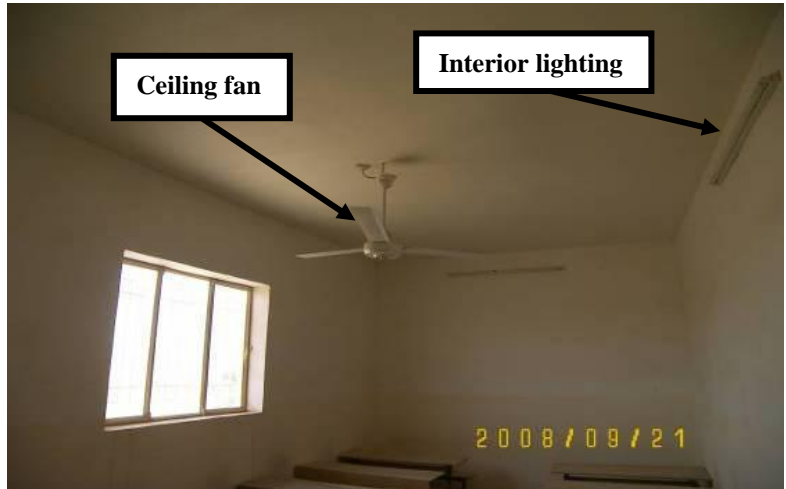
Site Photo 13. Newly installed ceiling fan and interior lighting

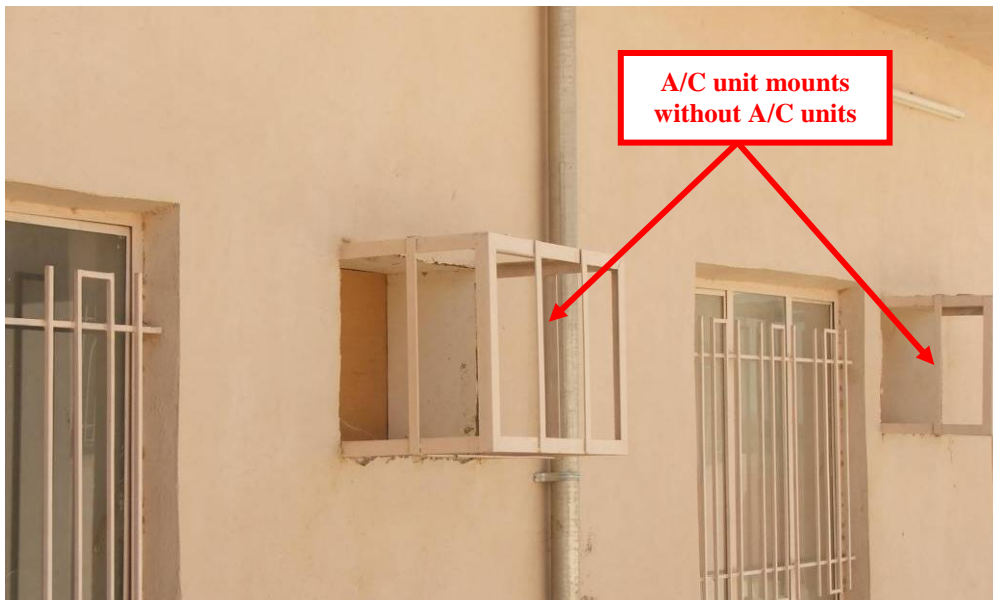
that the units were not part of the contract. However, according to the contract's SOW, the contractor was required to "install AC units." SIGIR also observed the main electrical circuit board, which appeared to be adequately installed.

Site Photo 14. Properly installed A/C mounts; however, no A/C units

The construction appeared to be adequate and to satisfy the work required by the Statement of Work, except for the issue of air conditioning units. During the site visit, SIGIR observed air conditioning mounting units, but not the actual air conditioning units.

According to the school's Headmaster, the contract did not call for the delivery and installation of the air conditioning units; however, this is contradicted by the Statement of Work, which required the contractor to "install AC [Air Conditioning] units." The project file lacked any documentation to determine whether the air conditioning units were ever delivered to the school.

SIGIR recommends that the Commanding General, Multi-National Corps-Iraq, and the Commanding Officer, U.S. Marines Regimental Combat Team determine the status of the air conditioning units - specifically whether the contractor was paid to deliver and install the air conditioning units.

The Multi-National Forces-Iraq responded that the Iraqi Director General of Education is in the process of verifying the location of the air conditioning units. Once the Director General of Education completes the verification process, he will send a status report to the Multi-National Forces-West.

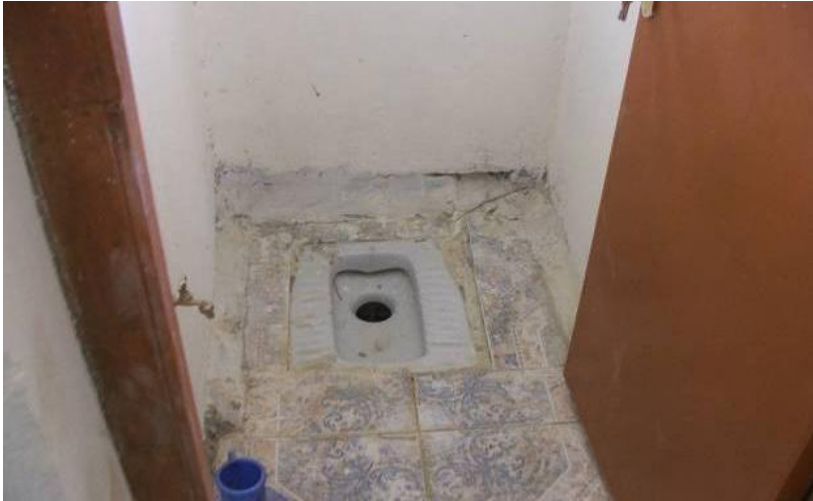
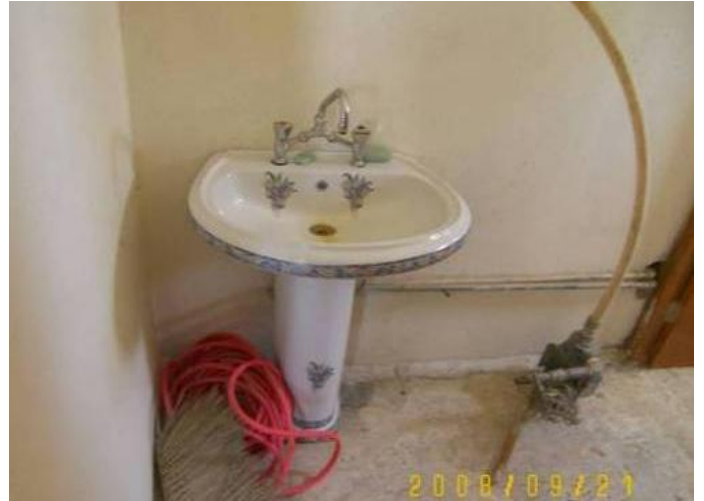
The school's bathroom facilities consisted of an inside bathroom for the teachers and administration staff and an outside bathroom for students. The inside bathroom consisted of four eastern-style toilets and a single sink (Site Photos 15 and 16). There were instances of crude construction techniques used in the inside bathroom, such as the tile installation securing of plumbing; however, the toilets and sink were functional and operational when tested.

Site Photos 15 and 16. Eastern-style toilet and sink in the inside bathroom facility

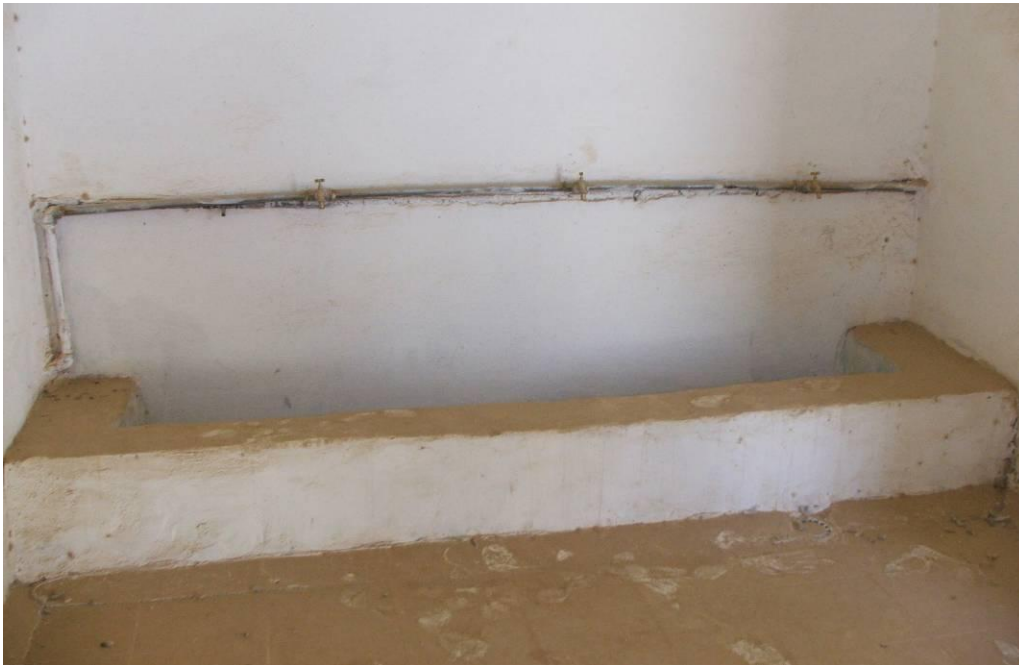
The outside bathroom facility consisted of eastern-style toilets, a sink, and a concrete bench to wash feet (Site Photo 17). This facility was more difficult to assess because of a significant amount of dirt throughout (Site Photo 18). Some of the toilets were clogged with debris from a lack of routine maintenance.

Site Photo 17. Feet washing bench within the students' outside bathroom facility

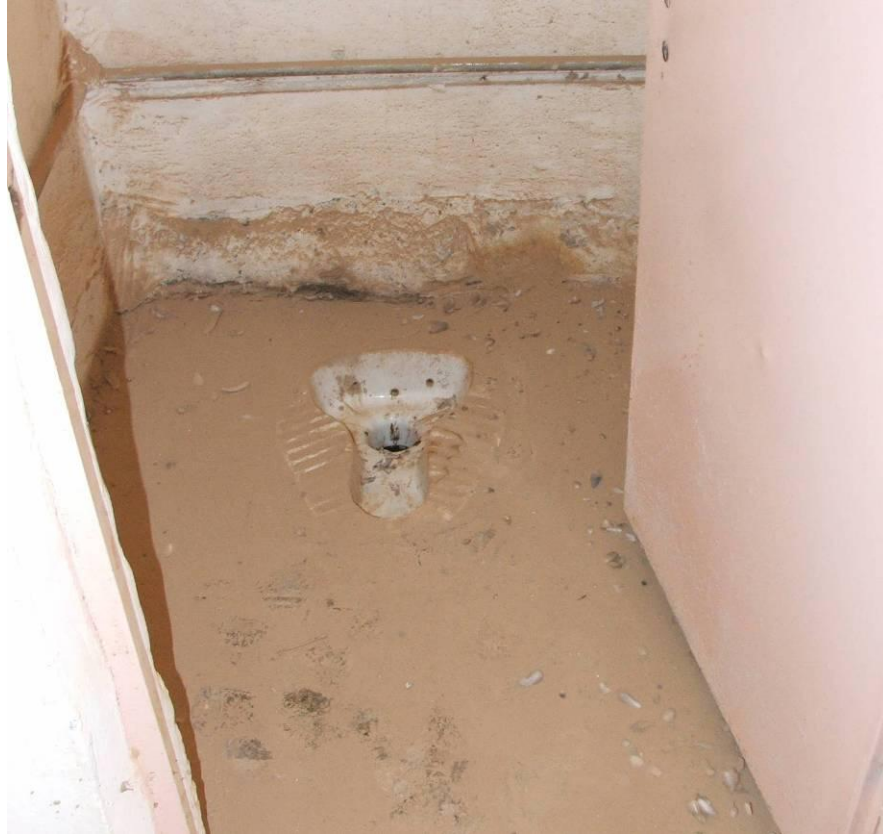
Site Photo 18. Evidence of no routine maintenance performed - excessive amount of dirt within the bathroom facility

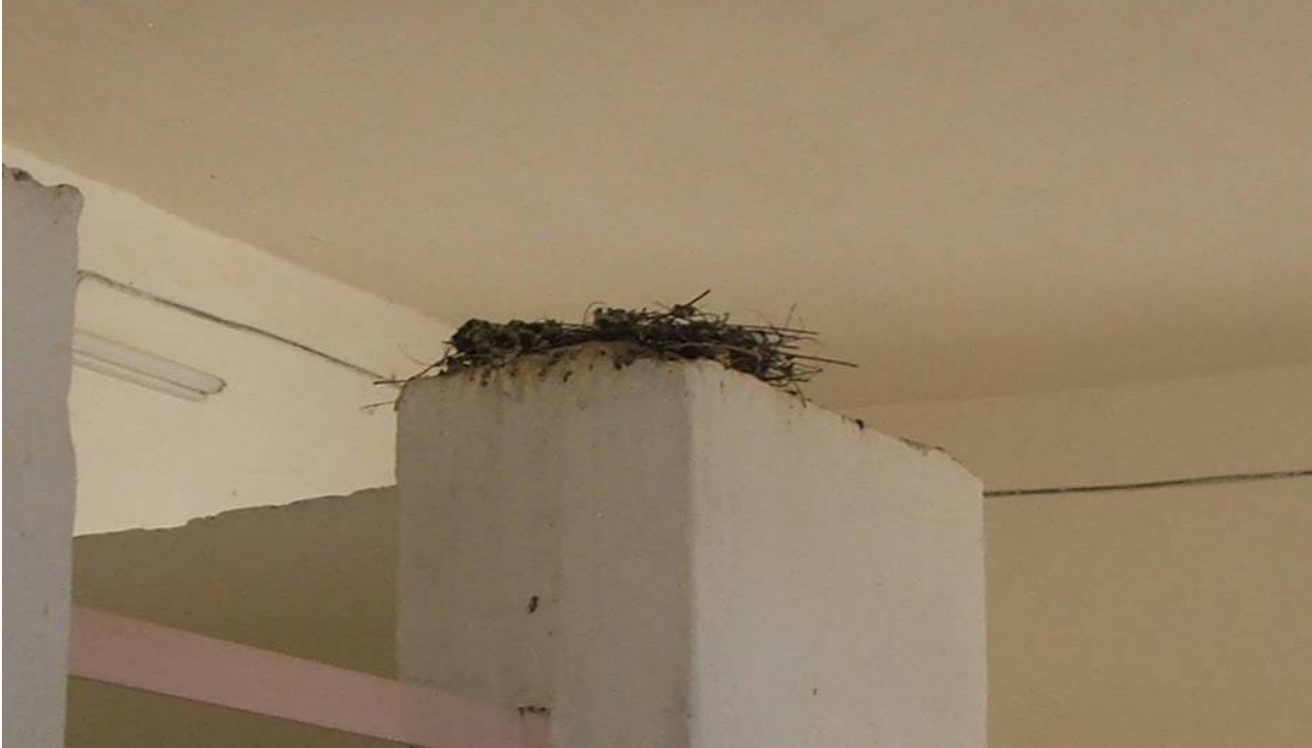
During the site visit, there were obvious signs that the school was not being properly maintained. For example, in the outside bathroom facility, a large bird’s nest (Site Photo 19) and a significant amount of dirt and dust were observed. According to the Headmaster, school was to begin approximately one week after the site visit. In order to be ready for the first day of school, a considerable amount of cleaning is required.

Site Photo 19. Further proof of no routine maintenance – a large bird’s nest within the students’ bathroom facility
