**REHABILITATION OF THE SUROOR  
ELEMENTARY SCHOOL  
UNDER THE ECONOMIC SUPPORT FUND  
HUSSEINIYA, IRAQ**

**SUSTAINMENT ASSESSMENT**

**SIGIR PA-08-135  
APRIL 7, 2009**

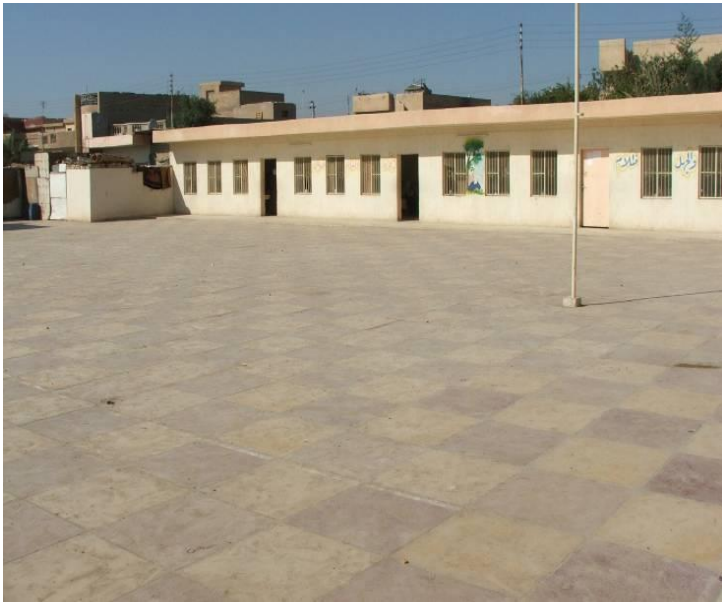
During the site visit, SIGIR identified the new walkway tiles for the school (Site Photo 5). While many windows were replaced, SIGIR noticed at least one instance where a screen was damaged (Site Photo 6); however, it was not clear whether the screen was poorly installed or subsequently damaged. In addition, SIGIR observed painted murals on several school walls (Site Photo 6).

**Site Photos 5. New walkway tiles**

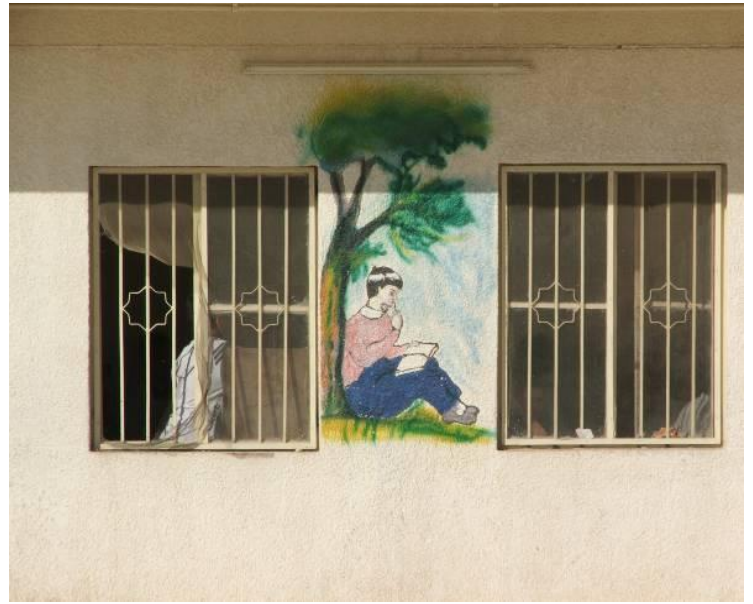
**Site Photo 6. Broken screen and new wall mural**

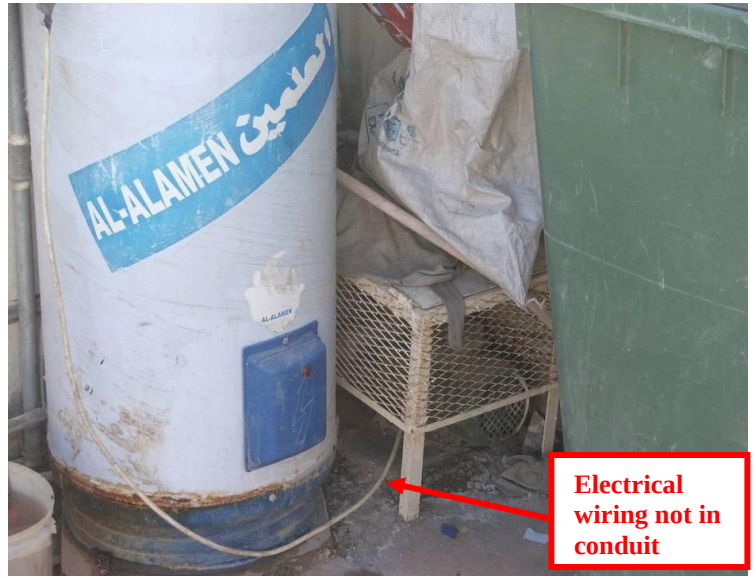
During the site visit, SIGIR identified unsafe electrical wiring and outlets; however, it appeared that someone tampered with the electrical wiring and outlets (Site Photo 7). Also, it did not appear that the contractor corrected existing electrical and plumbing deficiencies addressed under the GOI contract. Further, the wiring and the circuit breaker for the water heater and water pump appeared to be non-functioning, and its electrical wiring was not inside a conduit (Site Photo 8).

**Site Photo 8. Used hot water heater and pump**

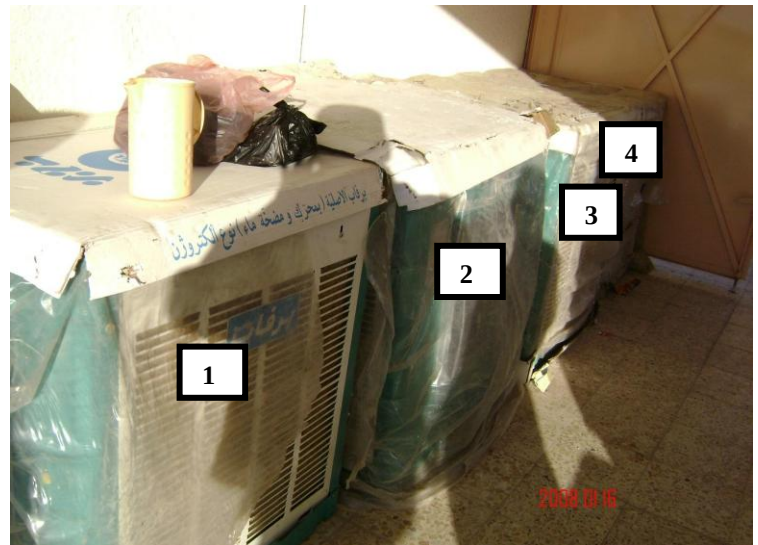
The BOQ required the contractor to provide and install four evaporative coolers, and according to USACE's final inspection report, all four evaporative coolers were delivered and installed. However, during the site visit, SIGIR only observed one window air conditioning unit (Site Photo 9). After SIGIR briefed GRD that no evaporative coolers were on site, GRD sent representatives to determine the status of the evaporative coolers. GRD subsequently provided SIGIR a photograph of the four evaporative coolers delivered to the Suroor Elementary School (Site Photo 10). In addition, GRD stated that "in October 2008, at the request of a government official, the school principal released three coolers on loan to other schools." This still leaves one evaporative cooler unit unaccounted for; however, at the time of the site visit, SIGIR was unable to inspect several rooms because they were locked and access to the roof was denied. Therefore, SIGIR cannot definitely state whether or not a single evaporative cooler unit was still at the school.

**Site Photo 10. Four evaporative cooler units delivered to school (Courtesy of GRC)**

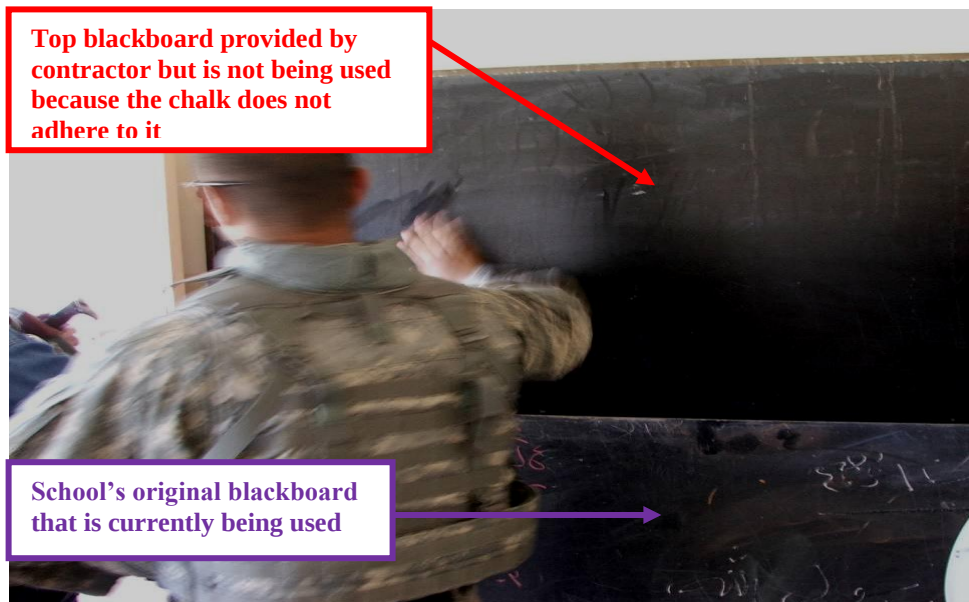
During the site visit, the school's headmaster stated the contractor provided "poor quality" blackboards. Specifically, the blackboards were not properly treated, and as a result, chalk would not adhere well to the blackboards. Consequently, the school's administration decided to use the old blackboards instead (old blackboards were hung over the newly provided blackboards) (Site Photo 11). SIGIR also concluded the newly provided blackboards were of poor quality.

Site Photo 11. New blackboard (top) Original blackboard (bottom)

SIGIR advised GRD about the contractor's poor quality blackboards. A GRC representative subsequently visited the school to inquire about the blackboards. According to GRD, the school recently received 12 new whiteboards. The school maintenance staff plans to "put all blackboards in storage and install the new whiteboards in the classrooms because most Iraqi schools are now using whiteboards." GRD did not provide a photograph of the new whiteboards.

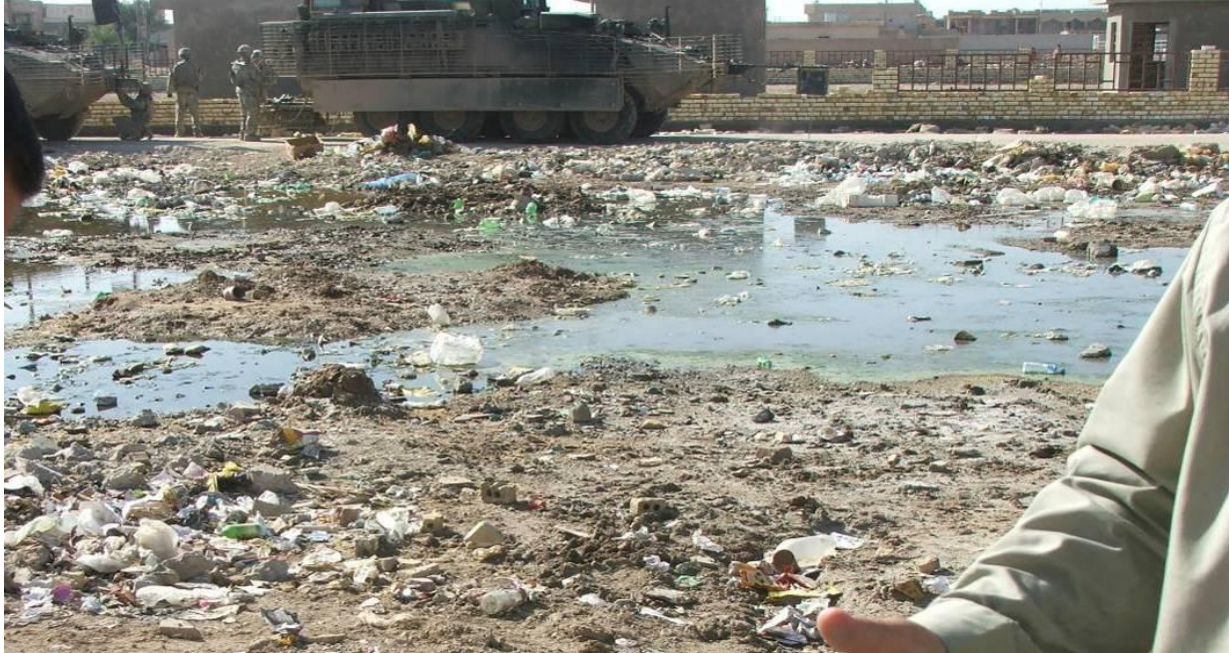
In addition, the sanitary sewer septic system's capacity is not large enough for the school, and according to the headmaster, the septic tank is full because the school does not have a septic cleaning contract. According to the headmaster, a trench was dug to allow discharge out of the full septic tank (Site Photo 14). While this provided an instant relief for the full septic tank, it resulted in large quantities of untreated sewer water being released into the neighboring areas directly bordering the school. As a result, the properties adjacent to the school grounds are unsafe and unsanitary. SIGIR observed

standing water, sewage, and trash surrounding the school. This standing water and sewage can lead to dangerous diseases, such as cholera.

**Site Photo 14. Trench dug to allow discharge out of the full septic tank**

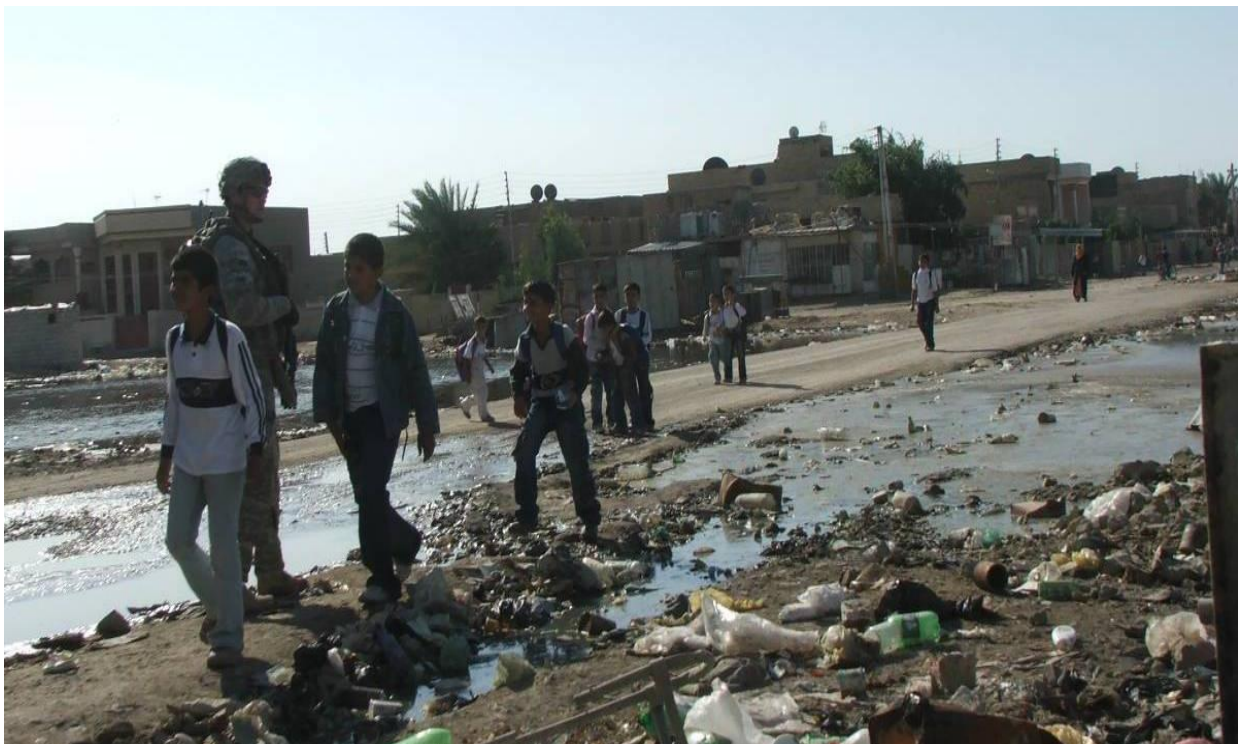
In order to avoid walking through the standing water and sewage from their homes to the school, a make-shift levee was made for the children (Site Photo 15). SIGIR had to use the levee to access this site.

**Site Photo 15. Make-shift levee for students to avoid walking through standing water and sewage**
