**NSWCCD-65-TR-2005/04** March 2005

## **Preliminary Report on the SIDER Testing of Large-Scale Sandwich Panels**

1. Reference (a) requested the Naval Surface Warfare Center, Carderock Division (NSWCCD) to investigate the use of broadband vibration data to determine the integrity of composite structures. Enclosure (1) presents the results of Structural Integrity and Damage Evaluation Routine (SIDER) inspection demonstrations of two large-scale balsa core panels.

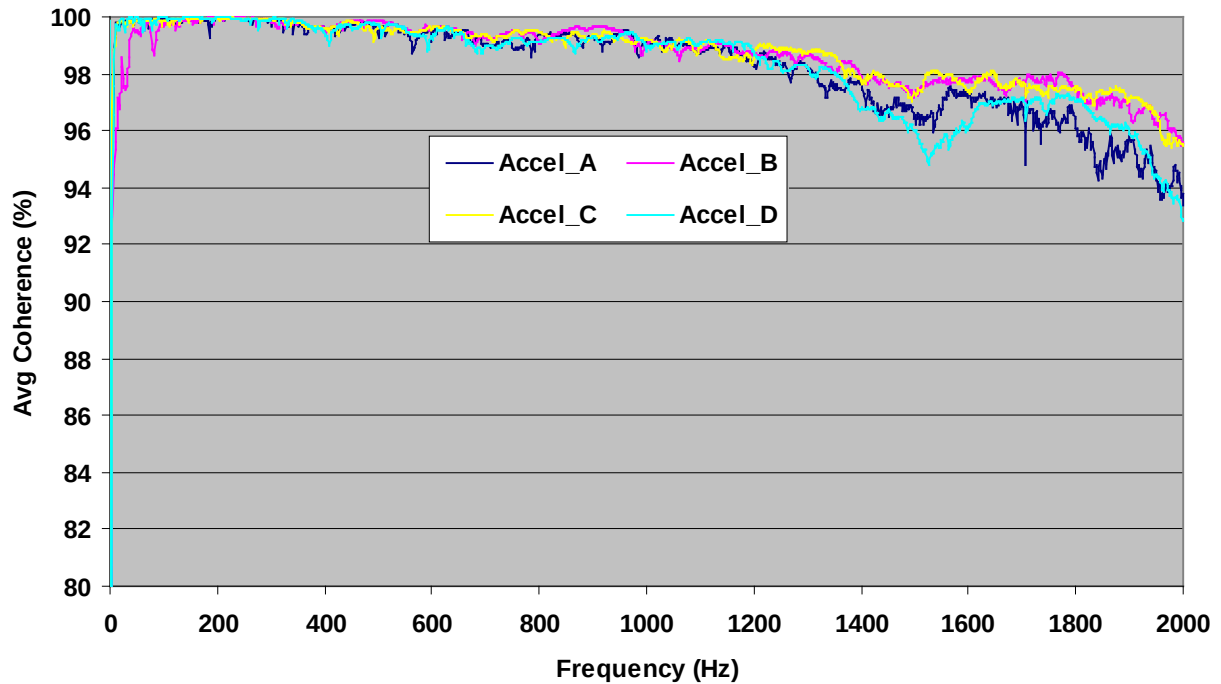
**Figure 4. Average Coherence Comparison – Test Part #2 by Accelerometer**

Part #2 has a slightly lower average coherence. This is consistent with the visual observation that Part #2 looked like it had more manufacturing problems. This corresponds to the panel that had noticeable debonding of the face sheets from the balsa, and the swelling of the balsa.

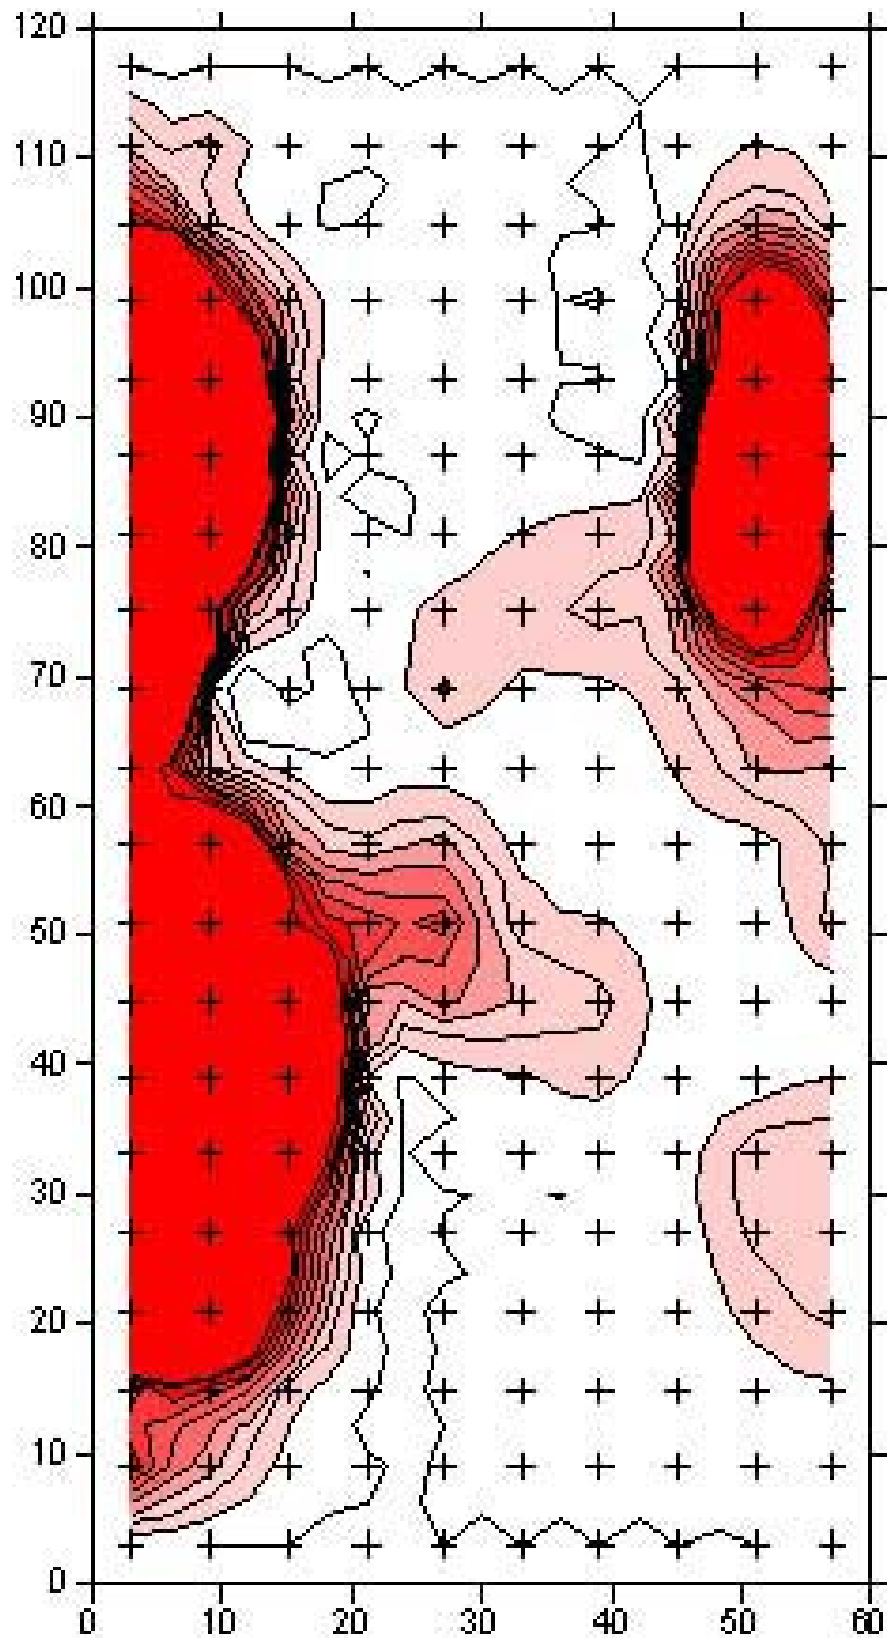
Figure 13. Part #2, Y-Direction Analysis with 10x Magnification

Due to the severe nature of the damage identified in Part #2, it was decided to replot the SIDER results using a different scale. In a single SIDER inspection, when a component demonstrates a feature which significantly dominates the plots, the original auto-scale plots can hide other less severe features that may still be of interest. Rescaling will often enable these less severe features to be identified. If multiple parts were to be inspected, a scaling could be established which would automatically indicate regions above the component norm. Figure 11 through Figure 14 repeat Figure 5 through Figure 8, but with a tenfold magnification. On these plots anything over an original value of 10% is set to a uniform maximum value.

Panel #2 had several large areas of significant damage. These areas cover virtually the entire plate.

*The main recommendation is to use ultrasonics to map out the boundaries of the major delaminations/debonds in order that they can be compared with the SIDER results. Additionally, if time permits, it may be appropriate to test the "SIDER-good" areas to ensure that they are, indeed, damage free.*
