Review of Electrocution Deaths in Iraq:  
Part I - Electrocution of  
Staff Sergeant Ryan D. Maseth, U.S. Army

This project was undertaken to examine underlying causes of the January 2008 death of Staff Sergeant (SSG) Ryan Maseth, who was electrocuted while showering in his quarters at the Radwaniyah Palace Complex (RPC), Iraq. The Army investigation determined that SSG Maseth was electrocuted while showering when he came in contact with water pipes that had been energized when an ungrounded water pump failed. Equipment and building maintenance at the time was performed under the Logistics Civil Augmentation Program (LOGCAP) III contract with Kellogg, Brown, and Root (KBR). Our review focused on management decisions, contracting procedures, and criteria for and execution of facility inspections and maintenance preceding the incident. See Appendix A for project initiation documentation.

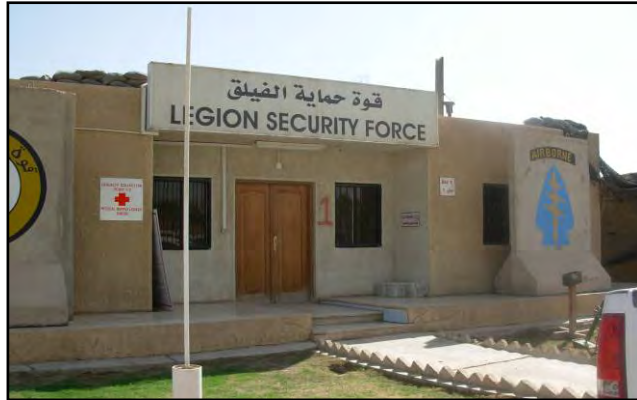
**Figure 1. Legion Security Force Building 1.**

At about 8:30 p.m. on January 2, 2008, fellow Special Forces soldiers found SSG Ryan Maseth unresponsive on the floor in his bathroom at the Legion Security Forces Building No. 1 (LSF-1), RPC, Baghdad, Iraq (Figure 1). He was found partially in the shower with the water still running.<sup>4</sup> According to witness statements, a soldier received a strong electric shock when his clothed arm brushed a water pipe during initial incident response. A soldier from the unit, trained as an electronics technician and not part of the group attempting to resuscitate SSG Maseth, tested the water on the floor of the room and found strong voltage present. Realizing the system was energized and still dangerous, he cut the power to the entire building by turning off the circuit breakers located in the LSF-1 circuit breaker box.

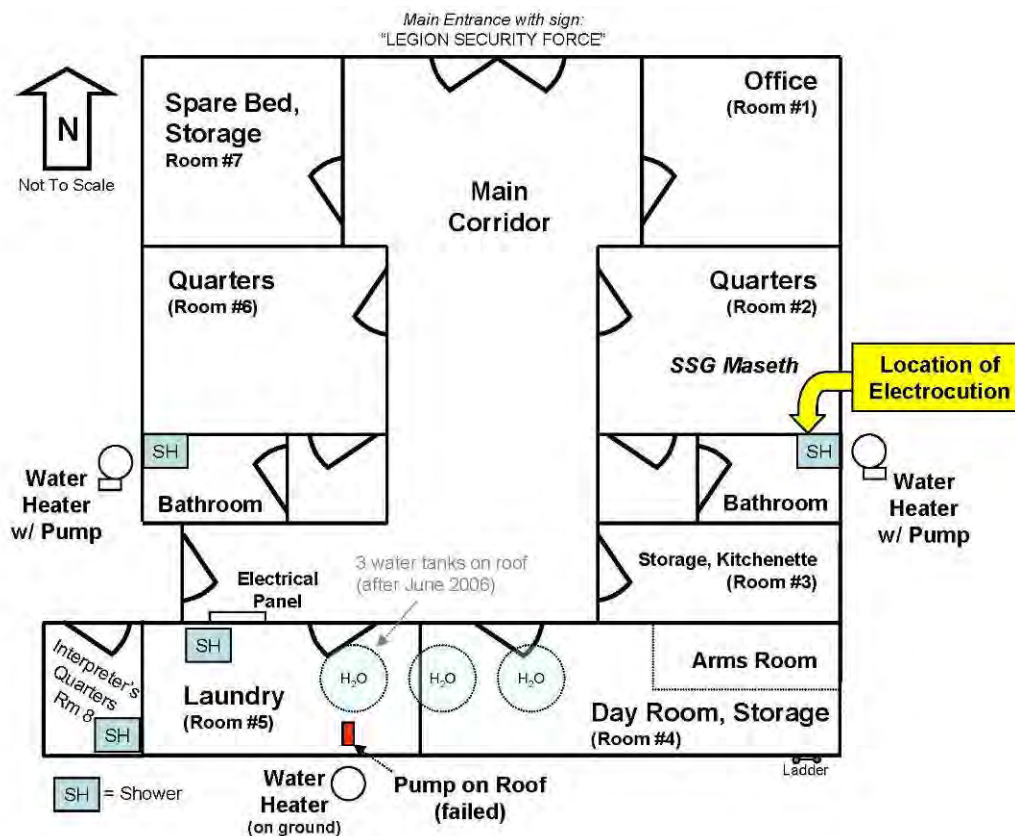
**Figure 2. Floor Plan of Legion Security Force Building 1.**

We determined that KBR installed the pump on the roof which contributed to the electrocution of SSG Maseth, as well as adjacent water tanks during the first week of June 2006 (Figure 2). We reached that determination based on KBR work order documents, interviews with four LSF-1 occupants and a KBR subcontracted plumber, and photographs of LSF-1. A soldier recalled placing a work order to replace the tanks on the roof because the old tanks were leaking,

and a plumber from Card Industries (a subcontractor for the KBR Mid-East Region Office) recalled doing the work in early June 2006. The pump to fill those tanks would have been installed concurrently. Photographs of LSF-1 from before and after June 2006 are consistent with the believed installation date. A forensic engineering analysis of the failed pump conducted at the request of the U.S. Army Criminal Investigation Command found that the pump was installed without providing a separate ground conductor. Installation of the tanks and pump on the roof was only one of many repairs made to the plumbing and electrical system of LSF-1 prior to January 2008 (Appendix C).

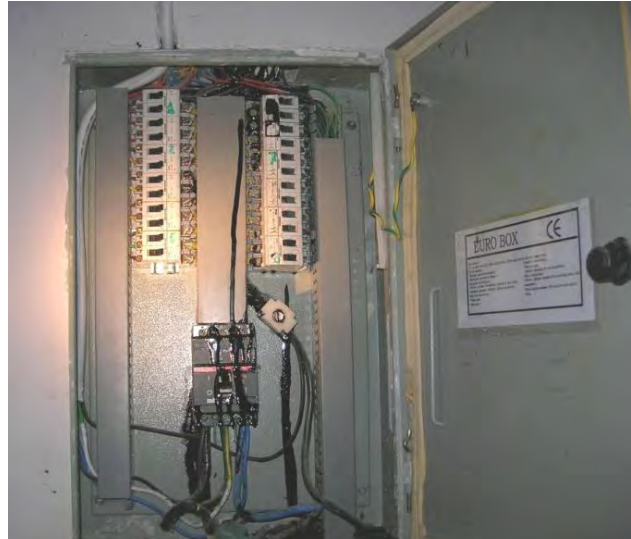
**Main Circuit Breaker Panel, LSF-1  
(From Army photographs taken on January 2, 2008)**

The LSF-1 renovation project included installing windows, doors, electrical fixtures, plumbing fixtures, and at least one water pump, heater, and tank for the bathroom in room 2. The main circuit breaker for LSF-1 is shown in the photograph to the right. We believe the panel in use at the time of the electrocution was installed during this renovation. We found no work orders or testimony indicating the panel was replaced. Two occupants who lived in LSF-1 in early 2006 recognized the panel as it appears in the photo to the right.

Evidence suggests the black substance on the panel was tar used to repair the roof. Electricians who have examined the actual panel or photographs stated the tar should not have any impact as the circuit breakers were designed to function no matter the position of the external switch.
