Review of Electrocution Deaths in Iraq:
Part II - Seventeen Incidents Apart from
Staff Sergeant Ryan D. Maseth, U.S. Army

SUBJECT: Review of Electrocution Deaths in Iraq: Part II – Seventeen Incidents Apart
From Staff Sergeant Ryan D. Maseth, U.S. Army (Report No. IPO2009E001)

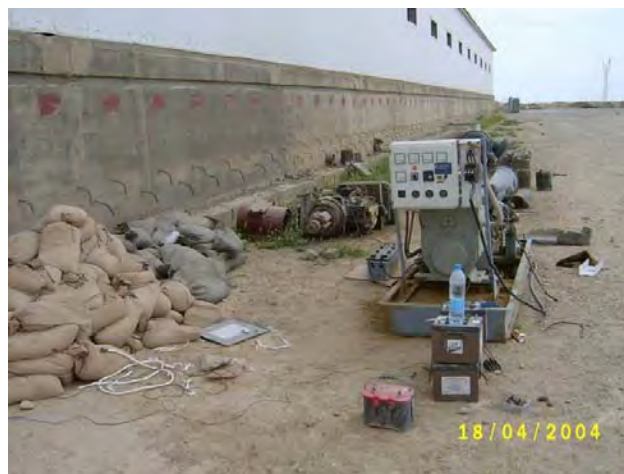
Specialist Marvin A. Campo-Siles was electrocuted while attempting a generator repair at Pad 9, Forward Operating Base Brassfield-Mora, Samarra, Iraq, on April 17, 2004. The generator and exterior of the housing unit involved in the incident are shown in the figure below.

**Figure 1. Generator and Housing Area
Involved in the Specialist Campo-Siles Electrocution
(From Army Photographs)**

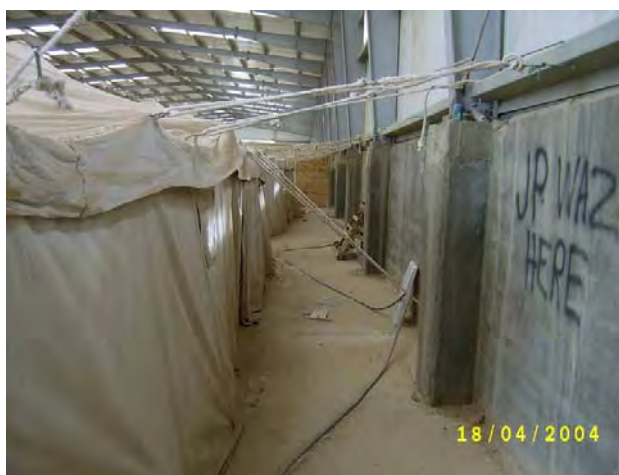
Specialist Campo-Siles was a trained and experienced generator repairman. On April 17, 2004, he and two other soldiers were performing maintenance on a generator supplying electrical power to two warehouse-like structures that housed U.S. soldiers on Forward Operating Base Brassfield -Mora. The generator was functioning, but the housing units were not receiving electrical power. The team checked voltage at the breaker box and concluded that electricity was not flowing through the breaker box. While Specialist Campo-Siles remained at the breaker box, the two other soldiers began following the wires to determine where the electrical “drop off” was occurring. The wiring from the generator (located outside the housing unit) and the interior of the housing area are shown in the figure below.

Figure 2. Generator Cable and Housing Unit Involved in Specialist Campo-Siles Electrocution (From Army Photographs)

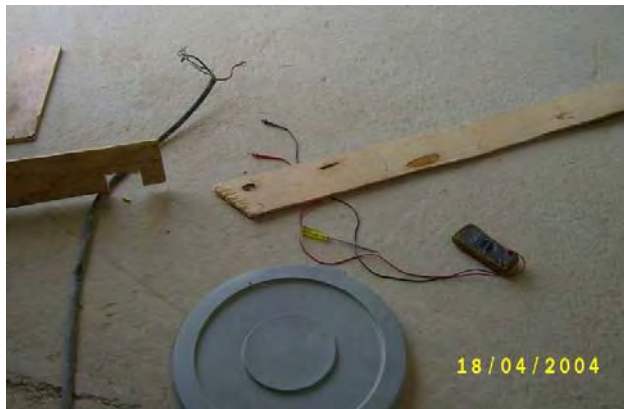
Shortly after leaving Specialist Campo-Siles, the two other soldiers heard a scream and, upon checking, discovered Specialist Campo-Siles lying on the ground. He apparently had disconnected wires from the breaker box and was holding live electrical wires in his hands. A yellow screwdriver apparently used for the disconnections was found near the electric meter. The incident site is shown in the figure below.

**Figure 3. Site Where Specialist Campo-Siles
was Electrocuted (From Army Photographs)**

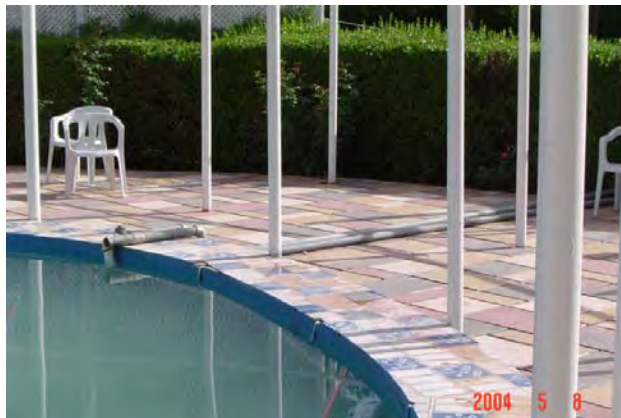
Specialist Chase R. Whitham was electrocuted while swimming in an outdoor pool at Forward Operating Base Patriot, Mosul, Iraq, on May 8, 2004. The site is shown in the figure below.

Figure 4. Pool Where Specialist Whitham was Electrocuted (From Navy Photographs)

- North Swimming Pool: The sides/edges were straight on the north, south, and east sides, and the west side was semi-circular. The two silver metal pipes extending from the west side to the water pump were above ground/visible. Specialist Whitham was observed touching one of these metal pipes before he was electrocuted. Two other pools at the site were not in use/not filled with water.

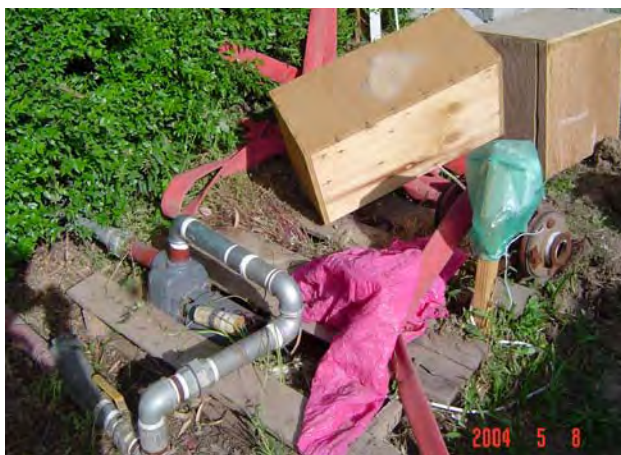
- **Water Pump:** The pump was located above ground, adjacent to a fuse box, and connected a water supply pipe, which continued to the pool, to a second above ground pipe, which also continued to the pool. The pipes were both 3-inch diameter metal pipes that extended about 20 feet through a hedge to the North swimming pool West side. Report of investigation photographs indicate boxes made of wood/lumber covered the pump and fuse box, as shown in the figure below.

**Figure 5. Covers for Pump and Fuse Box
in Area Where Specialist Whitham was Electrocuted
(From Navy Photographs)**

- From photographs, the water pump nomenclature read “BU...RKS.” A model or serial number was not identified. Photographs at the scene were inadequate to help with nomenclature identification.

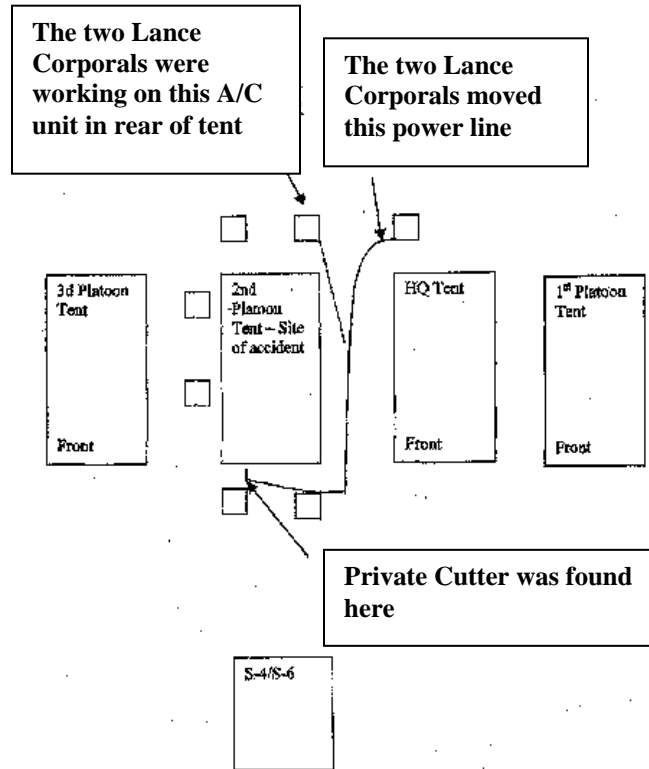
Private First Class Brian K. Cutter was electrocuted while attempting repair on an air conditioner unit at Al-Asad Airbase, Iraq, on May 13, 2004. The site is depicted in the figure below.

Figure 6. Drawing Depicting Area Where Private Cutter was Electrocuted (From Army Report of Investigation)

Private First Class Cutter died from electrical shock while using a metal tool and attempting to rewire an air conditioning unit to the breaker box and subpanel/junction box. Resuscitation attempts were unsuccessful.

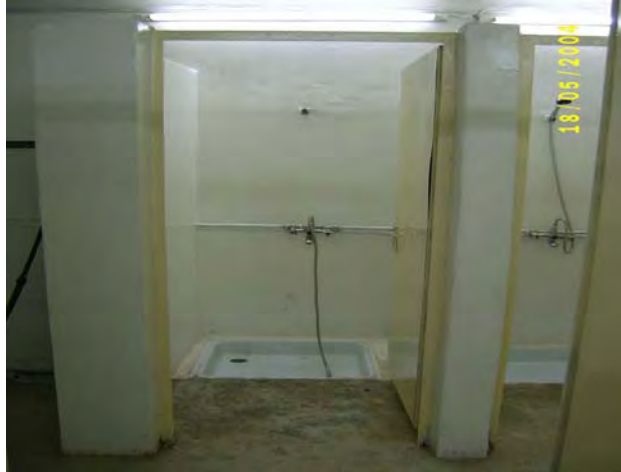
Specialist Marcus O. Nolasco was electrocuted while showering at Forward Operating Base Summerall, Bayji, Iraq, on May 18, 2004. The shower is shown in the figure below.

Figure 7. Shower Where Specialist Nolasco was Electrocuted (From Army Photographs)

(Note: An automatic water pump did not maintain water in water heaters, causing a heating element to rupture, resulting in electricity traveling through the metal water lines into the shower.)

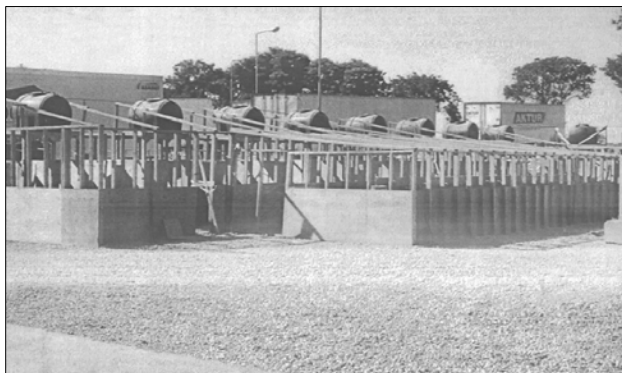
Hospital Corpsman Third Class David A. Cedergren died in a shower facility at Camp Iskandiriyah, Iraq, on September 11, 2004. The shower facility is shown below.

Figure 8. Shower Area Where Hospital Corpsman Cedergren Was Electrocuted (From Navy Photographs)

- Outdoor wooden showers with wood slat floors covered in chicken wire mesh. Photographs in the investigative files depict signage at the shower facility warning of "Danger" and "Electric Shock Hazard;" however, the signage is not explained.

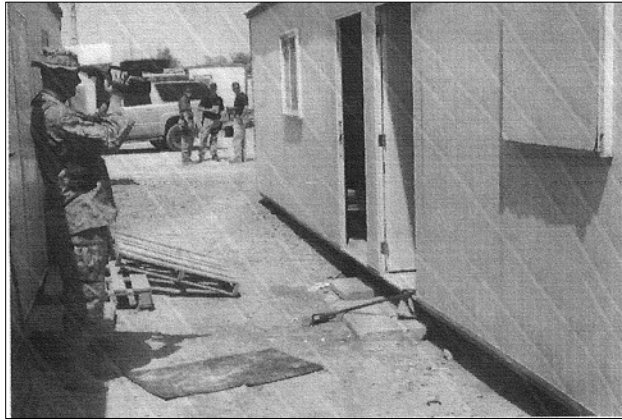
Mr. Sohan Singh was electrocuted while attempting to enter his quarters at Fallujah Surgical, Camp Fallujah, Iraq, on July 19, 2005. The exterior of the quarters are shown in the figure below.

**Figure 9. Quarters Where Mr. Singh Was Electrocuted
(From Navy Photographs)**

The NCIS investigation determined that Mr. Singh or his roommate improperly installed an air conditioning unit sitting on the floor in Mr. Singh's living quarters. The electrical plug had been removed, and the wires "stripped and stuck" into an electrical receptacle connecting the neutral wire to a live feed, which caused the metal floor, walls and door to become electrified with 217.7 volts. Witness interviews revealed that Mr. Singh had been pouring water on his bare feet to rinse off dust immediately before attempting to open the door to his quarters, at which time he fell to the ground in a convulsion and became unresponsive. The investigation did not disclose any evidence of

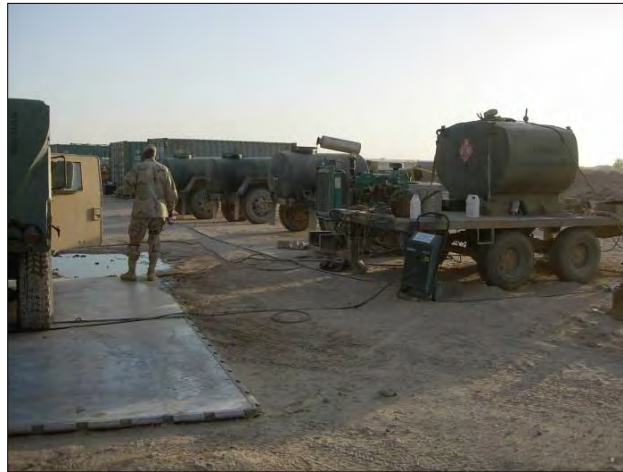
Sergeant Christopher L. Everett was electrocuted while using a power washer at Camp Taqaddum, Iraq, on September 7, 2005. The death scene is shown in the figure below.

Figure 10. Area Where Sergeant Everett Was Electrocuted (From Army Photographs)

In early August 2005, a contractor moved an electrical generator to replace an ineffective diesel generator. The new generator provided power for various nearby activities, including a power washer used to clean vehicles. Almost immediately, a military member without electrical or generator training connected the power washer to the new generator. Over the next 2 weeks, people who used the power washer received electrical shocks, including Sergeant Everett and a member of the base's generator repair team. A military maintenance supervisor told the same generator repair team member (who had no formal training in electricity or generator repair) to ground the generator. The team member inserted a grounding rod and connected it to the generator. The power washer continued to shock Service members, and they reported it. On September 7, 2005, Sergeant Everett was electrocuted using the power washer to clean a vehicle.

- Power Washer: Gerni brand, Model 482A, Serial Number: 030401000326 2003; Green, Black and Yellow in color, plastic and metal construction. Power washer had a black rubber hose and handheld washing wand attached.
- Generator:
 - Model and Serial Number: AX91375 and GAUJC027M, respectively. (Note: In some instances, the contractor's Power Generation Dept. Fault/Repair Sheets have the two numbers inverted, so we are unsure which is the model number and which is the serial number.)
 - KW = 400. KVA = 500.
 - Engine Model Number: 2806C-E16TA
 - Engine Serial Number: 2PXL15.8H16 or HGB061025U0 (Note: Some Power Generation Dept. Fault/Repair Sheets list the engine serial number as 2PXL15.8H16. Others list it as HGB061025U0. Also, some identify the engine as a "Perkins" brand name.)

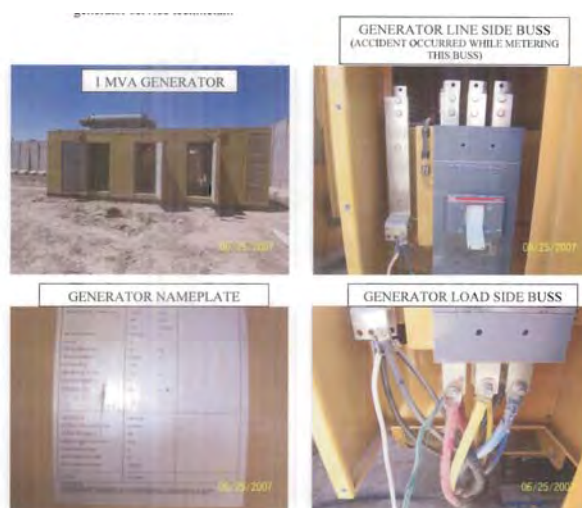
Sergeant Michael J. Montpetit was electrocuted while attempting a generator repair at the Joint Security Station, Forward Operating Base Prosperity, Iraq, on June 22, 2007. The generator is shown in the figure below.

Figure 11. Generator on Which Sergeant Montpetit was Attempting Repair When Electrocuted (From Army Photographs)

The accident review board found that Sergeant Montpetit accidentally touched one or more hot bus bars and received an electrical shock through his body, which killed him.

- a) The generator was producing over 400 Volts and pushing about 230 volts to each bus bar.
- b) The burn marks on the back of his hands, indicate that Sergeant Montpetit touched one or more bus bars and was electrocuted as a result. . . .

. . . A week before the accident 15th BSB [Base Support Battalion] fixed an oil leak on the generator's engine. During the visit by the safety team, the electrical engineer noted that the generator was not properly grounded and the Iraqis had placed three feed wires to provide one-phase electricity to some of the buildings on the compound. . . .

As a result, the safety investigation concluded that improper grounding may have contributed to the severity of the injuries. The basic finding, however, is that a trained mechanic accidentally touched one or more bus wires carrying 230-400 volts each with the back of his right hand and was electrocuted while performing maintenance on a
