**Technical Report 1628**  
September 1993

# **Dynamic and Static Exposure Tests and Evaluations of Alternative Copper-Based Antifoulant Coatings**

**NAVAL COMMAND, CONTROL AND  
OCEAN SURVEILLANCE CENTER  
RDT&E DIVISION  
San Diego, California 92152-5001**

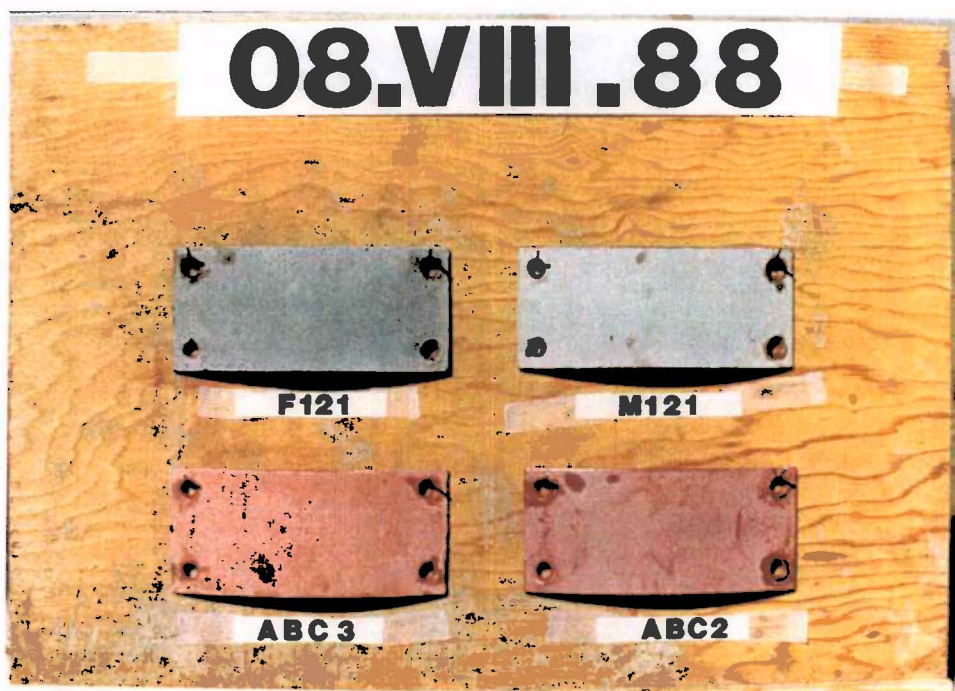
Figure 5. After 10 days of dynamic exposure, F121 and M121 developed green layer on the surface. ABC3 and ABC2 remain red.

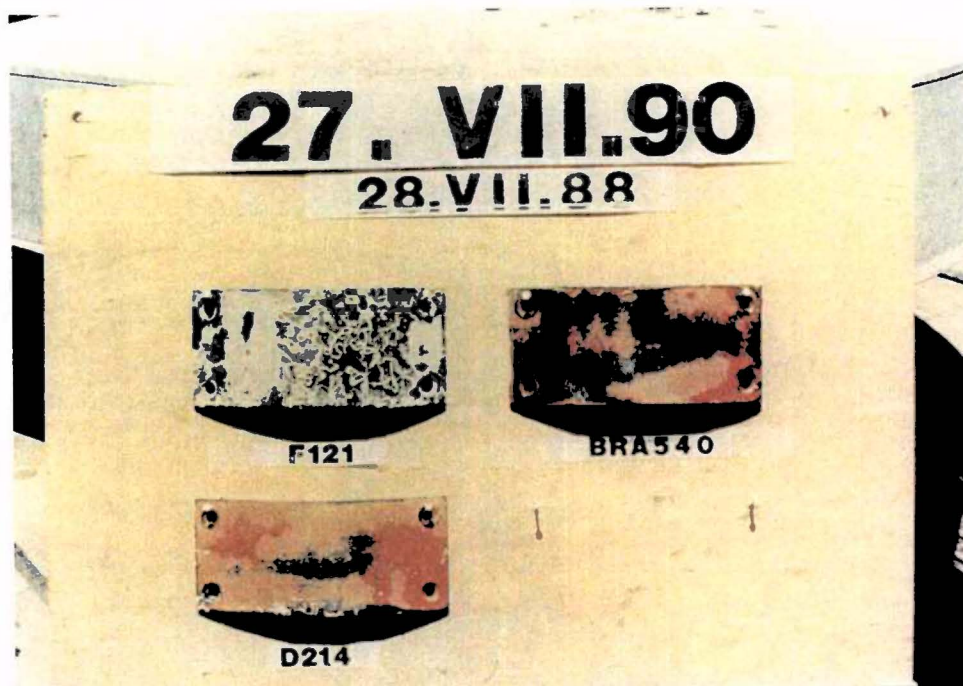
The F121 AF coating began eroding after 18 months of dynamic/static cycle exposure. Those panels, which were subjected to photography, leaching rate, and other test interruptions involving the drying of the AF surface, almost completely lost their AF coating within 27 months (graphs B-6 and B-7). To continue the exposure tests in July 1991, these panels were replaced with backup panels that had undergone the same dynamic/static cycle, but were not tested. The backup panels that had never been dried still had about 50% of their AF coating.

Figure 10. F121, BRA540, and D214 after 2 years of dynamic/static exposure. F121 accumulated fouling (tubeworms) during the static phase on surfaces where AF coating wore off. BRA540 and D214 are almost intact.

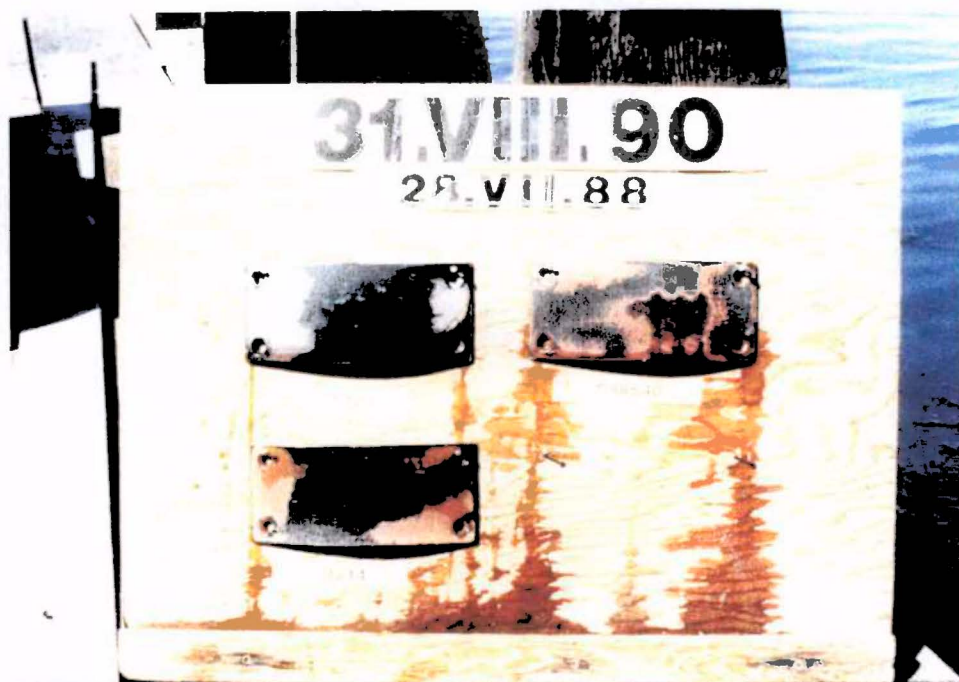
Figure 11. F121, BRA540, and D214 after 2 years of dynamic/static exposure at the end of the dynamic cycle. Fouling washed away from F121, the area (black AC F150) without AF coating is visible. Severe erosion of D214 appears. BRA540 is intact.

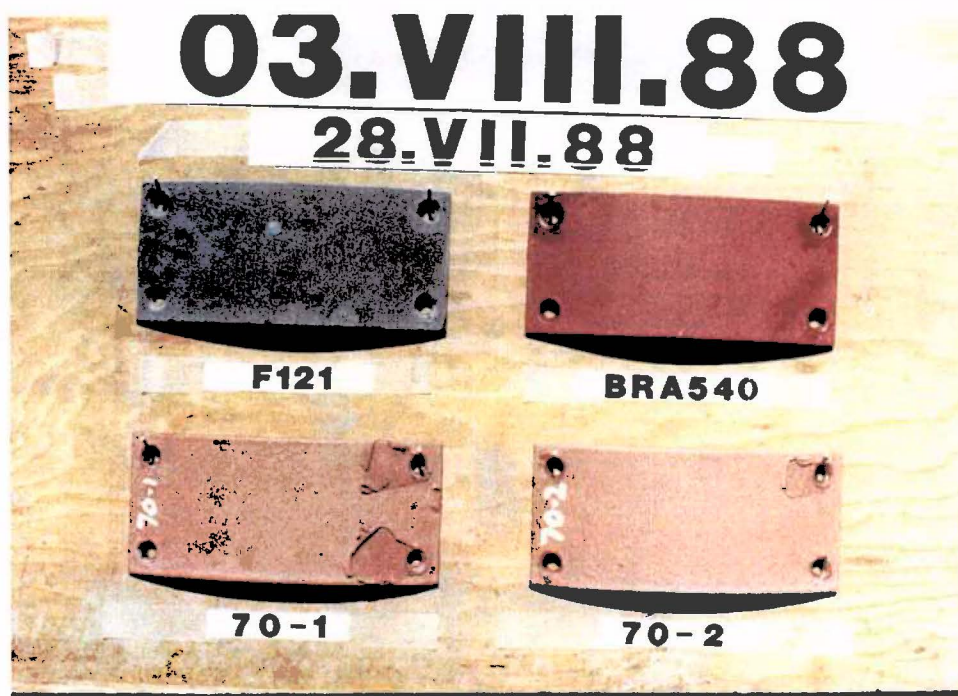
The dynamic exposure test of Ameron 70 was discontinued after the first month because about 50% to 100% of the top layer (AF) stripped off from all four panels (figures 12 and 13). This failure may have resulted from insufficient curing time before exposure to high currents. To allow for curing while stationary, a new set of panels was exposed at the beginning of the static cycle on 27 February 1989 (table A-6). For control, F121 was exposed at the same time. Simultaneously, two panels coated with Ameron 70 were exposed for static conditions (table A-17).

Figure 12. The top layer began peeling off at the corner holes of both Ameron 70 panels after only 4 days of dynamic exposure.

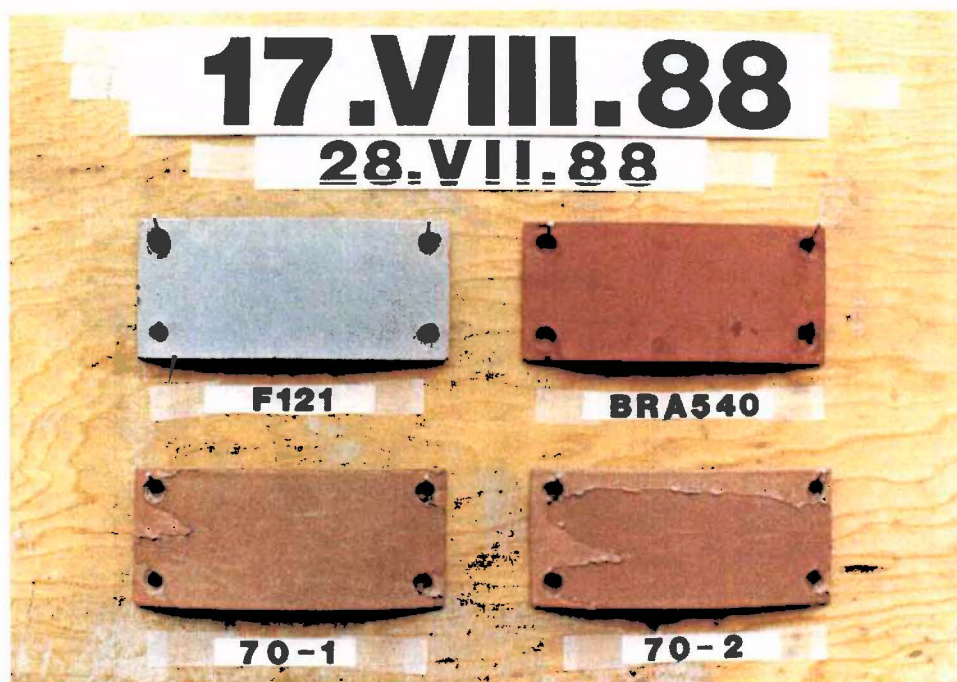
Figure 13. Most of the top layer of both Ameron 70 panels peeled off within 20 days of dynamic exposure.
