# ESD Repair of Army Main Battle Tank Components

January 26, 2006

# Repair of M1 Sun Gear Shaft

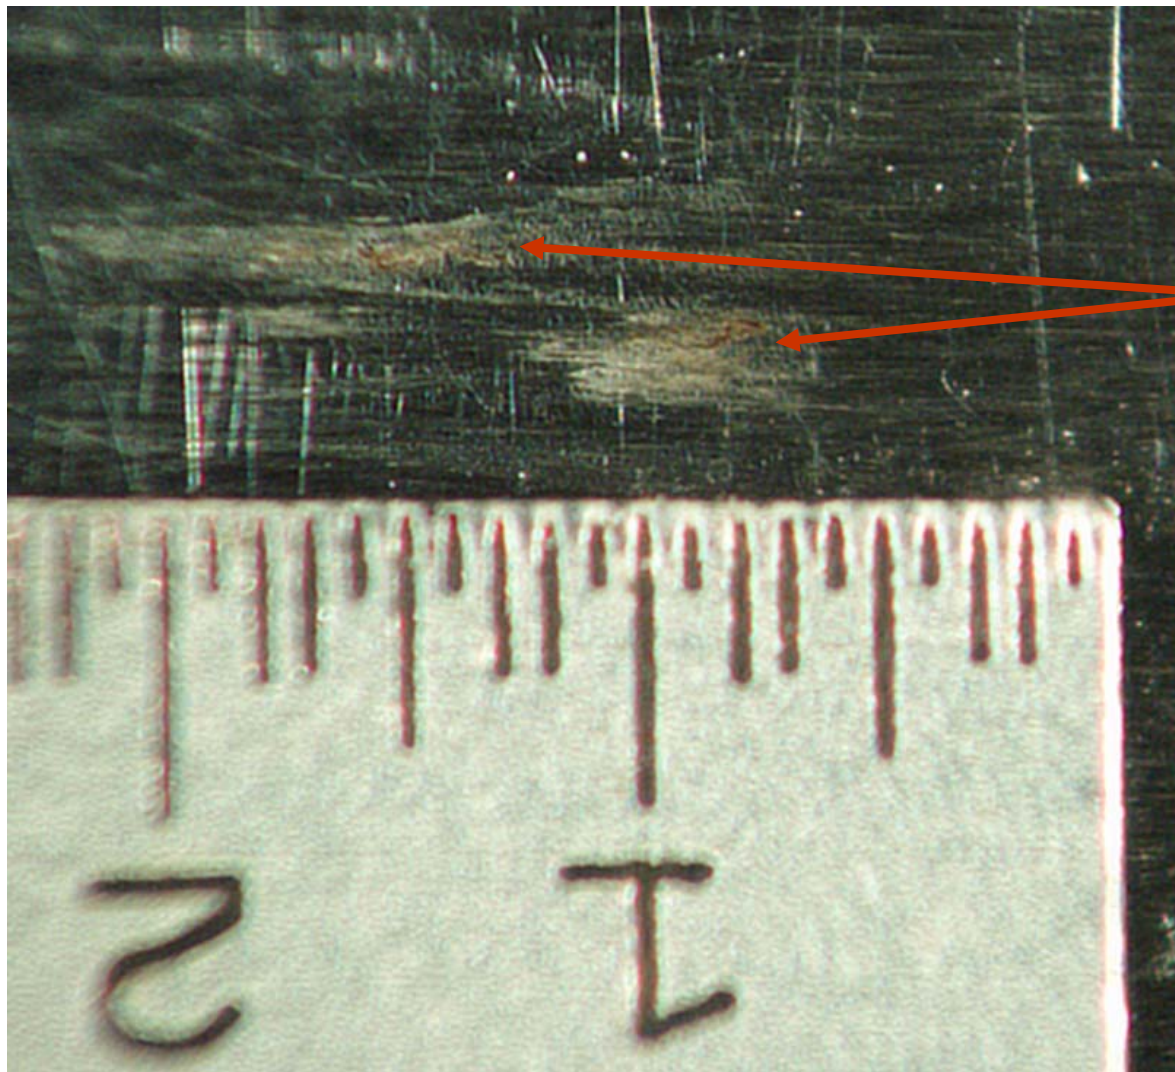
- Small corrosion pits and wear marks noted on chrome plated surfaces on the exterior and interior of the Sun Gear Shaft. Some damage extends into base metal
- Shaft is AISI 9310 steel with chrome plating in some regions.
- Shaft is part of the RGB (Reduction Gear Box), which transmits power from the M1's turbine engine to the transmission.
- The Sun Gear Shaft has an input RPM of 32,000, and drives a planetary gear with an output of 3,000 RPM.
- The seals which ride on the chrome plated surfaces are carbon based spring loaded seals, providing very low levels of wear to this part.

# Corrosion Pits on M1 Sun Gear Shaft Chrome Plating

Corrosion Pits

- Remove Chrome Plating via grinding.
- Using a hand held grinding tool with mild abrasive bit, grind away any corrosion product until clean metal surfaces are present.
- Clean the surface to be repaired with a solvent such as ethyl alcohol and dry.
- Apply a 35 CFH flow of argon gas over the area to be repaired.
- Install a clean Inconel 718 electrode in the rotating torch.
- Perform ESD process to fill the corrosion pit to a level above the surface of the part.
- Using a hand held grinding tool and a polishing bit, polish away excess ESD material until the surface being repaired is flat and flush with the rest of the part.
- Finish polishing the surface of the part using an ultra-fine grit silicon carbide paper (>1200 grit).
- Plate with Chrome to thickness of 0.002-0.005."

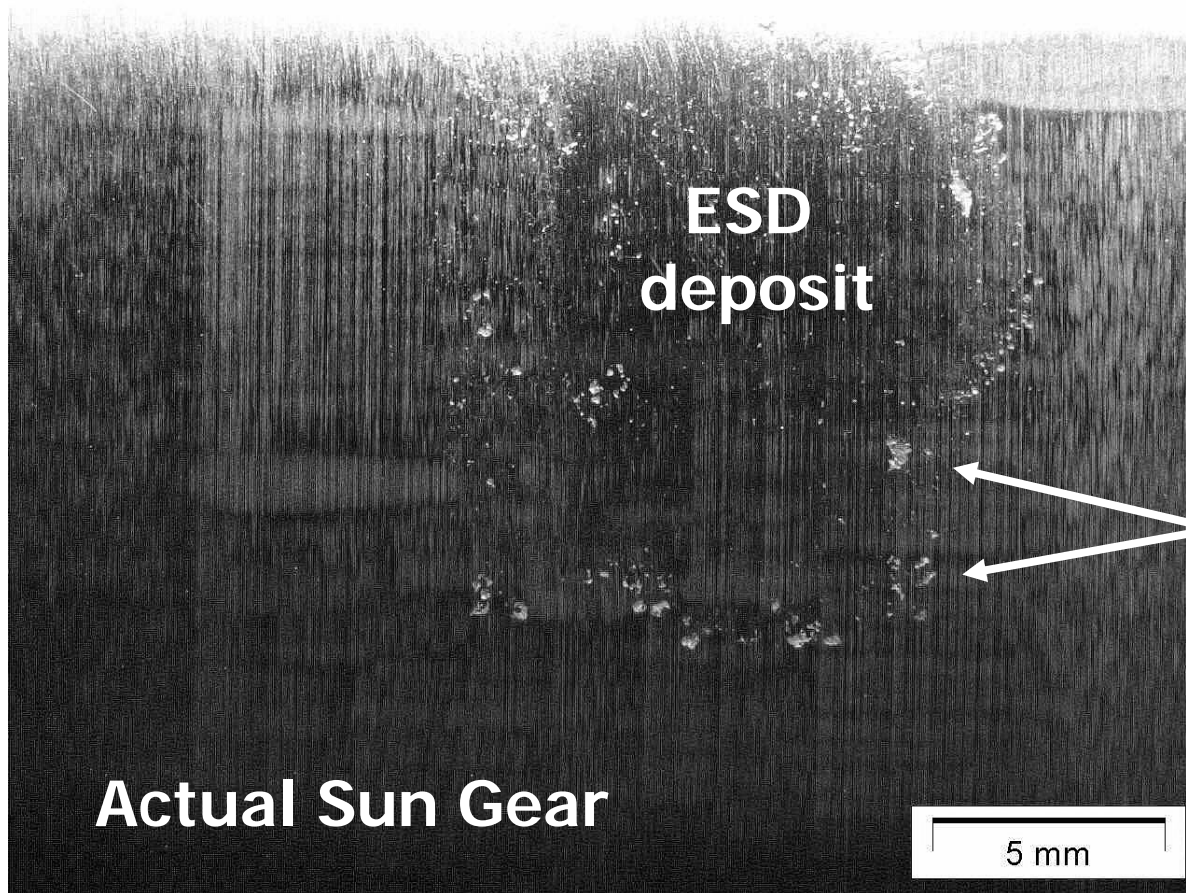
# Defects Noted at Interface of Chrome and ESD

“Halo” effect around periphery of ESD deposit on chrome-plated sun gear.

Pitting at periphery of deposit

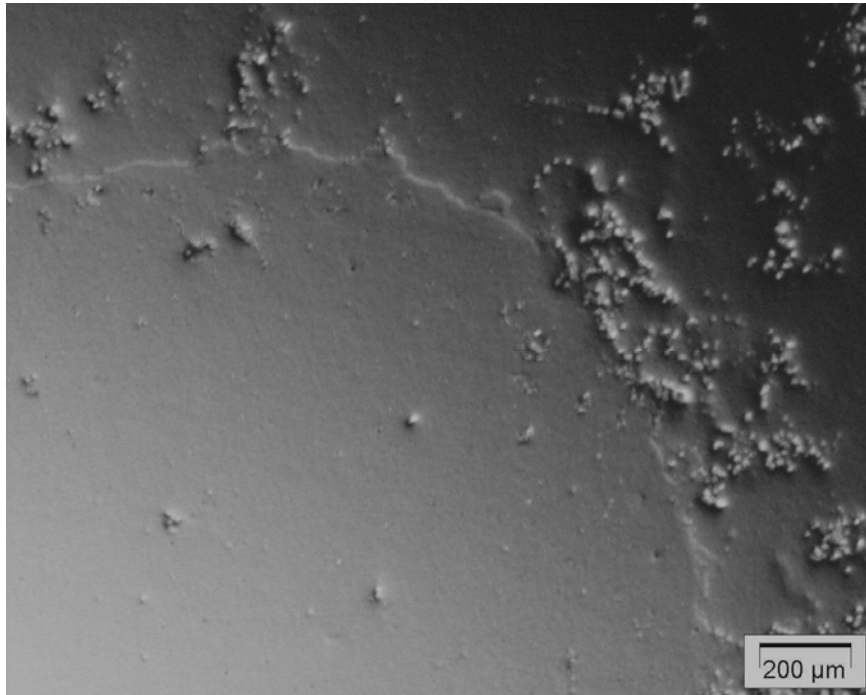
- Repair of defects within chrome plating led to inconsistent ESD results. A defect characterized as the “Halo Effect” was noted in many cases. This defect occurs at the interface of the deposit and the chrome plated substrate. **This problem convinced ARL and ANAD to only repair pits and wear marks through the chrome plating into the base metal.**

“Halo” effect around periphery of ESD deposit on chrome-plated sun gear.

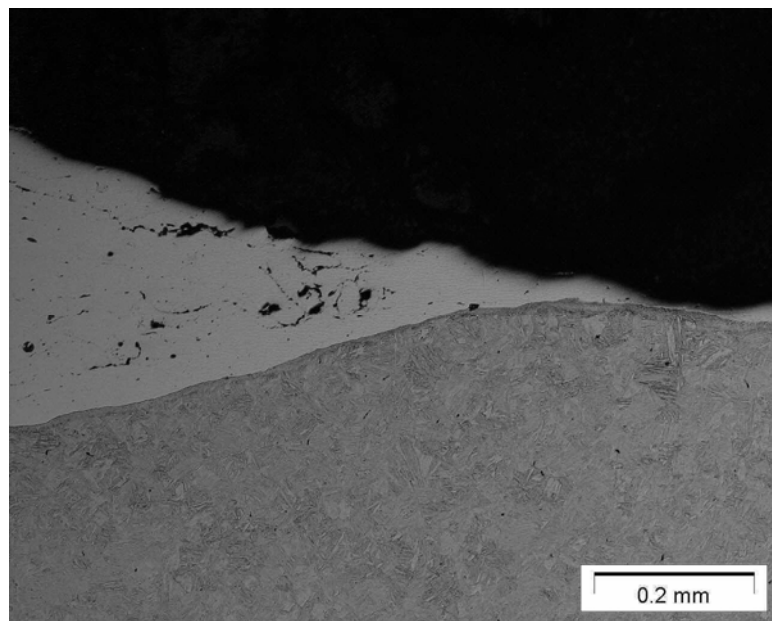
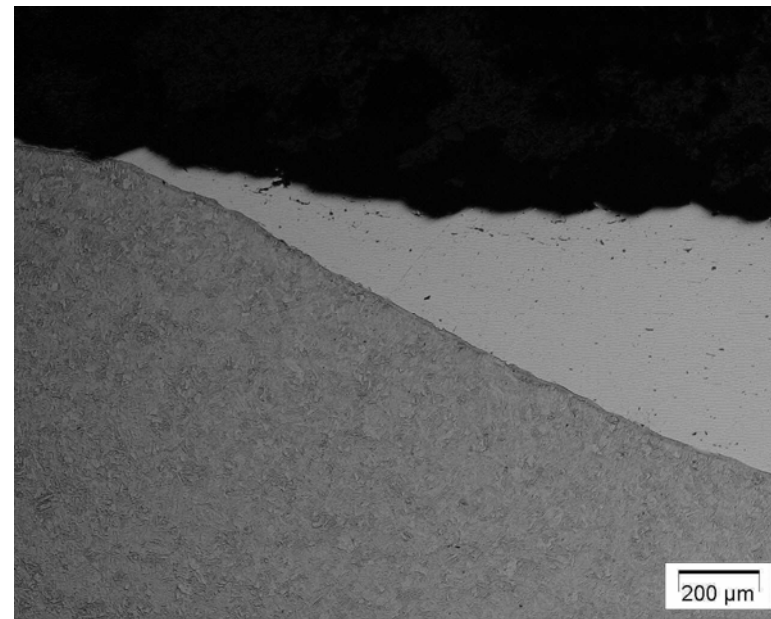
- ESD of defects in chrome-plated steel yielded mixed results – porosity noted (left), defect-free repair (right).

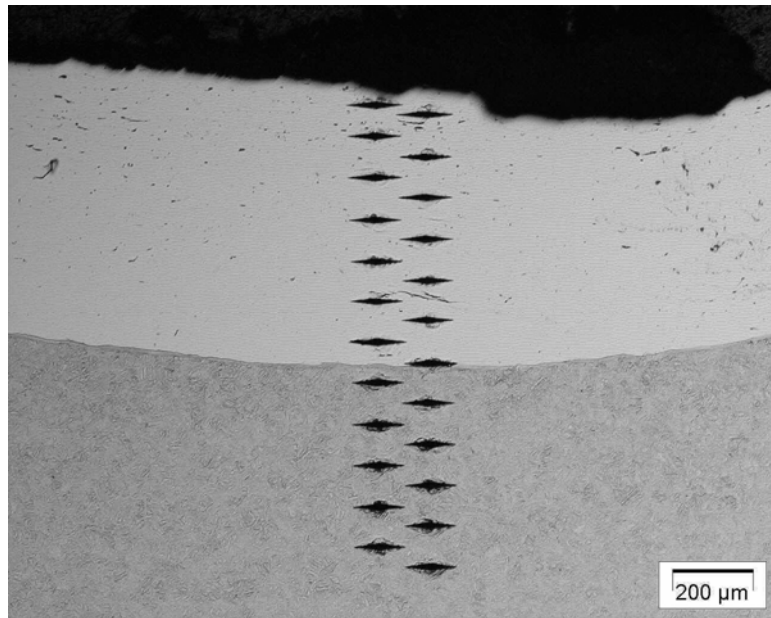
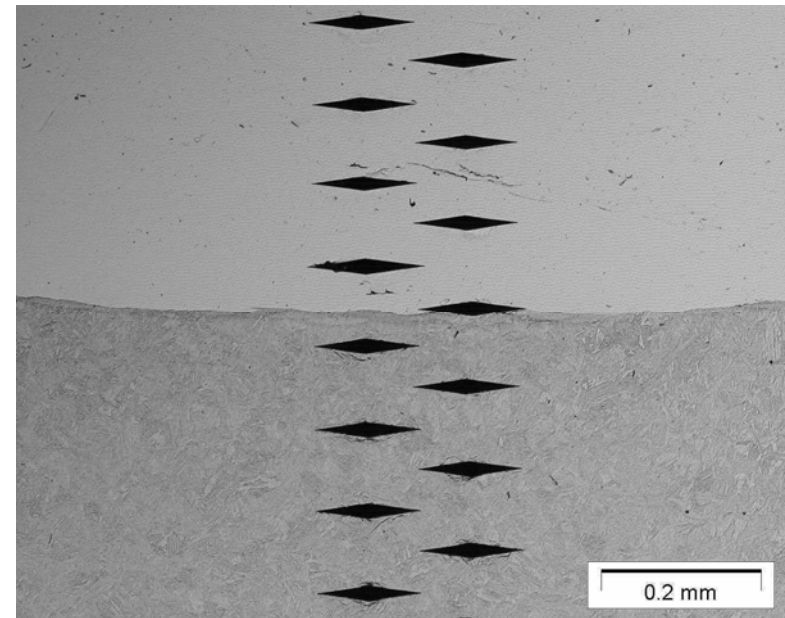
- Knoop microhardness measurements taken through ESD deposit into base material (AISI 9310). Photo on left is 50x magnification, photo on right is 100x magnification. No appreciable hardness difference between deposit and base material.

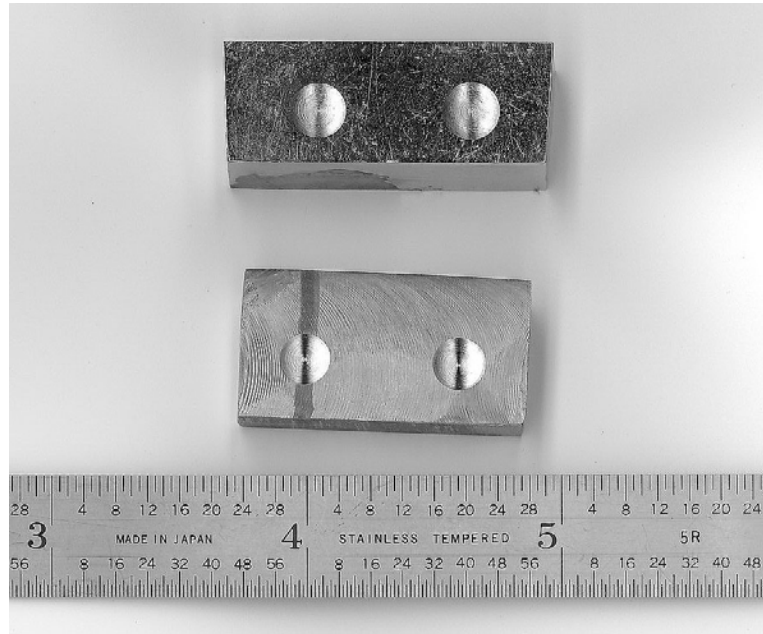
Type 1 Defects machined into chrome plated (top) and bare AISI 9310 steel samples. These defects were ESD filled as practice for fatigue test specimen deposition.
