**TECHNICAL REPORT**  
**TR-NAVFAC-EXWC-PW-1303**  
**SEPTEMBER 2013**

**BUILDING INTEGRATED PHOTOVOLTAIC (PV)  
ROOFS FOR SUSTAINABILITY AND ENERGY  
EFFICIENCY**

**ESTCP Number: EW-200813**

**September 2013**

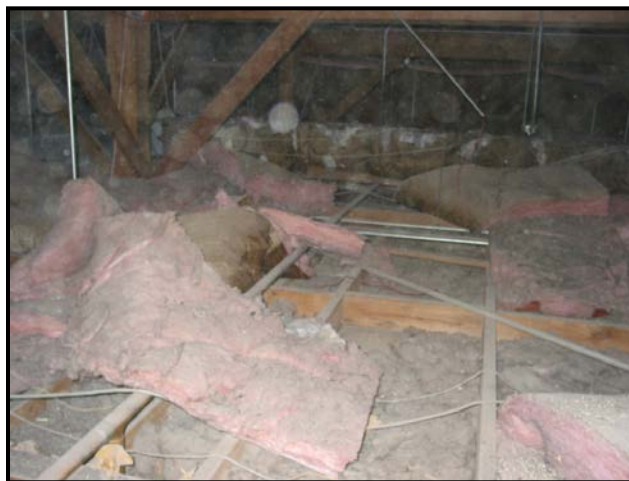
**Figure-12: Attic space of Building 228 at Site III (MCAS Yuma) showing poor insulation.**

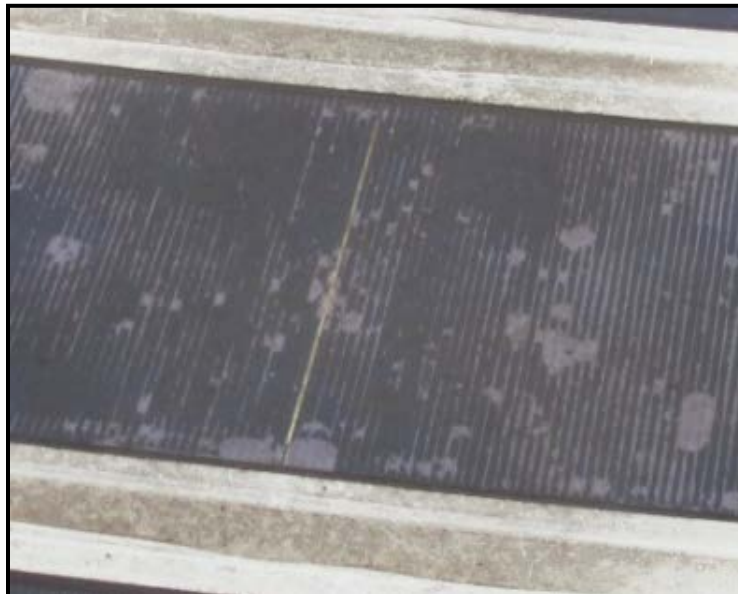
**Figure-46: Evidence of PV delamination.**

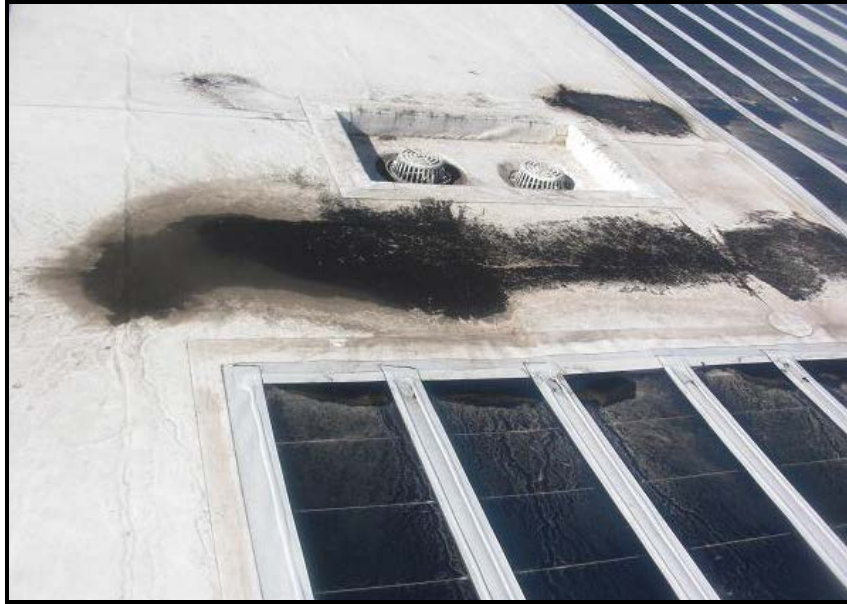
**Figure-47: Severe, localized mold growth due to water ponding before it reaches the drains.**

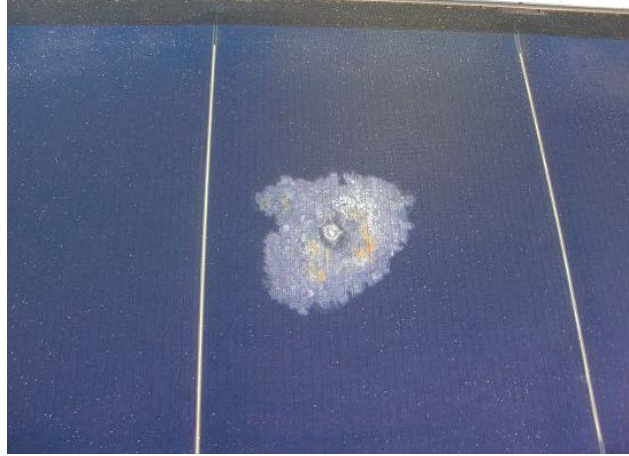
**Figure-50: Corrosion of PV material due to a pin-size hole at Site II (NAS Patuxent River).**
