## Barren Island Dredged Material Placement for Regional Sediment Management

by Robert N. Blama

**PURPOSE.** This Coastal and Hydraulics Engineering Technical Note (CHETN) describes activities that have occurred in the Chesapeake Bay to assist with Regional Sediment Management (RSM) activities by the US Army Corps of Engineers Baltimore District, Baltimore, MD. The Baltimore District employs the beneficial use of dredged material, specifically at Barren Island in the Chesapeake Bay, to prevent erosion of the remote island. This CHETN describes the beneficial use of dredged material at Barren Island. Finding a cost-effective, environmentally acceptable disposal site for the dredged materials is a challenge for all dredging projects, particularly for small navigational dredging projects. One such project is the Honga River and Tar Bay small navigation project in the Chesapeake Bay. An eroding barrier island that is protecting the mainland is located close to this Federal project. This technical note describes the use of geotextile tubes and dredged material to accomplish the Baltimore District's Operation and Maintenance (O&M) dredging mission for the Federal navigation project, wh

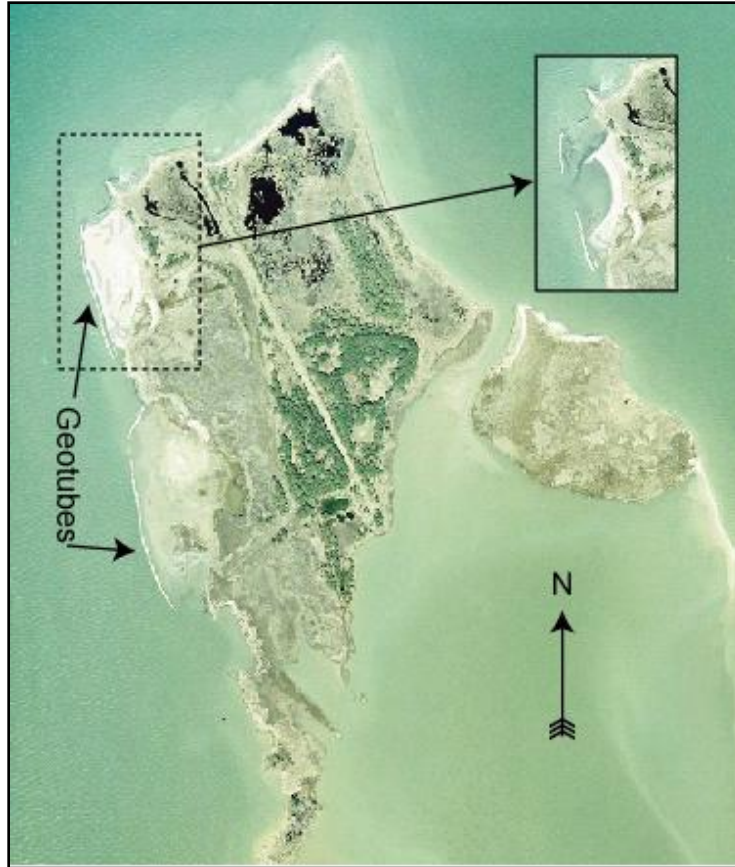
In 1994, a contract was awarded to allow filling and placing of geotextile tubes along the western side of Barren Island using material dredged from the Federal navigation channel (Figure 2). A medium-sized hydraulic dredge was used that had a 12-in. discharge pipe. The geotextile tubes were placed in the same area as the 1989 location, but in deeper water. The 4-ft contour was used as the line for all additional tubes. A series of geotextile bags were filled to obtain the required height. After installation of the bags, a dredging contract was awarded to pump the remaining material from the channel and place that material behind the geotextile bags. The initial tubes placed in 1989 that had failed were located within the 1994 site, and were covered with this dredged material. After the material was allowed to settle for approximately 1 month, the area was planted with *Spartina alterniflora* (smooth cordgrass) and *S. patens* (salt meadow cordgrass). Initial success occurred as the wetlands thrived. However, erosion of the wetland began to occur in areas where the geotextile bags failed.

**Figure 2. Location of geotextile tubes on western side of Barren Island (photo 1994).**

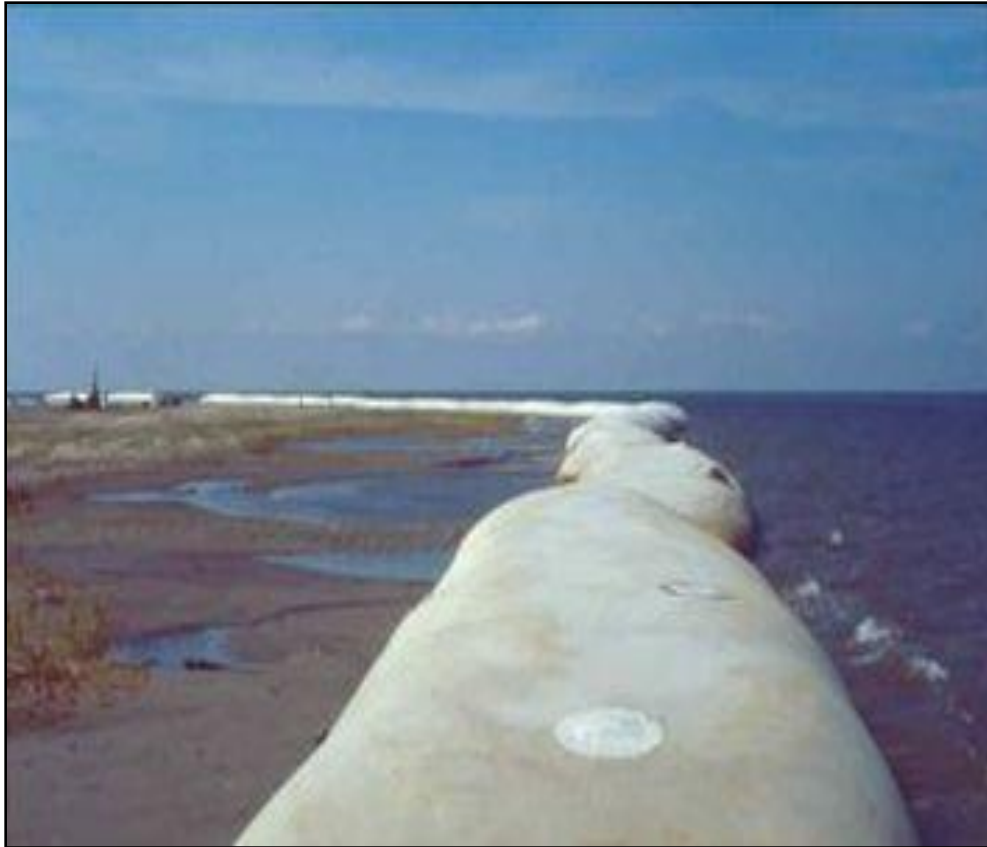
Coarse sand was purchased and brought to the site, and used to fill the geotextile bags (Figure 3). The bags were placed end-to-end to create an in-water confined placement site (Figure 4). Even though the bags were constructed according to specifications, the closure structure (snorkel or filling sleeve) could not be kept tied and, when wave action caused this filling sleeve to open, sand was lost and re-suspended once again in the tube. Once more, wetlands species were planted on the dredged material and thrived (Figure 5), but some of the geotubes lost height, which caused wetlands in those areas to erode.

**Figure 4. Geotextile tubes after dredged material had been placed behind them, western side of Barren Island (photo 2000).**

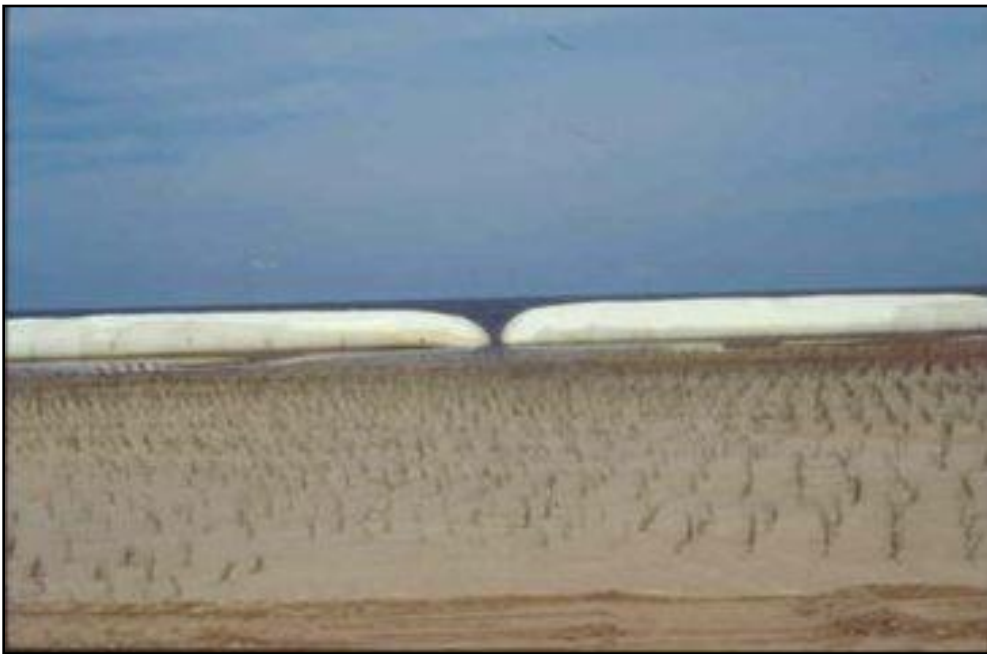
**Figure 5. Wetland species planted on dredged material behind geotextile structure, western side of Barren Island (photo 2000).**

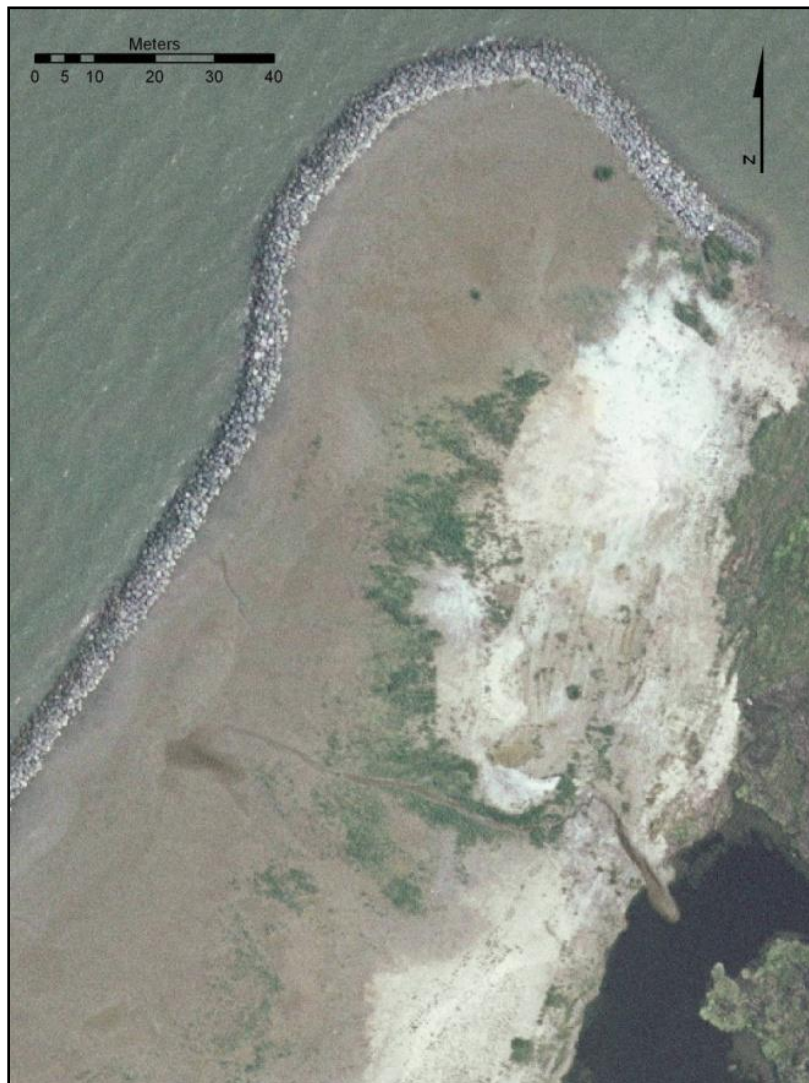
The northern end of Barren Island had been experiencing heavy erosion and was subjected to some of the worse winds to hit the island. This area did not have any geotextile tubes placed there. The 4-ft contour was again used as the line for placement, and a continuous offshore rock breakwater was constructed in 2003 until it reached some of the surviving geotextile tubes on the western side. Rock was applied to and beyond the area where geotubes were working (Figure 6). Rock was placed anywhere there were gaps in the tubes, and at the end of the tubes. The rock structure was constructed to a height of +2.5 ft above mean lower low water (mllw) with some notches created in the breakwater at a +2.0 ft above mllw to allow for tidal flushing and species ingress and egress. Dredged material placed inside this structure was planted with *Spartina* and *Juncus* (rushes) (Figures 7 and 8). This area has been very successful, and wetlands were established and still thriving with no subsequent loss of the dredged material (Figure 9). Additionally, other features were created within the marsh area. In the area where the pipeline was discharging, a bowl or kettle was formed in the placement site and allowed to stay. When this area was inundated by the tide, a tidal pond was created, which is now used by various aquatic species.

**Figure 6. Northern end of Barren Island where stone breakwater was constructed in 2003, dredged material was placed, and planted with *Spartina* (photo August 2005).**

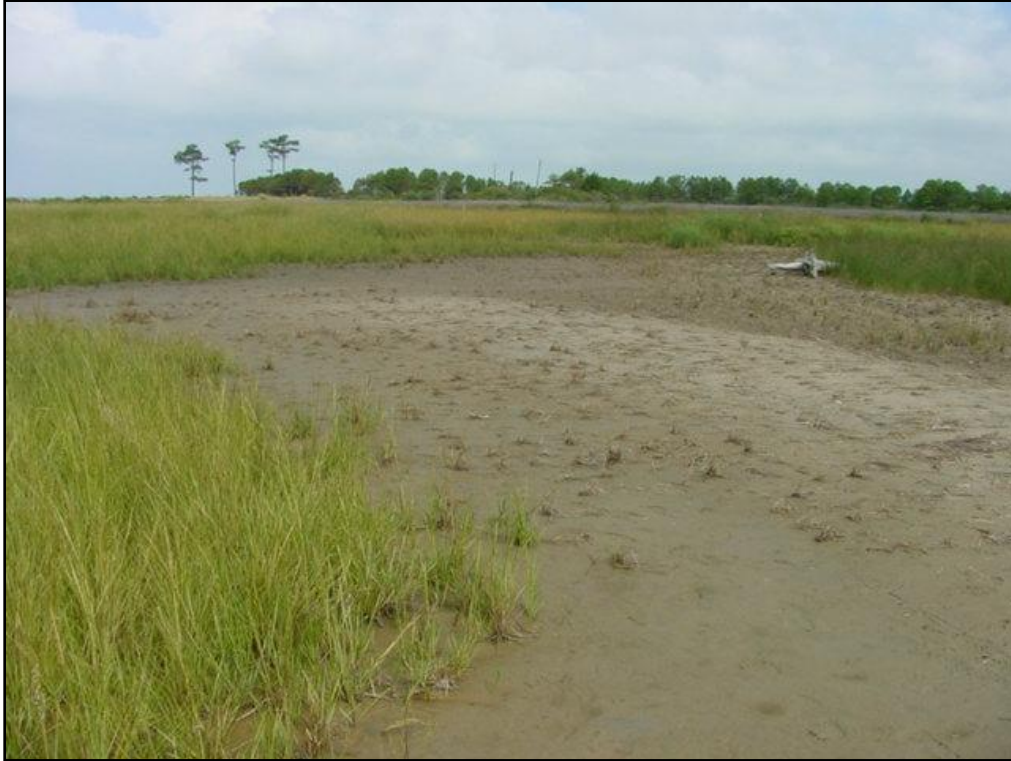
**Figure 7. Non-planted gaps between *Spartina* plantings, northern end of Barren Island (photo 2005).**

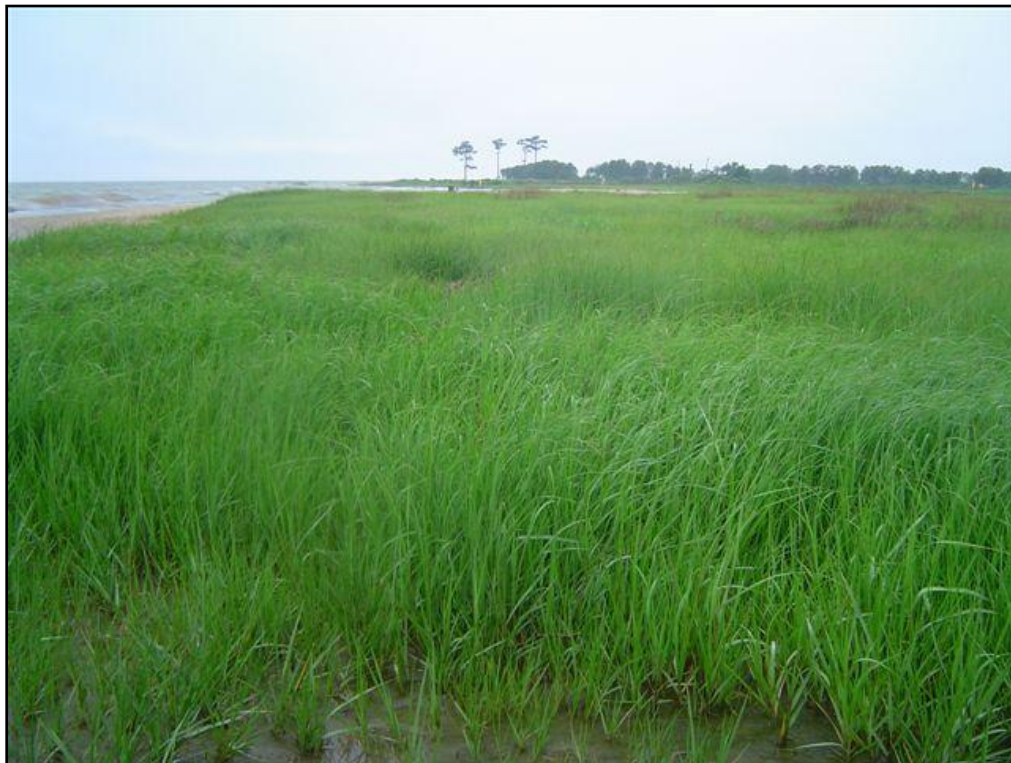
**Figure 8. *Spartina* filled in gaps between planted areas to cover non-planted areas, northern end of Barren Island (photo 2008).**

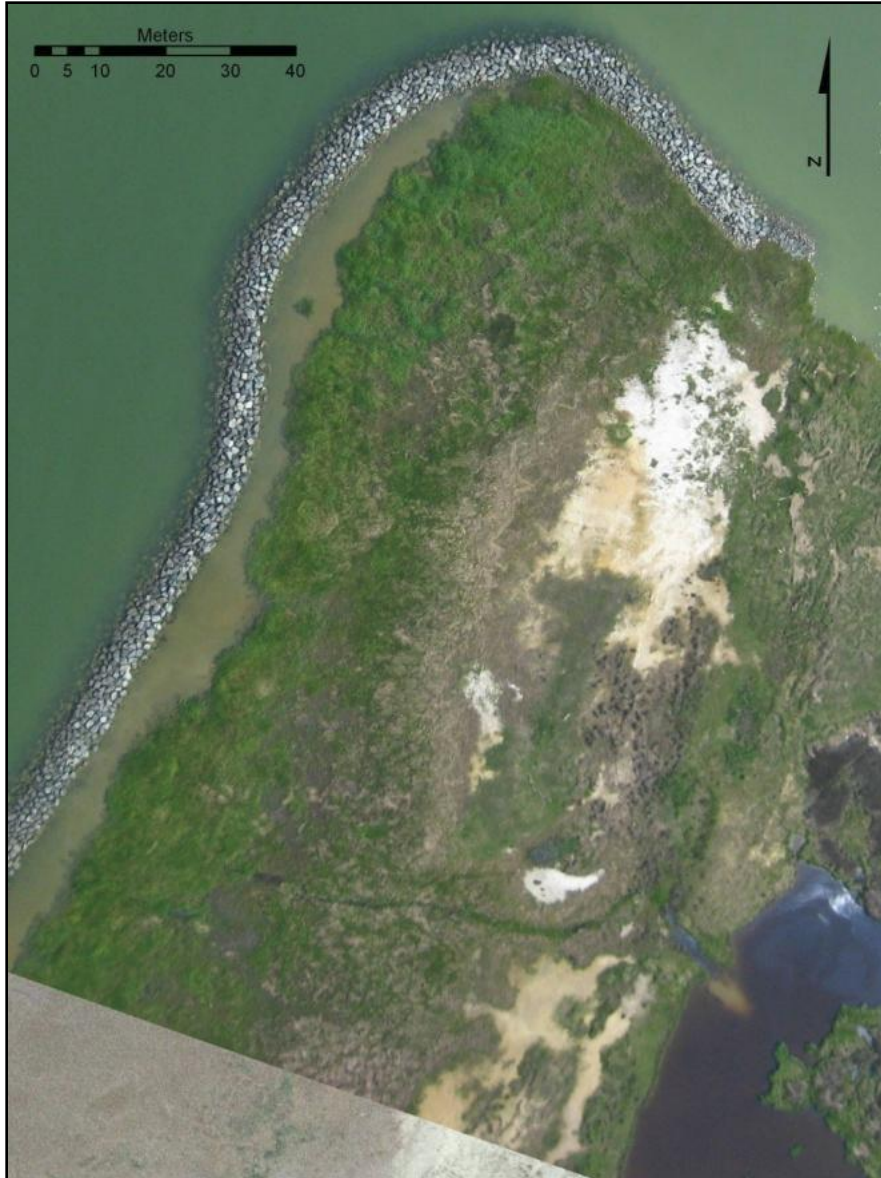
**Figure 9. *Spartina* growth on dredged material placed behind stone breakwater on northern end of Barren Island in August 2008, 3 years after planting.**

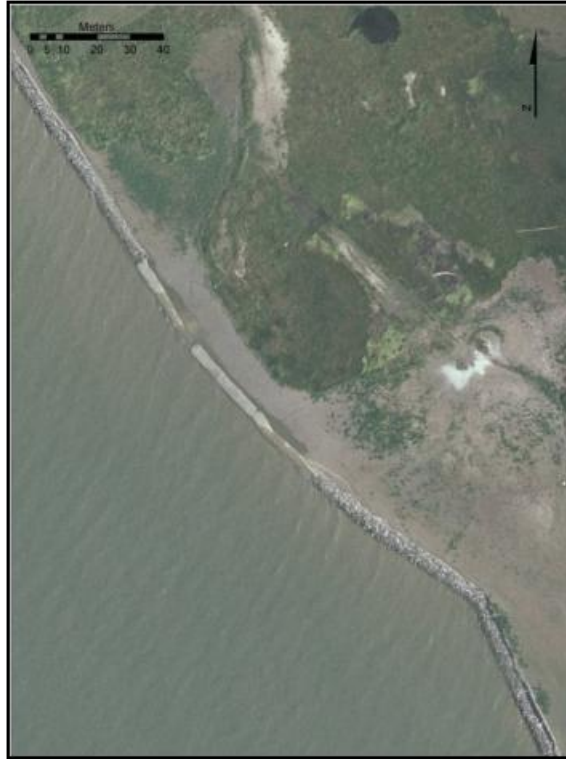
By the time of the next maintenance dredging in 2000, the geotextile tubes had become distorted and lost some height. Because of strong wave action, the sand was re-suspended in the bags and forced toward the landward side of the bag, thereby causing stress on the fabric. It was surmised that this was due to the fine-grain material used for filling the tubes. In areas where the bags were lower than mean high water, erosion occurred in the area established as a wetland. Additional bags were needed to extend the placement site. However, it was decided that coarser sand would be required to be placed in the tubes.

At this point in time, the Baltimore District was successfully using dredged material to restore wetlands along this shoreline. However, use of the geotubes as a containment structure was not entirely satisfactory as they stretched, split, and lost height after they were placed. If the geotubes were torn, the bags also lost sand. Additionally, the cost of purchasing and installing the geotextile tubes was approaching, and sometimes surpassing, the cost to install rock breakwaters. After several attempt to use the geotubes, it was determined that rock would be a better, more stable, and more economically viable alternative for containing the dredged material.

**Figure 10. Western side of Barren Island where geotextile tubes were installed and failed (photo August 2005).**

The National Aquarium of Baltimore has conducted post-monitoring of the placement sites. As of 2006, all previous planted areas continued to thrive, with robust and spreading plant growth. Additionally, there is evidence of colonization by typical marsh fauna, including salt marsh periwinkles, fiddler crabs, killifish, and other species. In particular, areas to the north and south planted in 2004 and 2005 appeared to be thriving, with the plants spreading aggressively beyond the footprint of the original plantings. The only area not exhibiting this strong performance is in the areas on the western side of the Island where the original geotextile tubes have failed or partially collapsed (Figures 10 and 11). These sites continue to erode. In the areas where the failed tubes have been replaced with stone, erosion has been arrested, and the restored marsh is growing landward from the breakwater. In the areas behind the failed tubes, some erosion is ongoing and will likely continue until additional stone is placed in the location of the failing tubes.

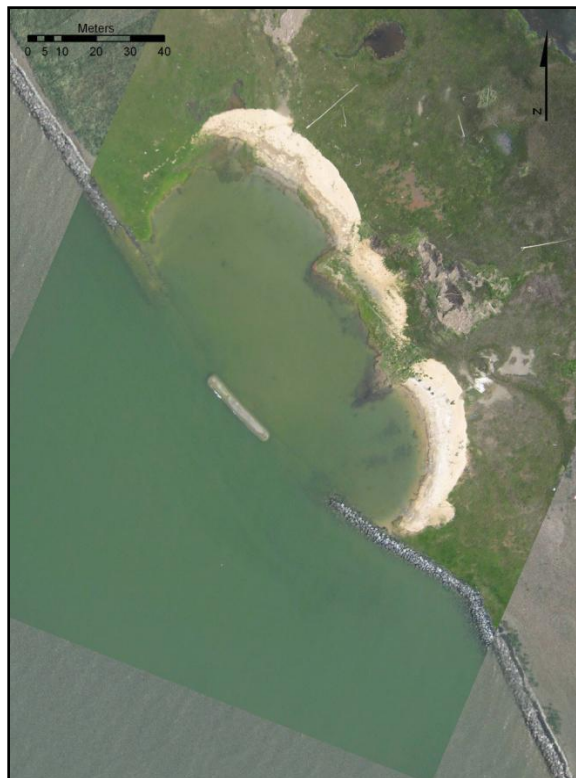
**Figure 11. Dredged material eroded from the placement site after the geotextile tubes failed, western side of Barren Island (photo August 2008).**

There was enough room behind the breakwater system initially created that it could contain the 2008 dredging with wetlands established over the entire area. In 2009, American Recovery and Reinvestment Act (ARRA) funds became available and were used to extend the stone breakwaters farther down the Island to some vulnerable areas. Also, wherever geotextile tubes were failing and erosion was occurring, stone was placed in those areas to create pockets of areas that could accept dredged materials.
