**TEARDOWN AND INSPECTION OF THE CUMMINS  
VTA-903 - EVALUATED USING THE SINGLE COMMON  
POWERTRAIN LUBRICANT (SCPL)**

**INTERIM REPORT  
TFLRF No. 450**

**Contract No. W56HZV-09-C-0100 (WD21 – Task 2.6)**

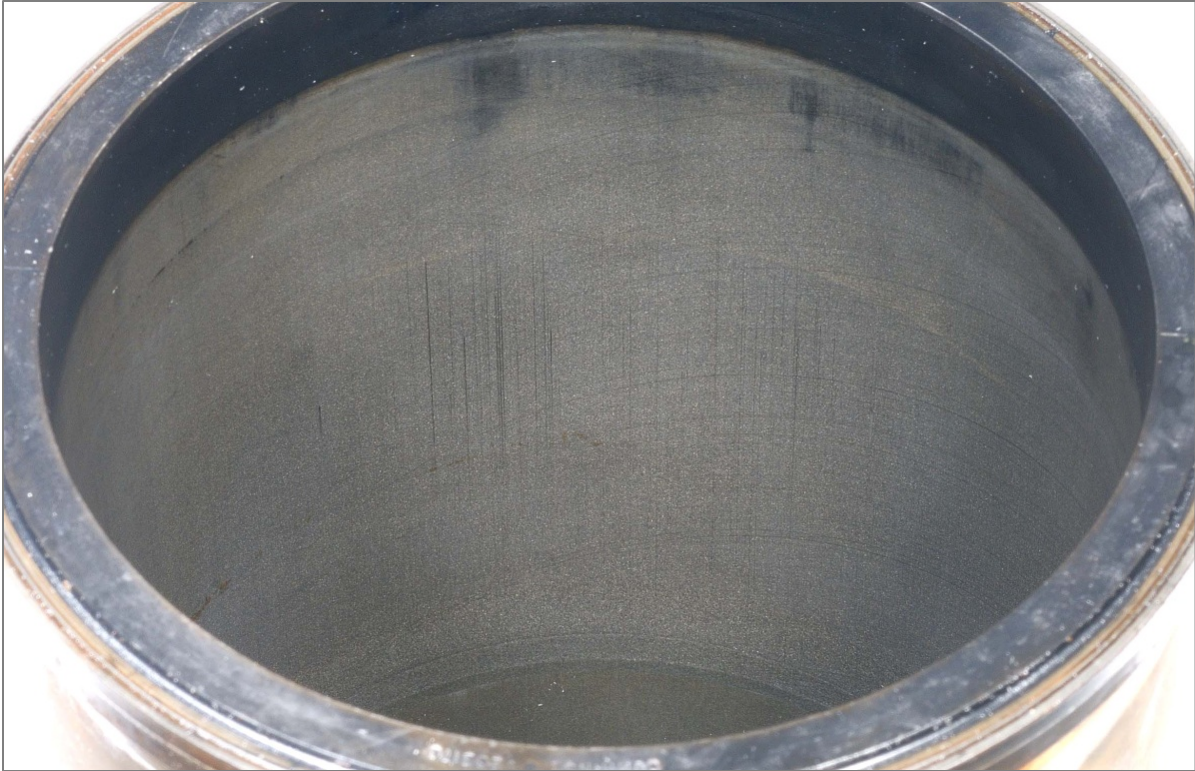
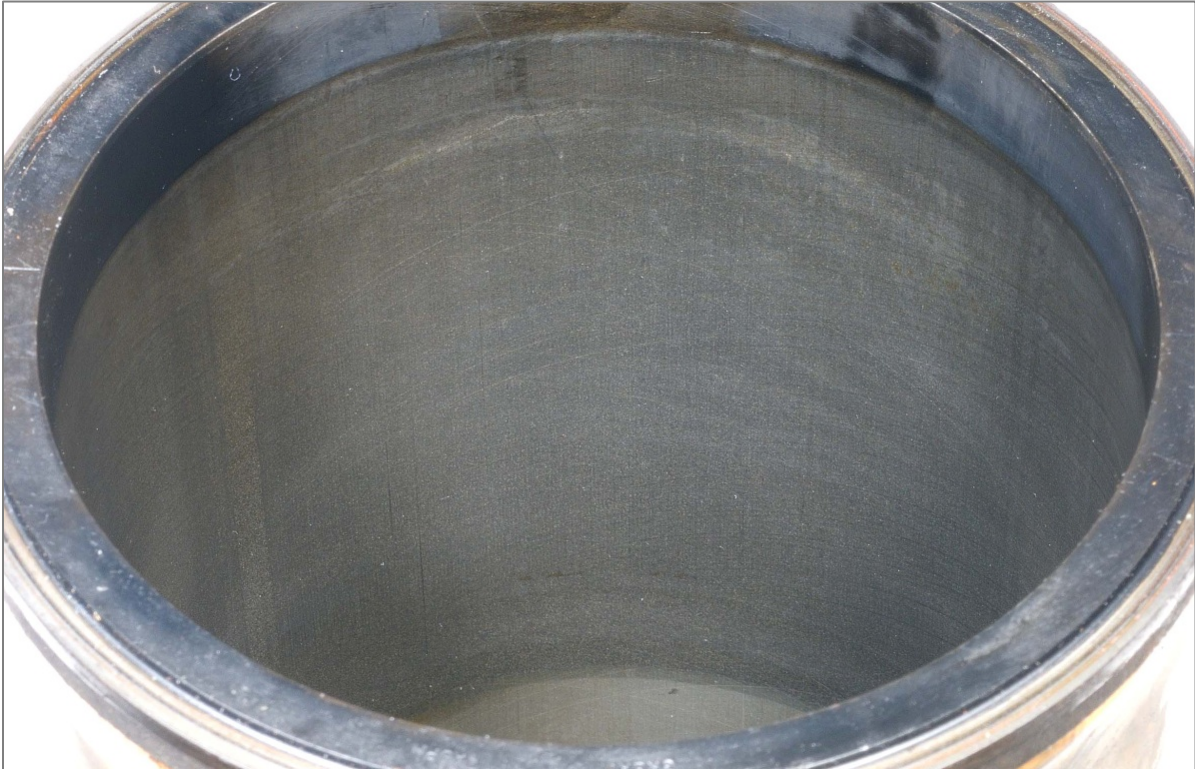
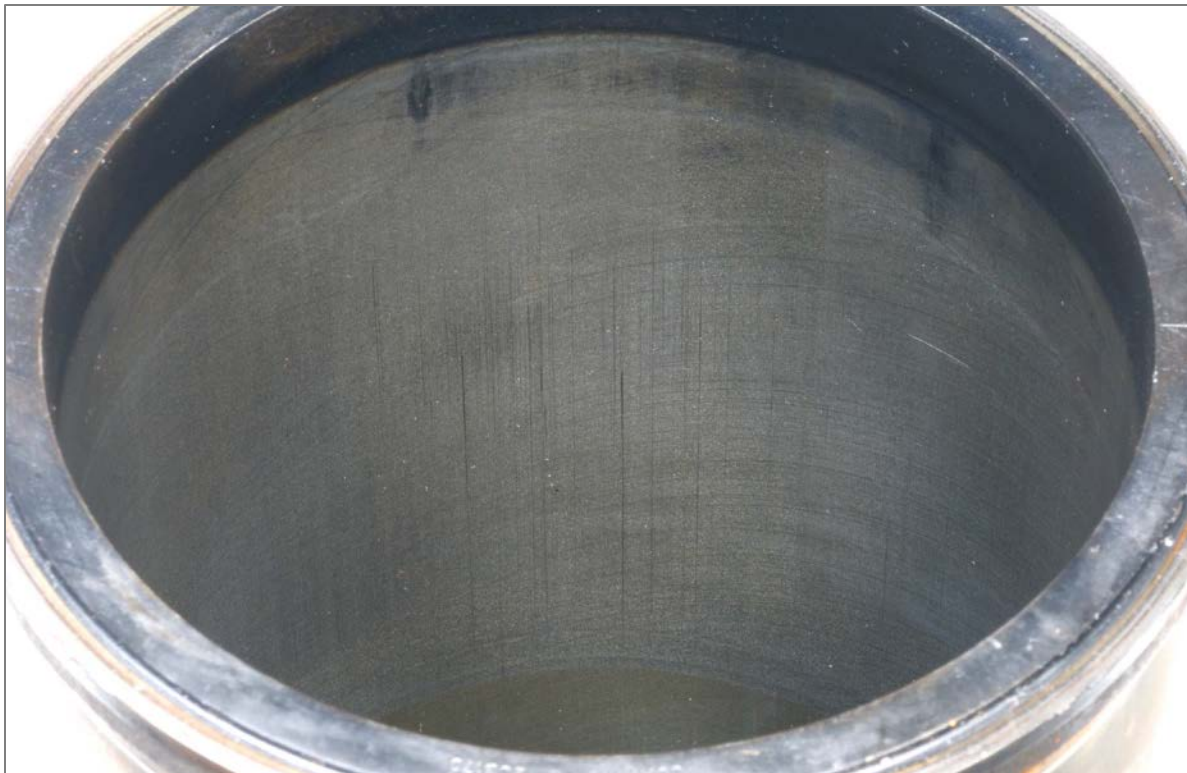
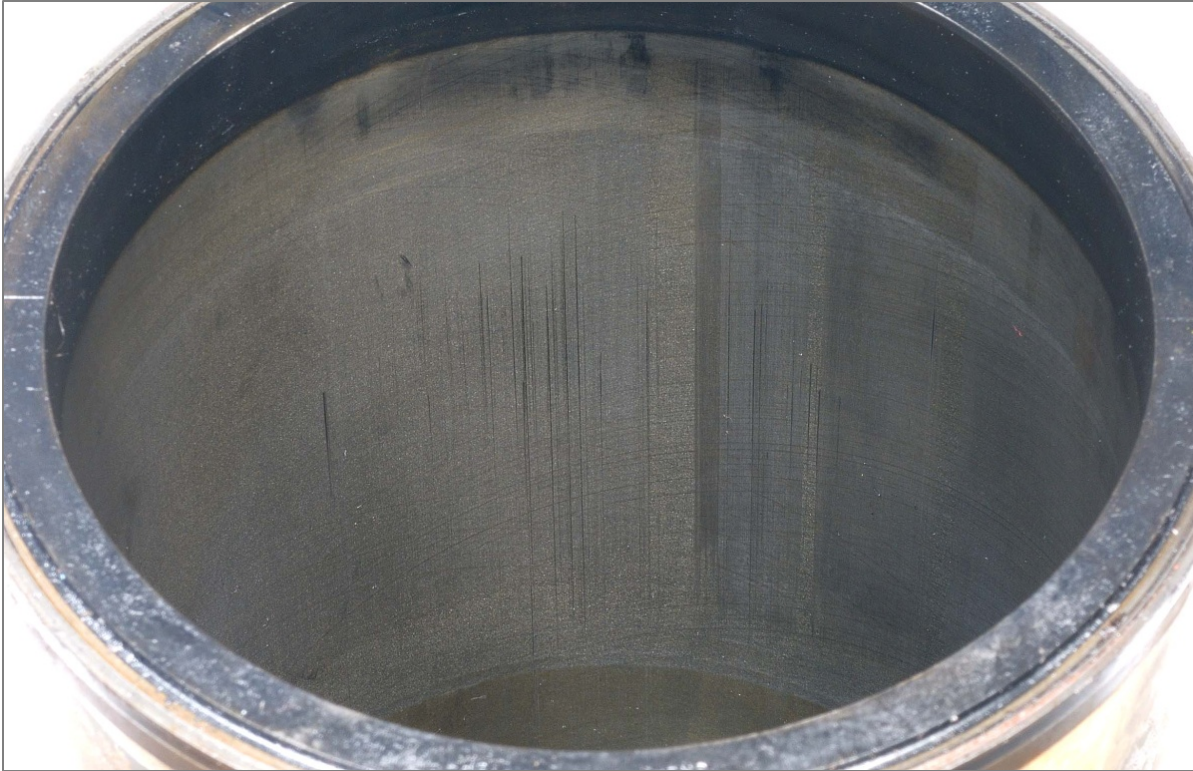
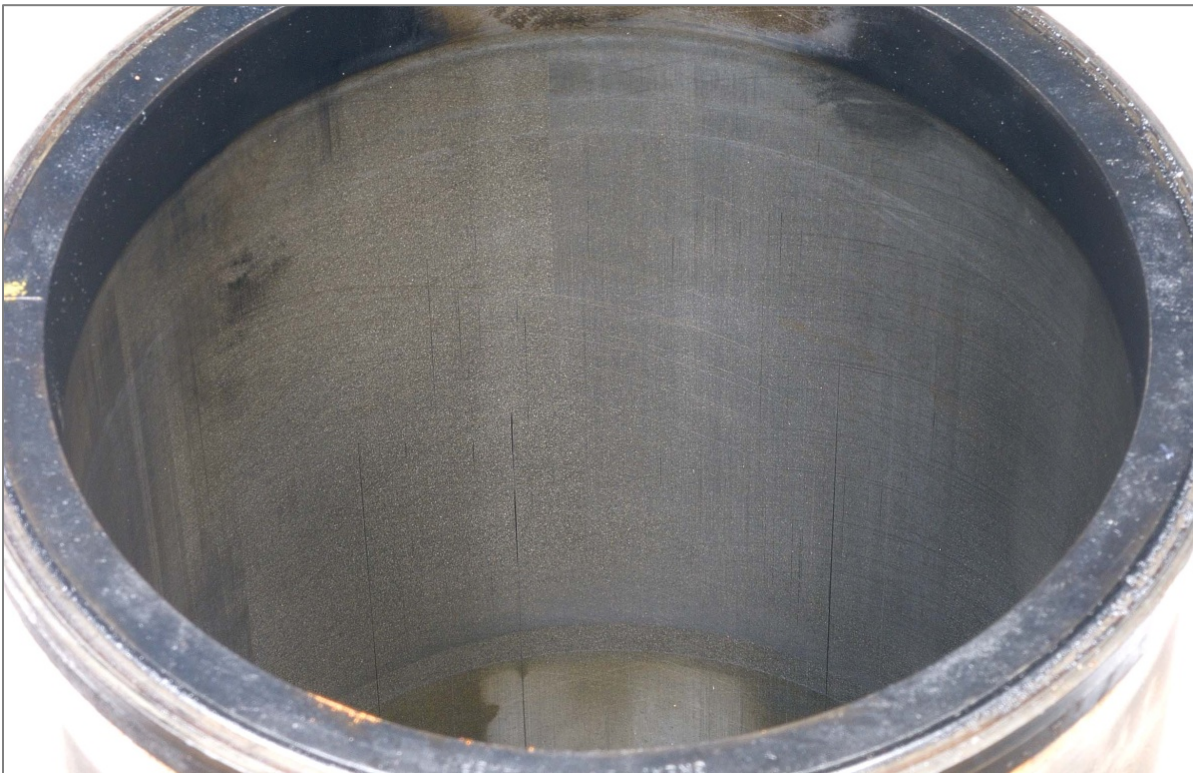
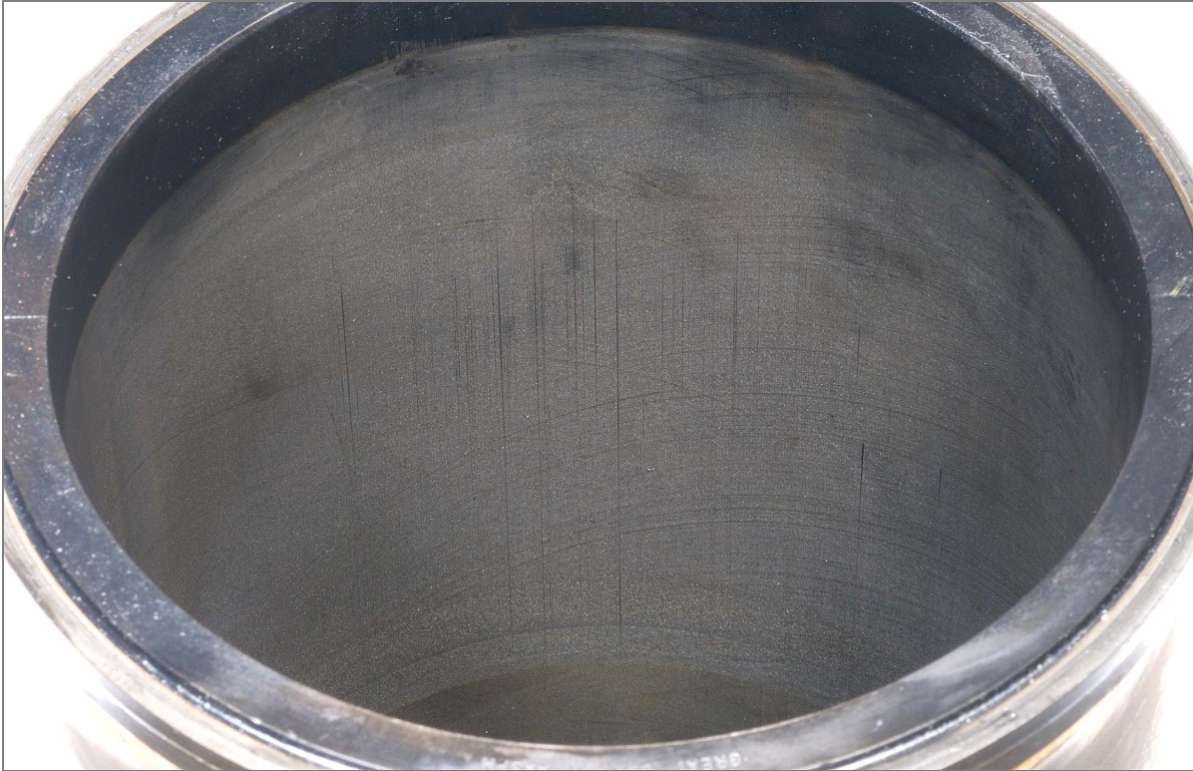
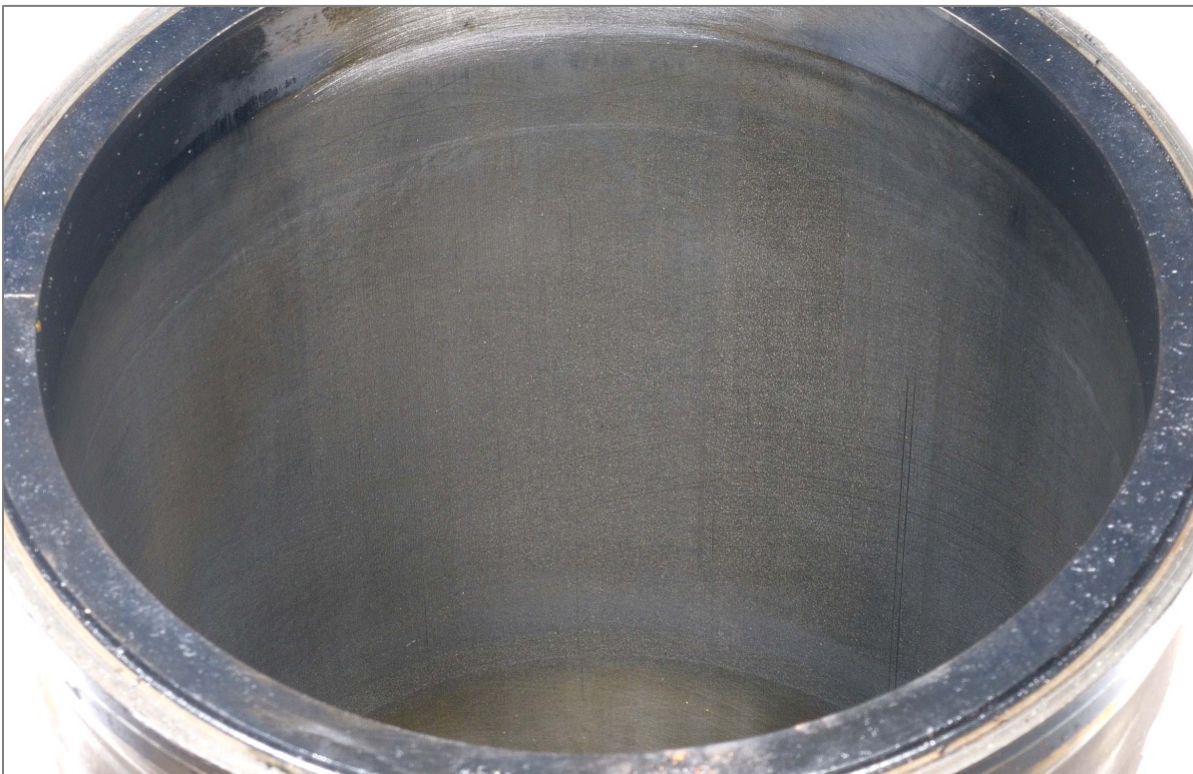
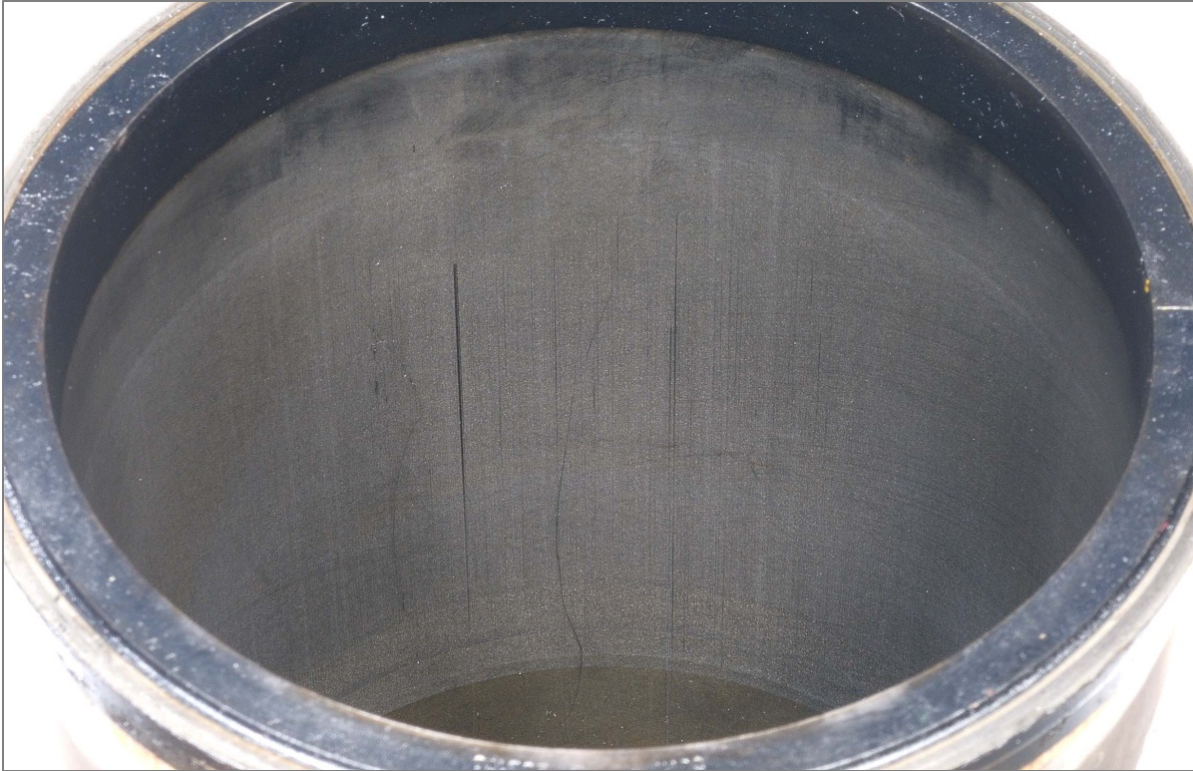
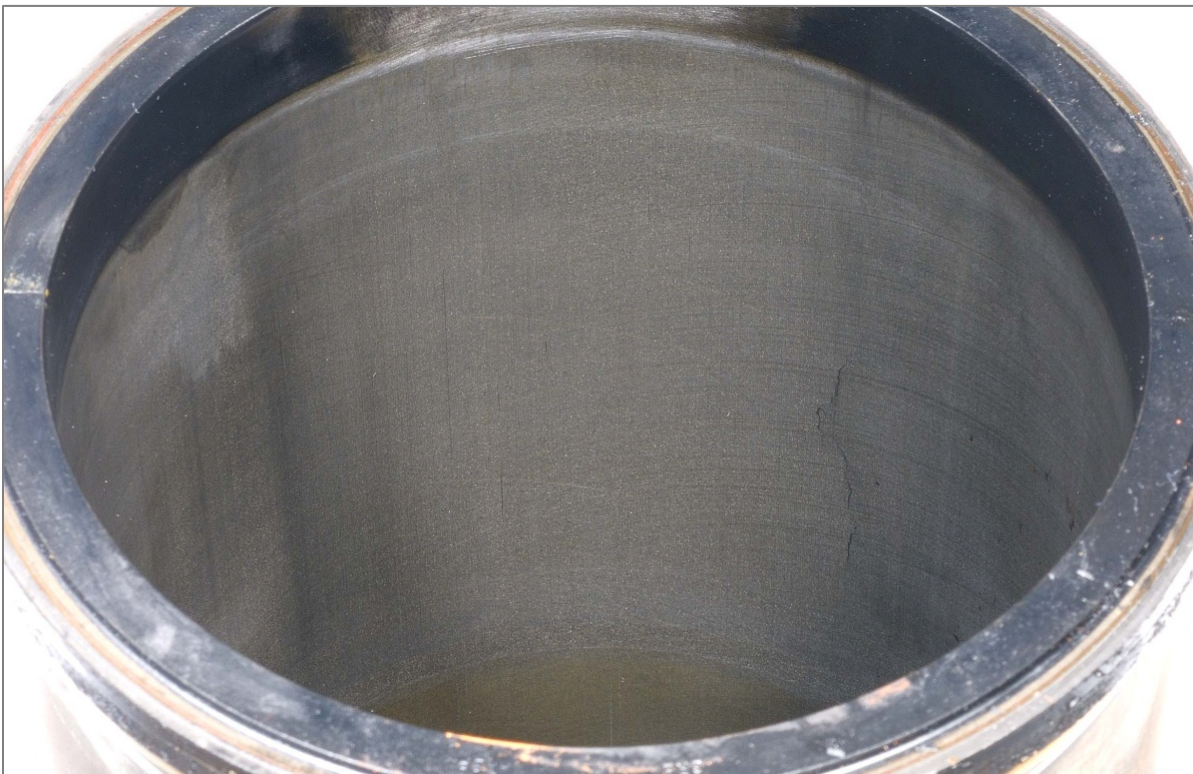
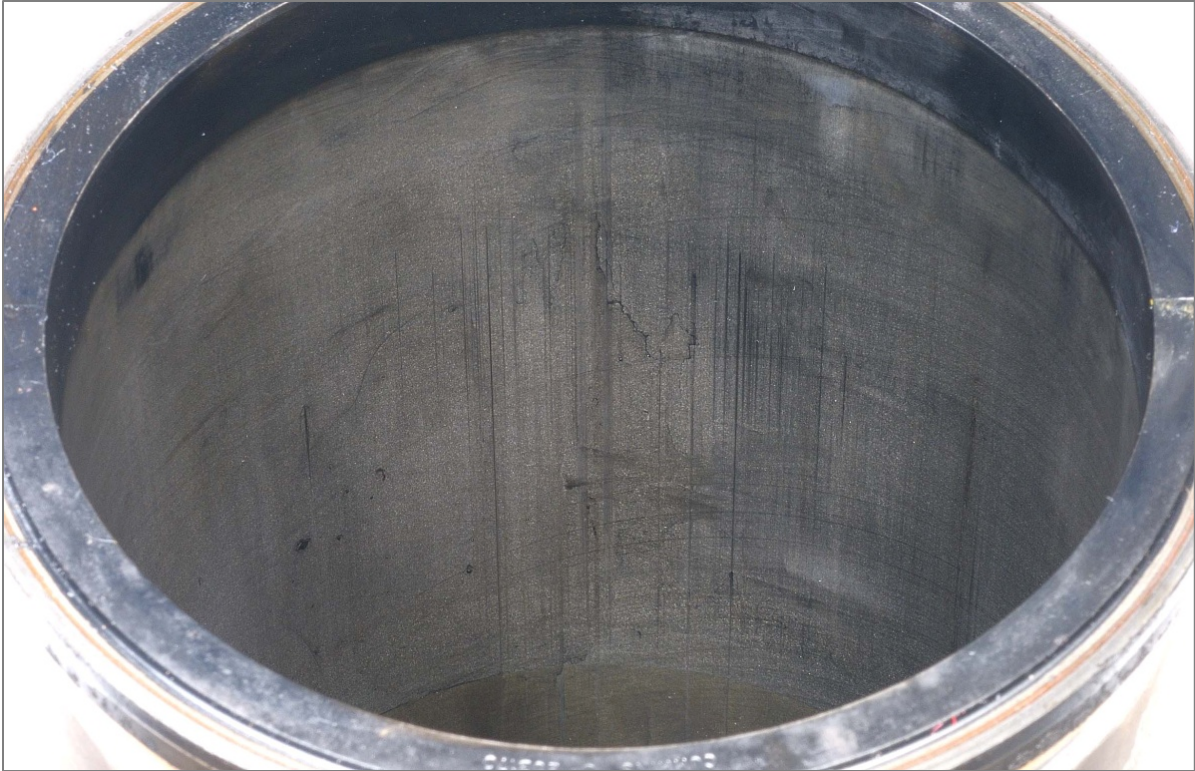
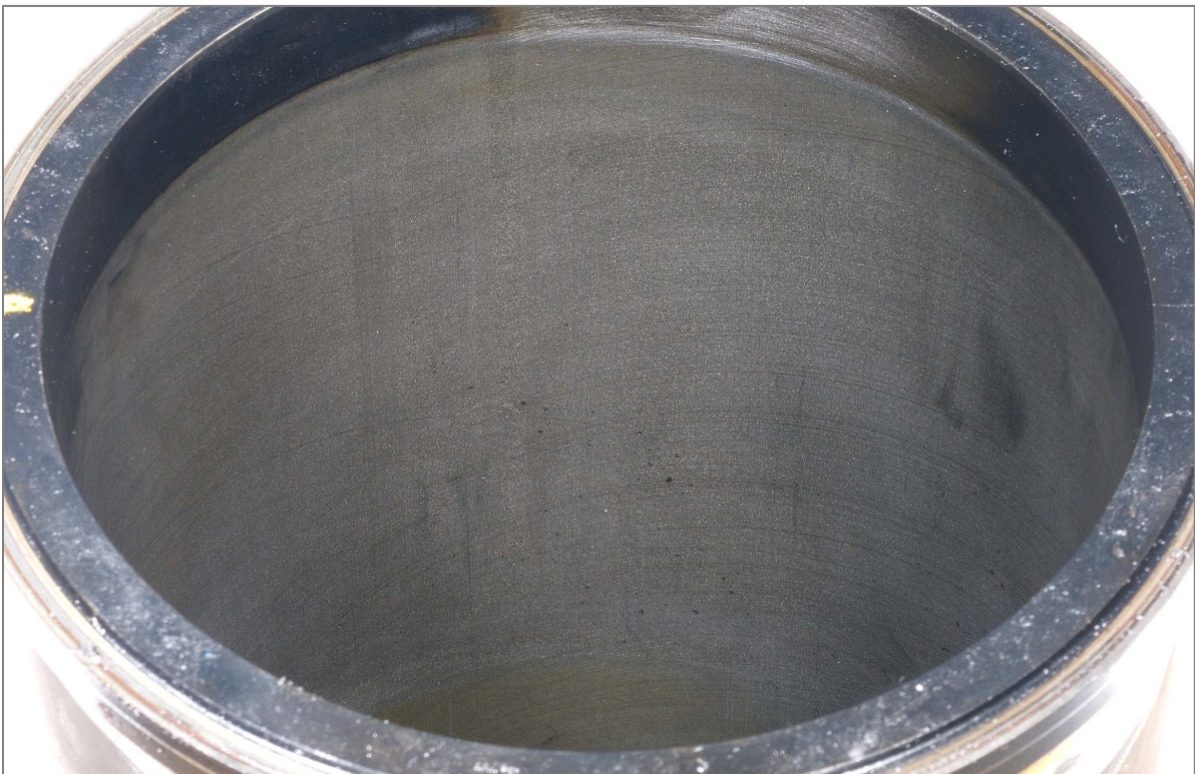
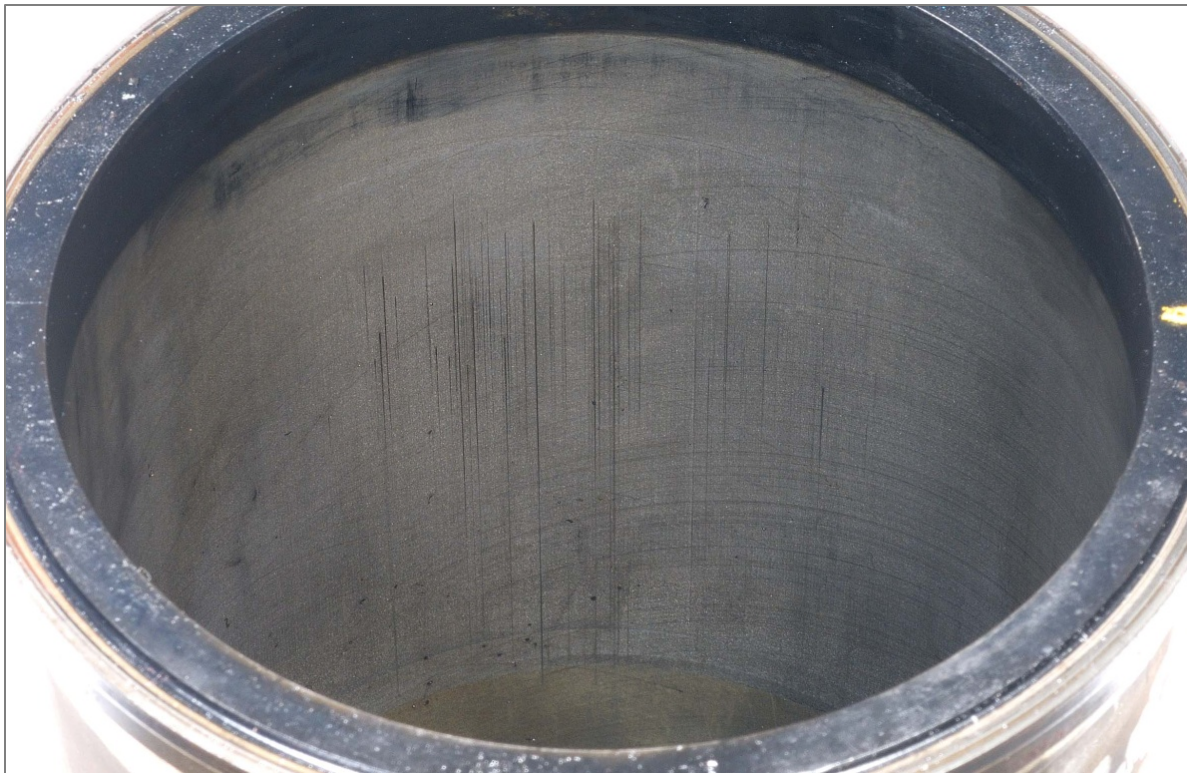
Each liner bore was photographed along its thrust and anti-thrust surfaces for comparison, and are shown in Figure 6 through Figure 21. Each is labeled to identify its location (i.e. cylinder number) on the engine. As seen in the ratings results, none of the individual liners showed evidence of scuffing or bore polish. All lines showed light vertical scratches consistent with normal operation.

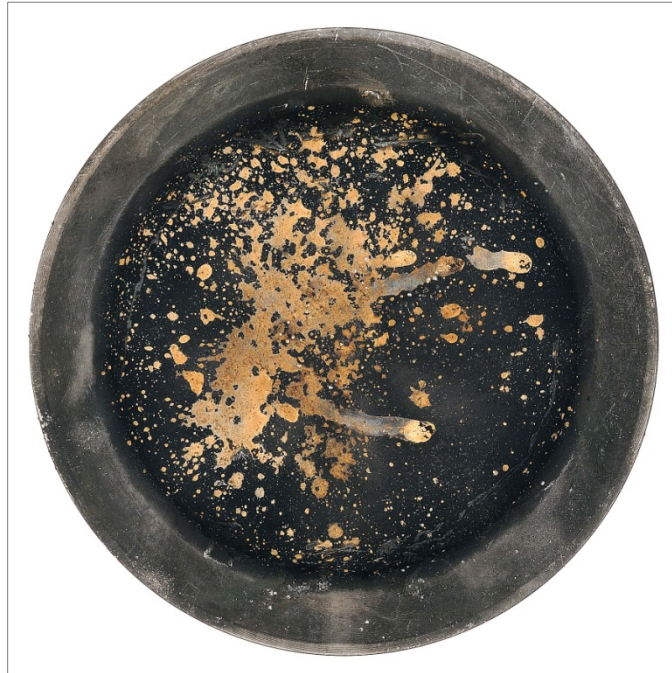
**Figure 28. Piston Crown, Cylinder #2**

Note, rust/water markings shown in the bowl of the number two piston looks to have occurred during the length of storage.

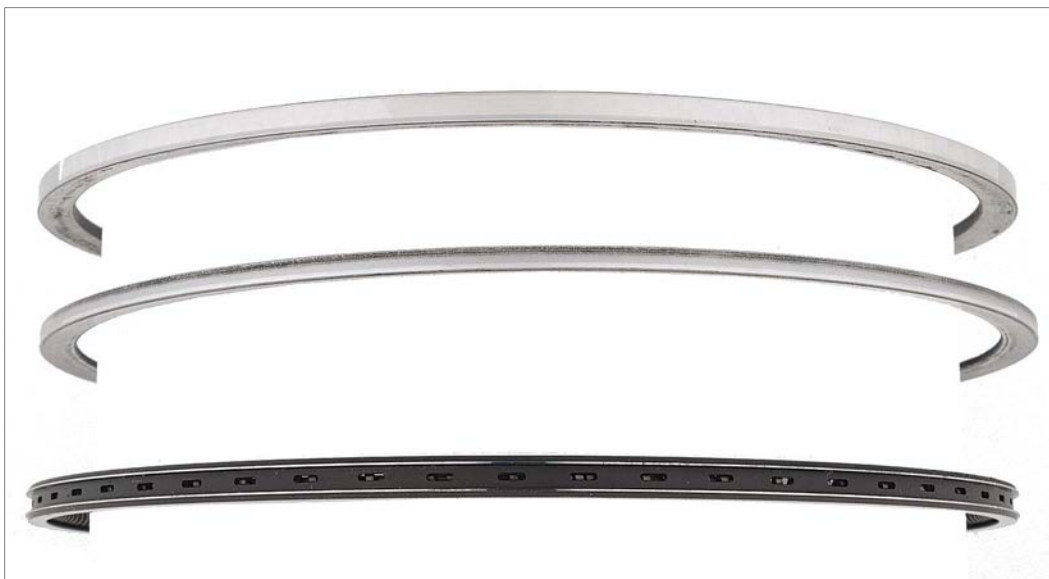
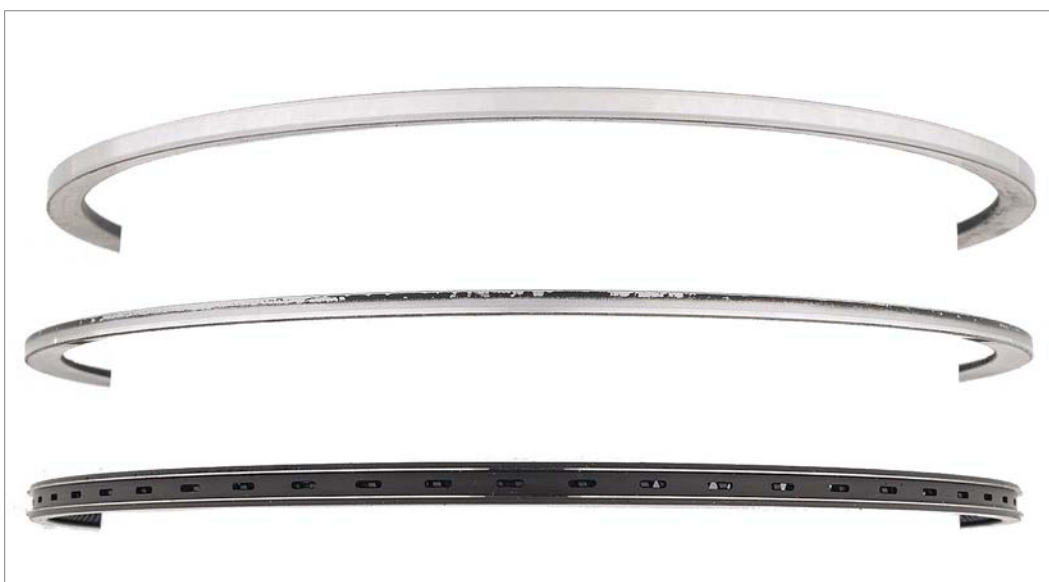
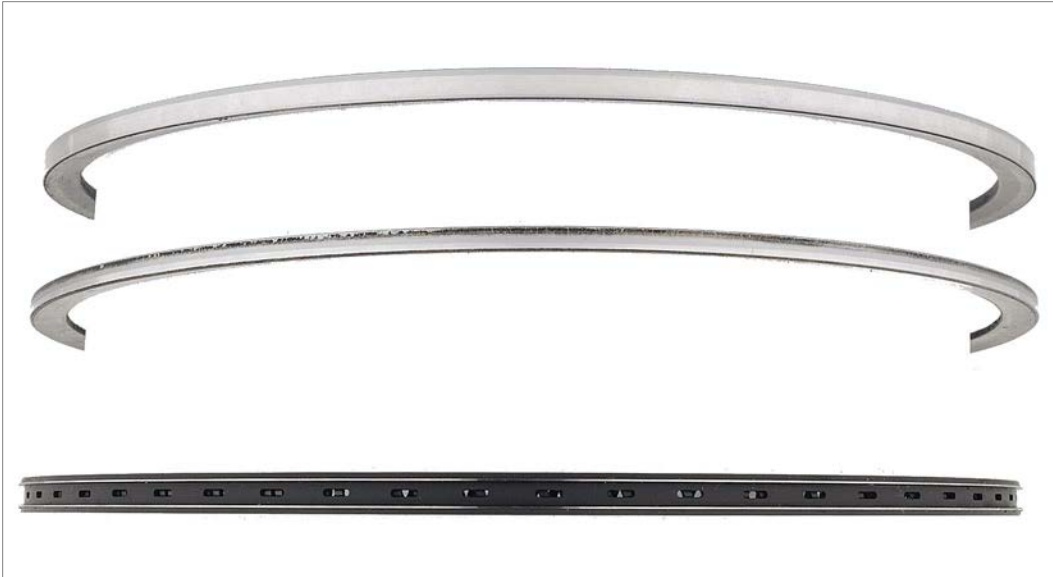
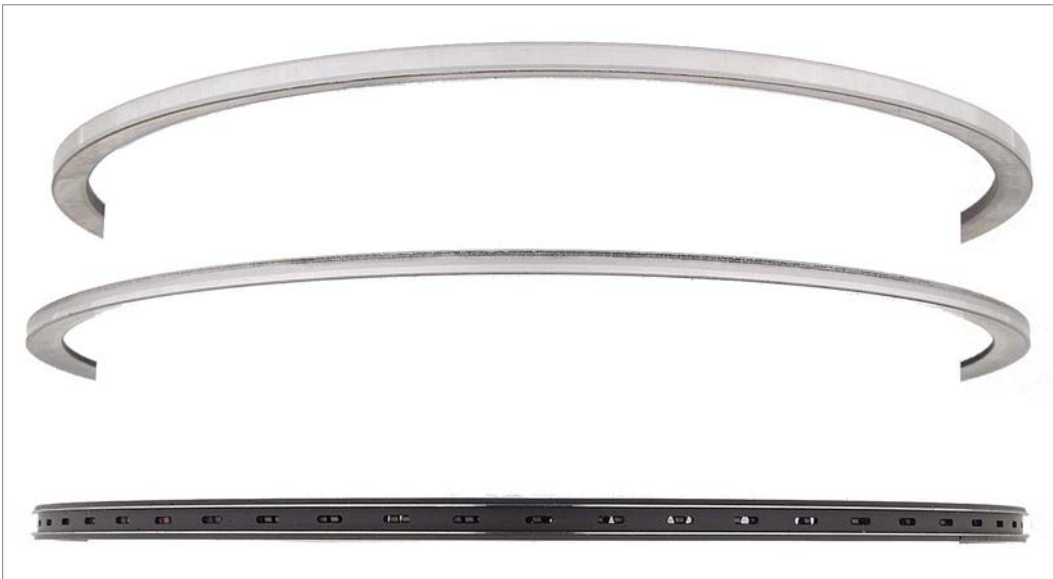
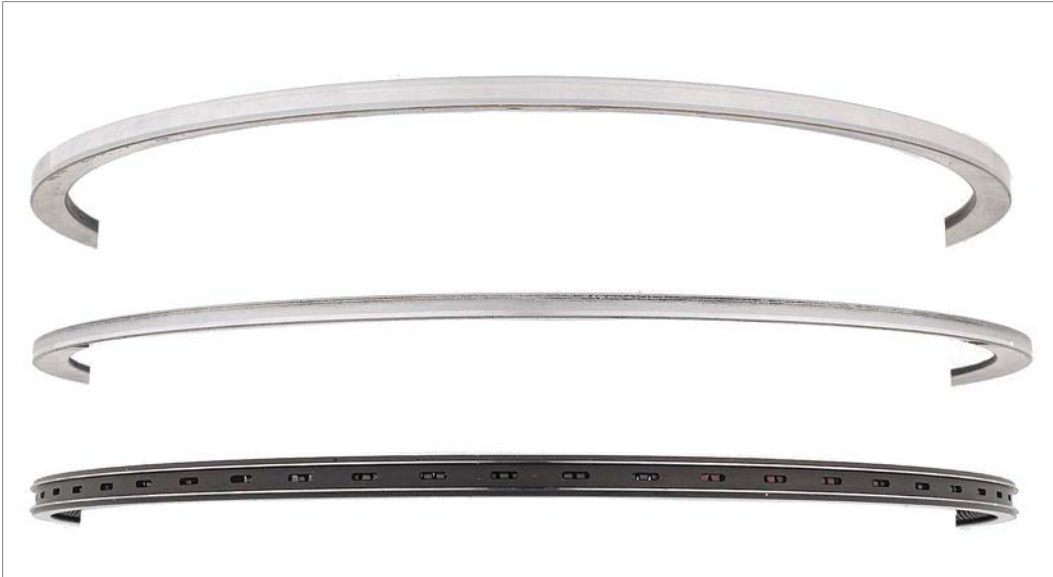
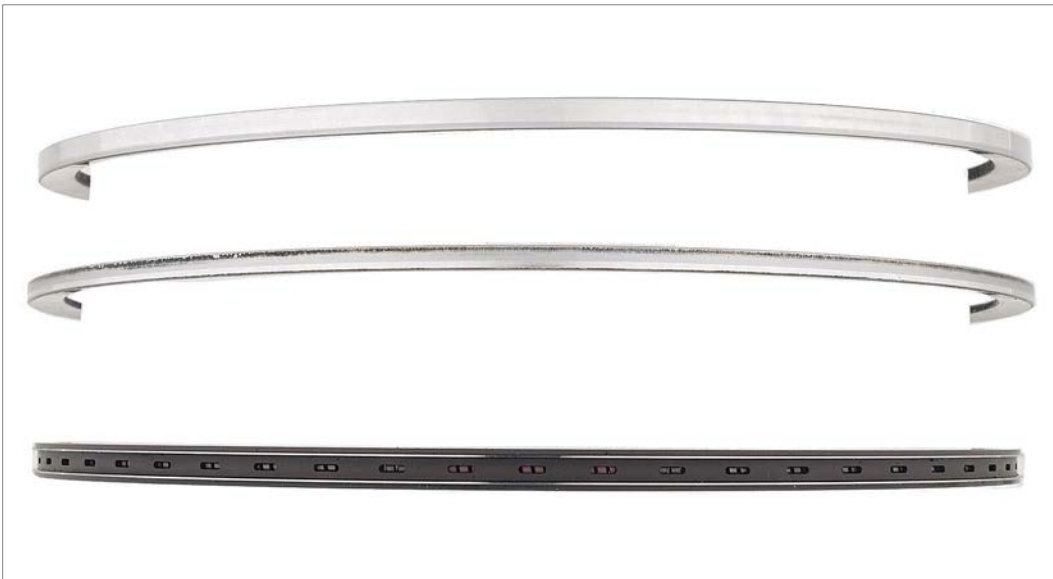
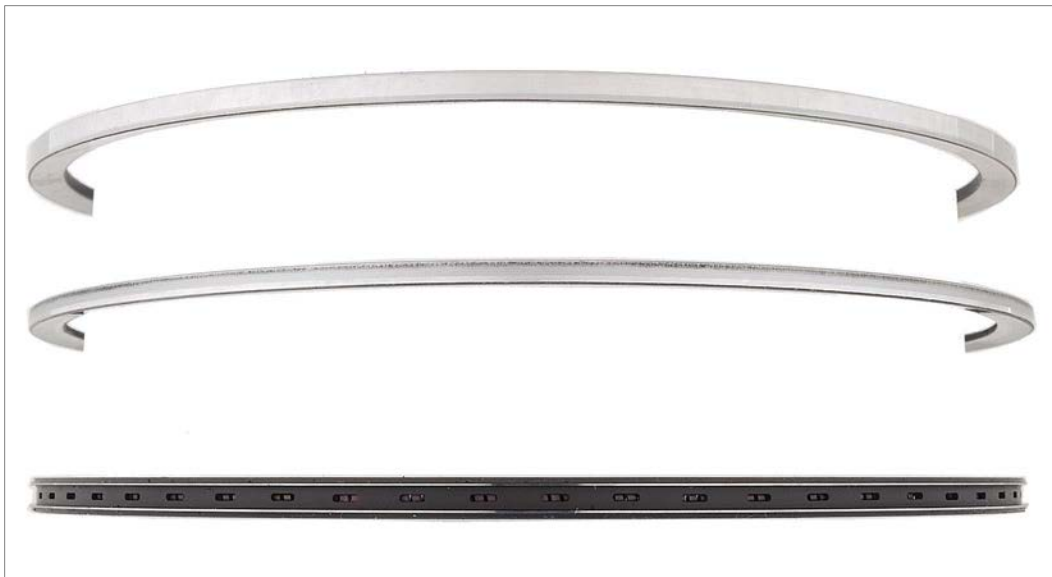
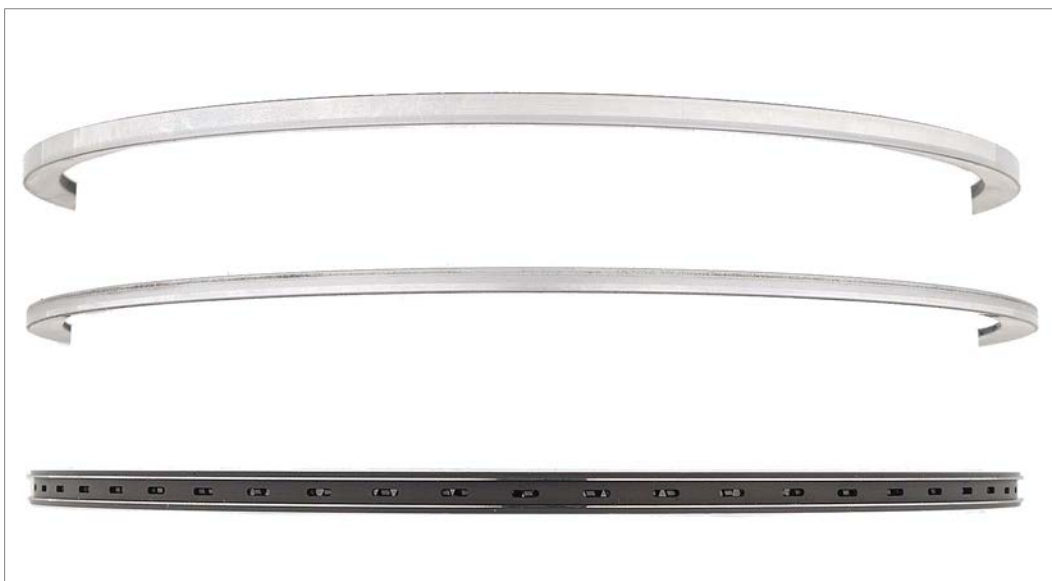
Ring pack measurements show the top (fire), second, and third (oil control) rings for each respective cylinder. No distress was noted for any ring packs removed from the engine, as shown in Figure 54 through Figure 61.

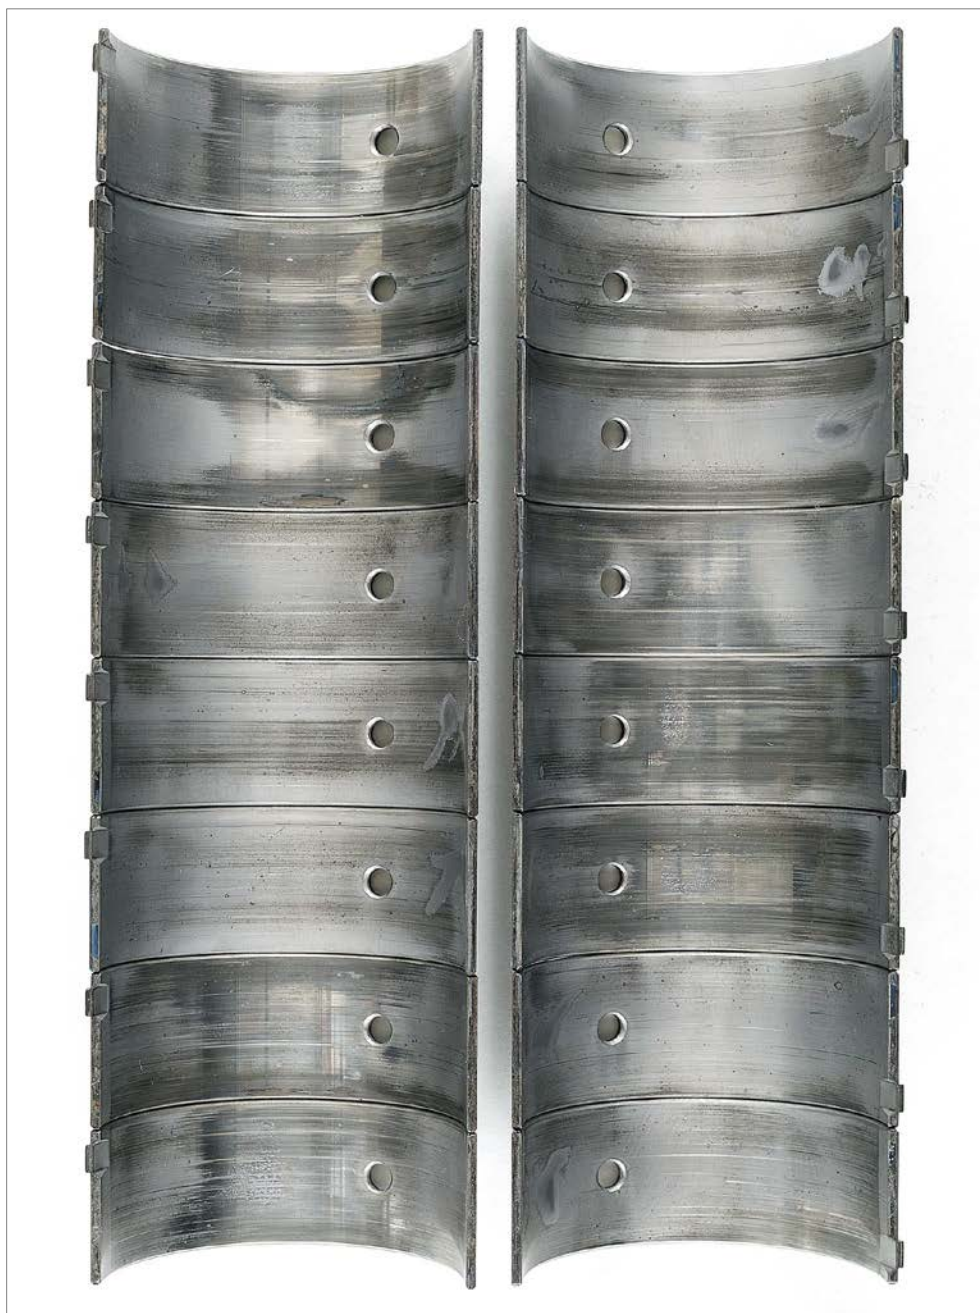
**Figure 62. Connecting Rod Bearings**

Orientation for connecting rod bearings is as follows: upper shell shown left, lower shell shown right, top to bottom cylinders 1 through 8. No shells showed exposed copper. Wear on all shells appears consistent with normal use, as shown in Figure 62.

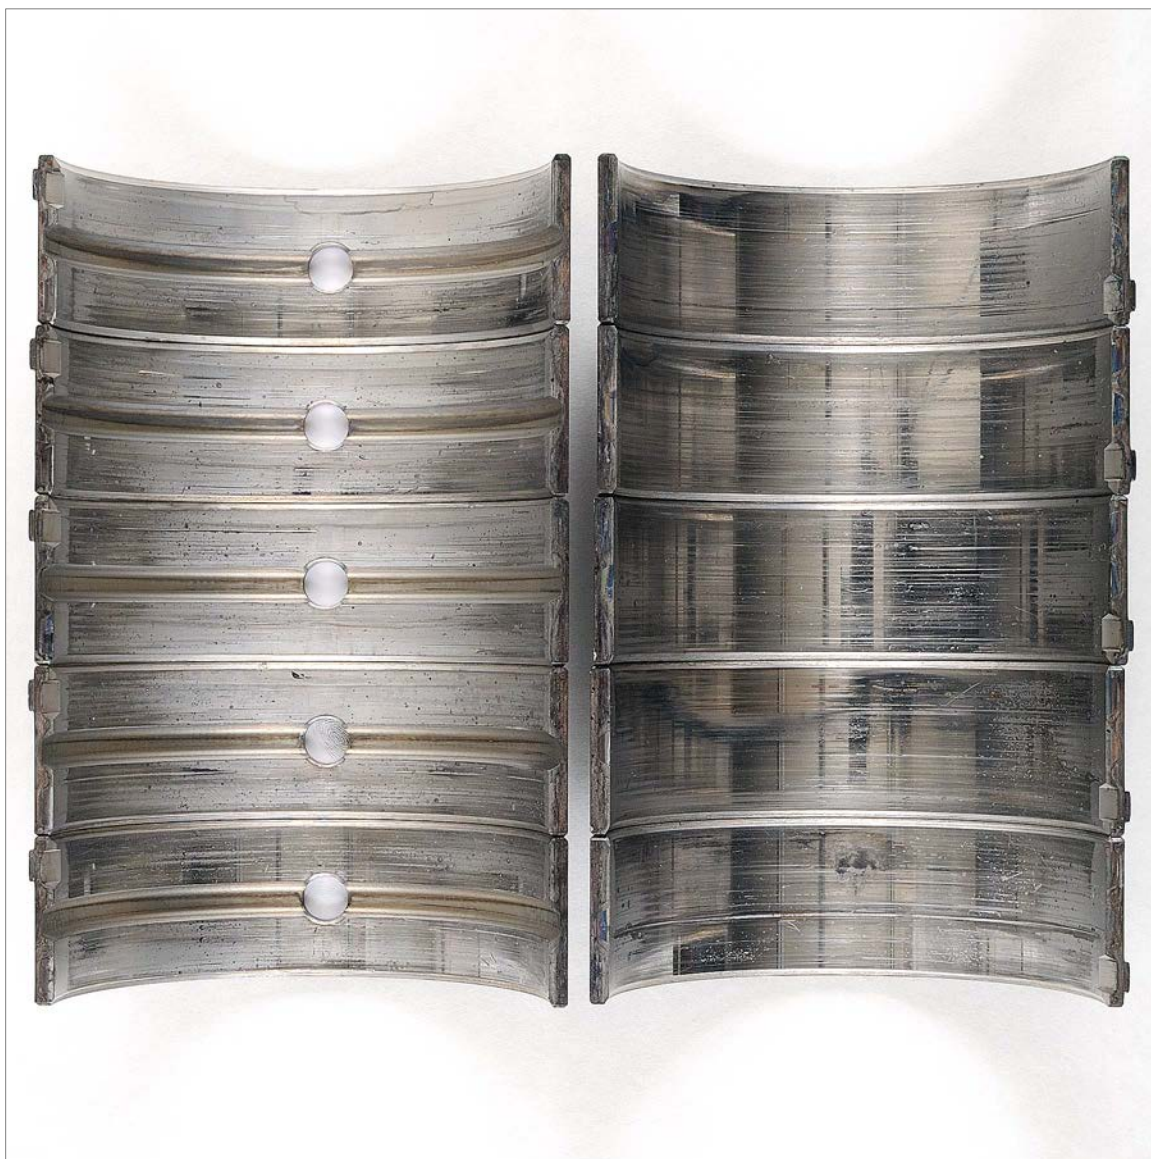
**Figure 63. Main (Crankshaft) Bearings**

Orientation for main bearings is as follows: upper shell shown left, lower shell shown right, journals 1 through 5 shown top to bottom (note: main bearing number 5 is at thrust location). As with the connecting rod bearings shown above, none of the main bearings showed any exposed copper. All markings present are consistent with normal use, as shown in Figure 63.

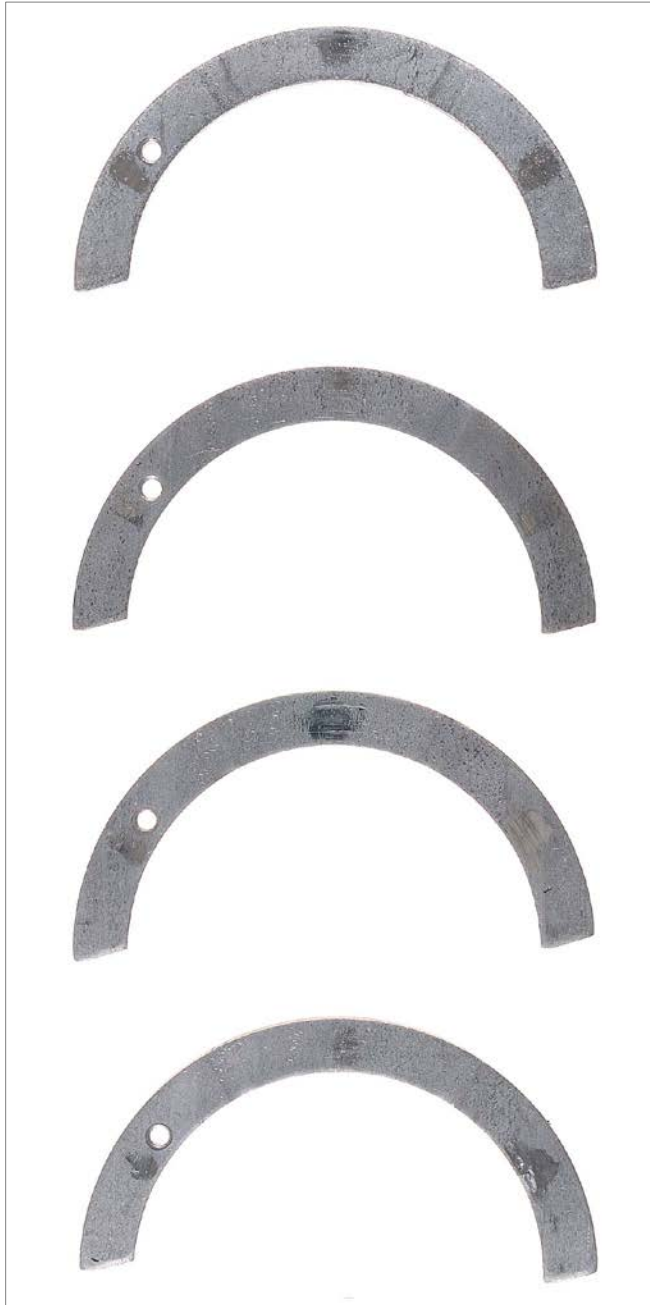
**Figure 64. Crankshaft Thrust Bearing Plates**

Orientation for crankshaft thrust bearing plates is as follows top to bottom: upper front, lower front, upper rear, lower rear. None of the thrust plates showed excessive wear, as shown in Figure 64.
