**TEARDOWN AND INSPECTION OF THE CUMMINS  
VTA-903 - EVALUATED USING THE SINGLE COMMON  
POWERTRAIN LUBRICANT (SCPL)**

**INTERIM REPORT  
TFLRF No. 450**

**Contract No. W56HZV-09-C-0100 (WD21 – Task 2.6)**

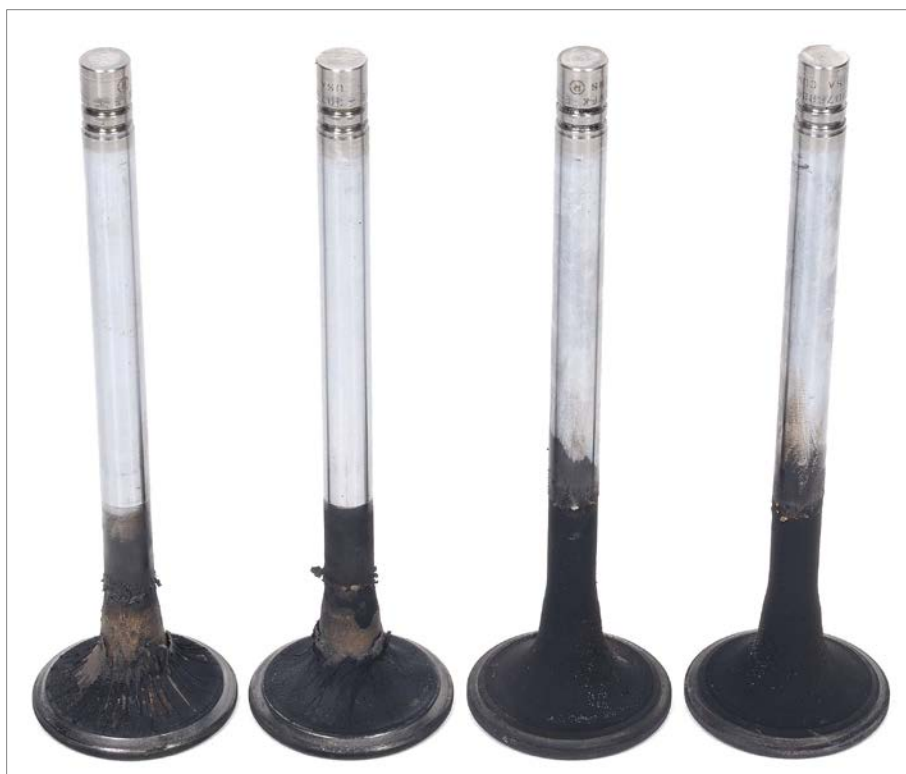
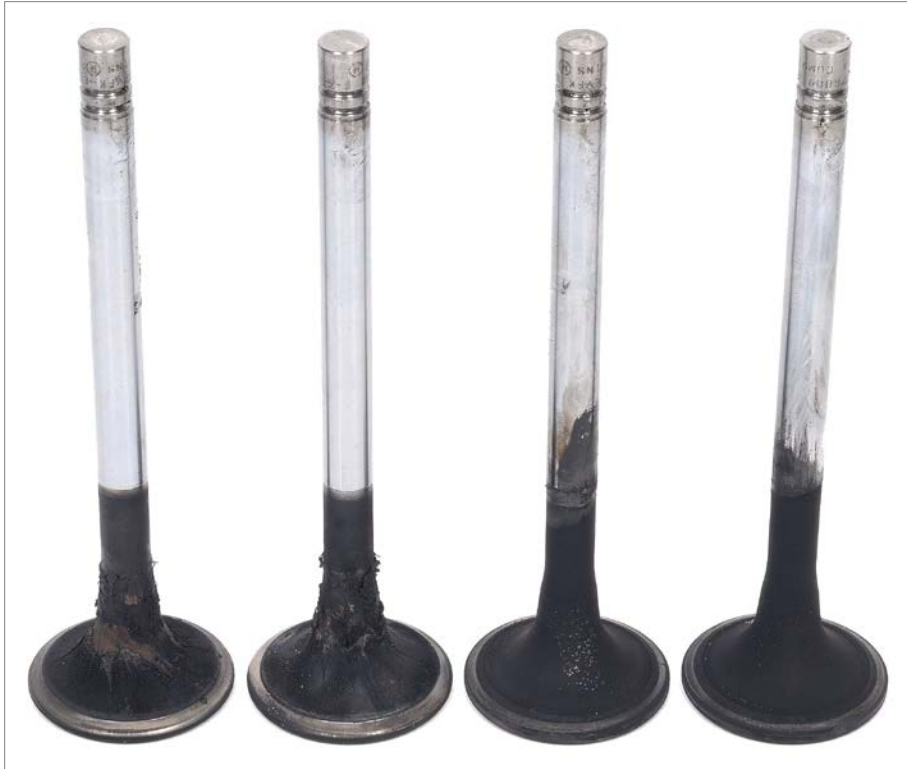
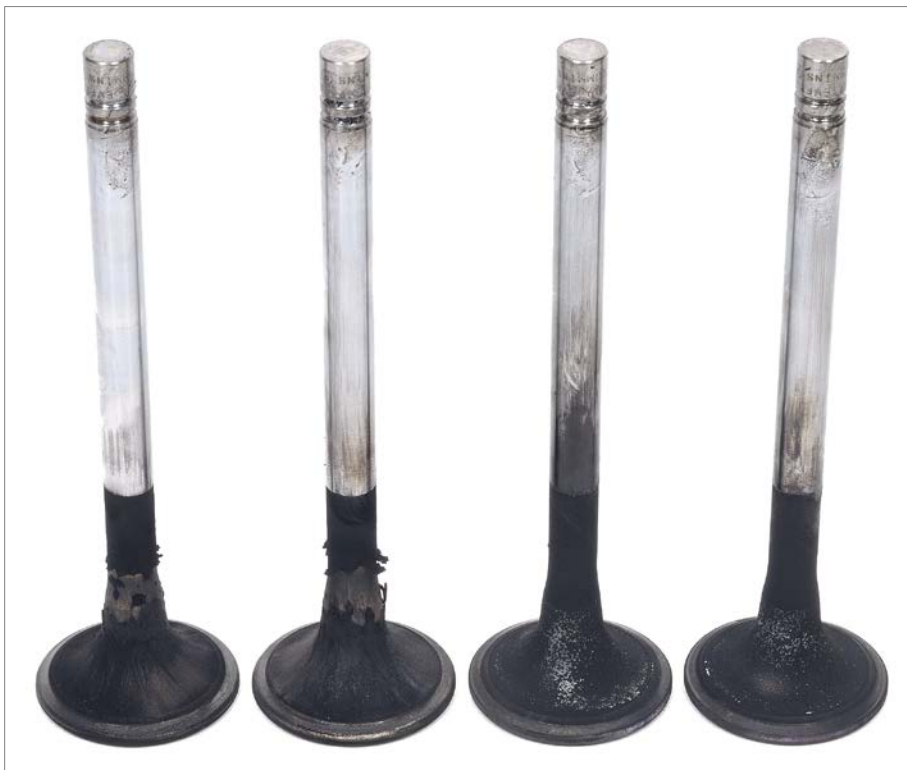
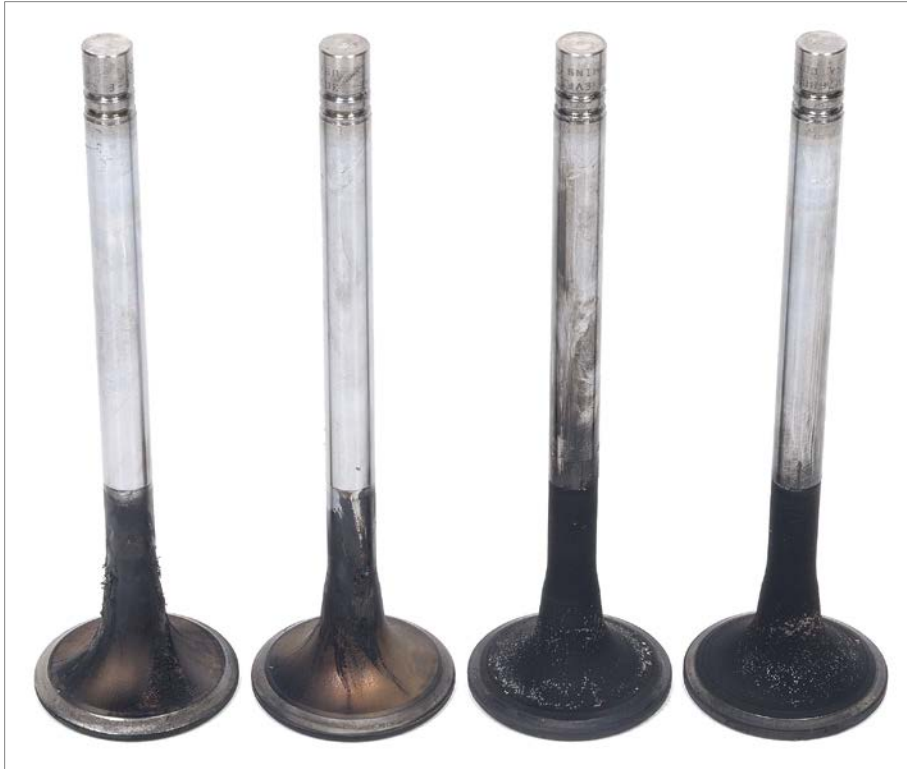
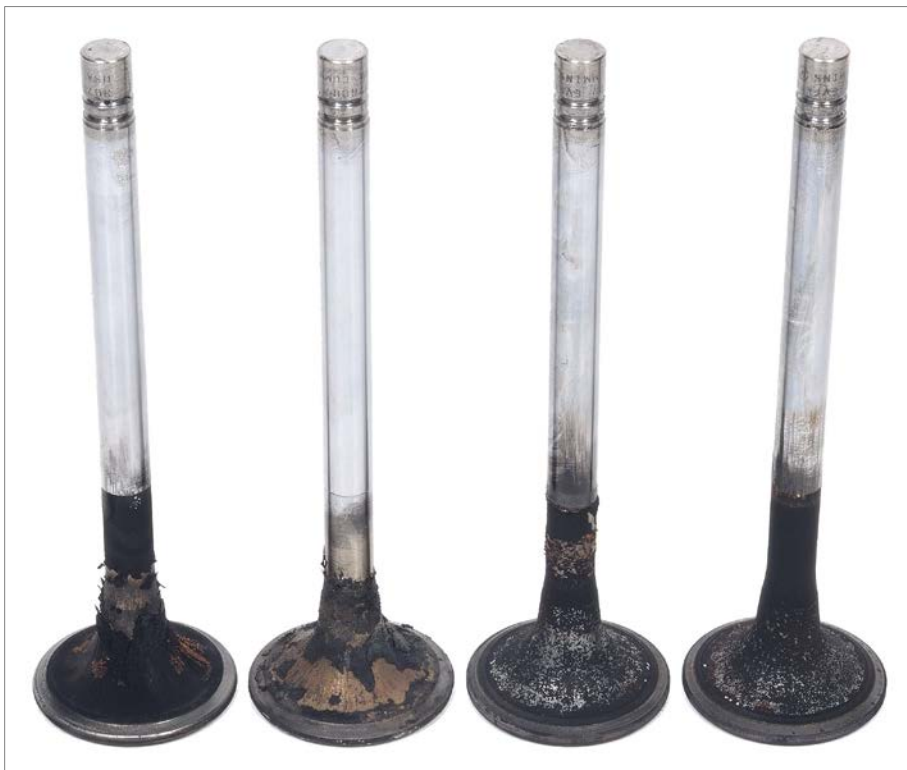
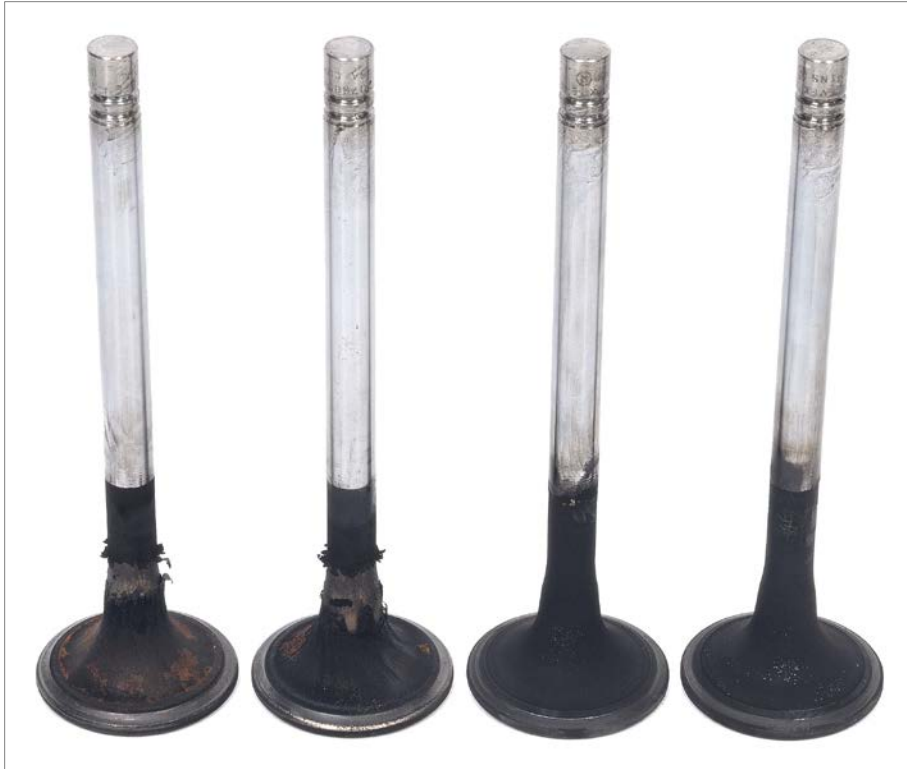
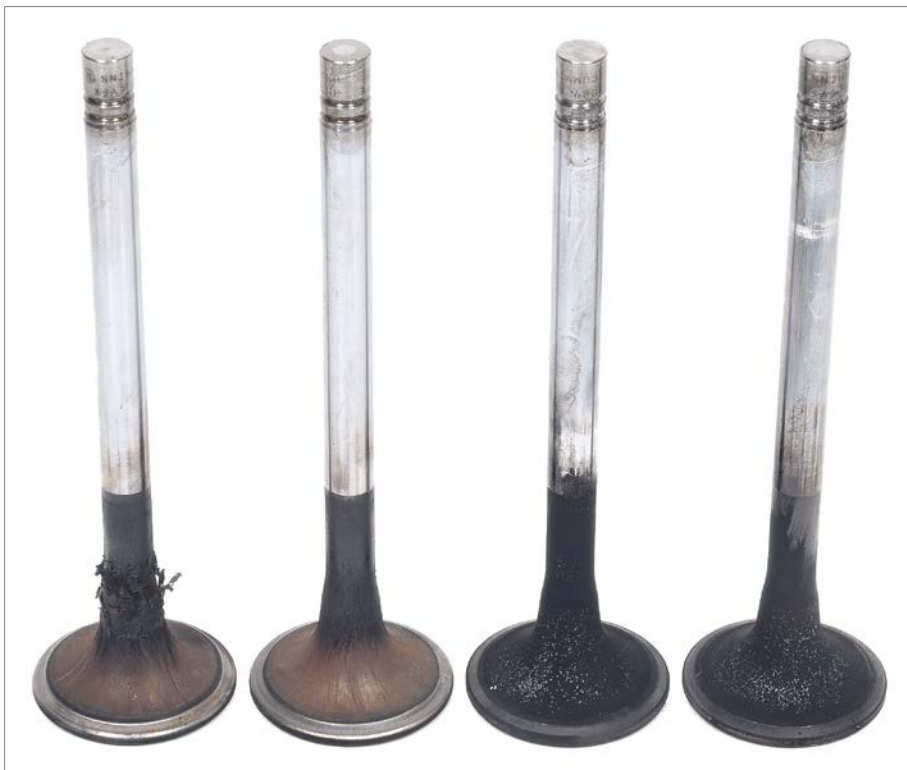
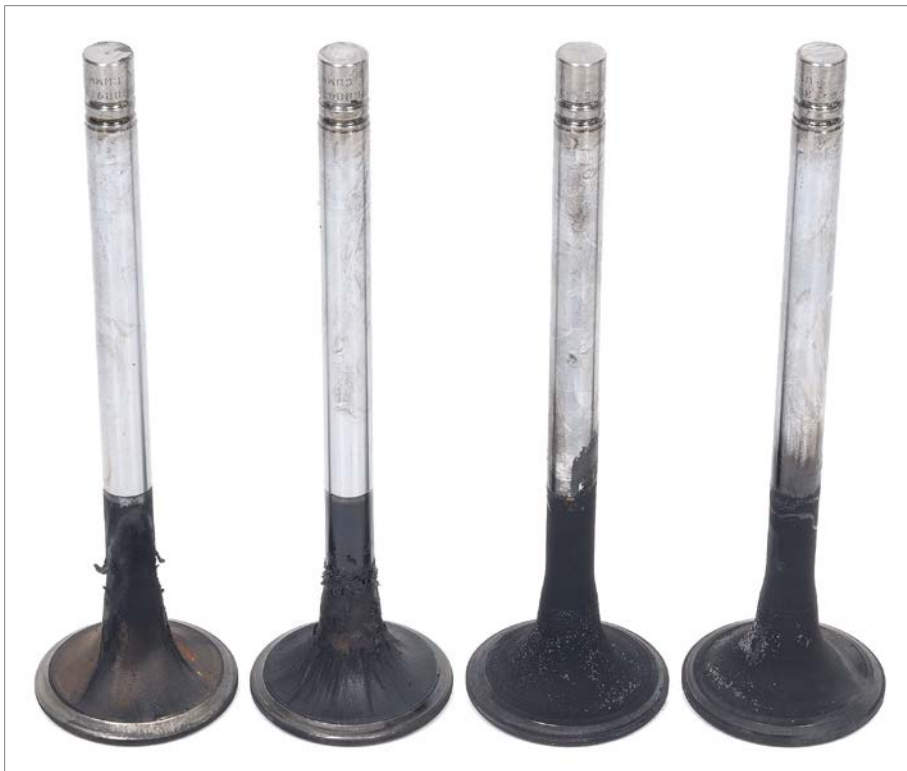
Valve orientation for all cylinders are shown as follows: intake left, intake right, exhaust left, exhaust right (Figure 65 through Figure 72). Several of the valve sets show the collection of the light flaked carbon deposits on the intake valves that did not fall off into the port area during storage and handling. These were previously described in the ratings section of the report. In all, the valves removed from the engine were found in good condition.

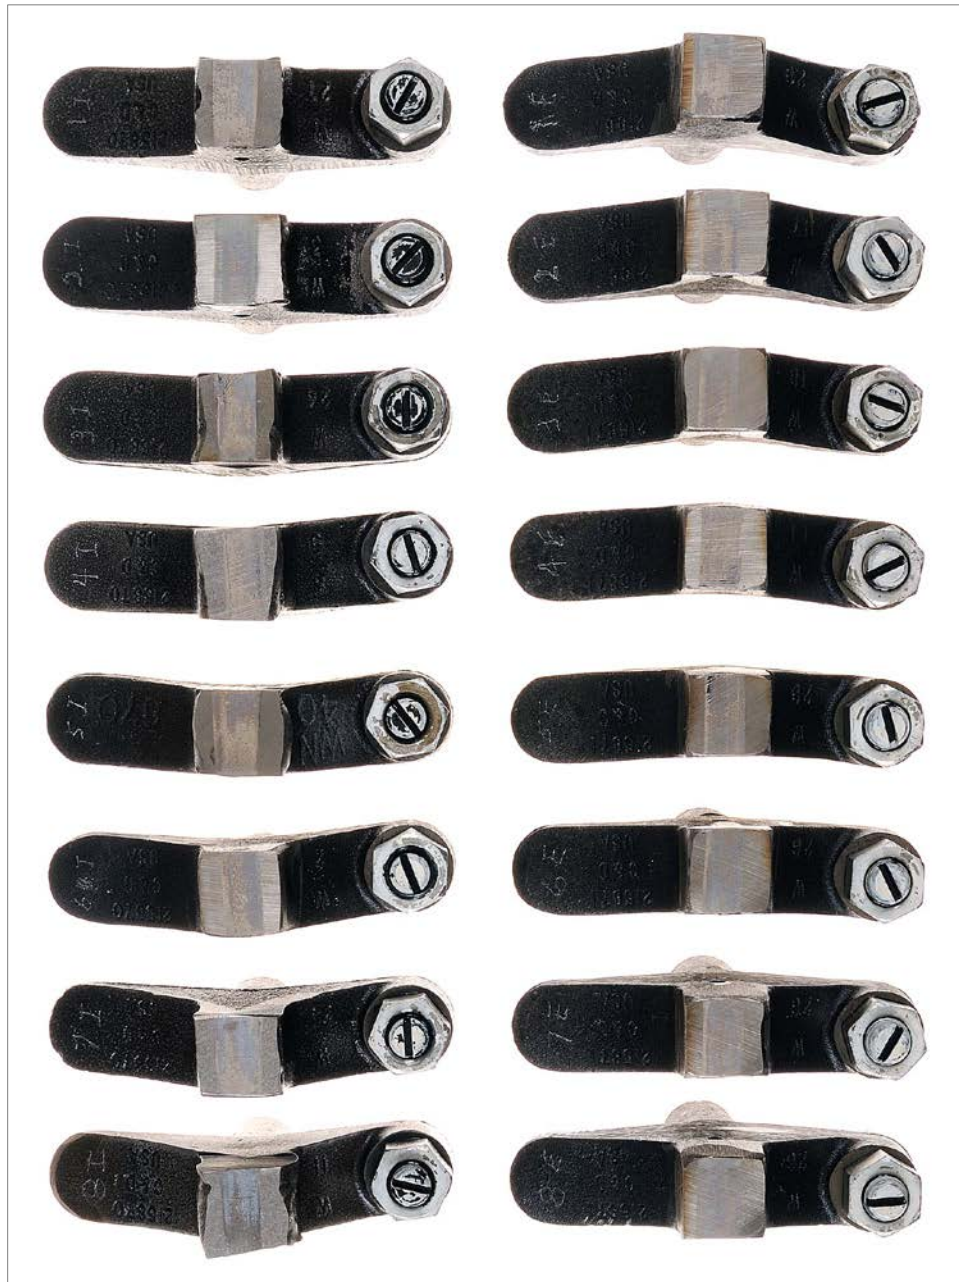
Figure 73. Intake & Exhaust Valve Cross Heads

The valve cross heads did show visual wear, which is consistent and normal for a used engine. This area is a known critical area for several engines in the Cummins engine family. Overall, the distress ratings ranged from a number 6 to number 8 rating, which coincides with a range of trace to light (8) and light to medium (6) distress. Trace distress is in general barely discernible, and can require a 10x magnification to fully assess condition. Light distress is more prominent, and can be seen without magnification, but is still much lighter than a medium, heavy, or catastrophic distress level. Full cross head ratings can be seen below in Table 21. Overall the condition of the cross heads was found to be good, and results suggest that the SCPL candidate provided adequate protection for this critical engine interface.

Valve cross head orientation is as follows: left column intake, right column exhaust, cylinders 1 through 8 top to bottom. The polished section at the center of the bridge was the area rated for distress, as shown in Figure 73. Although visible wear is noted, it was found to be normal, and below what would be considered critical.

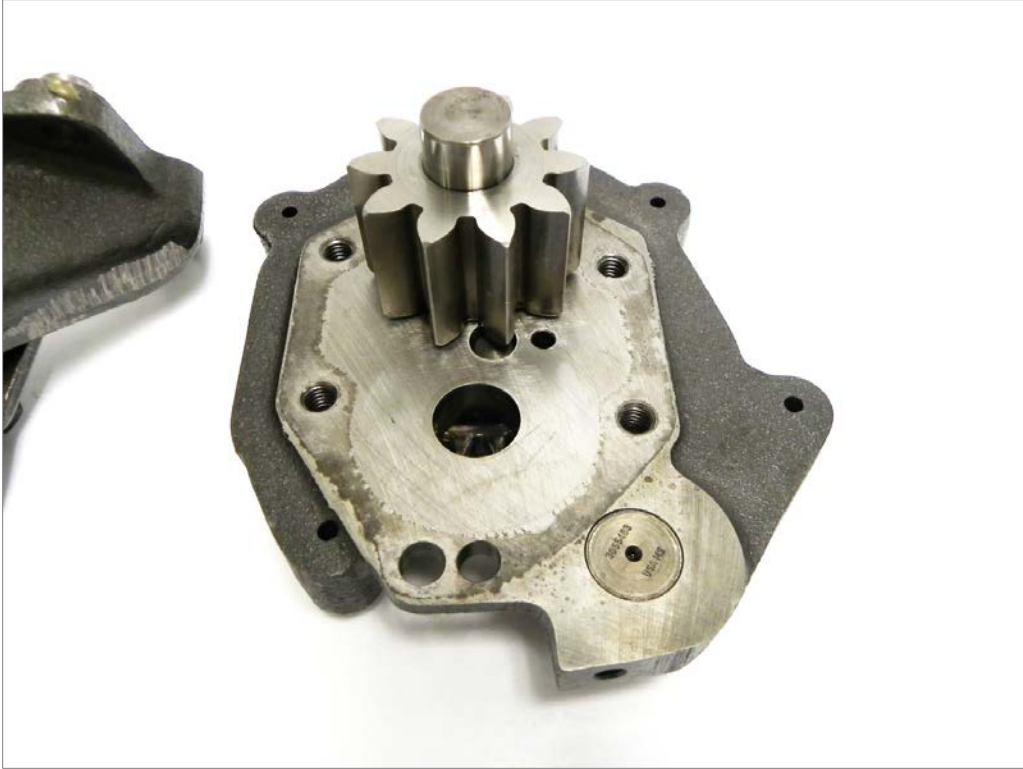
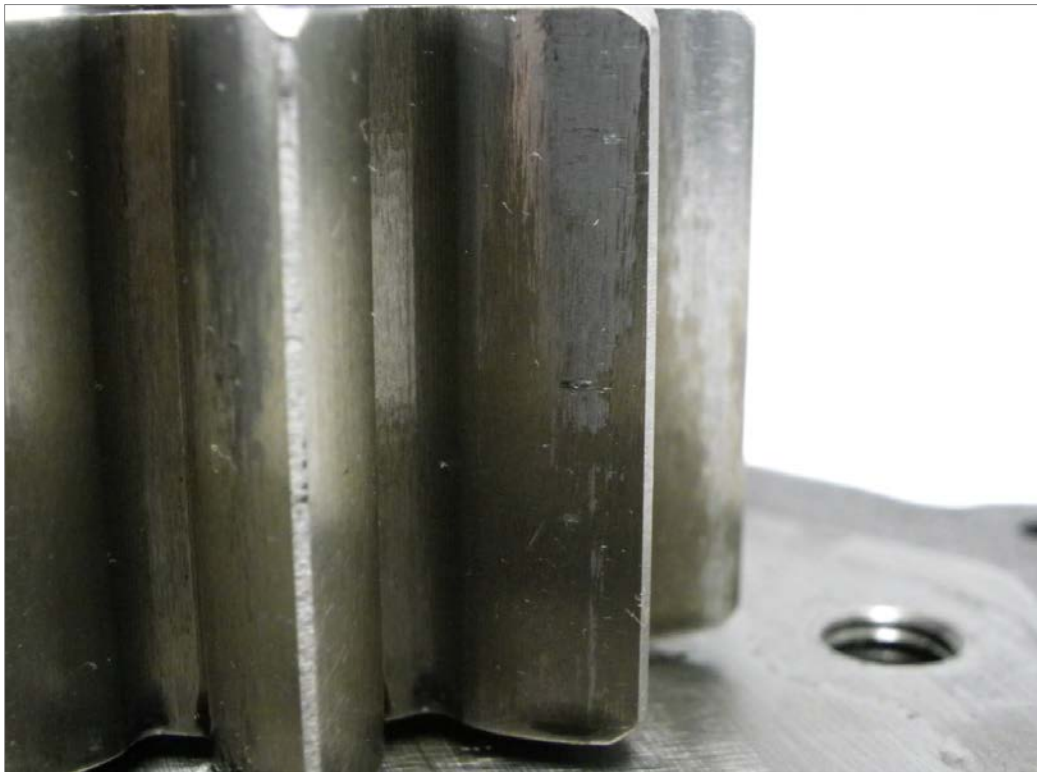
Figure 75 and Figure 76 on the following page show close up shots of the oil pump cover/drive gear condition. As seen in the photographs, no excessive wear or damage was present on the cover or gear teeth surface. Normal wear of the surface coating on the drive gear teeth was observed, but the overall condition of these components were normal, as expected from typical use.

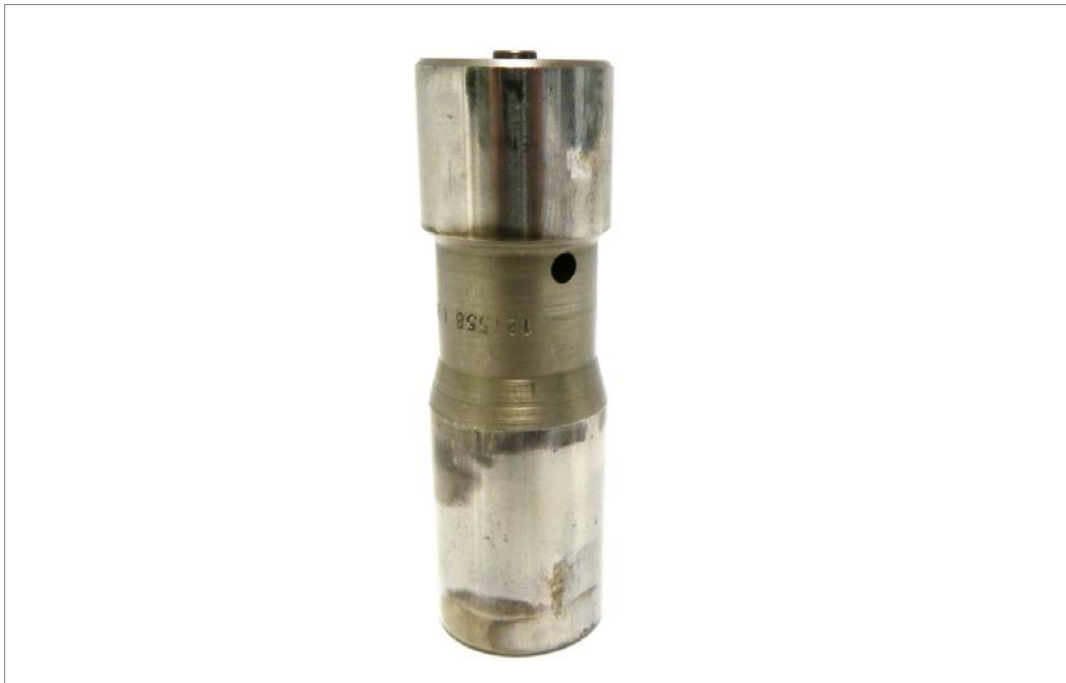
**Figure 79. Secondary Oil Pressure Relief/Bypass Piston (Oil Cooler)**

Immediately upon investigation of the secondary oil relief/bypass valve, difficulty was noted during its attempted removal from the valve body/bore that it sits in. After working with the assembly, the piston was eventually removed, and surprisingly appeared to be in slightly better condition at the surface than the primary valve seen at the oil pump. This valve can be seen below in Figure 79.

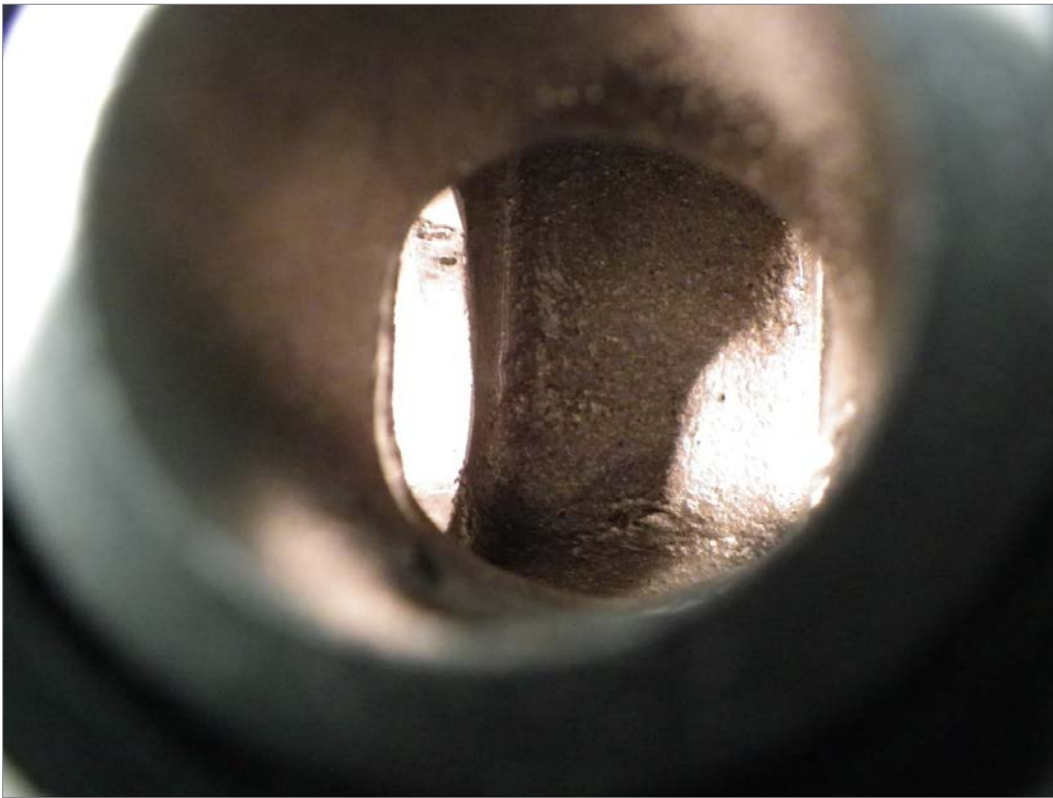
**Figure 80. Secondary Oil Pressure Relief/Bypass Valve Bore (Oil Cooler)**

After initial inspection, the valve and bore were cleaned and reassembled to further check the fit and movement of the piston within the bore it operates in. A very distinct resistance to movement was occasionally noted when the relief piston was slid up and down in the bore by hand. This resistance to movement was intermittent, and varied as the piston was moved up and down in the bore while also being slightly rotated by hand. A failure or resistance to movement of this particular valve would explain the erratic oil pressure and flow trends observed during

testing, assuming oil pressure and flow measurements were taken prior to this valve in the lubricating system. This is likely considering this valve's particular location on the engine is at/on the last external piece of hardware of the lubricating system on the engine (i.e. flow and pressure measurements would be expected prior to this point). After removing the valve, inspection of the bore surface was completed to assess condition. When inspected, damage was noted on one of the inner bore surfaces that the piston rides in, and is the likely cause for the intermittent movement of the relief piston. This damage can be seen below in Figure 80 (note, this area of the bore proved difficult to photograph, and the bulk of the bore surface washed out due to lighting. The damage noted can be seen near the very top of the ring on the left hand side of the hole being viewed through). This damage in the bore appears to be more consistent with tool damage from previous assembly or disassembly of this component, or could possibly be attributed to foreign object or debris that passed through the oil system and was lodged into the surface by the piston itself. Although the source of this damage is speculative, TFLRF feels this is the likely cause of the trends noted during operation.

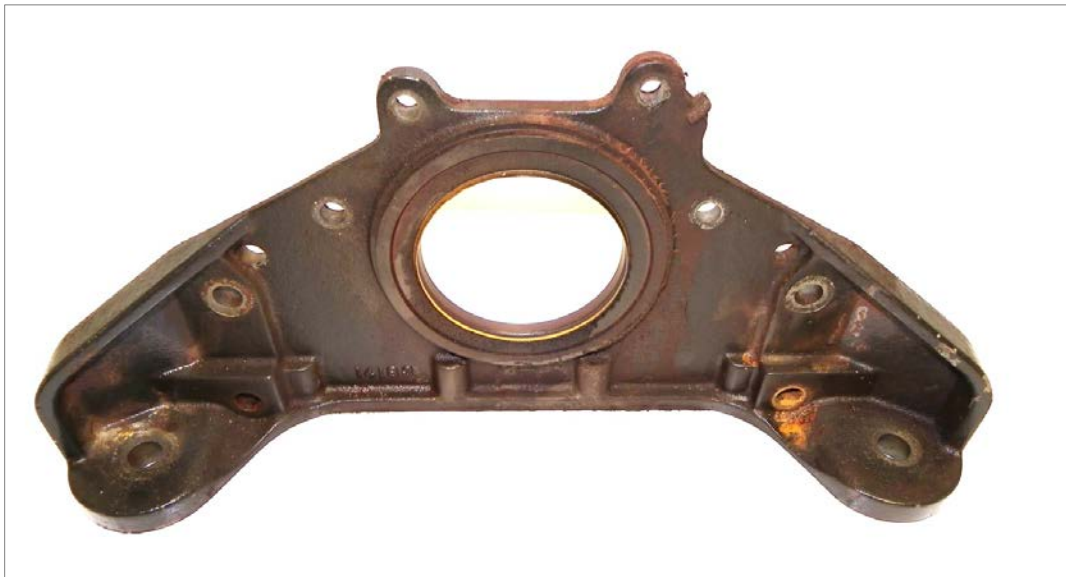
**Figure 82. Crankshaft Seal Housing at Balancer**

In addition to the oil pressure and flow fluctuations, a significant oil leak was noted by TARDEC at the engines “rear main” seal during dyno testing. TFLRF was asked to pay particular attention to this area upon disassembly to try and indentify the cause of the leak. Upon inspection, it was found that the front crankshaft seal (harmonic balancer end) was the area of the leak as opposed to the rear seal (flywheel end). This was determined by significant accumulation of oil and dirt in this area of the engine. The rear main seal (flywheel end) was clean and showed no evidence of leaking. This discrepancy in terminology is likely just a result of frame of reference differences when discussing the engine, and is compounded by the fact that the Cummins 903 engine sits “backwards” from normally expected when installed into the Bradley Fighting Vehicle (i.e. flywheel end facing front of vehicle). The front crankshaft seal carrier assembly can be seen below in Figure 82.

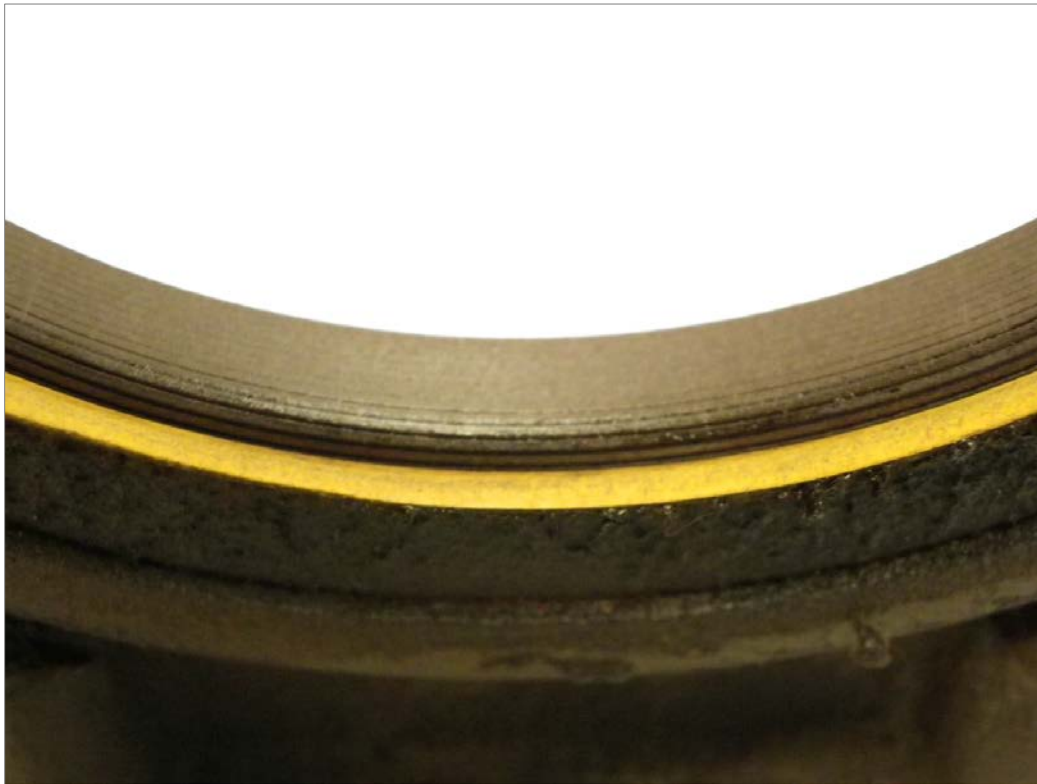
**Figure 83. Front Crankshaft Seal Surface Close-up (Balancer End)**

Close inspection of the seal didn't reveal any obvious defects that would result in oil leaks at this sealing surface. The sealing lip showed uniform wear, with no heavy abrasion or tears present in its surface. The seals lip was also found to be pliable, and would be expected to work as it should. The seal itself also appeared to be installed square and flush in the carrier. Figure 83 shows a close up of the seal lip. Uniform condition was noted around the entire seal circumference.

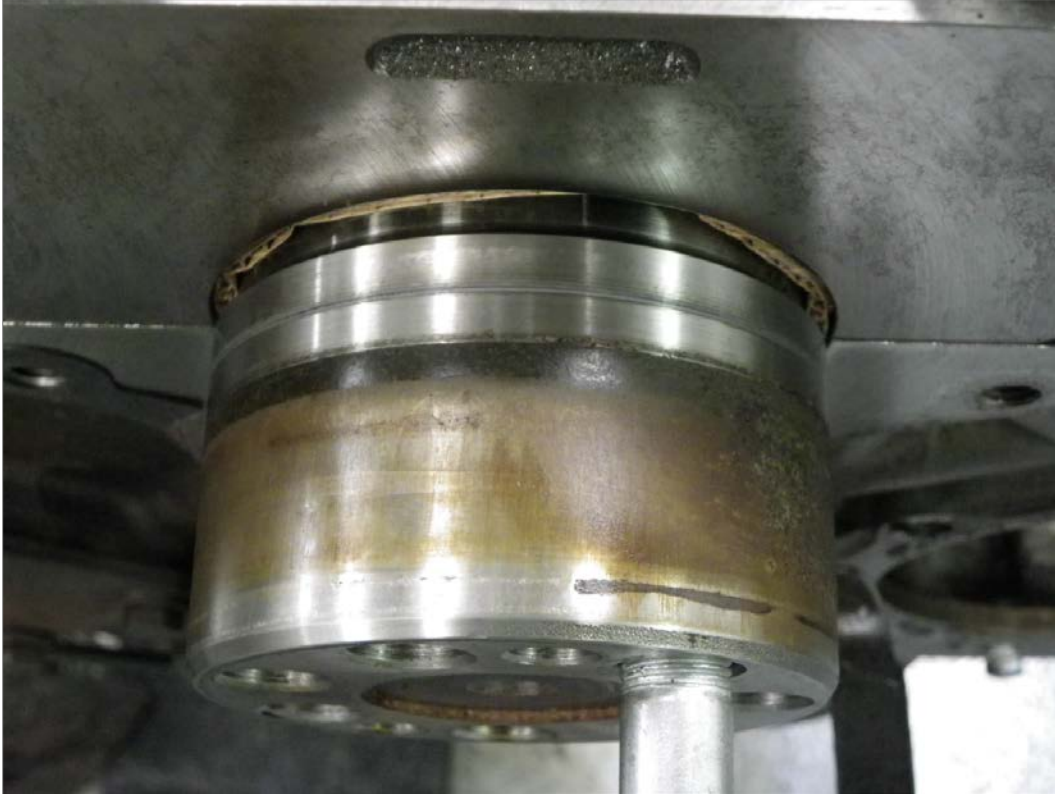
**Figure 84. Crankshaft Front Sealing Surface (Balancer End)**

In addition, the crankshaft sealing surface was inspected for heavy wear or defects that would contribute to leaks in this area. Although a visible wear pattern was noted where the seals lip rides on the crankshaft surface (noted by the dark line appearing in the surface), there was not significant physical wear to suggest problems. Just past the sealing surface was a heavy accumulation of rust on the surface of the crankshaft, but this area appears to be well outside the area of concern for the seal. This area of the crankshaft is shown in Figure 84.

At this time, a definitive cause for the leak in this area was not apparent, although evidence of the leak is obvious upon disassembly. The front seal carrier is bolted to the front of the engine with multiple bolts, but is ultimately located in the x and y direction by the use of one circular dowel pin, and a second semi-circular pin on either side of the seal carrier. It is possible that alignment of the carrier in respect to the engine block (i.e. crankshaft centerline) could be offset and contribute to leaks. Although it would be expected to show wear/evidence on the seal lip surface if the seal was not concentric to the crankshaft due to offset loading. This was not the case. Another potential contributing factor could be not related to the mechanical condition of the seal and sealing surface. Excessive crankcase pressure can also contribute to leaks at sealing interfaces, but data was not apparent for crankcase pressure in the TARDEC draft report, only blow by flow rate. Although there is not enough evidence to determine the true cause of the oil leak, nothing was found that suggested the candidate SCPL as a contributing factor. During its development, the SCPL underwent extensive industry standardized seal compatibility testing,
