# ESTCP

## Cost and Performance Report

(WP-0202)

### Electrospark Deposition for Depot- and Field-Level Component Repair and Replacement of Hard Chromium Plating

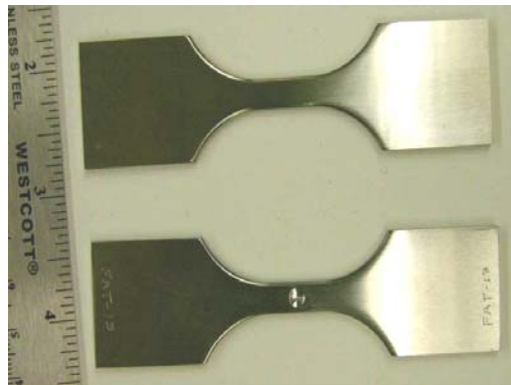
**Figure 8. IN718 Fatigue Specimens Without (top) and With (Bottom) the Type 1b Defect.**

The test specimens were fabricated from IN718 with flat plate geometry and a constant gage width. The defect was a small divot in the center of the gage length to allow the evaluation of the effect an ESD deposit has on the fatigue life of the substrate. The specimens were used to provide full stress versus number-of-cycles (S-N) curves to determine fatigue life and fatigue initiation locations. Some specimens had a Type 1b defect at the center of the gage section that was filled via ESD and machined back to specification. Others had a defect without an ESD fill. Still others had no defect but an ESD overlay (bead-on-plate). Baseline data was established on specimens with and without a defect and without ESD. Figure 8 shows a photograph of fatigue specimens with and without the defect.

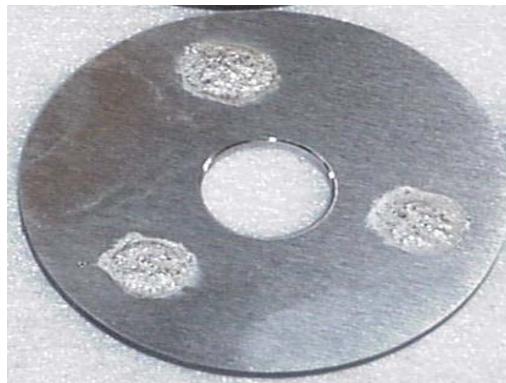
**Figure 9. Pin-on-Disk Wear Test Specimen After Defects Repaired Using ESD but Prior to Surface Finishing.**

The pin-on-disk wear test was basically used as a screening test to demonstrate that an ESD repair of a defect in a disk could restore a surface to a point such that there would be no difference between virgin and repaired material in sliding wear. The disk was fabricated from IN718 and had a diameter of 1.9 in and a thickness of 0.125 in. Three Type 1 defects were machined into one face of the disk and then repaired using ESD as shown in Figure 9. The pins were 0.125-in-diameter 52100 steel balls with a hardness of Rockwell C 58.

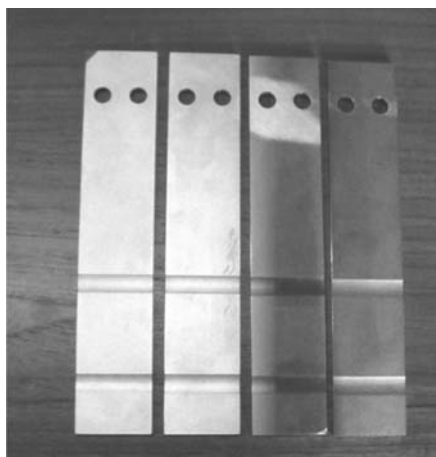
**Figure 10. Sliding/Fretting Wear Test Plates Showing Type 2 Defects (grooves).**

Wear test plates fabricated from IN718 of size 1.5 in x 8 in x 0.25 in-thick had four Type 2 defects machined into them, as shown in Figure 10. These were subsequently filled using ESD and surface-finished to the same level of roughness as the remainder of the plate. Four IN718 counterface specimens of size 2 in x 0.25 in x 0.125 in-thick were used in each test.

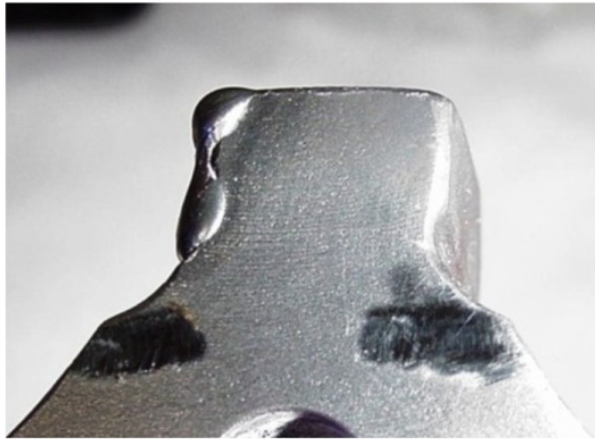
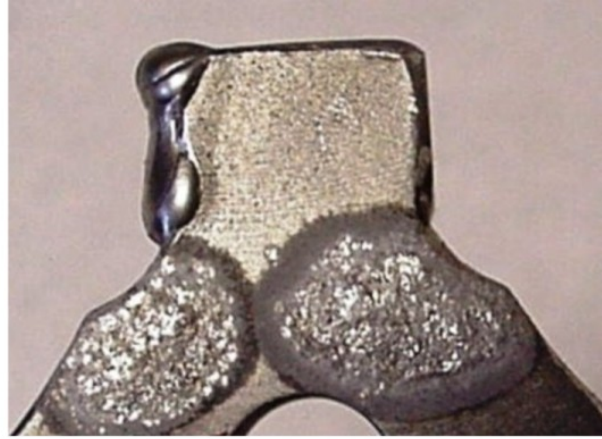
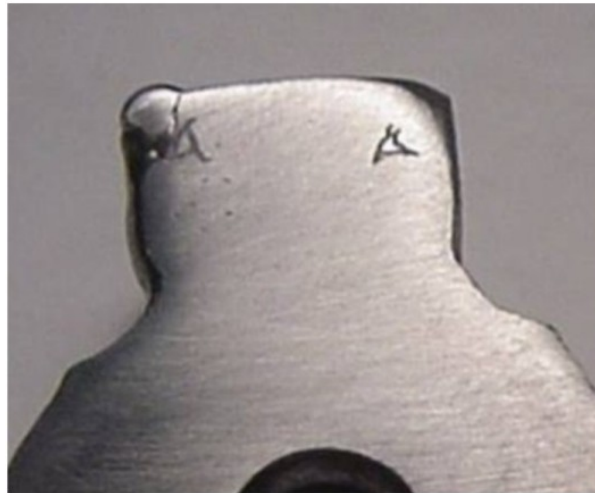
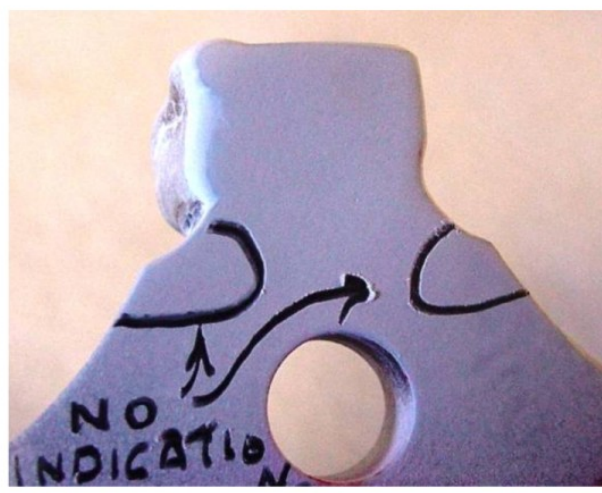
**Figure 15. No. 5 Bearing Housing Repair.**

*a) Excavate damaged area*

*b) Repair excavated area*

*c) Surface finish repair area*

*d) Perform FPI on repair*

Figure 15 shows the procedure for ESD repair of worn areas in the vicinity of a lug on the component. In the process development, a metallurgical evaluation of the repaired areas was performed. Density measurements were conducted using image analysis which showed an average porosity of 1.7%. The average microhardness of the base material was 633 Knoop whereas the average microhardness of the ESD repair was 606 Knoop. The repaired areas were surface-finished and restored to the original dimensions. OC-ALC reported that the porosity, microhardness, and surface finish results all met their requirements. Welding specification documents were created to facilitate in the implementation of the repair process. One document

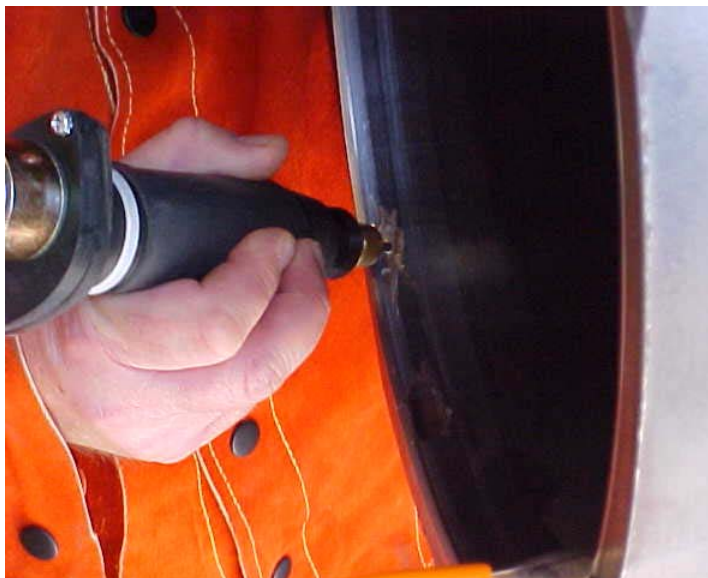
**Figure 16. Application of ESD Coating to M1A1 Cannon Cradle.**

The M1A1 cannon cradle is fabricated from 4130 steel and is subject to extensive corrosion pitting and wear in service. Many components have to be removed from service, and the rejection rate is an important issue since there is a shortage of available replacement parts. The Army Research Lab (ARL) and the Anniston Army Depot (ANAD) worked together to develop an ESD procedure that would be capable of repairing the damage to the components and returning them to service. In this case, IN718 was selected as the material to be deposited using ESD. Optimized deposition parameters were identified and extensive metallographic and microhardness measurements were taken to ensure a fully dense deposit with a hardness equivalent to that of the base material.

The reclamation procedure for the cannon cradle was approved by ANAD Engineering and has been performed since June 25, 2003. Figure 16 shows the application of an ESD coating to a cannon cradle at ANAD. The total amount of time required for this repair, including surface preparation prior to deposition and finishing subsequent to deposition, has averaged 9 hrs. A formal Reclamation Procedure 03-39 has been developed for repair of this component and is provided in the final report [6]. As of the date of this report, 15 cannon cradles have been repaired. A cursory cost analysis showed that approximately \$360,000 has been saved by using ESD to repair the components as opposed to acquiring replacement components.
