Infrared Reflectance Imaging for Corrosion Inspection Through Organic Coatings (WP-0407)

13. SUPPLEMENTARY NOTES ASETSDDefense 2009: Sustainable Surface Engineering for Aerospace and Defense Workshop, August 31 - September 3, 2009, Westminster, CO. Sponsored by SERDP/ESTCP.

TECHNICAL CONCEPT

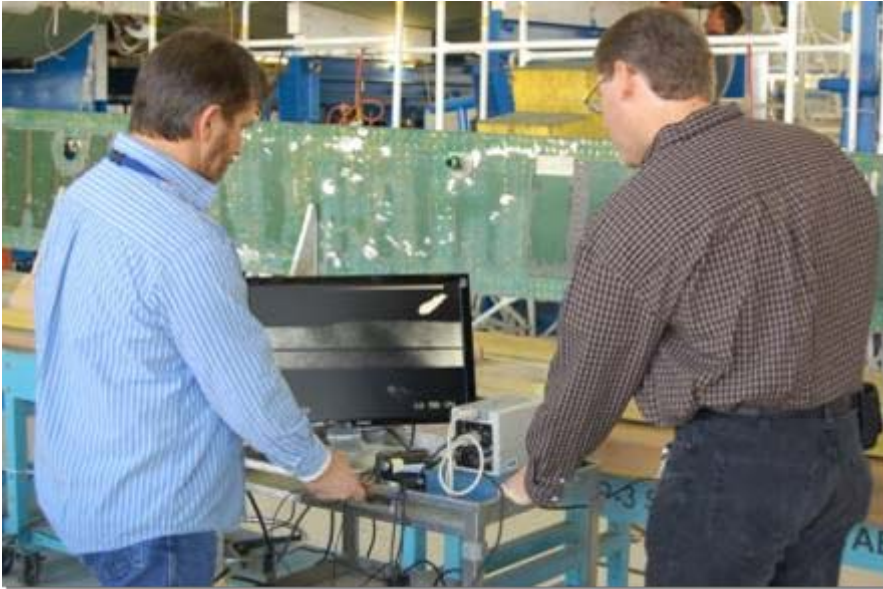
Mid-IR Inspection

- Wing Spar Inspection – Engineering evaluation of incoming material condition following visual ID of Corrosion.

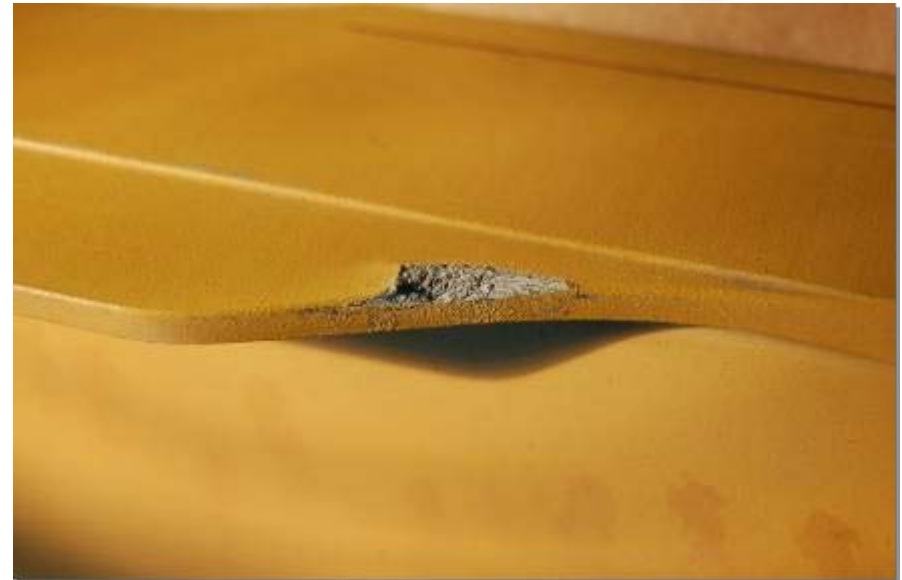
Exfoliation Corrosion

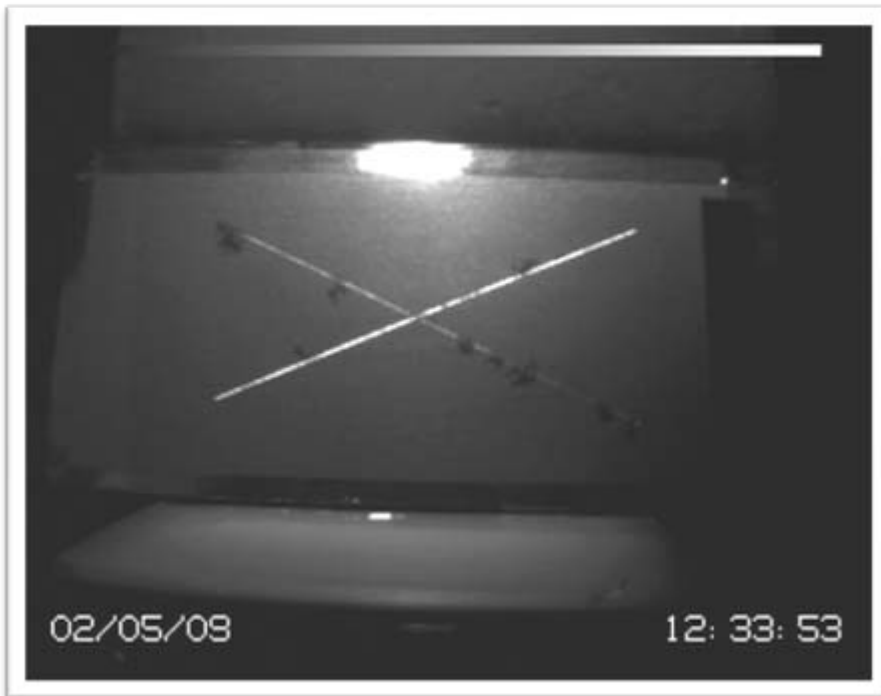
Scribe Line Corrosion

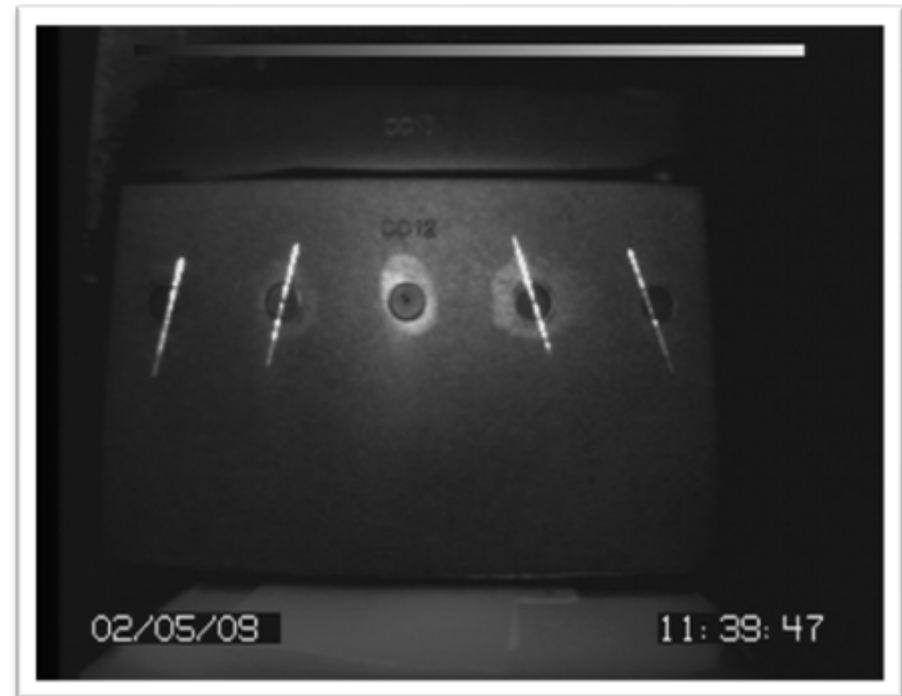
Fastener Panel Anomalies

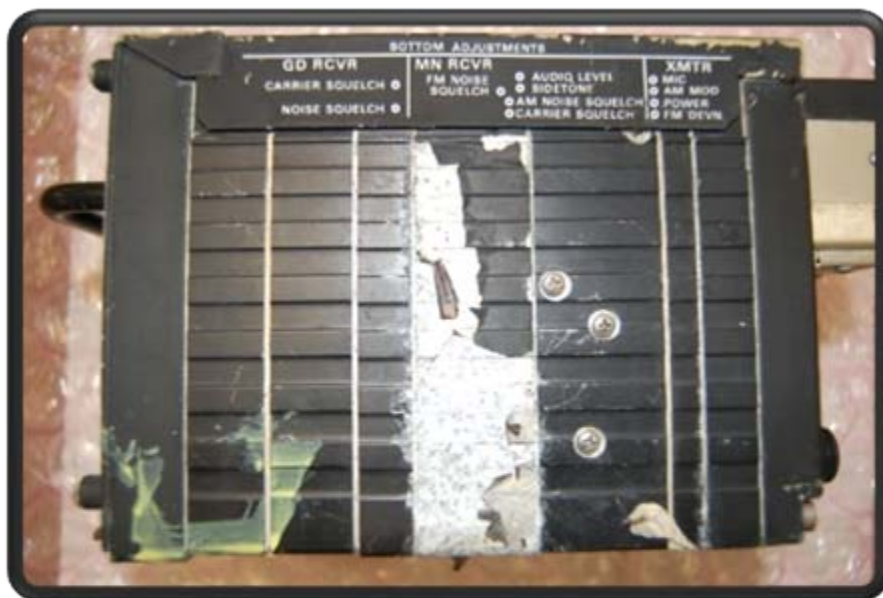
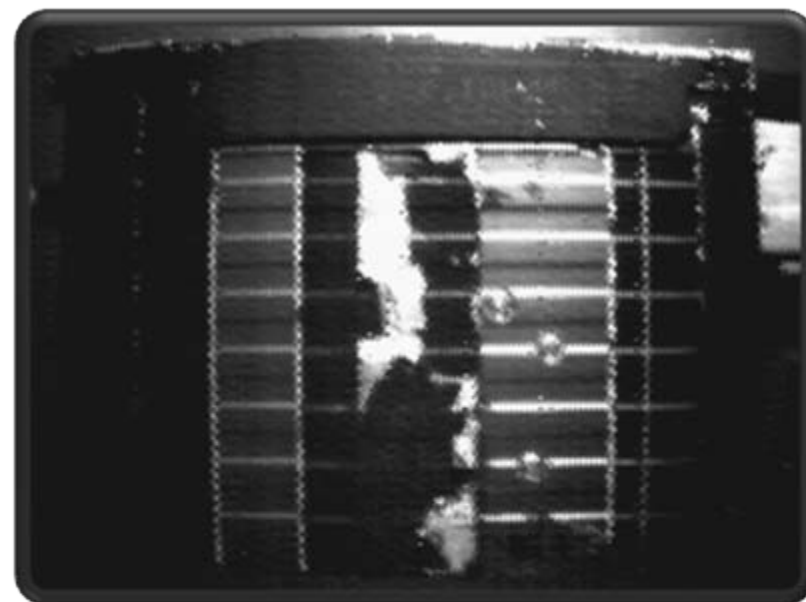
- Avionics Receiver/Transmitter – Evaluation of corrosion damage for root cause assessment.

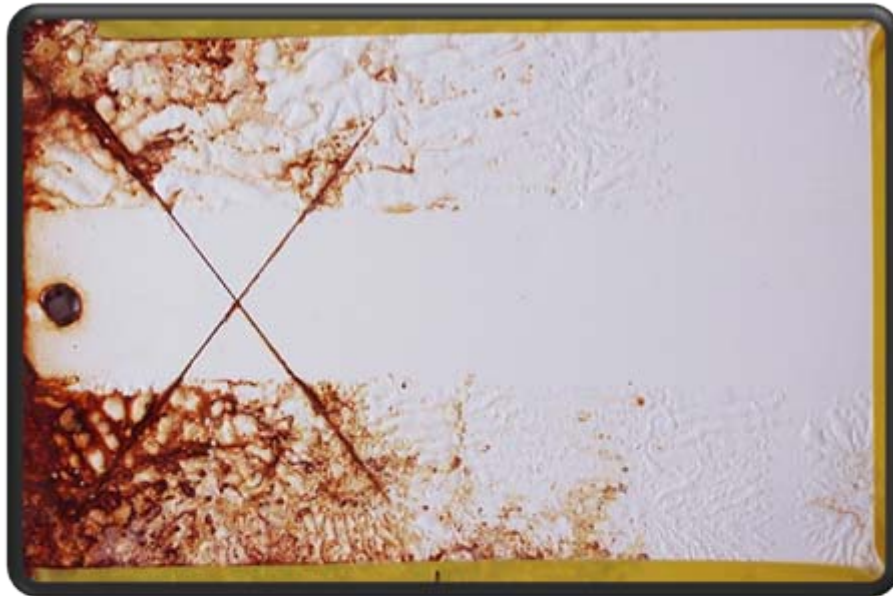
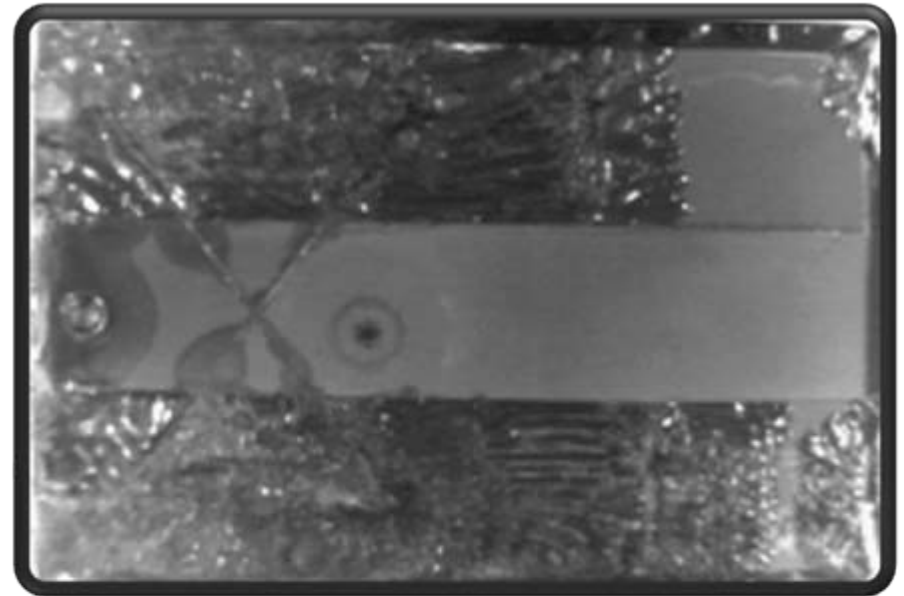
- ASTM B117 corrosion investigation in support of cadmium alternative brush electroplating repair of AISI 4130 substrate.

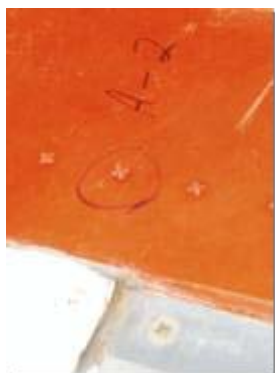
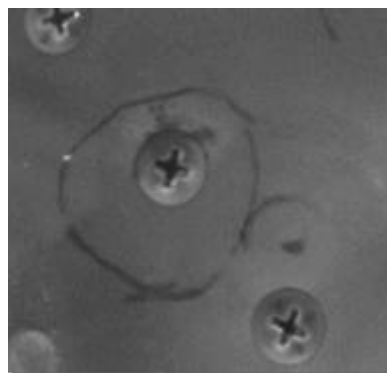
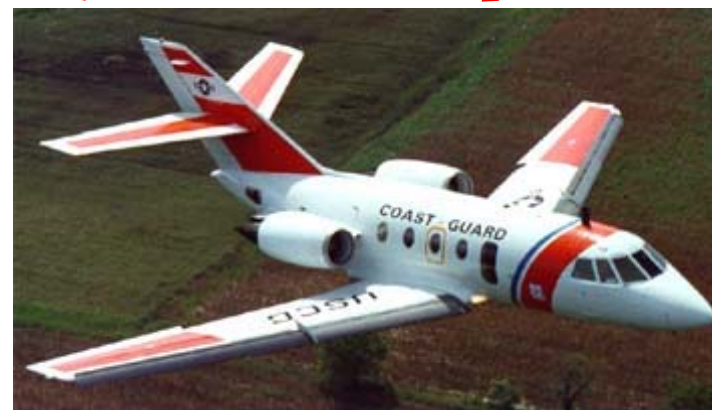
USCG HU-25 INSPECTION

Paint Thickness in this Zone = ~6.5 mils

Note: Several corroded areas were found while checking the scan rate on this region, all corroded areas found via the IRRIT were confirmed by chemically stripping.

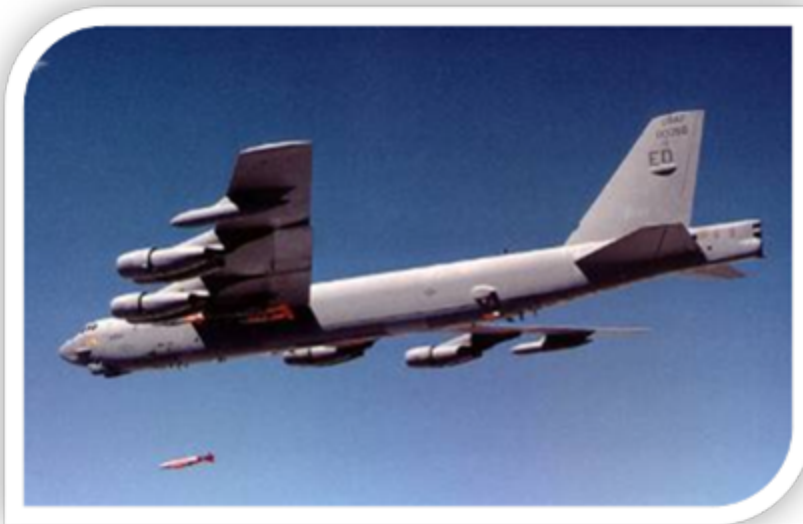
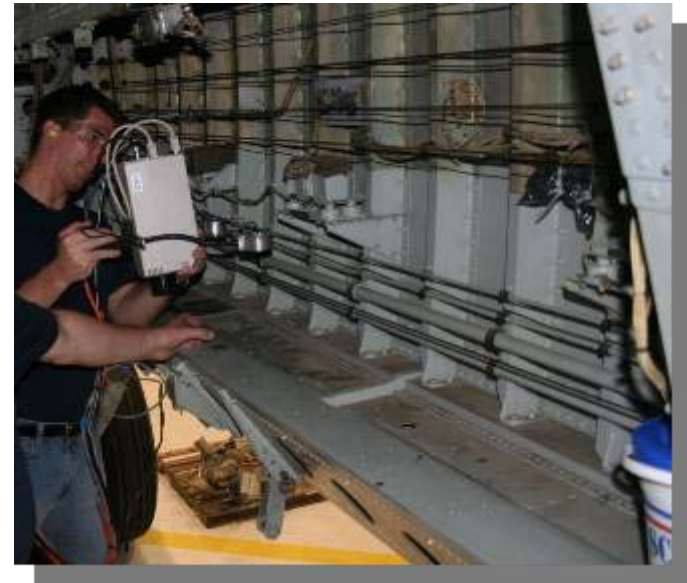
B-52 Demonstration

- *Surveyed Bomb Bay Longerons of (2) B-52 Aircraft at OC-ALC. Right and left sides inspected, each 15-16 feet in length.*
- *8 corrosion sites located via IR Inspection that were not identified through visible or eddy current inspection.*
- *All corrosion sites were confirmed following chemical spot stripping. 100% correlation achieved.*

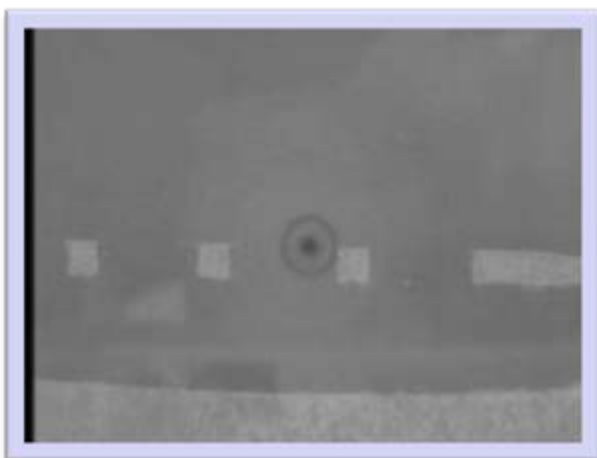
Emissive
Surface T = 95.7°F
IR source = 0W

**Corrosion Product
White**

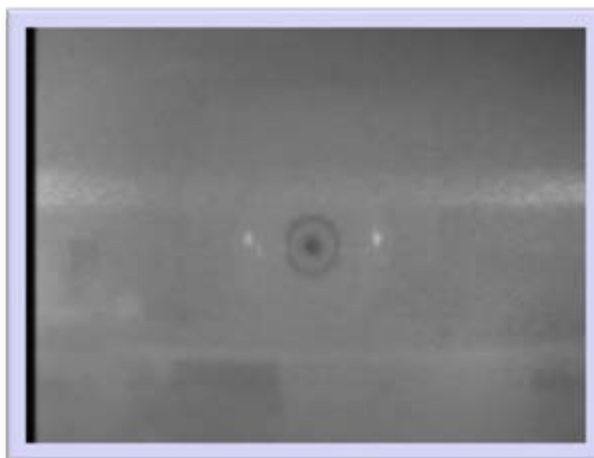
Equilibrium
Surface T = 95.6°F
IR source = 4.35W

**No Corrosion Product
Observed**

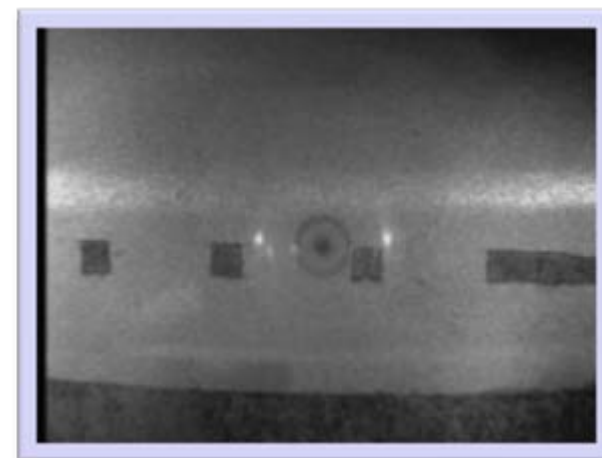
Reflective
Surface T = 95.0°F
IR source = 7.70W

**Corrosion
Product Black**
