# EA-6B HVOF-Coated Landing Gear: Post-Deployment Inspection Results

Tai Ngin  
Materials Engineer  
NAVAIR FRCSE, 43410

| Report Documentation Page | | | | Form Approved<br>OMB No. 0704-0188 | |
|---|---|---|---|---|---|
| 4. TITLE AND SUBTITLE<br><b>EA-6B HVOF HVOF-Coated Landing Gear: Post Post-Deployment Inspection Results</b> | | | | 5a. CONTRACT NUMBER | |

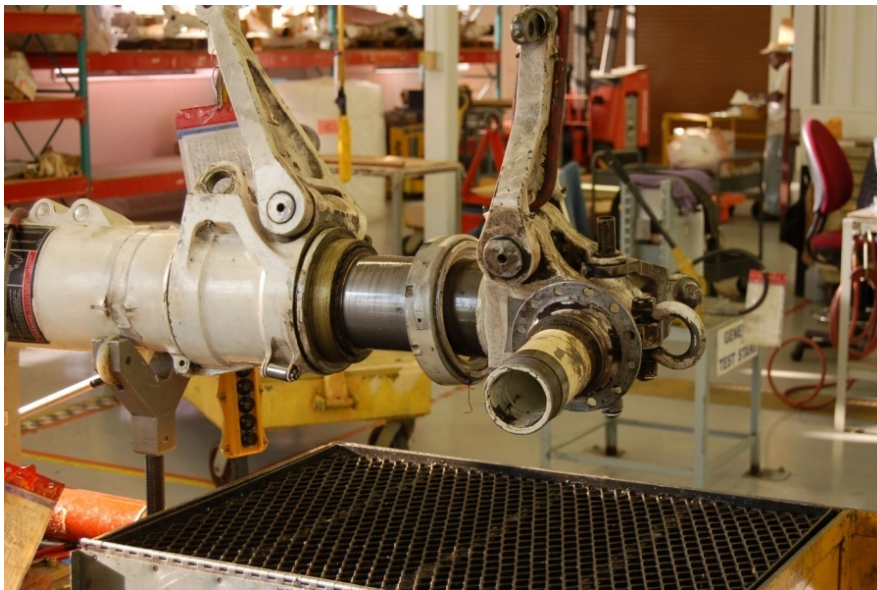
- Strut Disassembly
  - Performed due to leak in lower seal

HVOF coated axle and piston  
during tear down

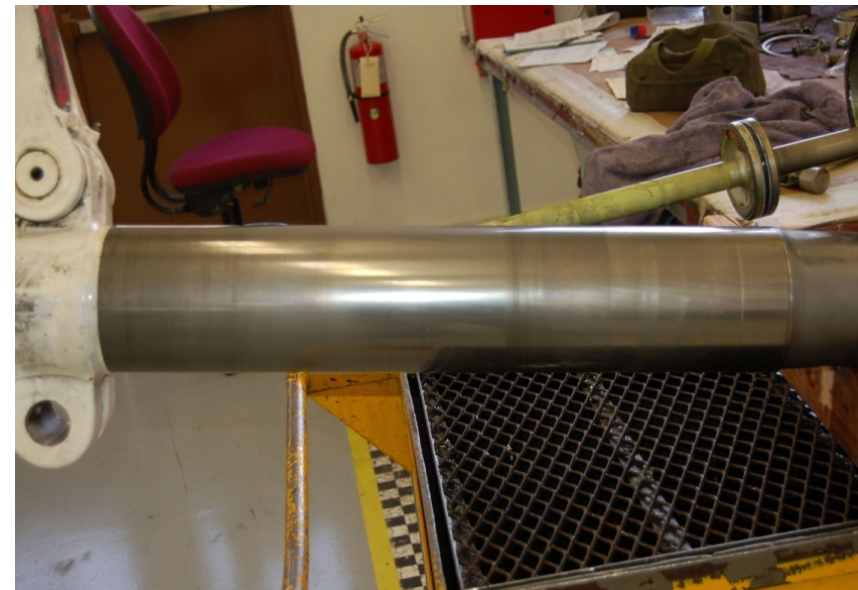
HVOF coated piston during  
disassembly

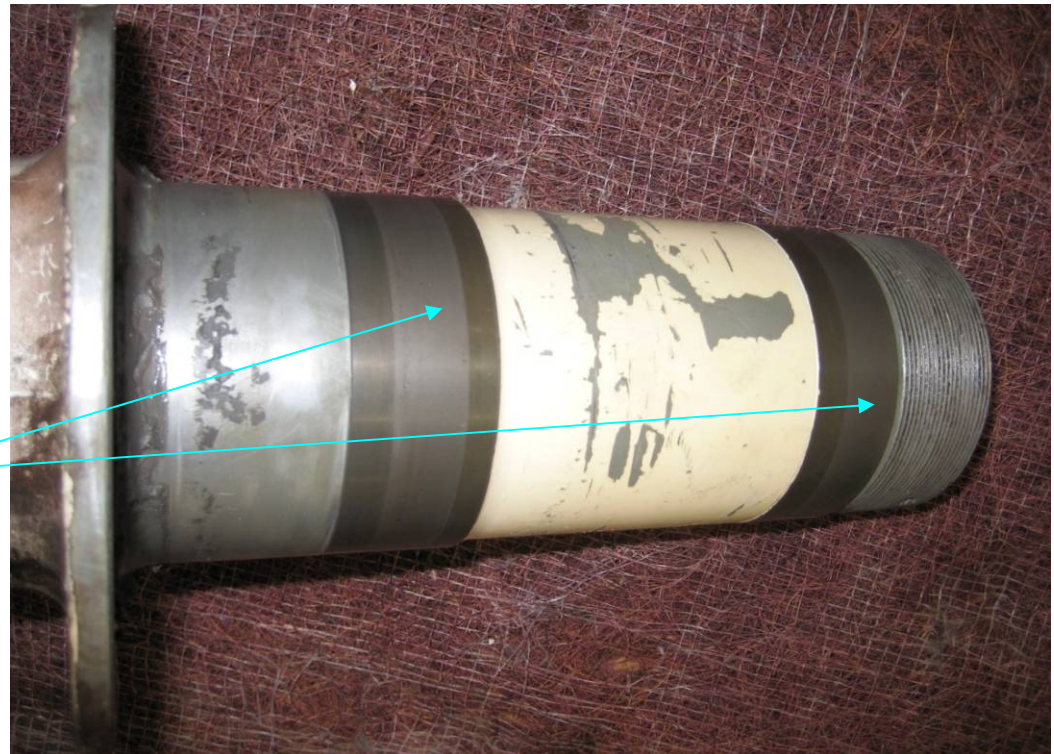
HVOF on Axle Journals, edges in good condition, coating appeared to be in very good condition

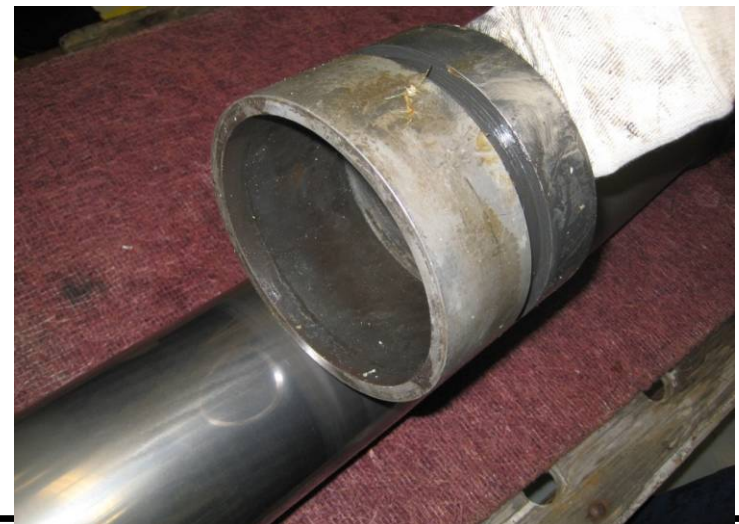
- Collar Bushing
  - The original item was discarded after disassembly
  - Operators reported part corroded
  - Corrosion typical for this part in service.

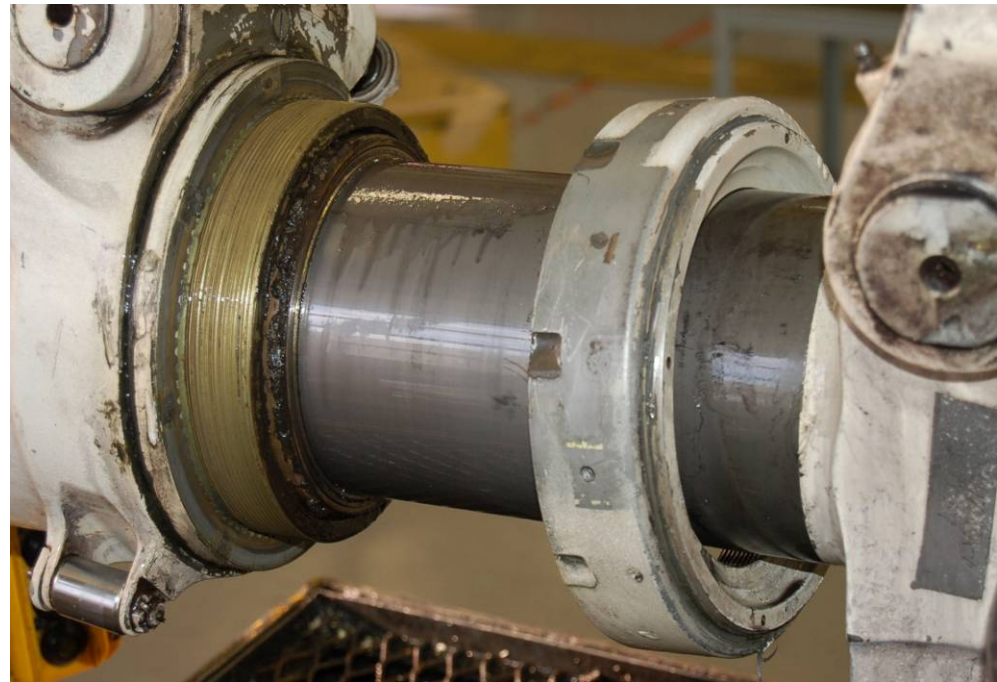
Disassembly of collar and seal retainer in location of leak

- Visual Inspection
  - Roughness Check
- Clean
- Vapor Degrease
- Fluorescent Penetrant Inspection (FPI)
- Re-superfinish
  - Recheck roughness

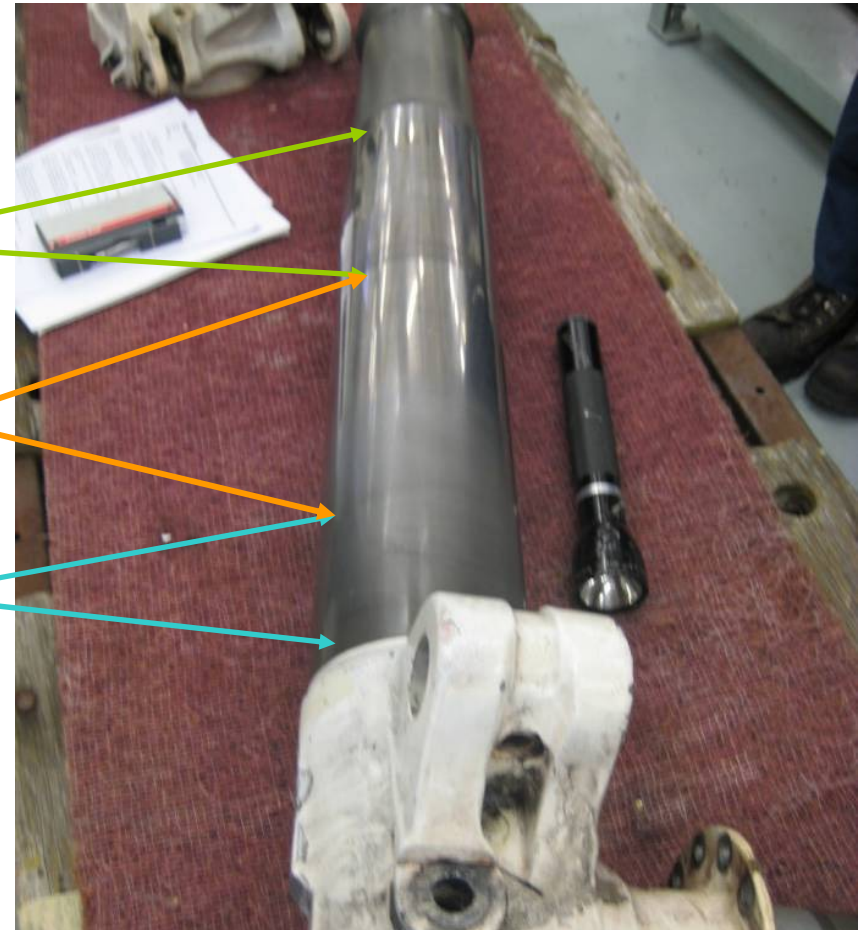
Surface finish measured Ra 3-4  $\mu\text{in}$

Surface finish Ra 8-10  $\mu\text{in}$  in center section

Surface finish measured Ra 11-18  $\mu\text{in}$  in area 2" to 8" from base

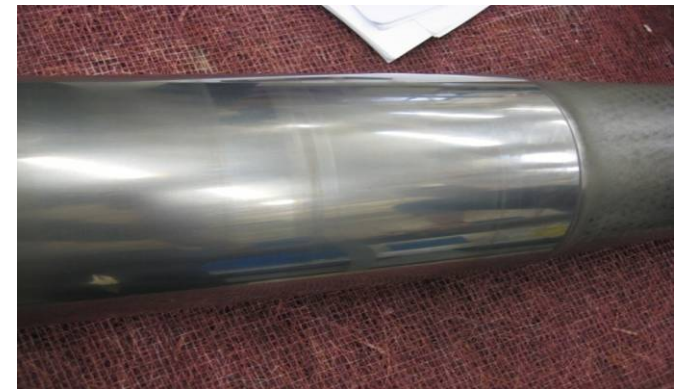
- HVOF Piston Surface
  - Upper Seal Area

Finish Roughness (Ra) = 2-3  $\mu\text{in}$

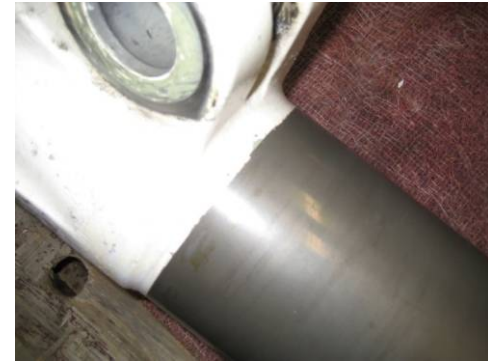
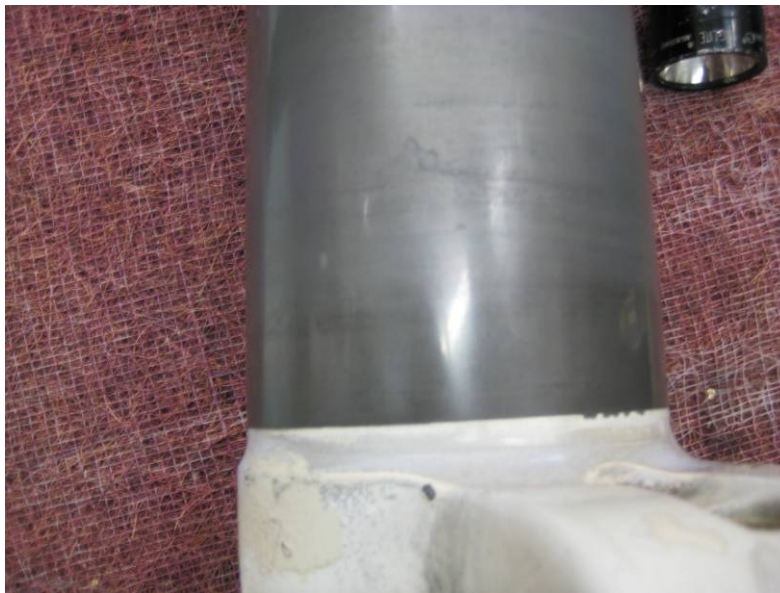
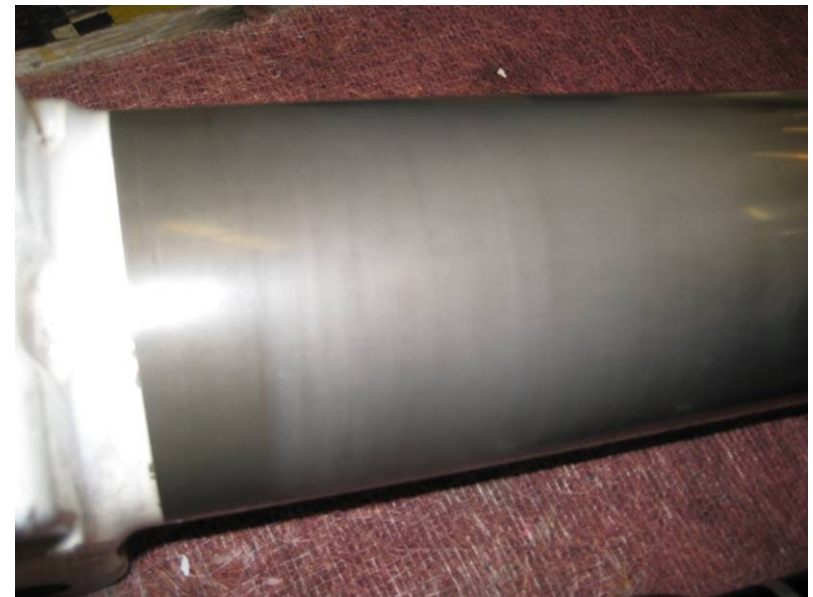
- HVOF Piston Surface
  - Lower Seal Area
