Geophysical Surveys for Detecting Anomalous Conditions, Algiers Canal Levees, New Orleans, Louisiana

José L. Llopis and Joseph B. Dunbar

August 2014

Final report

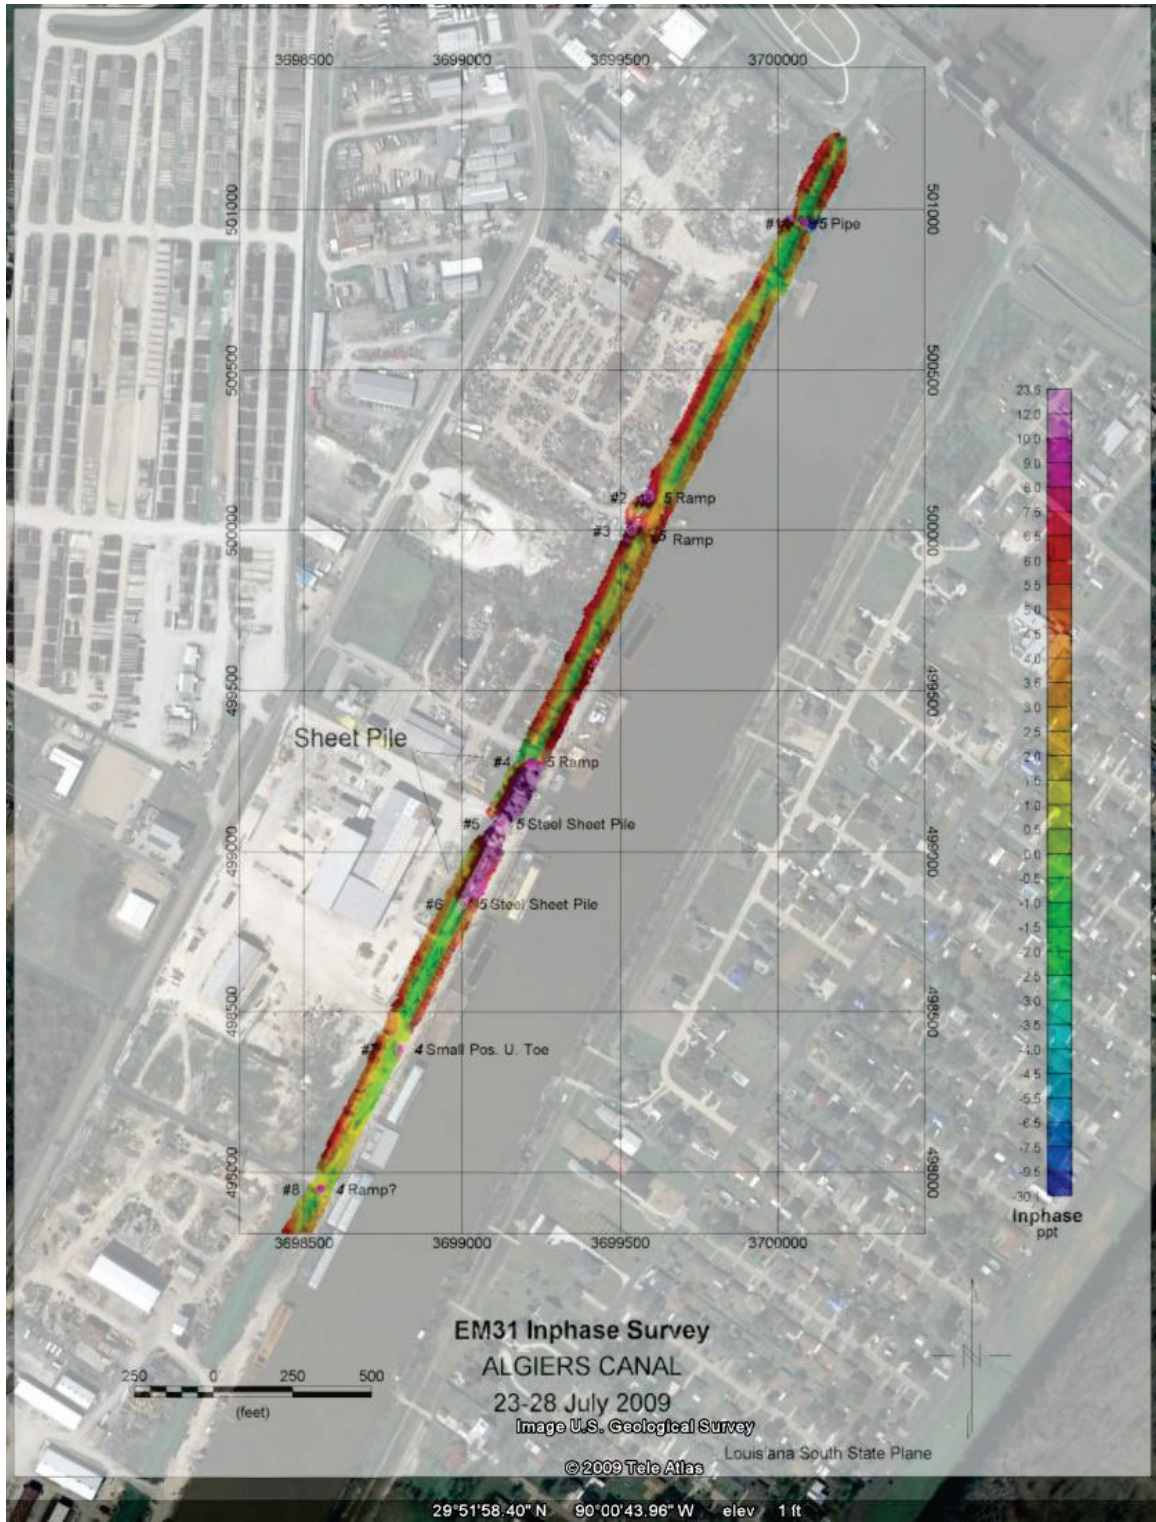
Section 1 extends from the Highway 23 tunnel (station 980+00) southwesterly to approximate station 1018+21. The survey results for Section 1 are presented in Figure 5. No priority 1 or 2 anomalies were interpreted for this

Figure 5. EM31 in-phase survey results overlaid on Google Earth image, Section 1.

section. The highest priority given to an anomaly in this section was a priority of 4. A steel sheet pile, located between approximate stations 1001+81 and 1006+78, is clearly evident (hot pink area). With the exception of the area in the vicinity of the steel sheet pile, the values along the center line of the levee are fairly consistent indicating very little or no metallic debris within the levee. However, the values along the toes of the levee have considerable variability. This variability is mainly caused by the effects of nearby metallic objects (e.g., cranes, metal buildings, pipes, reinforced concrete slabs). The anomalies along the toes are not considered to be a threat to the integrity of the levee and thus are not noted.

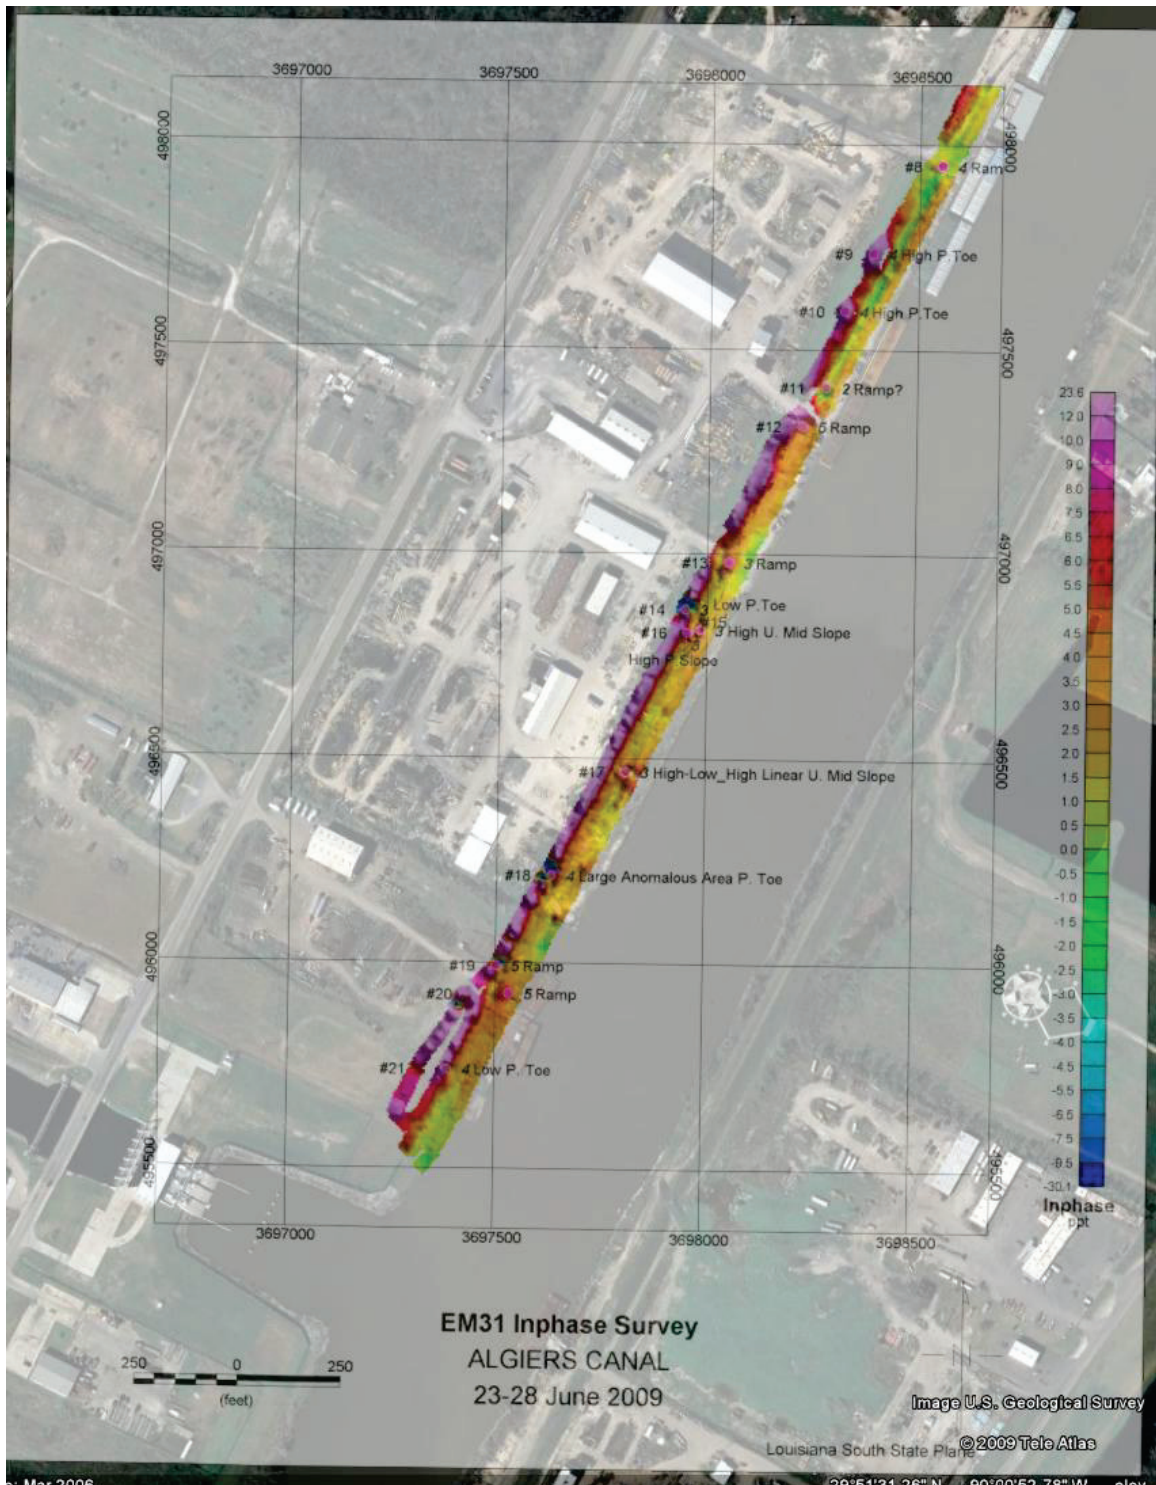
Section 2 continues in a southeasterly direction between approximate stations 1018+21 and 1044+18. The results are shown in Figure 6. A priority 2 anomaly is indicated for anomaly #11 at approximate station 1022+90 and may be caused by a small buried metallic object. A cluster of priority 3 anomalies (anomalies #14, #15, and #16) are shown near station 1029+48.

Figure 6. EM31 in-phase survey results overlaid on Google Earth image, Section 2.

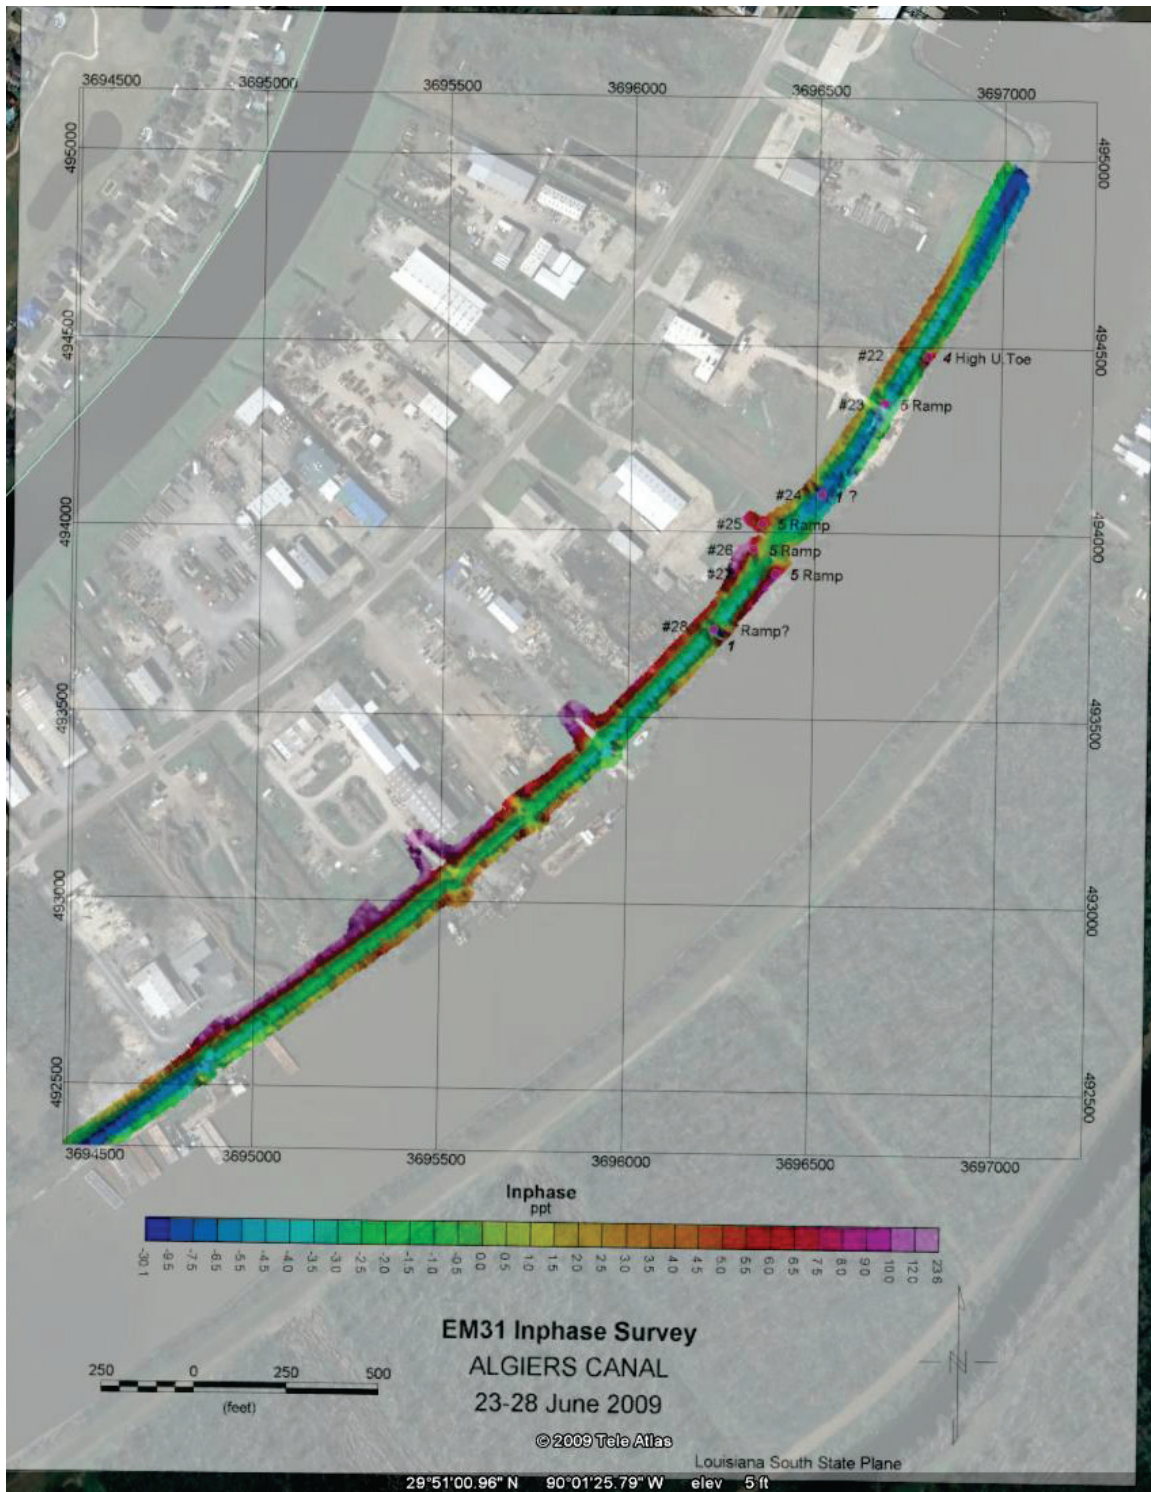
The results of the in-phase survey conducted along Section 3 are shown in Figure 7. The site extends between approximate stations 1044+18 and 1086+64. This site had numerous ramps crossing the levee. Anomalies 24 and 28 were assigned a priority 1 designation and are located at approximate stations 1060+01 and 1064+65, respectively. These anomalies are linear in nature and cross the levee at right angles. It is not certain whether anomaly 28 coincides with a ramp location. If it does, this anomaly should probably be designated with a priority of 5.

Figure 7. EM31 in-phase survey results overlaid on Google Earth image, Section 3.

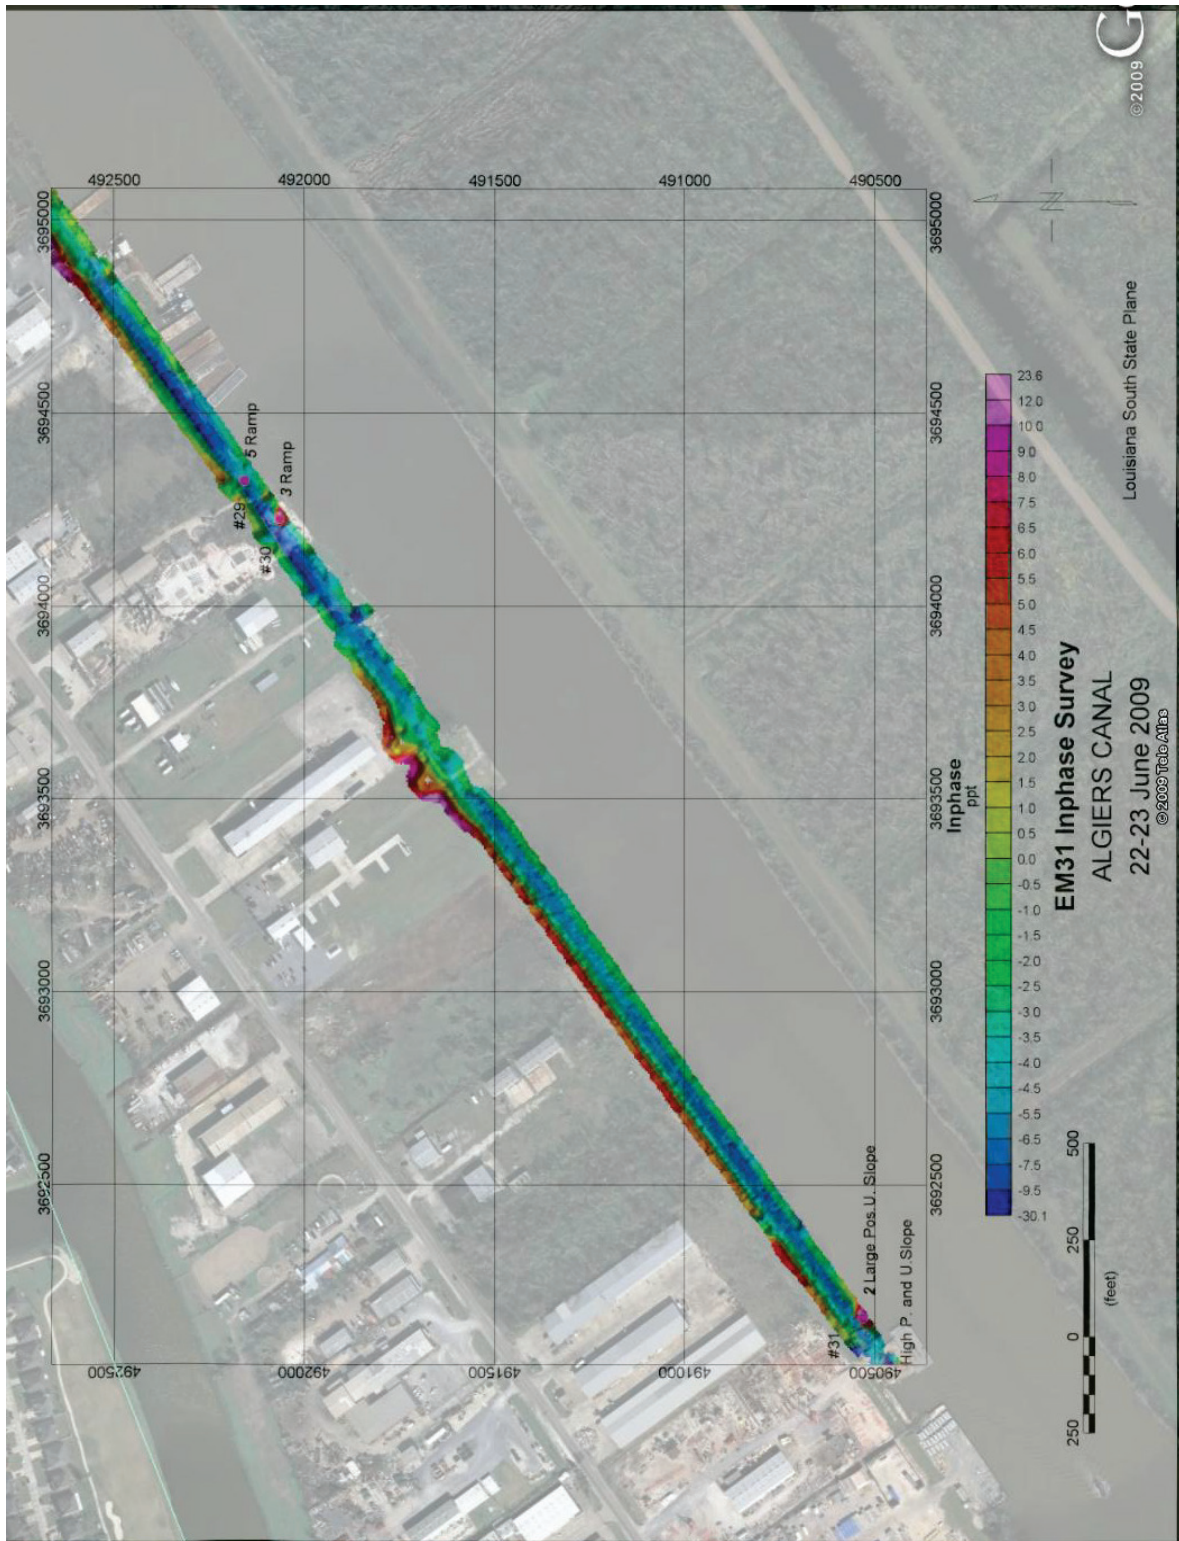
This section extends between approximate stations 1086+64 and 1116+53. Only three anomalies were interpreted as shown in Figure 8. A priority 2 anomaly was assigned to anomaly 31 located near station 1116+53. This anomaly may be caused by a buried or surface metallic object near the unprotected slope of the levee.

Figure 8. EM31 in-phase survey results overlaid on Google Earth image, Section 4.

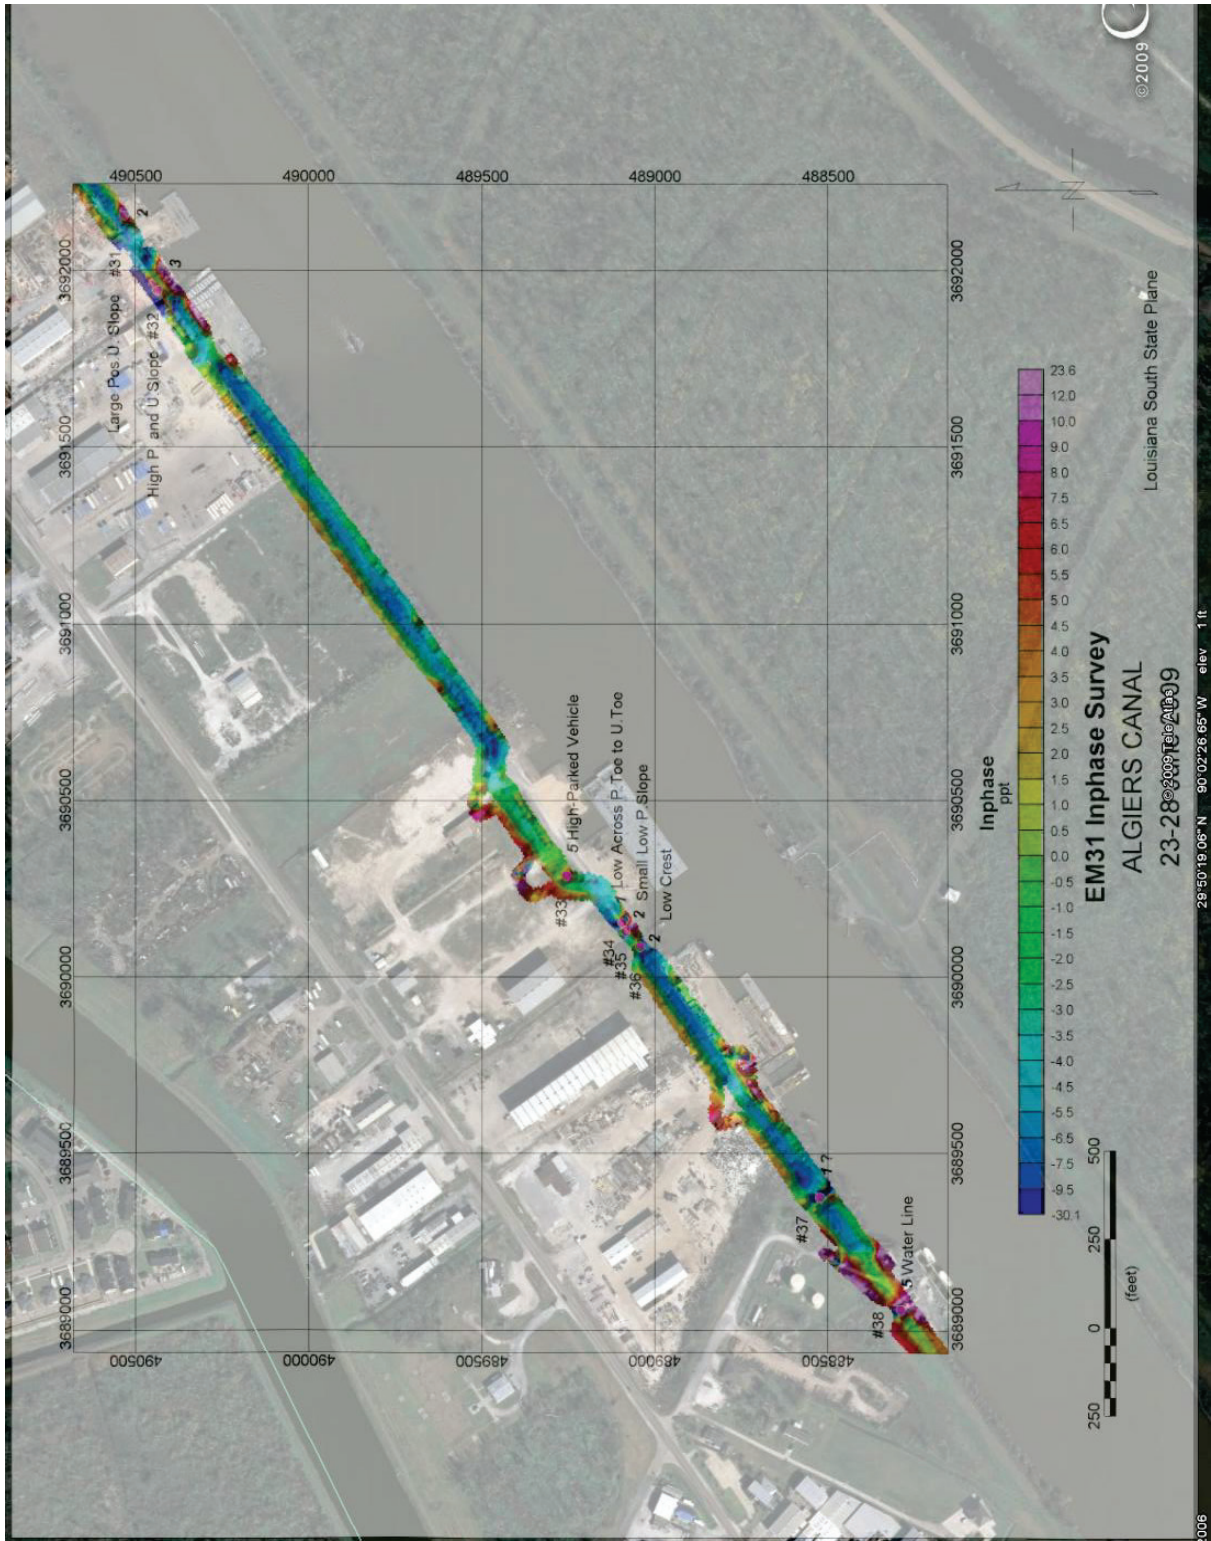
This section stretches between approximate stations 1116+53 and 1154+48 and has two priority 1 and two priority 2 anomalies as shown in Figure 9.

Figure 9. EM31 in-phase survey results overlaid on Google Earth image, Section 5.

The priority 1 anomaly located at station 1141+21 (anomaly 34) indicates the possibility of an object crossing beneath the levee. Anomaly 35, a priority 2 anomaly, indicates a small anomaly located on the landside slope of the levee near station 1141+06. It is possible that anomalies 34 and 35 may be caused by the same object. Anomaly 37, a priority 1 anomaly (station 1150+86), is located approximately 25 ft southwest of an area marked with cable crossing signs. No indications of a buried cable were noted with the EM31 instrument when crossing the marked area, which is also characterized by a noticeable hump in the levee. However, approximately 20 to 30 ft southwest of the marked cable crossing area, the instrument indicated a strong response to a buried metallic object oriented perpendicular to the axis of the levee. The strong linearly-oriented anomaly located near station 1154+48, anomaly 38, is caused by a buried steel pipe that crosses the levee and is visible on the protected toe.

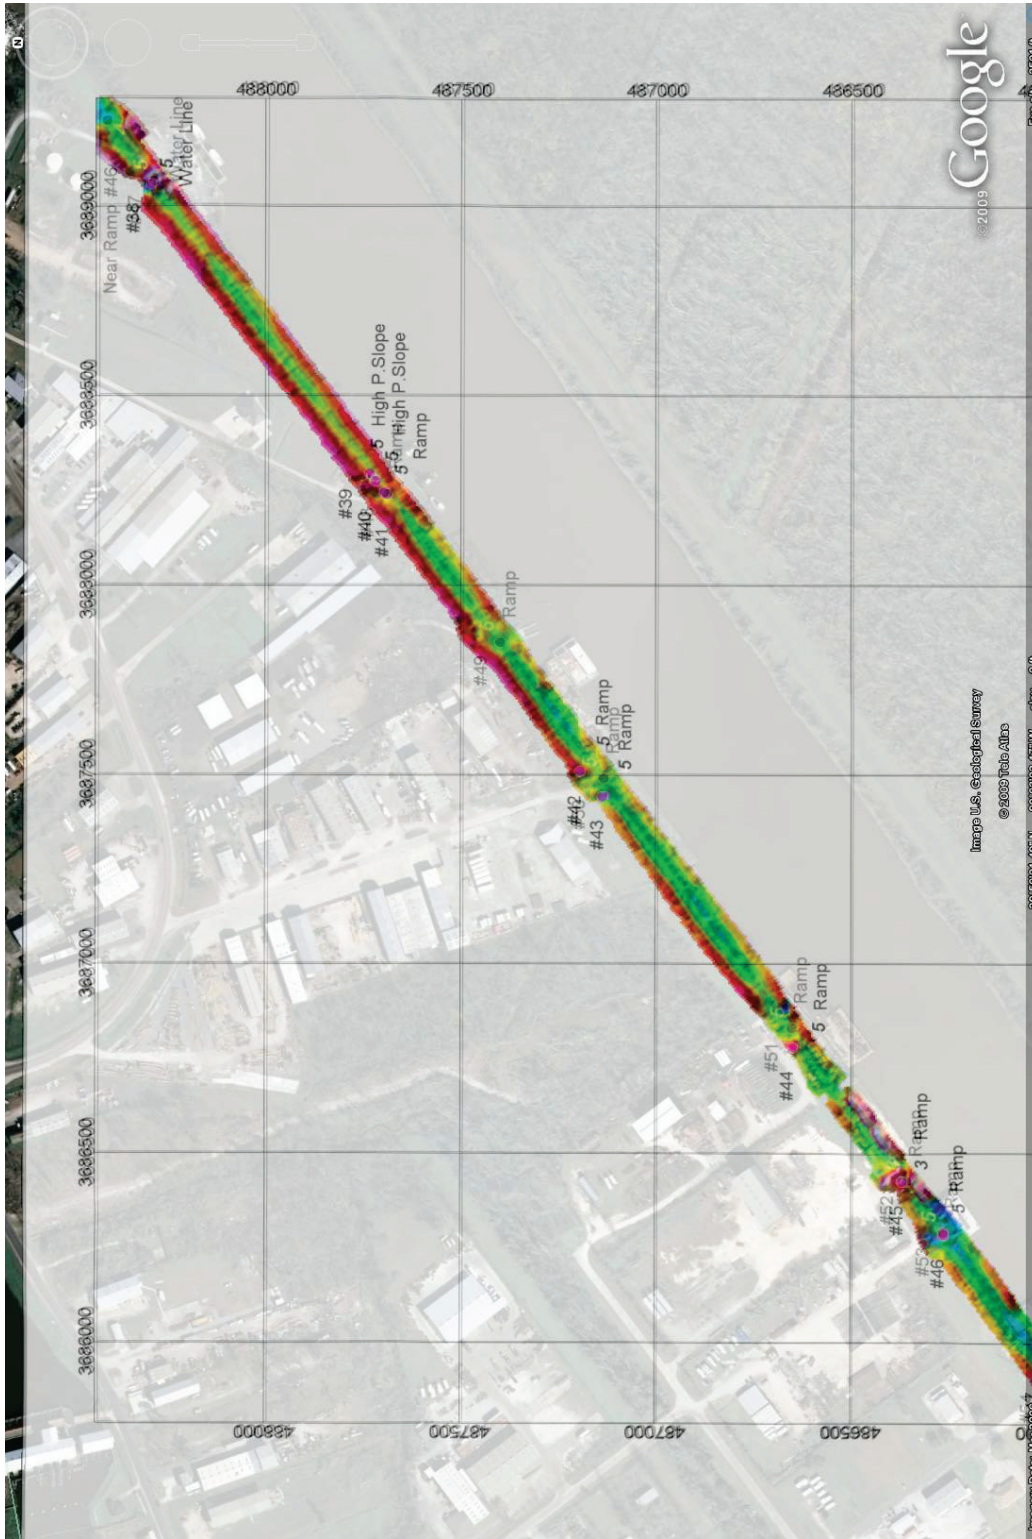
This section stretches between approximate stations 1154+48 and 1194+31 (Figure 10). All of the anomalies in this section have priority numbers of 5, with the exception of anomaly 45 that has a priority of 3. The location of anomaly 45 coincides with the location of a ramp. However, there is an indication of a localized metallic object.

Figure 10. EM31 in-phase survey results overlaid on Google Earth image, Section 6.

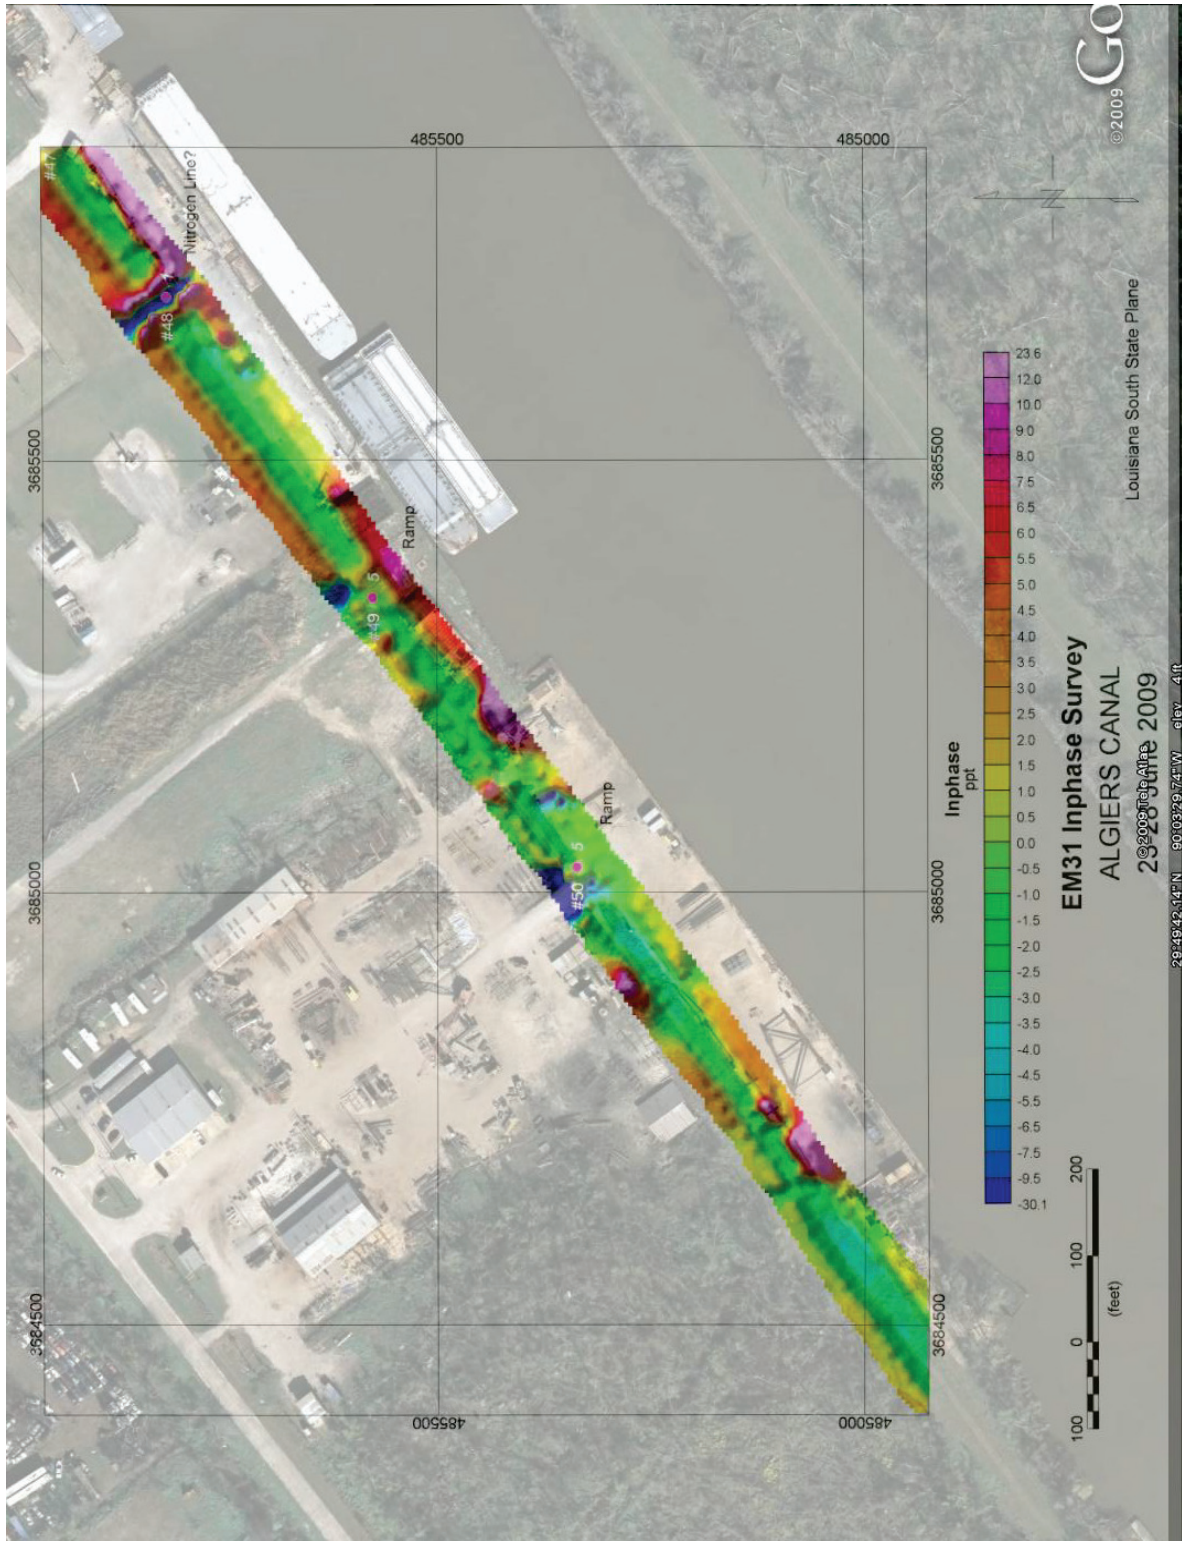
Section 7 is located between approximate stations 1194+31 and 1211+26. Three anomalies were interpreted for this section as shown in Figure 11. Anomaly 48, located at station 1196+64, is a strong linear-shaped anomaly that crosses the levee. A hump crosses the levee center line directly over the location of the anomaly. It is presumed that this anomaly is caused by a buried nitrogen line indicated in the construction drawings.

Figure 11. EM31 in-phase survey results overlaid on Google Earth image, Section 7.

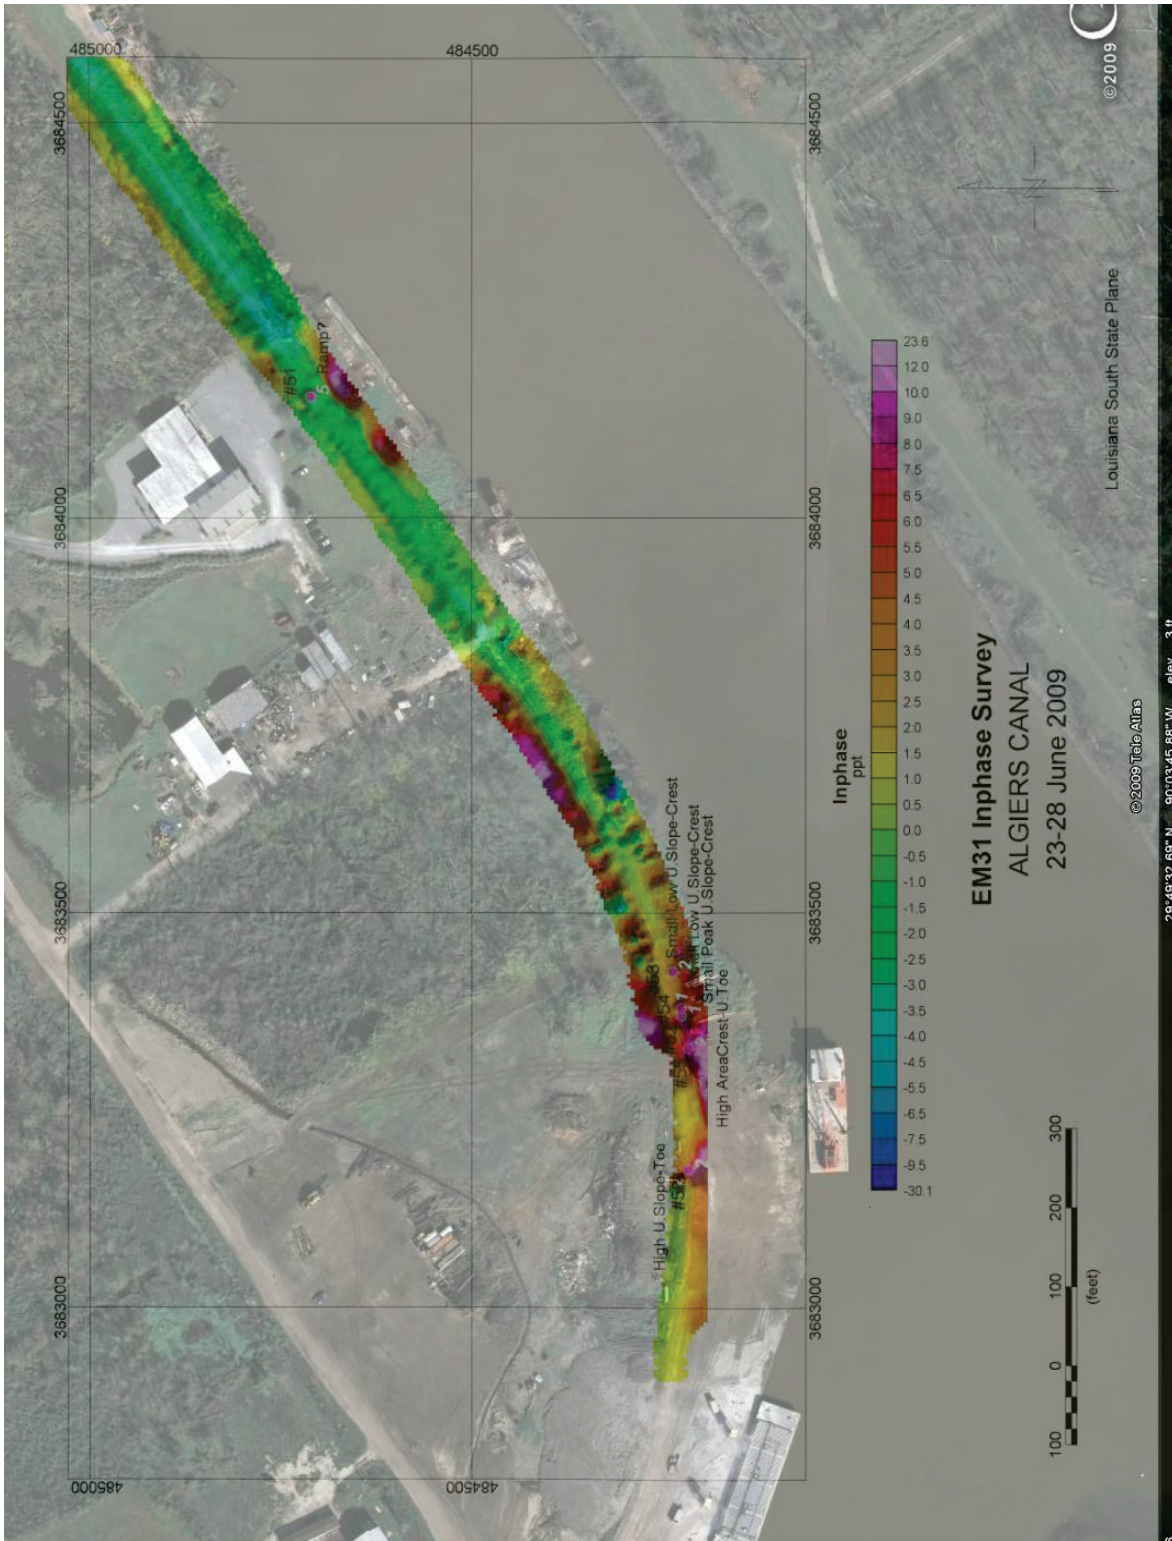
The southernmost section extends between approximate stations 1211+26 and 1229+44 (Figure 12). Anomalies 52 through 56 have priorities of 1 and 2 and are indicative of small metallic objects. This section of levee had not been raised at the time this survey was conducted.

Figure 12. EM31 in-phase survey results overlaid on Google Earth image, Section 8.

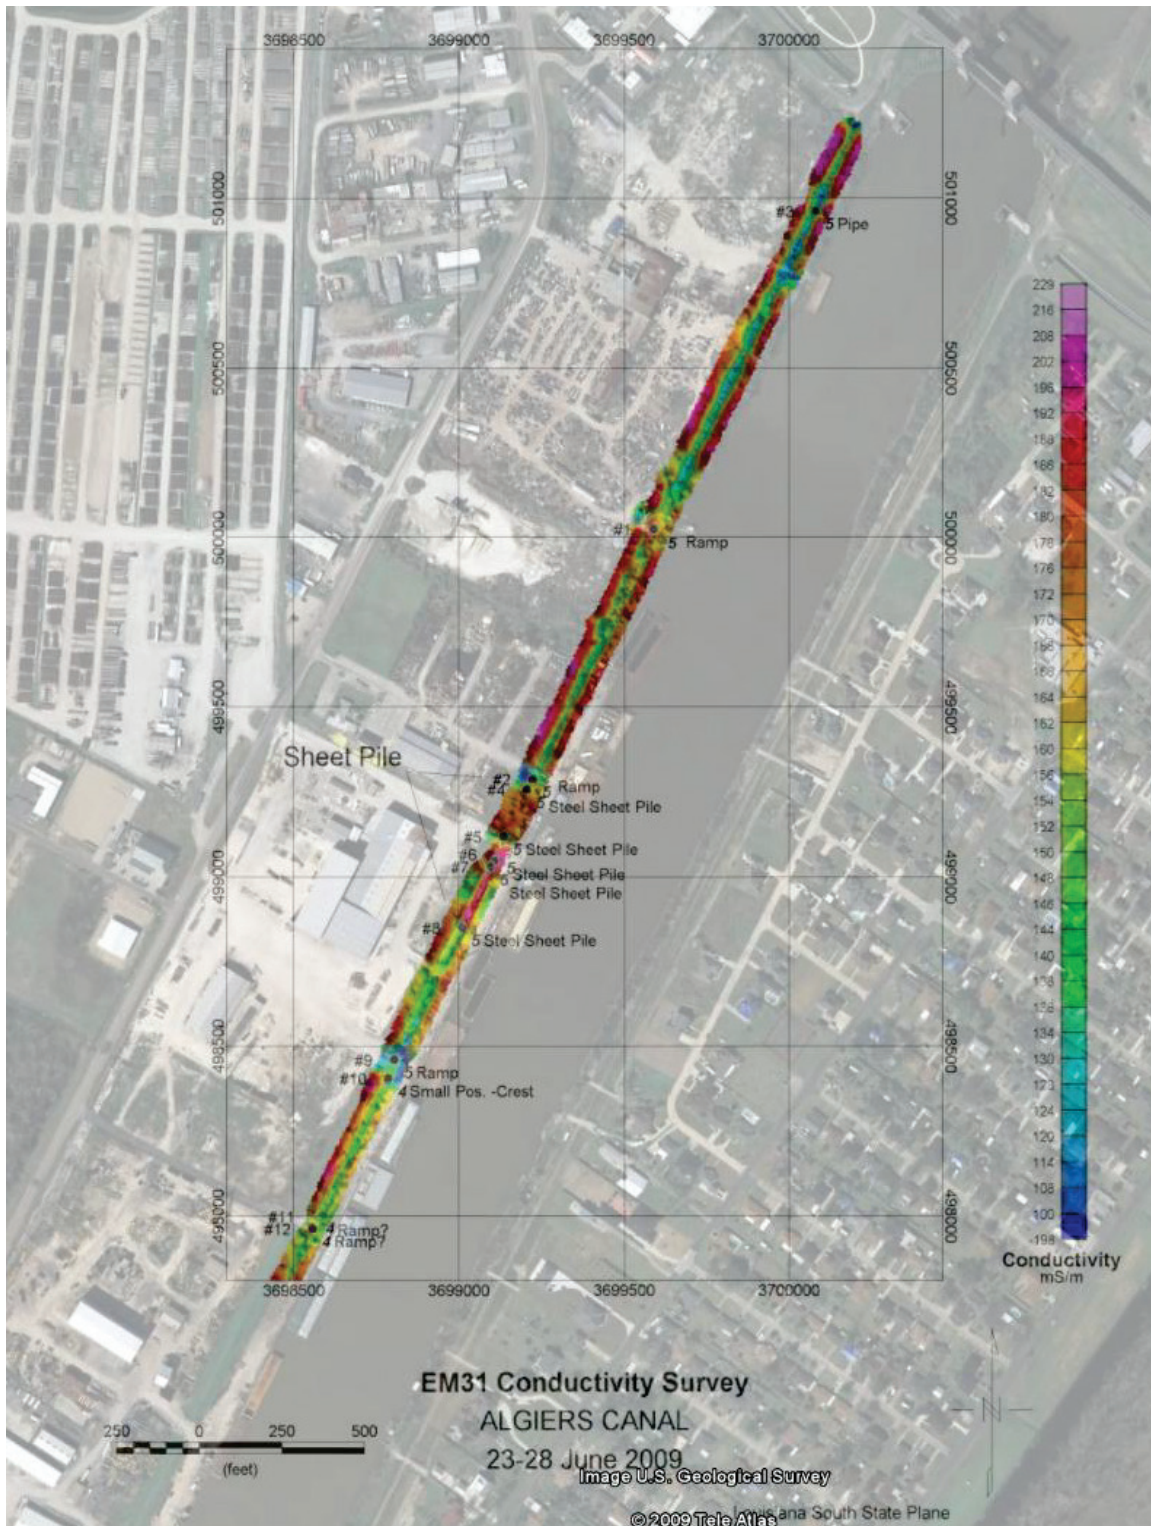
Section 1 extends from the Highway 23 tunnel (station 980+00) southwesterly to approximate station 1018+21. The survey results for Section 1 are presented in Figure 13. No priority 1 or 2 anomalies were interpreted for this section. The highest priority given to an anomaly in this section was a priority of 4. As was the case for the in-phase survey, a steel sheet pile, located between approximate stations 1001+81 and 1006+78, is clearly evident. It is again noted, with the exception of the area in the vicinity of the steel sheet pile, that the values along the center line of the levee are fairly consistent indicating little or no metallic debris within the levee.

Figure 13. EM31 conductivity survey results overlaid on Google Earth image, Section 1.

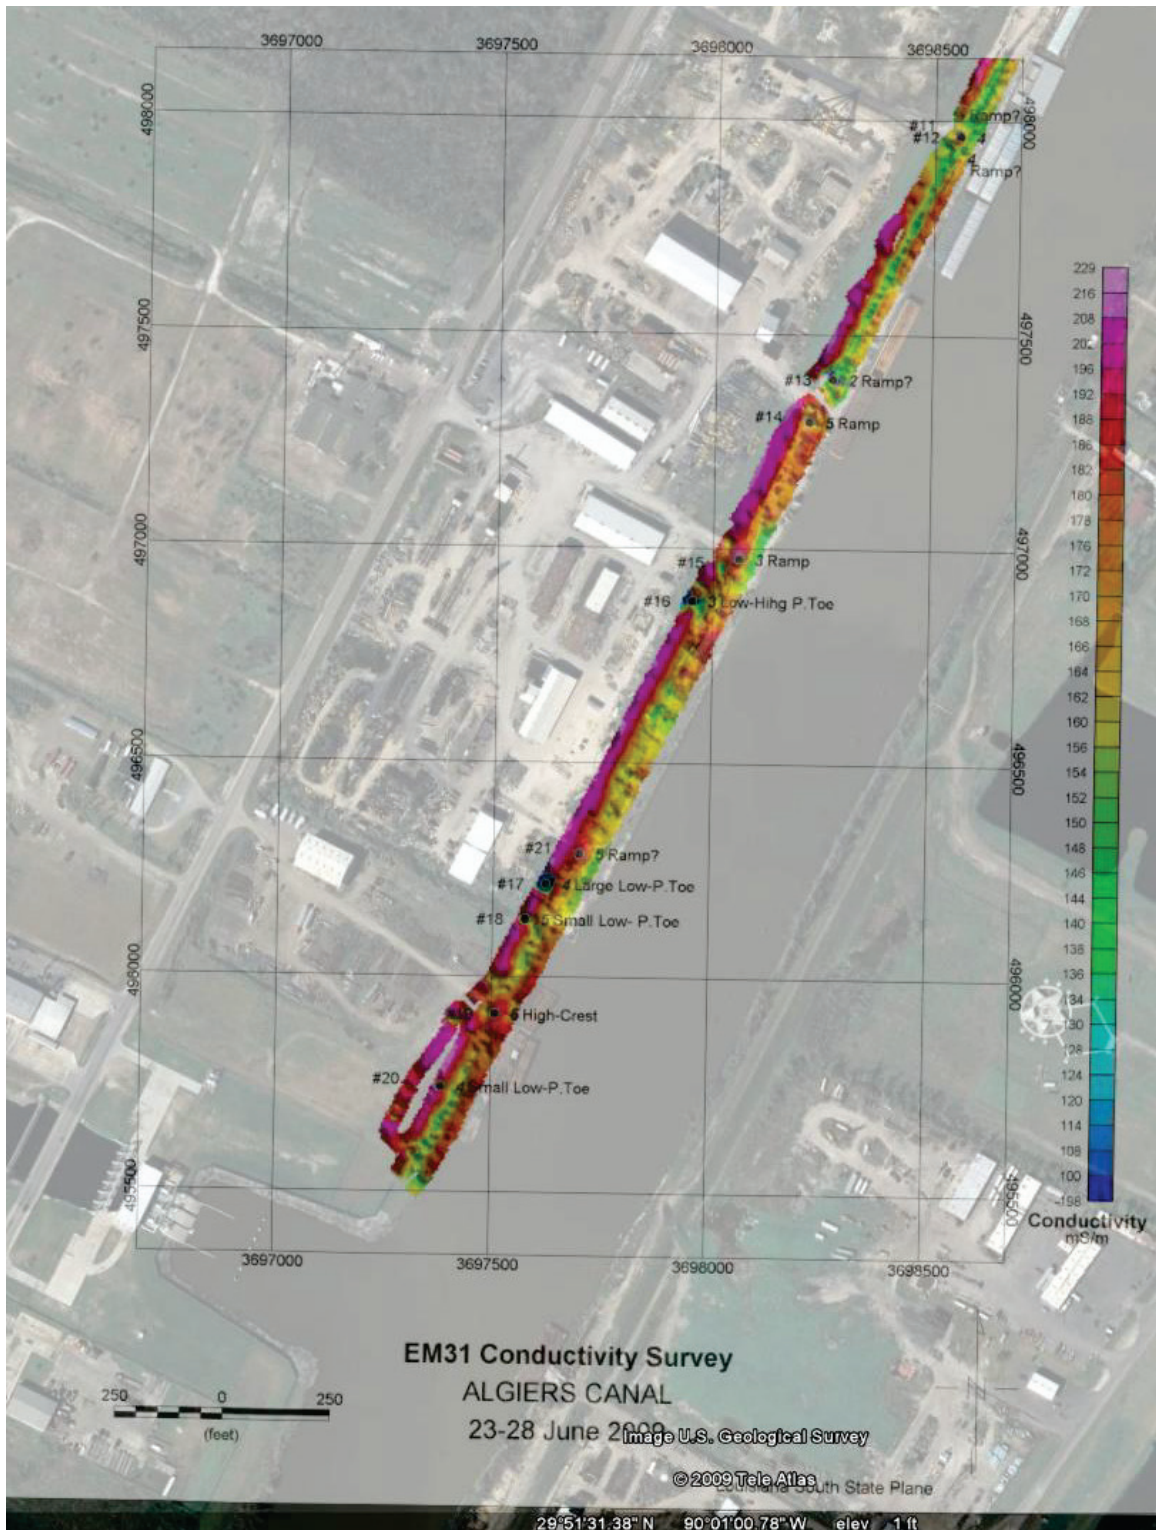
Section 2 continues in a southeasterly direction between approximate stations 1018+21 and 1044+18. The results are shown in Figure 14. A priority 2 anomaly is indicated for anomaly 13 at approximate station 1023+02 and may be caused by a small buried metallic object.

Figure 14. EM31 conductivity survey results overlaid on Google Earth image, Section 2.

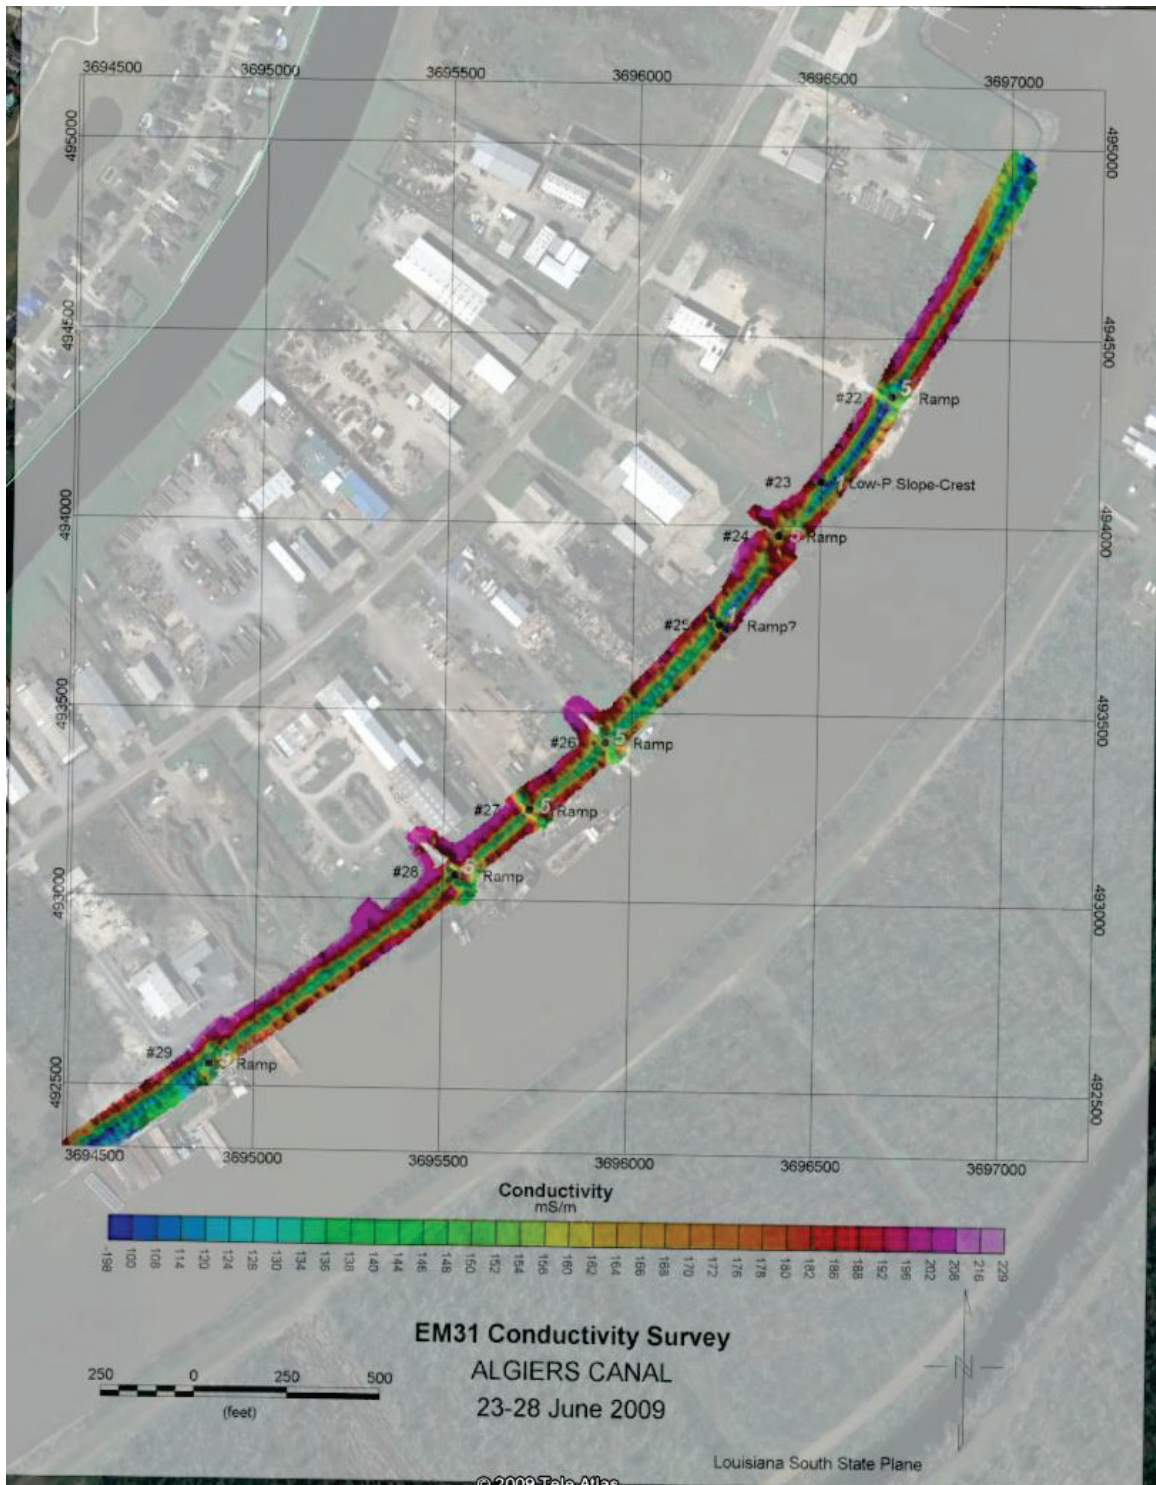
The results of the conductivity survey conducted along Section 3 are shown in Figure 15. The site extends between approximate stations 1044+18 and 1086+64. This site had numerous ramps crossing the levee. Anomalies 22 and 25, assigned a priority 1 designation, are located at approximate stations 1060+04 and 1064+65, respectively. These anomalies are linear in nature and cross the levee at right angles. It is not certain whether anomaly 25 coincides with a ramp location. If it does, this anomaly should probably be designated with a priority of 5.

Figure 15. EM31 conductivity survey results overlaid on Google Earth image, Section 3.

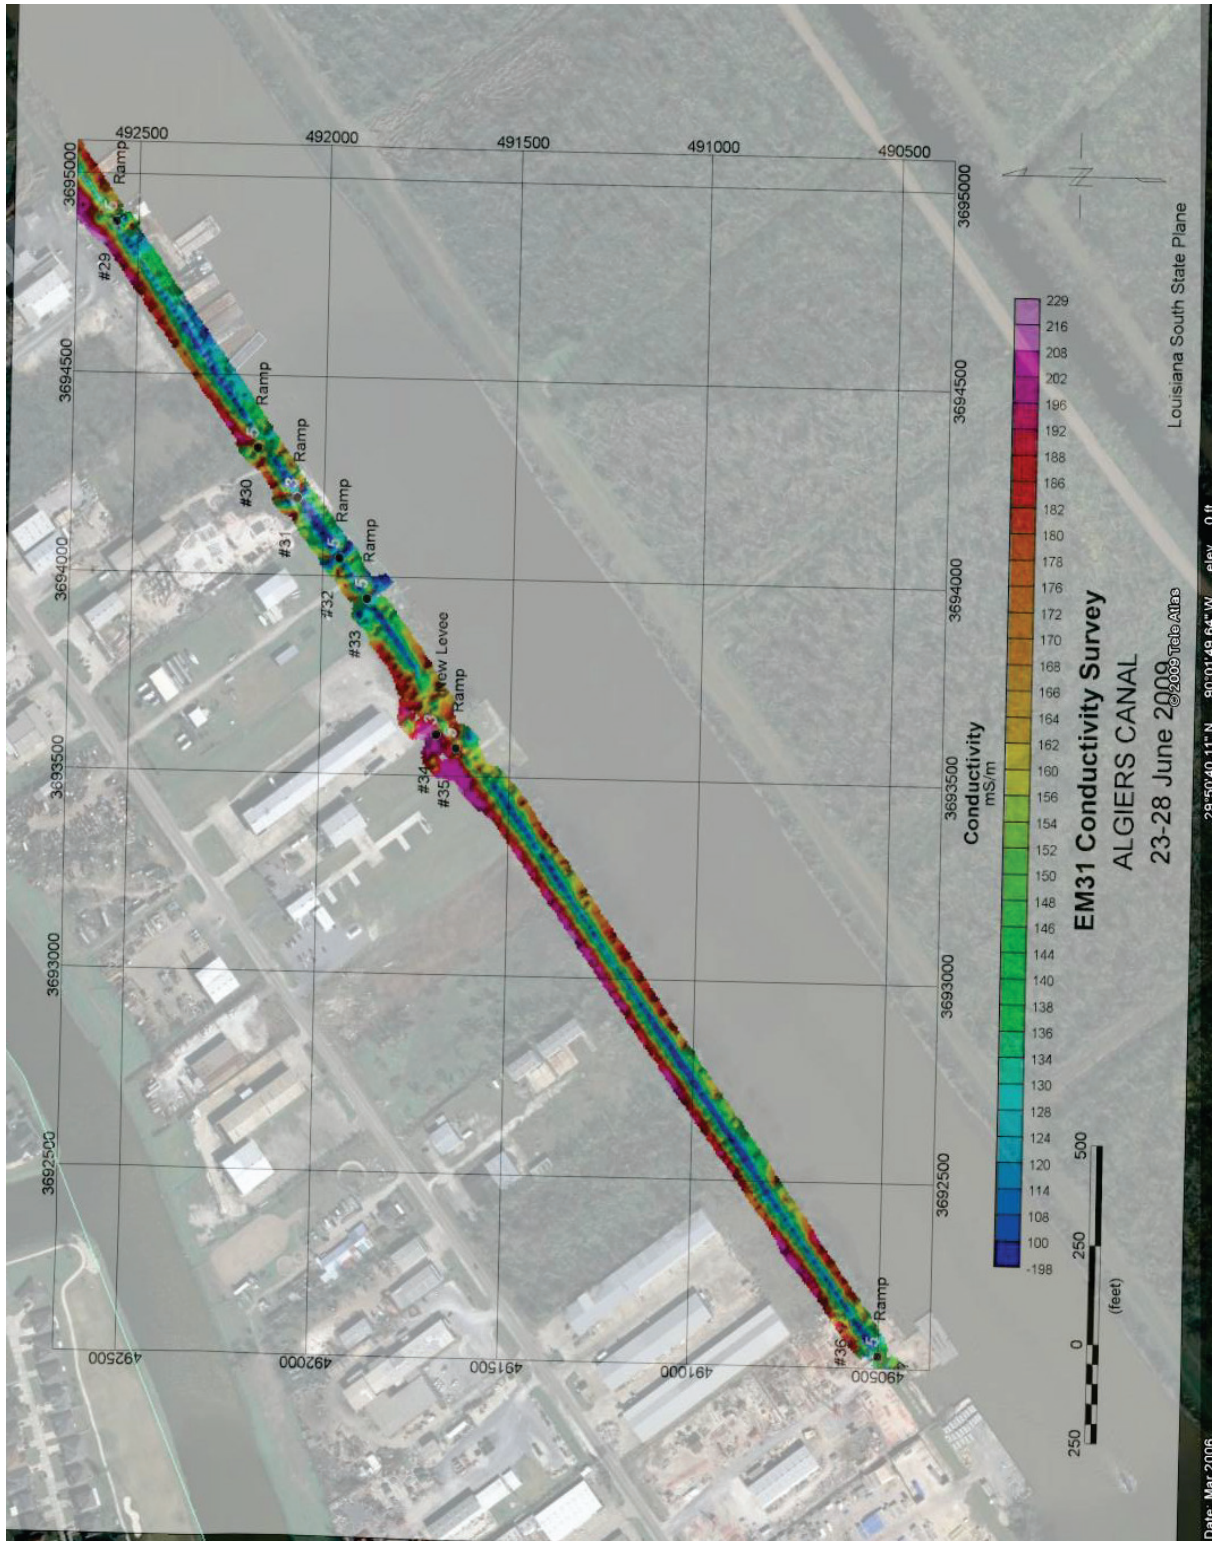
This section extends between approximate stations 1086+44 and 1116+53 (Figure 16). The values along the crest of the levee were fairly consistent with the exception of the ramp areas and the newly constructed levee area near station 1098+00.

Figure 16. EM31 conductivity survey results overlaid on Google Earth image, Section 4.
