Geophysical Surveys for Detecting Anomalous Conditions, Algiers Canal Levees, New Orleans, Louisiana

José L. Llopis and Joseph B. Dunbar

August 2014

Final report

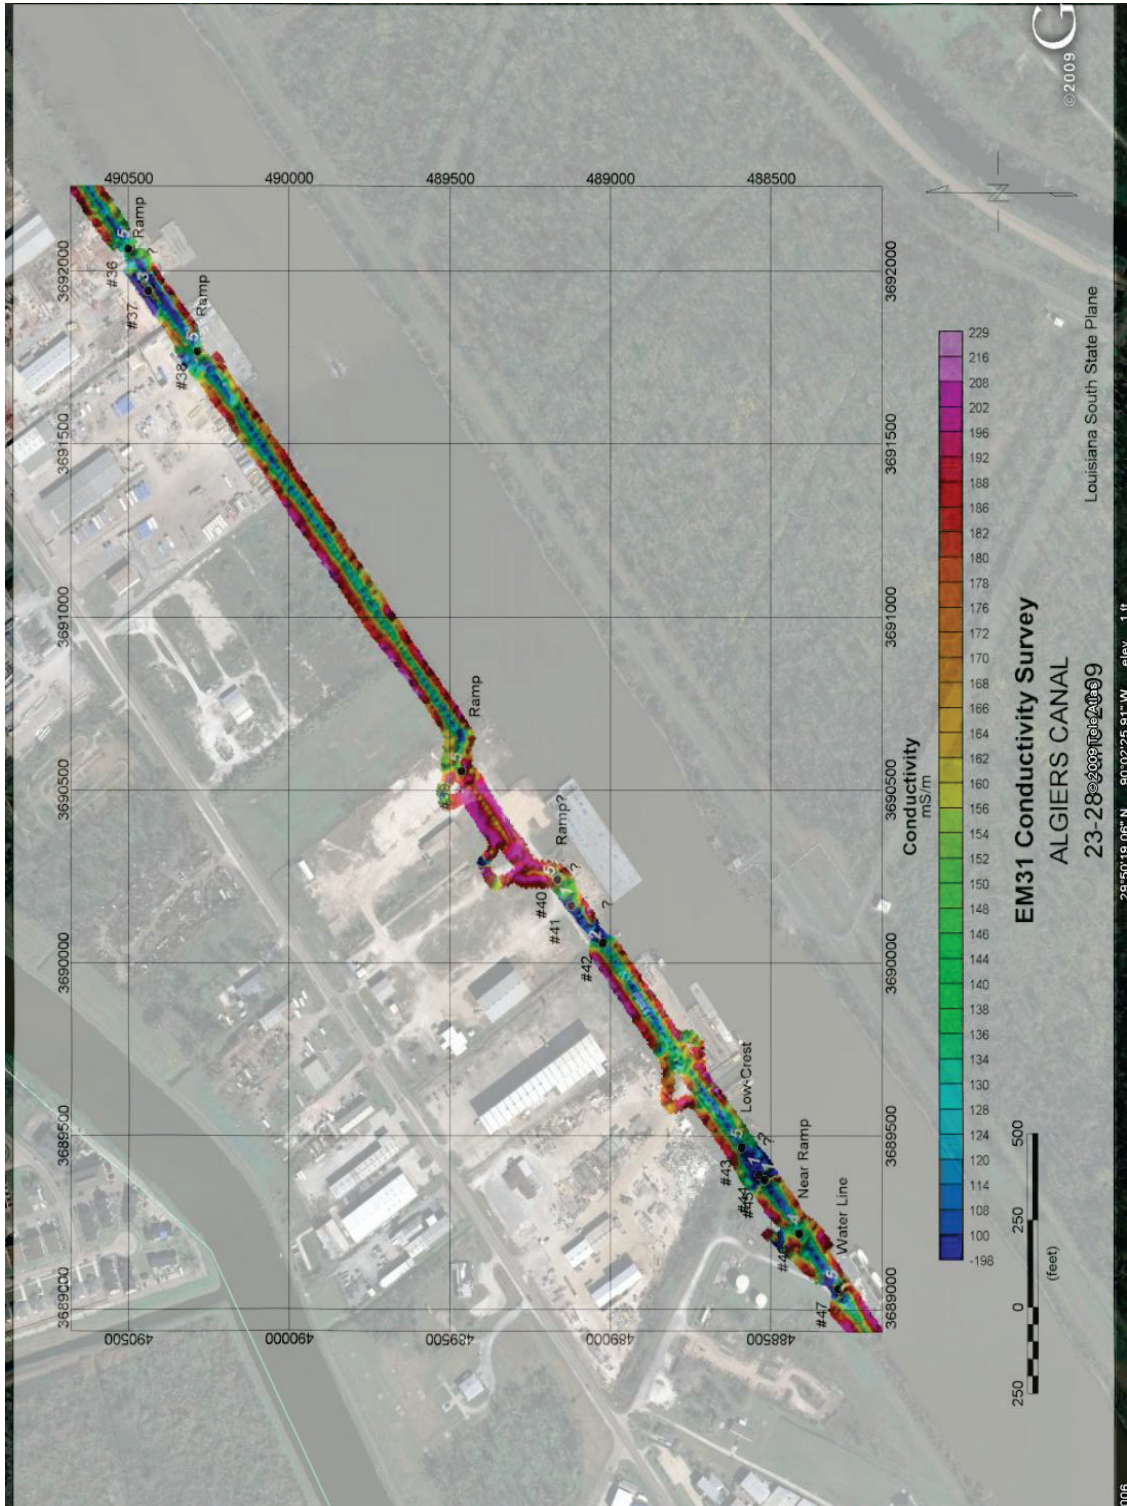
This section stretches between approximate stations 1116+53 and 1154+48 and has three priority 1 and one priority 2 anomalies as shown in Figure 17. The priority 1 anomaly located at station 1141+03, anomaly 41, indicates the possibility of an object crossing beneath the levee. Anomaly 42, a priority 2 anomaly, indicates an area of low conductivity values in the center line of the levee near station 1142+39. Anomaly 41 may be caused by a change in material type. Anomalies 44 and 45 (stations 1150+70 and 1150+86, respectively) are located approximately 25 ft southwest of an area marked with cable crossing signs. These are two priority 1 anomalies and are probably caused by the same item. No indications of a buried cable were noted over the marked area, which is also characterized by a noticeable hump in the levee. However, approximately 20 to 30 ft southwest of the marked cable crossing area, the instrument indicated a strong response to a buried metallic object oriented perpendicular to the axis of the levee. Anomaly 47, located near station 1154+79, is caused by a buried steel pipe that crosses the levee and is visible on the protected toe. However, it is not nearly as strong as an anomaly shown in the in-phase results.

Figure 17. EM31 conductivity survey results overlaid on Google Earth image, Section 5.

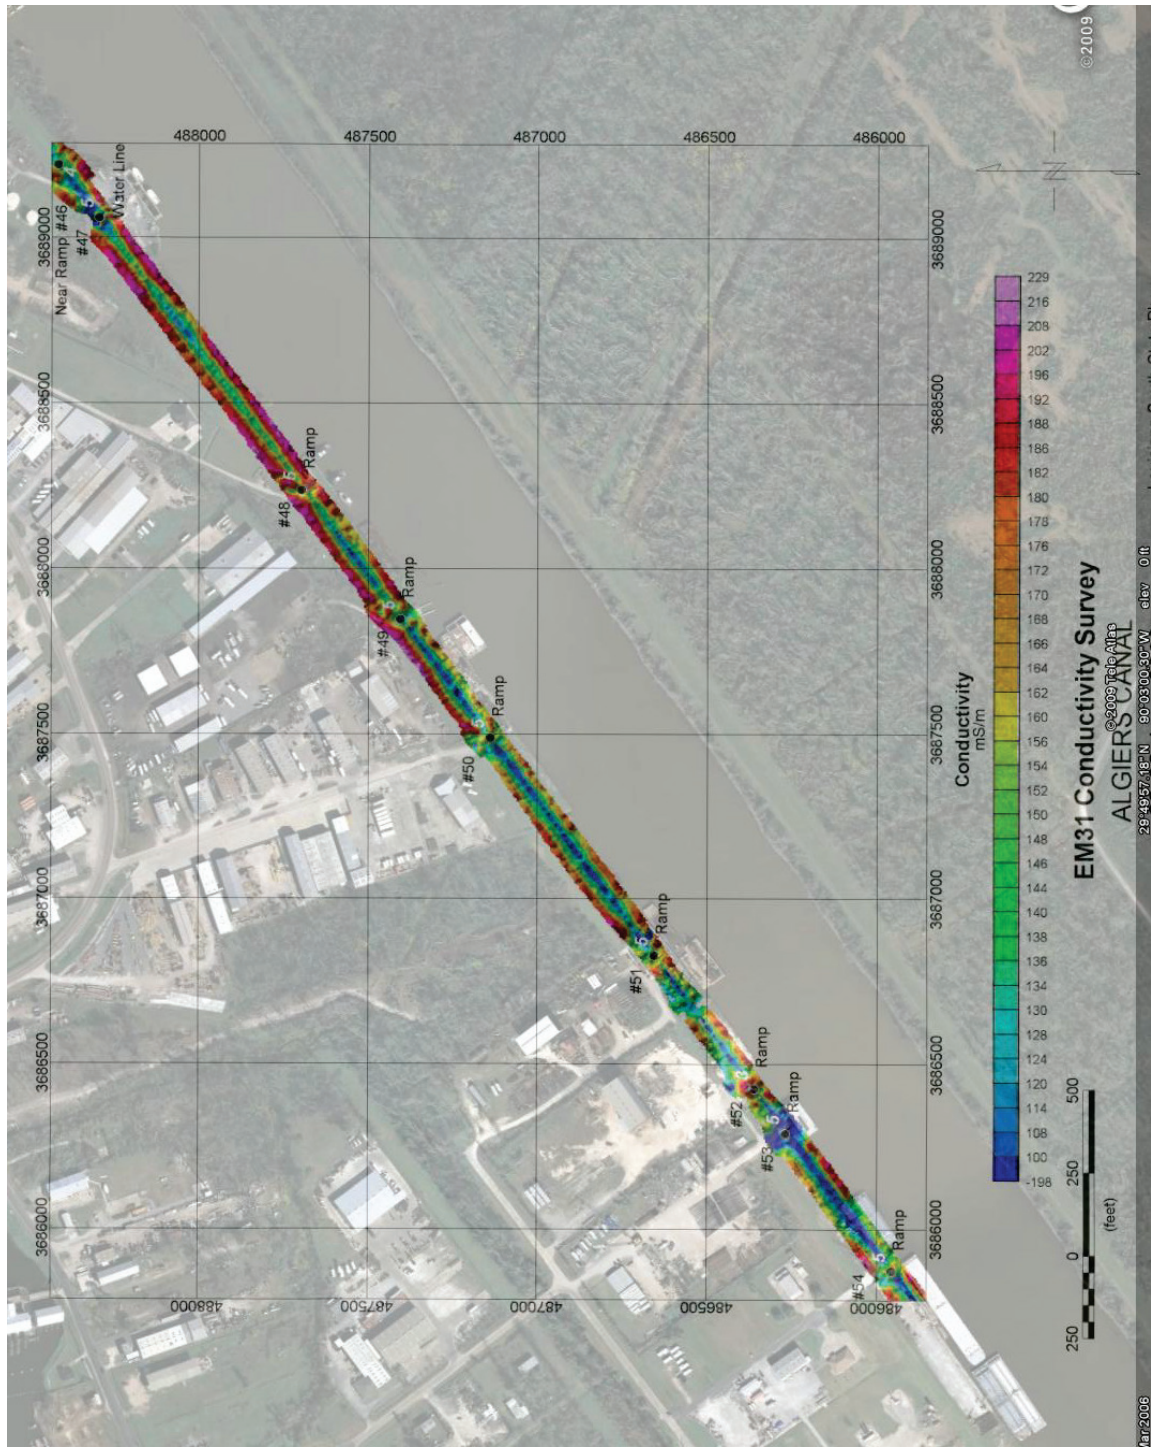
This section stretches between approximate stations 1154+48 and 1194+31 (Figure 18). All of the anomalies in this section have priority numbers of 5, with the exception of anomaly 52 that has a priority of 3. The location of anomaly 52, station 1187+50, coincides with the location of a ramp. However, there is an indication of a localized metallic object.

Figure 18. EM31 conductivity survey results overlaid on Google Earth image, Section 6.

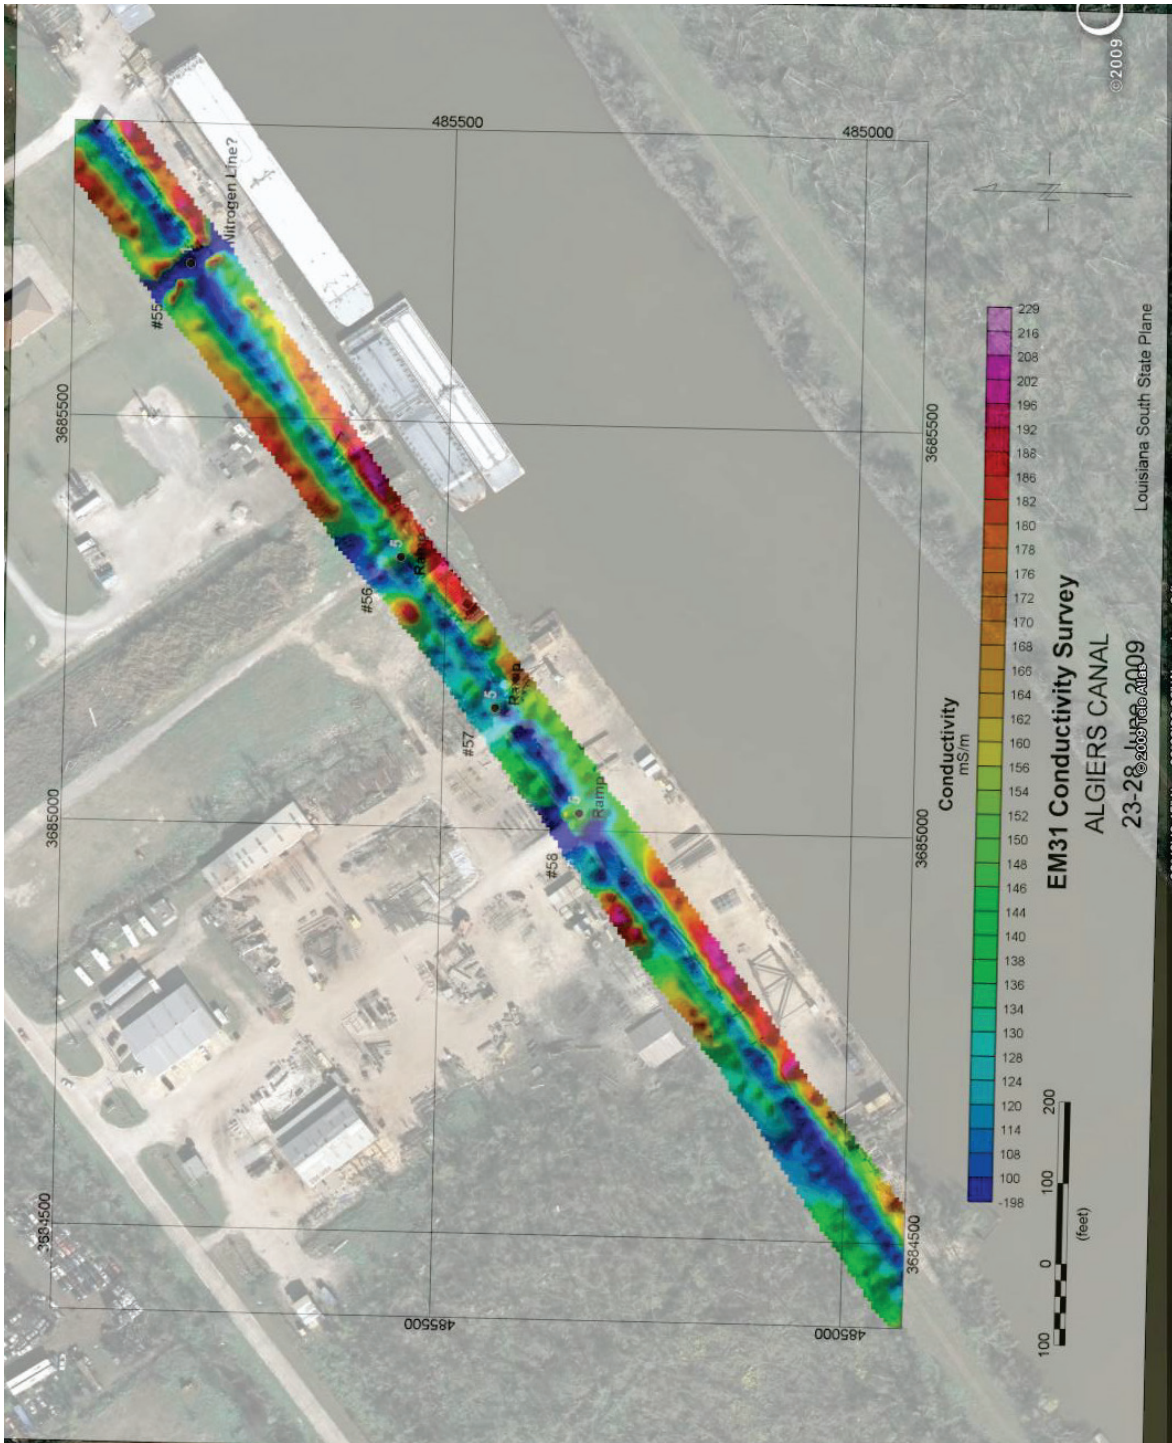
Section 7 extends between approximate stations 1194+31 and 1211+26 (Figure 19). Four anomalies, one a priority 1 and the remaining three priority 5 anomalies, were interpreted for this section. Anomaly 55, a priority 1 anomaly, is located at station 1196+63, and is a strong linear-shaped anomaly that crosses the levee. There is a hump in the levee center line directly over the location of the anomaly. It is presumed that this anomaly is caused by a buried nitrogen line indicated in the construction drawings. The remaining anomalies coincide with the locations of ramps.

Figure 19. EM31 conductivity survey results overlaid on Google Earth image, Section 7.

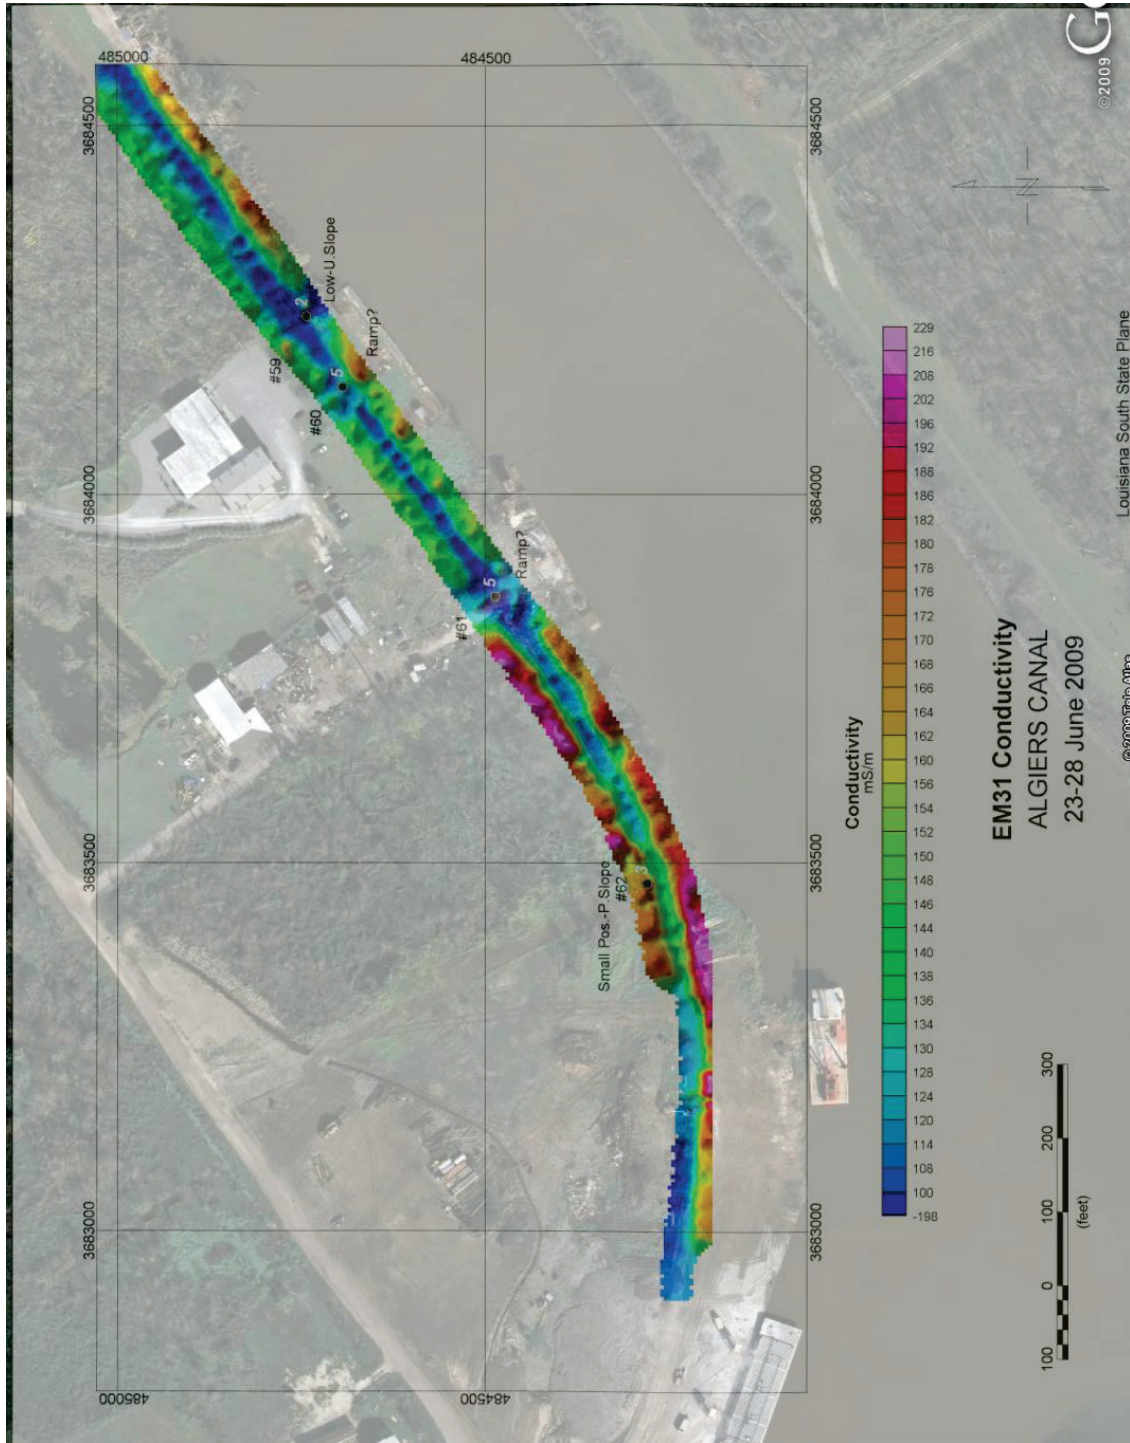
The southernmost section extends between approximate stations 1211+76 and 1229+44 (Figure 20). Anomaly 59, a priority 2 anomaly, indicates the possibility of an object on or below the unprotected slope or a change in material. This section of levee had not been raised at the time this survey was conducted.

Figure 20. EM31 conductivity survey results overlaid on Google Earth image, Section 8.
