# INSPECTOR GENERAL

OCTOBER 28, 2014

## Military Housing Inspections – Republic of Korea

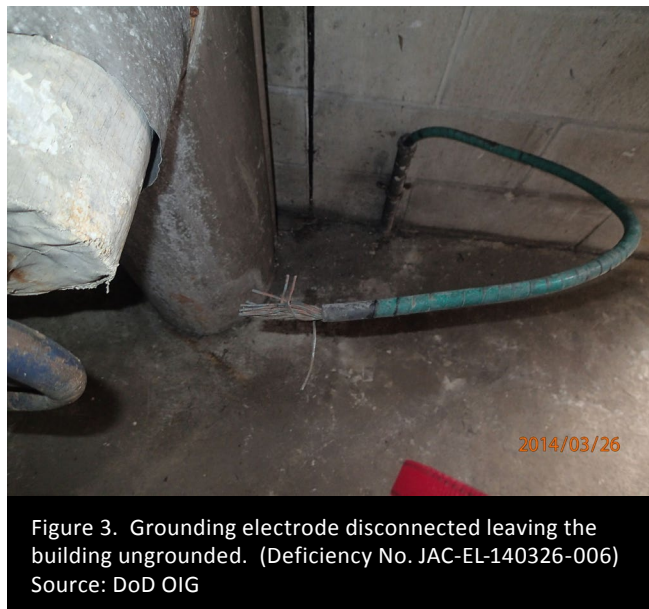
Figure 3. Grounding electrode disconnected leaving the building ungrounded. (Deficiency No. JAC-EL-140326-006)  
Source: DoD OIG

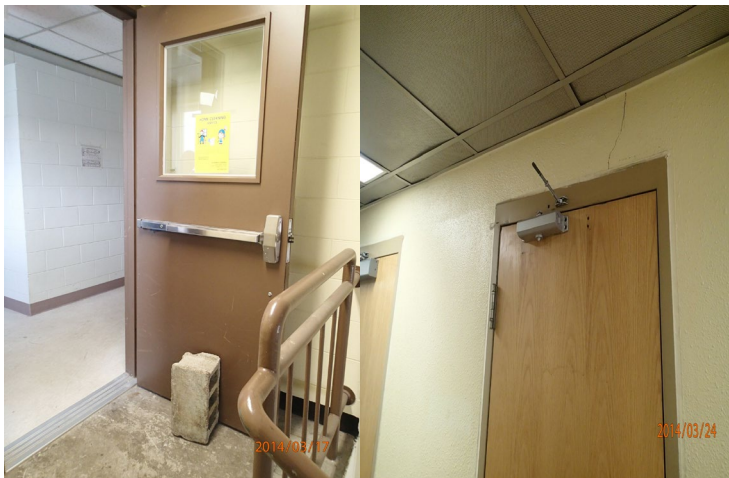
Figure 4. Ineffective use of fire doors allows fire to draft through the entire building. Left: Fire rated doors often propped open (Deficiency No. CAS-FP-140317-024) Right: Broken automatic closing mechanisms (Deficiency No. CRC-FP-140324-013) Source: DoD OIG

Fire protection deficiencies included fire doors that were propped open, did not automatically and fully close, and were not fire rated (see Figure 4). We found dryer vents that were disconnected, pinched or shredded, and constructed of improper material (see Figure 5). Also, we found multiple sprinkler systems that were out of service and without temporary life safety measures.

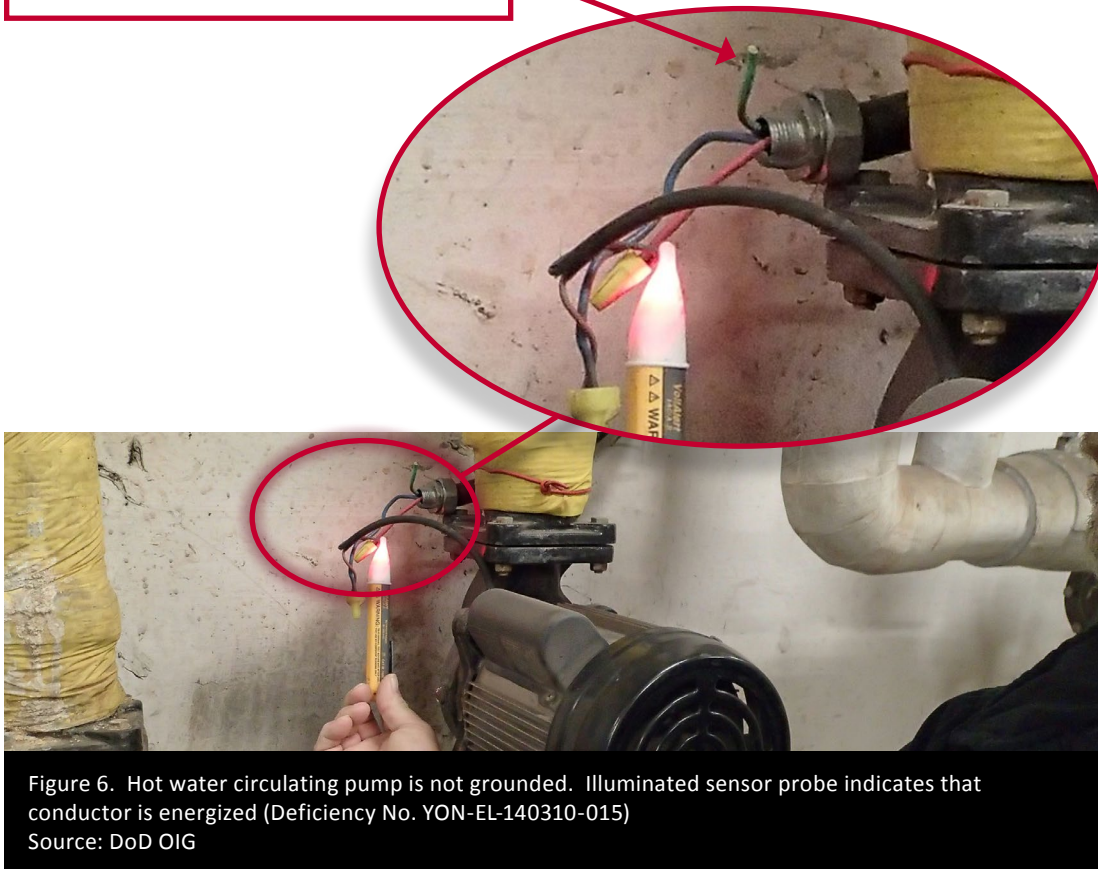
**Disconnected Ground Wire**

Electrical deficiencies included exposed energized wiring due to missing electrical service panel breaker blanks, missing knockout seals and covers in junction boxes, and missing exterior light fixture covers. We found that water circulating pumps in several buildings had missing or disconnected ground wires (see Figure 6). Similarly, we found that main electrical panels were not properly grounded through a bonding jumper in several buildings. Also, junction boxes were obstructed and inaccessible. These deficiencies create electrocution hazards for installation personnel.

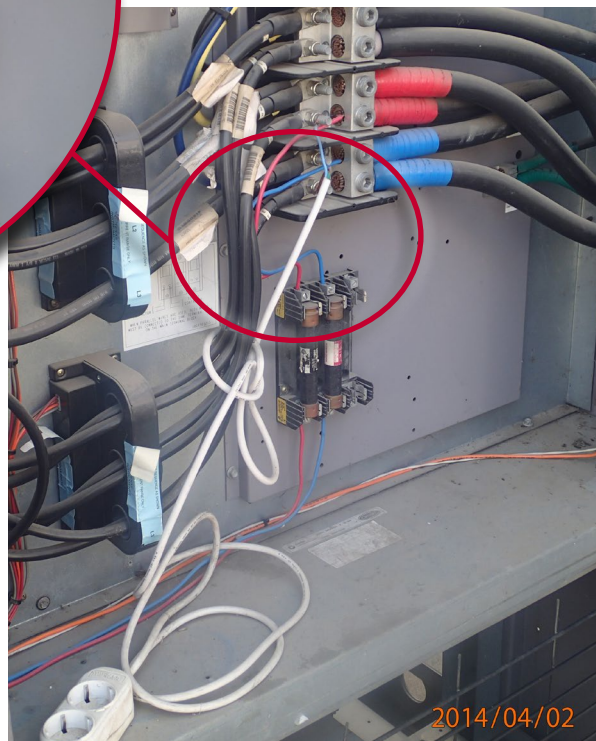
Figure 7: A drop cord hard-wired directly to conductors fused at 400 Amps inside the chiller electrical power panel (Deficiency No. HUM-EL-140331-021A)  
Source: DoD OIG

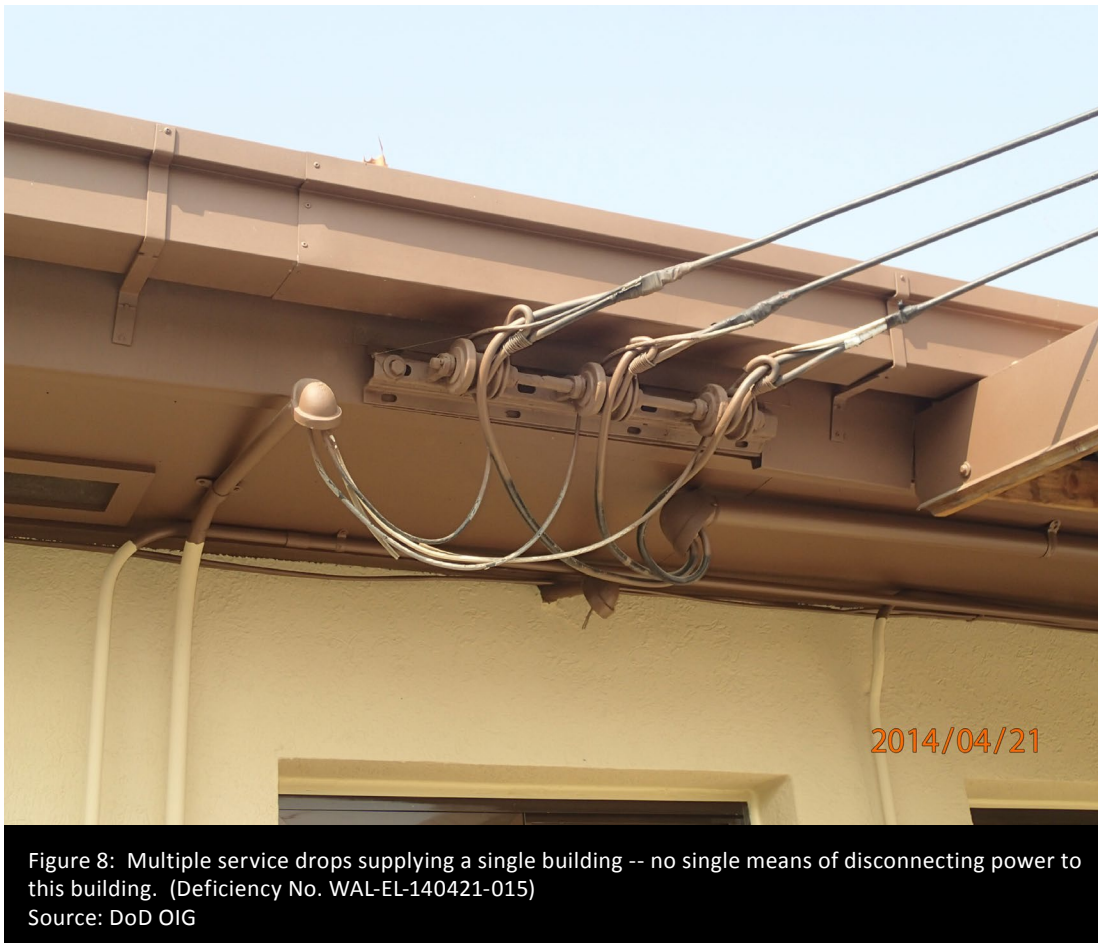
Electrical deficiencies included single buildings being supplied by multiple service drops (see Figure 8) and service drops/power lines that were too low. As at other bases, we found that water circulating pump motors were not grounded in mechanical rooms and several instances where GFCI protection was missing. We found exposed energized wiring due to missing electrical service panel breaker blanks or broken electrical covers, missing exterior light fixture covers, and missing knockout seals and covers in junction boxes. Additionally, we found several grounding issues where the first disconnecting means at the main electrical panel was not bonded. These deficiencies create electrocution hazards for installation personnel.

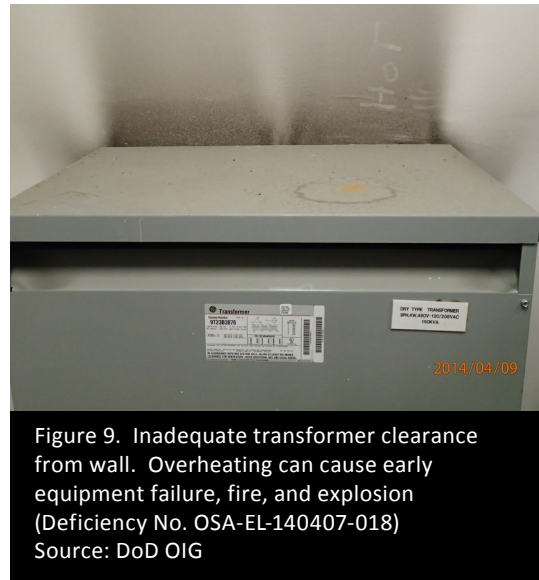
Electrical deficiencies included inadequate vent space for cooling transformers (see Figure 9), and improperly maintained or functioning temperature control equipment in mechanical and electrical rooms. As at other bases, we found broken conduits, receptacles with reversed polarity, and missing covers in junction boxes. We also identified missing GFCI protection in laundry rooms, vending machines, and water coolers. These deficiencies create electrocution hazards for installation personnel.

Figure 9. Inadequate transformer clearance from wall. Overheating can cause early equipment failure, fire, and explosion (Deficiency No. OSA-EL-140407-018)  
Source: DoD OIG

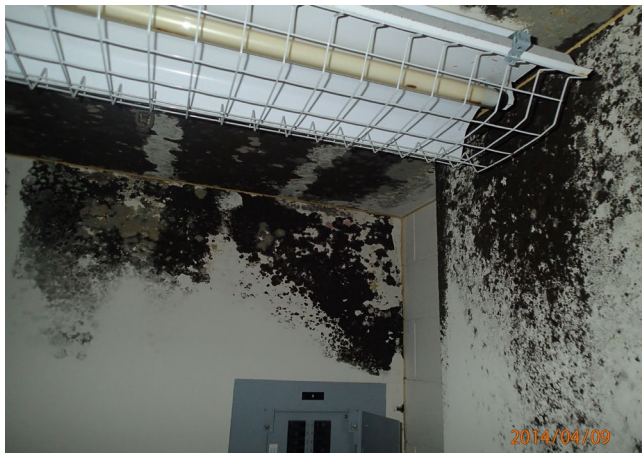
Figure 10. Mold unchecked, unreported, and unmitigated (Deficiency No. OSA-EN-140407-007)  
Source: DoD OIG

evidenced by mold found in several buildings (see Figure 10). In addition, Osan Air Base did not address the radon issue at buildings that exceeded acceptable radon levels and did not develop and implement a radon mitigation program for military housing, despite EPA studies stating that radon is a carcinogen that causes thousands of deaths each year.

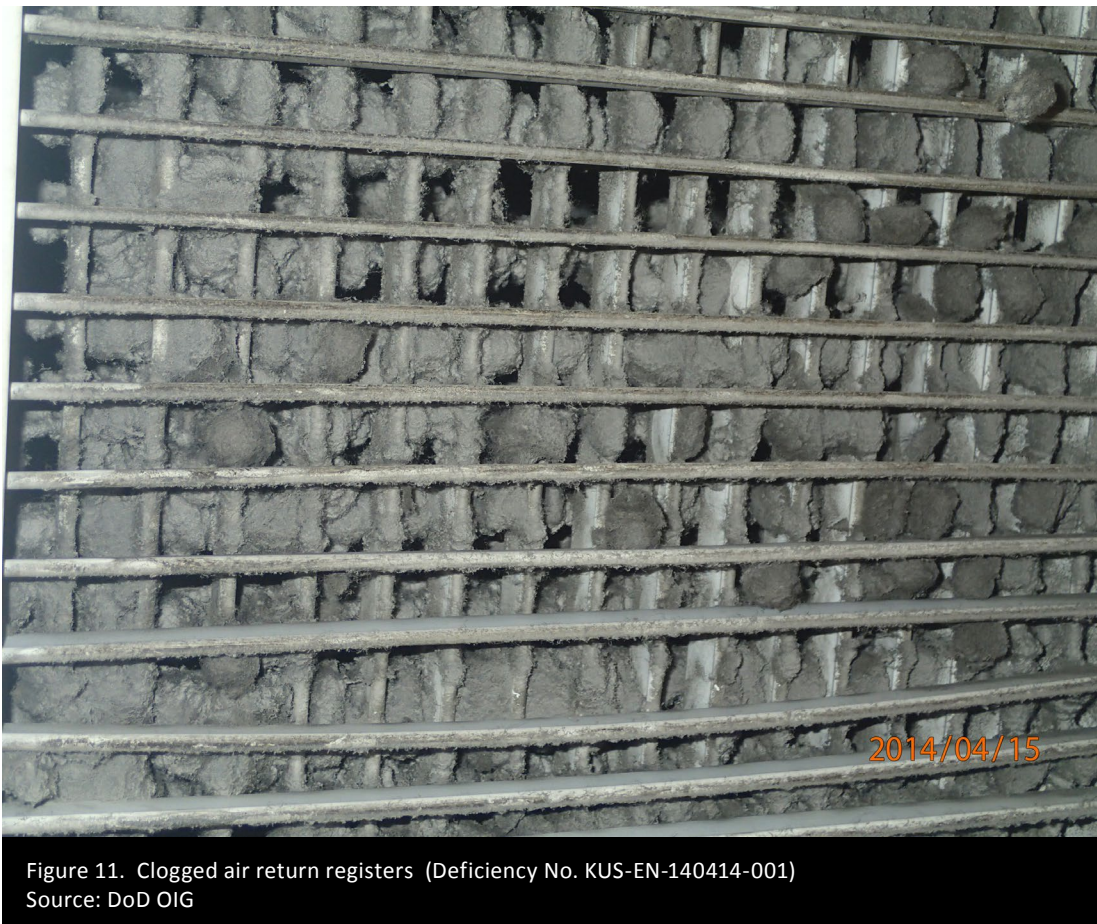
Environmental deficiencies included water damage to ceiling tiles and drywall due to poorly maintained HVAC systems and plumbing pipes. We also found that in some instances, the air handling units were not operating. We noted a lack of communication between unaccompanied housing and the civil engineering component on established roles and responsibilities. For example, there were no agreed-upon procedures for preventive maintenance of the fan coil unit filters and air registers (see Figure 11).

Figure 11. Clogged air return registers (Deficiency No. KUS-EN-140414-001)  
Source: DoD OIG
