## **Demonstration and Validation of a High-Performance Floor-Sealant System to Reduce Concrete Degradation**

Final Report on Project F10-AR02

Under Project F10-AR02, "Application of an Innovative, High Performance Concrete  
Floor Sealant at Hunter Army Airfield, Georgia"

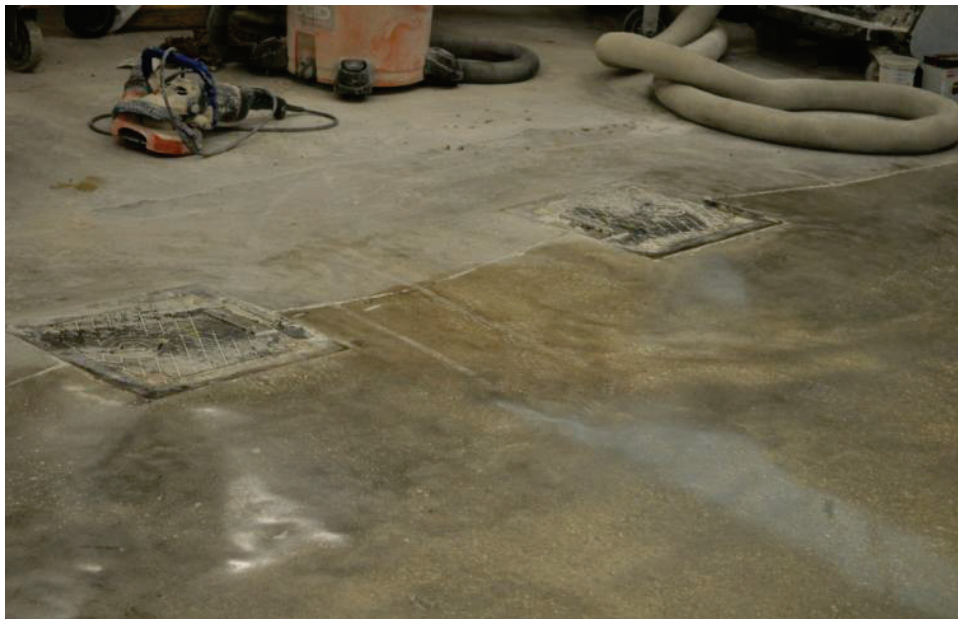
Figure 13. Uneven floor area ground by hand.

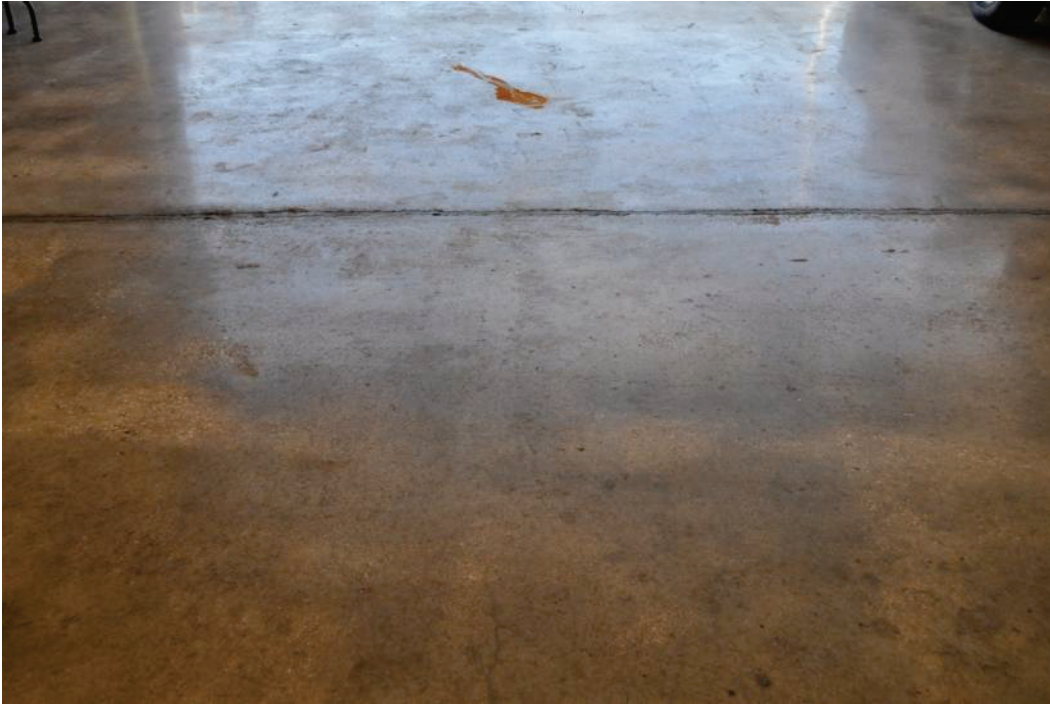
The floors continued to look good overall without much degradation since the previous assessment. Personnel continued to express satisfaction with the ease of cleaning the floors. However, some problems related to the concrete repairs and floor-joint seals in the maintenance bays were still evident. Also, repairs made to floor crack in the hallway continued to deteriorate. A patch applied to repair some spalled concrete on the maintenance bay floor had come off. There was an area of deteriorated floor finish that appears to have been caused by a spill, and minor stains were noted in a few places. The overall floor appearance remained good (Figure 23).

Figure 23. General floor condition at 9 months.

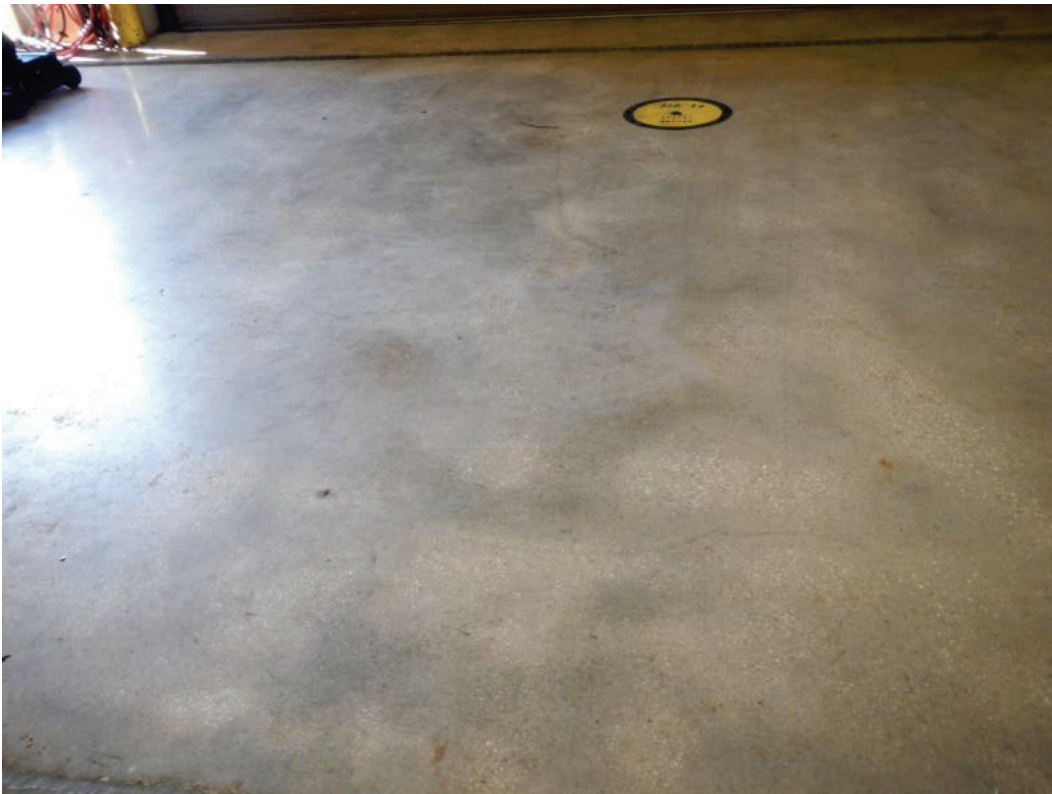
The floors continued to look good overall, with little degradation since the last assessment. Personnel were still satisfied with the ease with which the treated surfaces could be cleaned. At the time of this inspection, the facility was being used heavily and the floors in the maintenance bays were considerably more soiled than in previous evaluations. There were still deficiencies, as previously noted, mostly related to repairs made to the floor and the seals applied to the construction joints between floor slabs in the maintenance bays. In heavy-use areas, the floor was stained from spills of petroleum products. The floor crack repairs in the hallway continued to deteriorate (Figure 24), and this is considered by the building users to be the biggest issue with the demonstration project results. Although the floor in the vehicle maintenance bays were in use and had not been cleaned recently, the Hunter personnel stated that they cleaned up fairly well with pressure washing and buffing. At 1 year after installation, the floor appearance continued to remain good, overall. The sealant system has not chipped or scratched as the standard paint treatment does. It remains easy to clean, and it is reported to be less slippery than a painted floor (Figure 25).

Figure 25. Bay 4 floor surface area after 1 year of service.

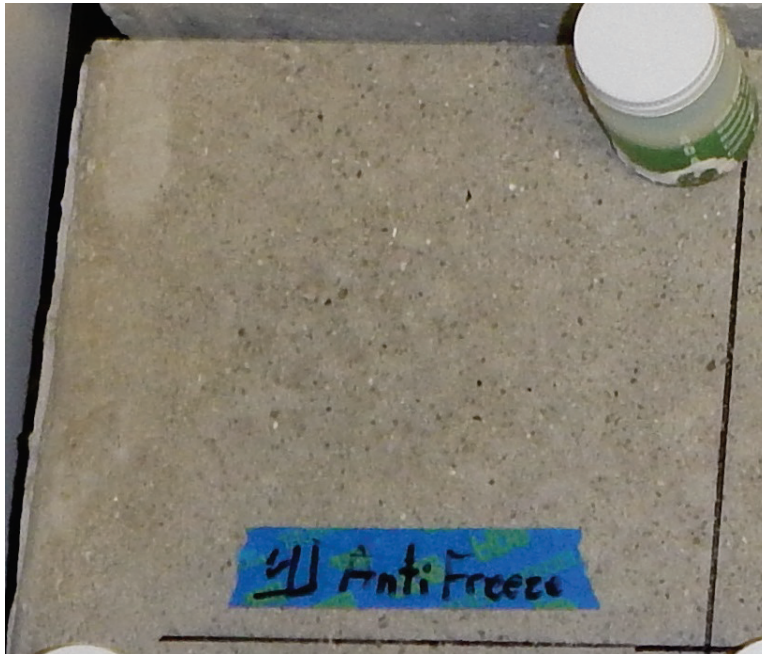
Figure D18. Test 4-A-A-52624 Type 1 recycled antifreeze.

The A-A-52624 Type 1 Recycled Antifreeze had no effect on the concrete or sealant system. All the other test chemicals penetrated the sealant system and were absorbed by the concrete coupons to differing degrees, leaving permanent stains.
