U.S. Air Force Airfield Damage Repair (ADR) Modernization Program

Large Crater Repair at Silver Flag Exercise Site, Tyndall Air Force Base, Florida

August 2015

Final report

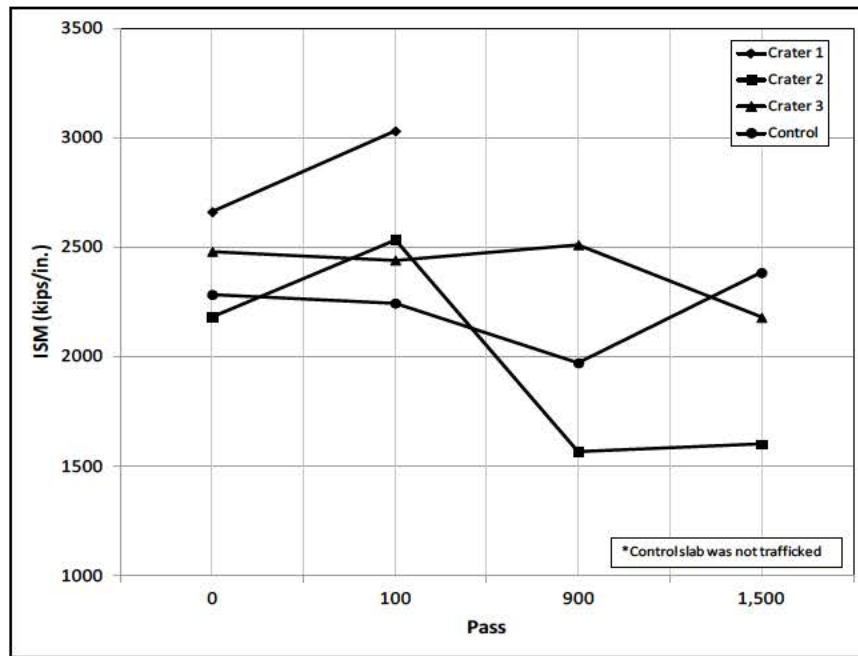
The ISM data from the HWD is plotted for each crater at each pass level in Figure 53. The ISMs before trafficking are considerably lower than those reported by Edwards et al. (2013) and Bell et al. (2013). Typically the ISMs for the rapid-setting concrete are between 3,500 and 4,500 kips/in. However, the measured ISMs collected at the 0 pass level ranged between 2,181 and 2,661 kips/in. The HWD data contradicts the compressive strength data discussed in Section 5.4.4, which showed that each quadrant of each crater repair exceeded the required 28-day compressive strength. For Crater 1, data was collected only at 0 and 100 passes, and the ISM increased slightly between those two intervals. Crater 2 showed a slight increase between 0 and 100 passes and then a considerable drop at 900 and 1,500 passes, as the crater repair began to fail under traffic. The ISM for Crater 3 generally remained the same until dropping moderately at 1,500 passes. The control test point showed that the PCC slab stiffness generally remained consistent. Overall, the stiffness of the repairs was generally as high or higher than the control slab, until accumulating damage from traffic.

Figure 53. HWD data of large crater repairs.

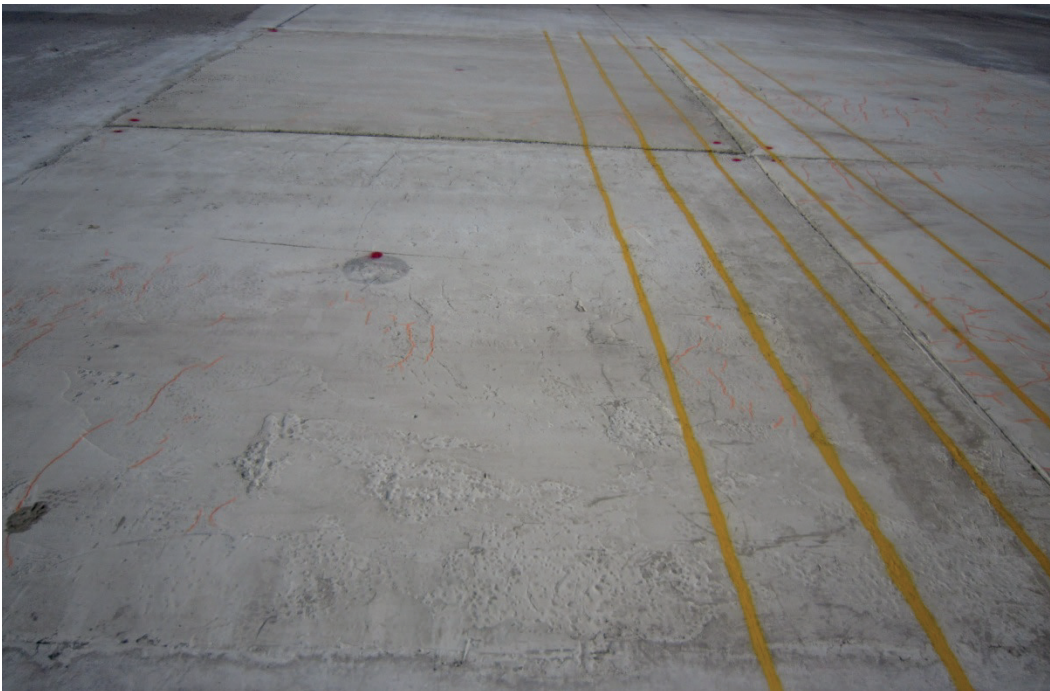
Figure 56 shows the west quadrants of Crater 2 after repair. Some shrinkage cracks (highlighted in orange) and small surface defects were noted. Figure 57 shows the east quadrants of Crater 2. Both quadrants exhibited shrinkage cracking, and the northeast quadrant contained considerably more than the southeast quadrant. Overall, the finish of Crater 2 was much smoother than Crater 1.

Figure 56. Crater 2, west quadrants, finished repair.

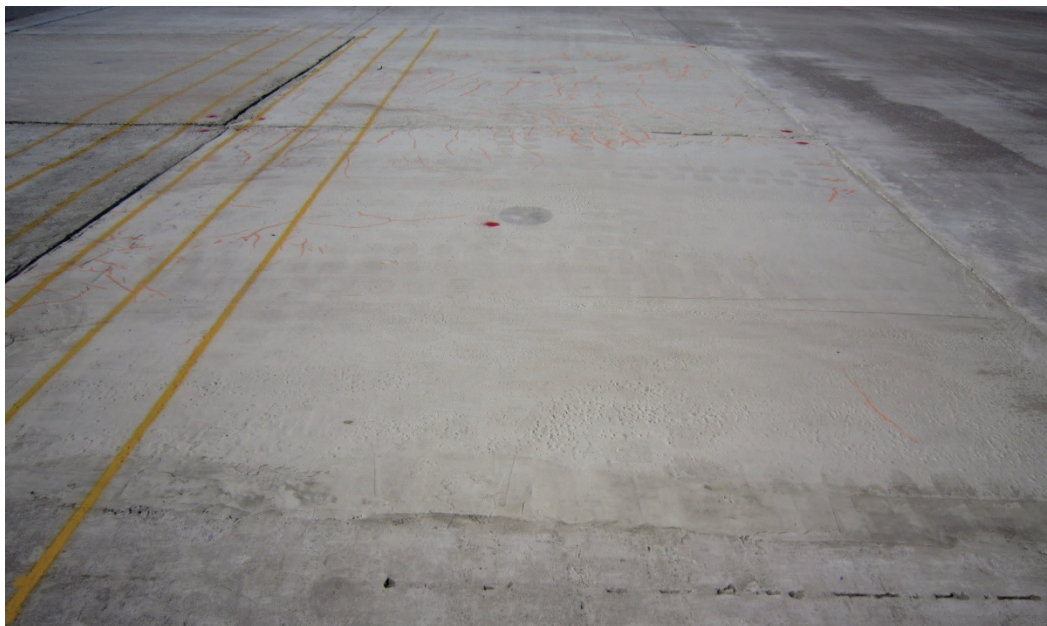
Figure 57. Crater 2, east quadrants, finished repair.

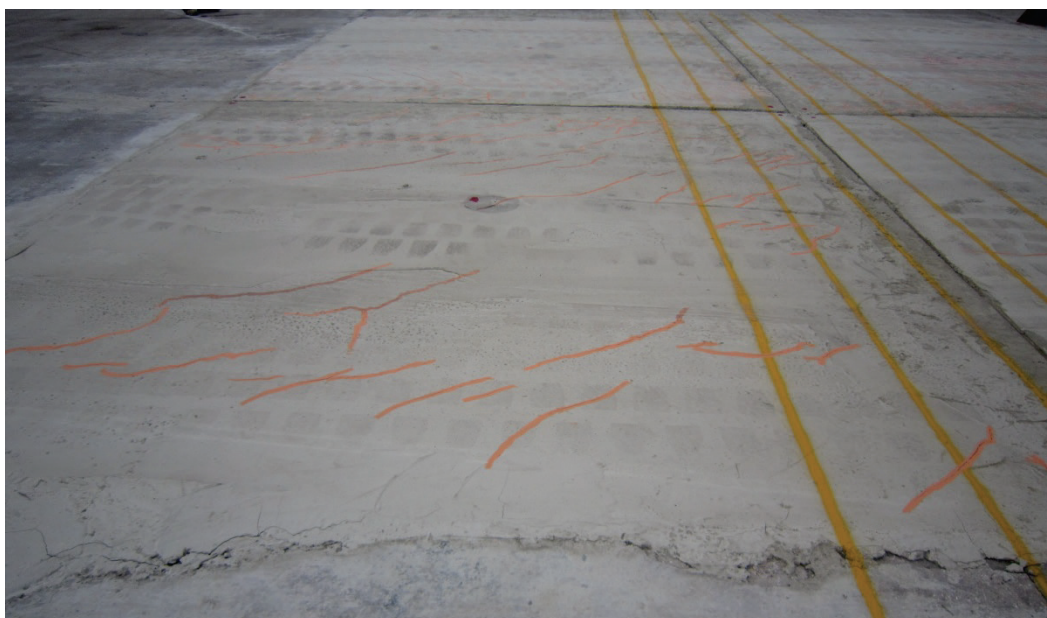
Figure 58 displays the west quadrants of Crater 3, and Figure 59 shows the east quadrants. Both western quadrants contained a considerable amount of shrinkage cracking. Also, the south edge of the southwest quadrant was not square due to damage sustained to that edge during excavation. The eastern quadrants both contained a substantial amount of shrinkage cracking. Figure 60 shows the large amount of shrinkage cracks in the northeastern quadrant.

Figure 58. Crater 3, west quadrants, finished repair.

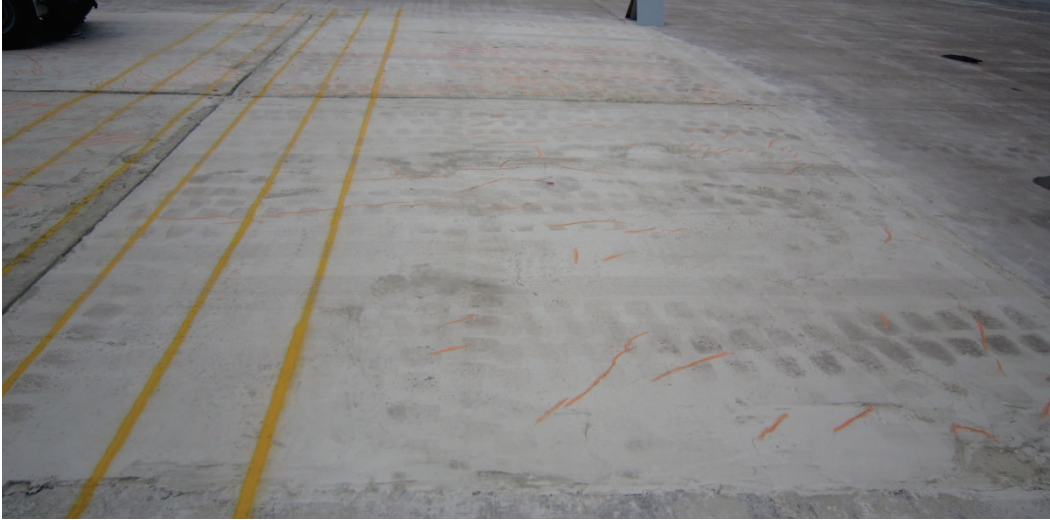
Figure 59. Crater 3, east quadrants, finished repair.

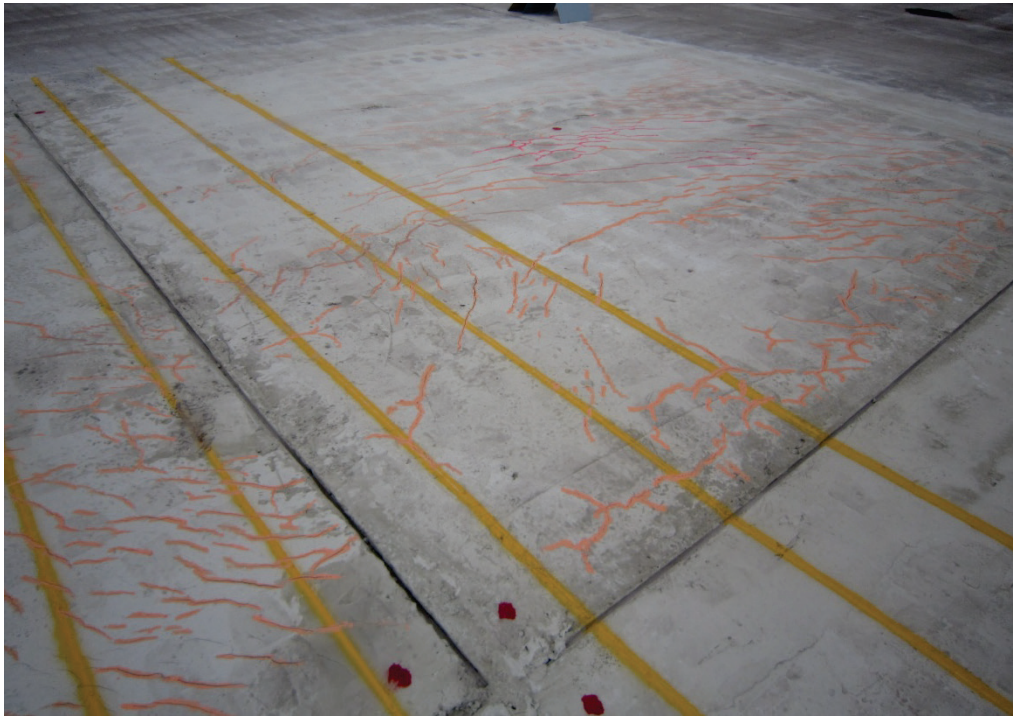
Figure 60. Crater 3, northeast quadrant, finished repair.

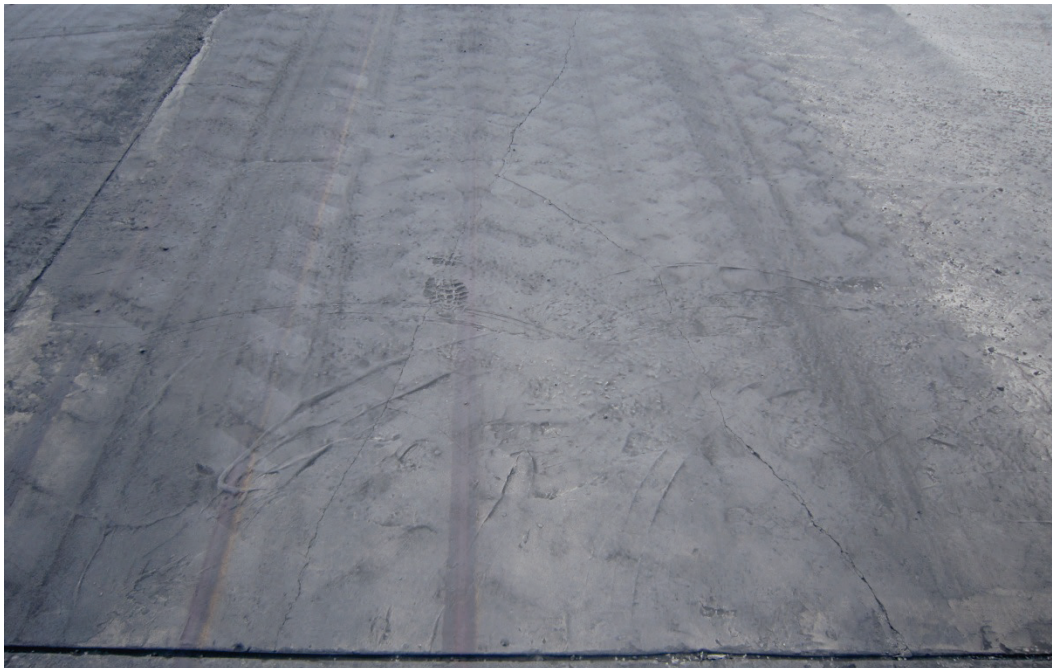
Figure 63. Crater 1, 400 passes, shattered slab in southwest quadrant.

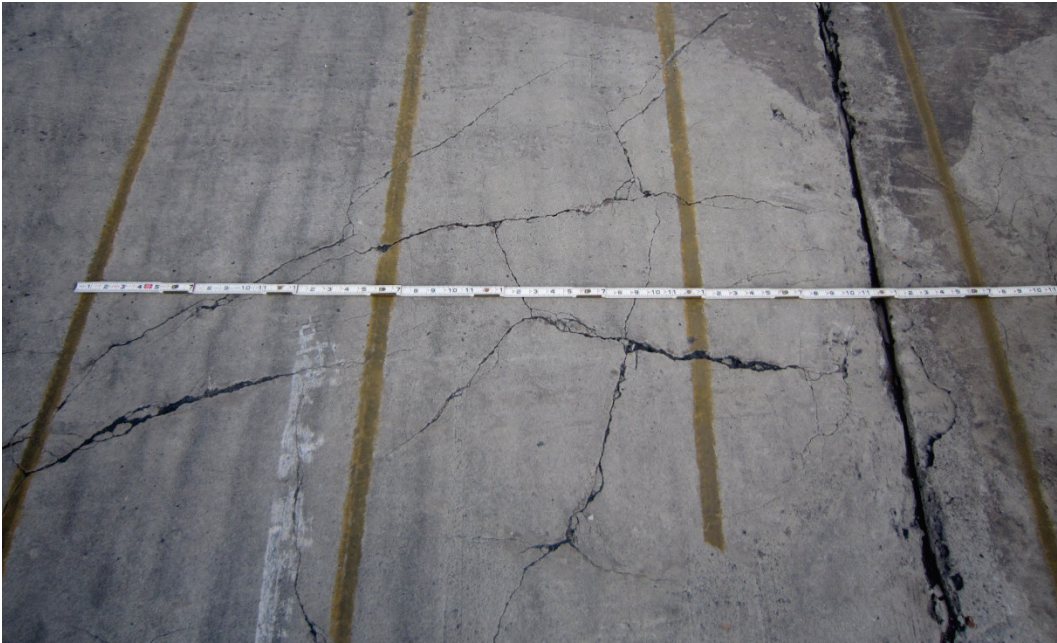
After 100 passes were applied to Crater 2, no new distresses were observed. At 200 passes, small, low-severity longitudinal cracking ($< 1/8$ in. wide) was apparent, and these cracks grew to medium-severity ($1/8$ in. to 1 in. wide) after 400 passes. At 900 passes, more of the medium-severity cracks began to connect, particularly on the southeast quadrant near the intersection of the four quadrants as shown in Figure 64. In addition, some delamination of a $1/2$ -in. layer in the traffic lane produced FOD potential as shown in Figure 65.

Figure 64. Crater 2, 900 passes, medium-severity cracking.

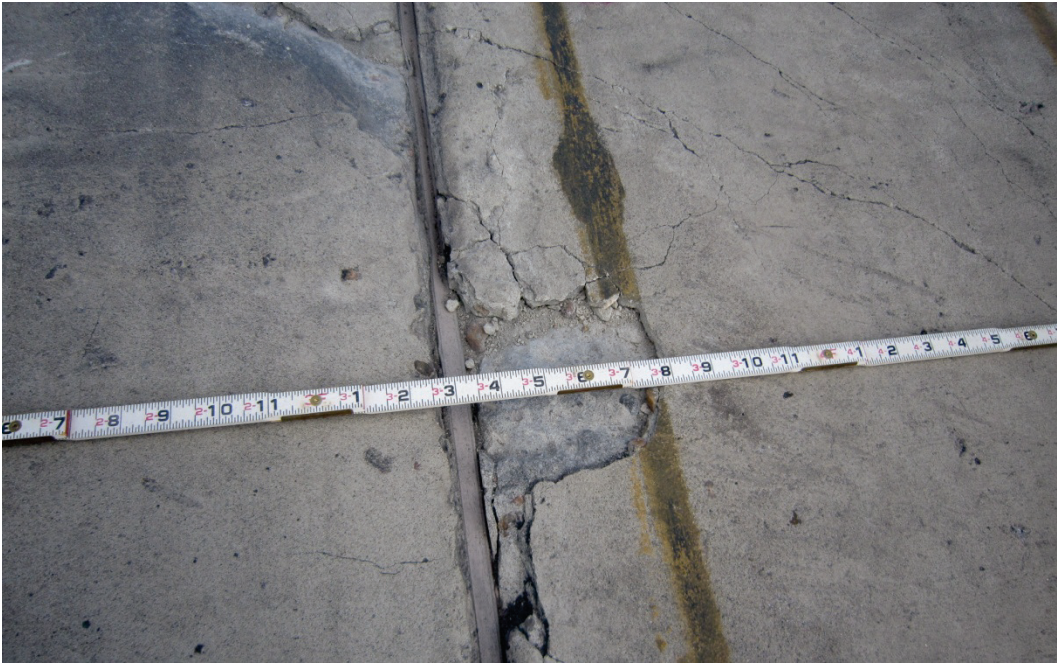
Figure 65. Crater 2, 900 passes, high-severity joint spall.

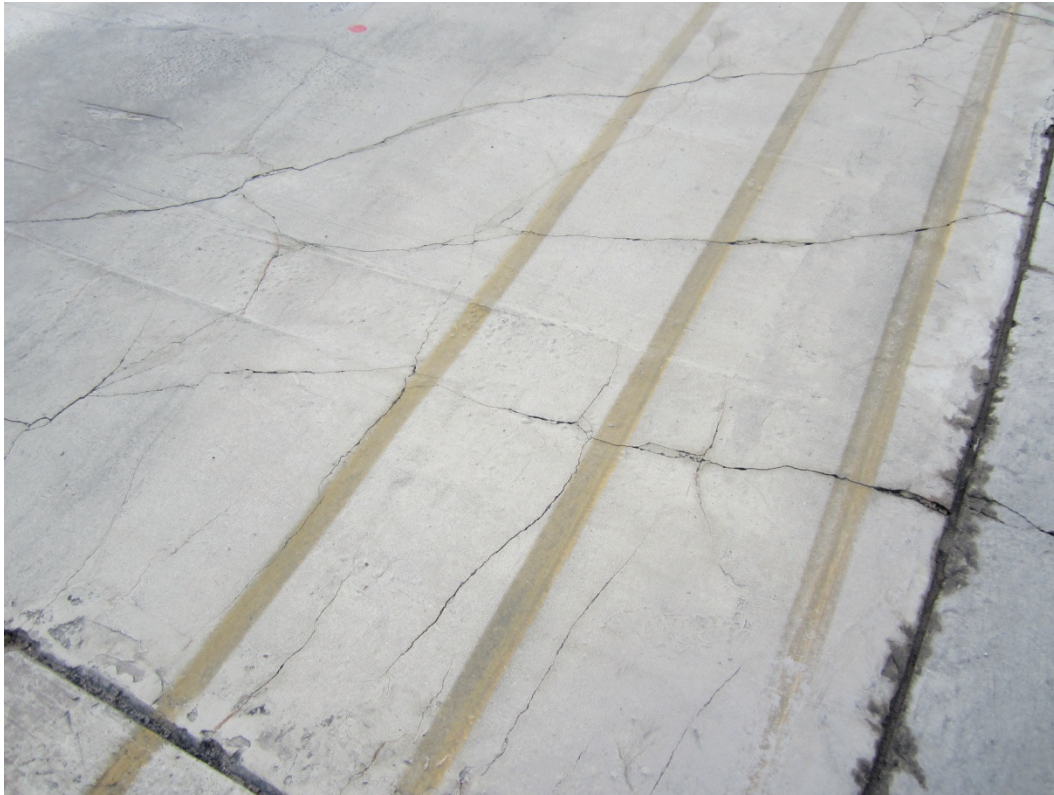
Figure 66. Crater 2, 1,500 passes, medium-severity longitudinal cracking.

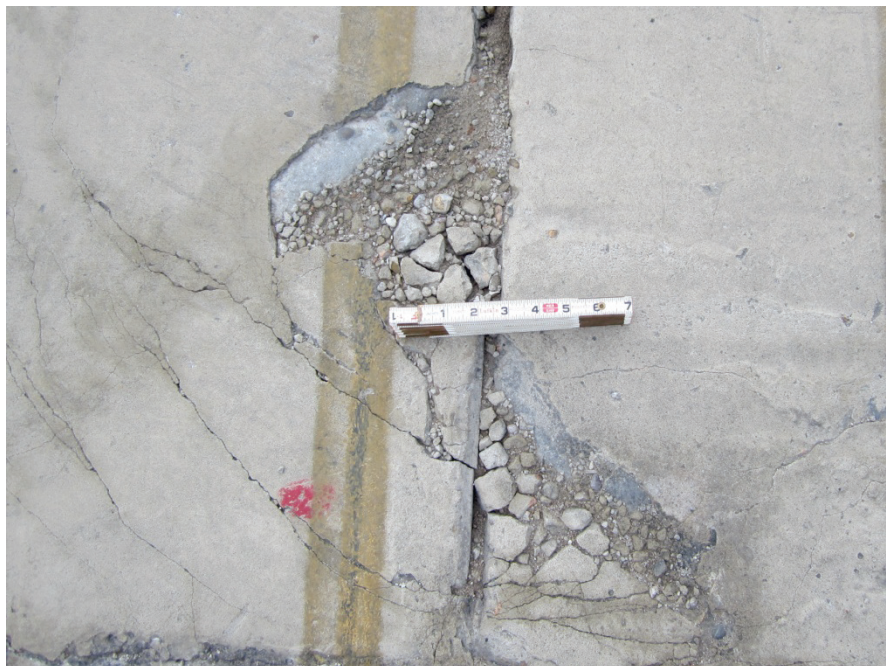
Figure 67. Crater 2, 1,500 passes, high-severity joint spall.

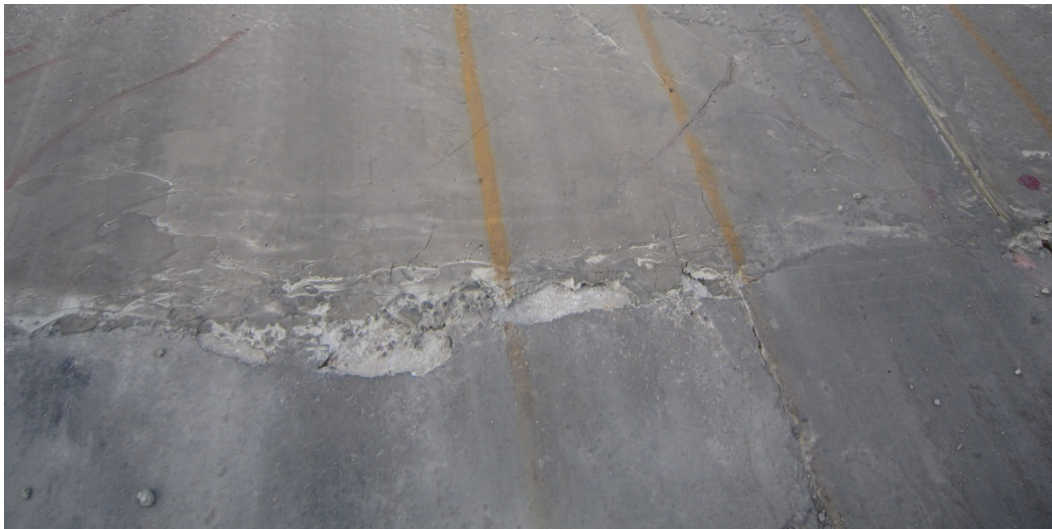
For Crater 3, the only new distress observed at 100 passes was some spalling along the joint that was perpendicular to traffic in the southwest quadrant as shown in Figure 68. The spalling was likely caused by a small amount of concrete that was placed to fill the void created during excavation, as discussed in Section 5.4.6. After 900 passes, a low-severity corner break and low-severity longitudinal cracking were noted. The spall shown in Figure 68 continued to produce FOD, but the joint was kept clean during trafficking. Trafficking continued, since this was not considered a structural failure and could be sustained by normal sweeping of the runway surface.

Figure 68. Crater 3, 100 passes, medium-severity joint spall.

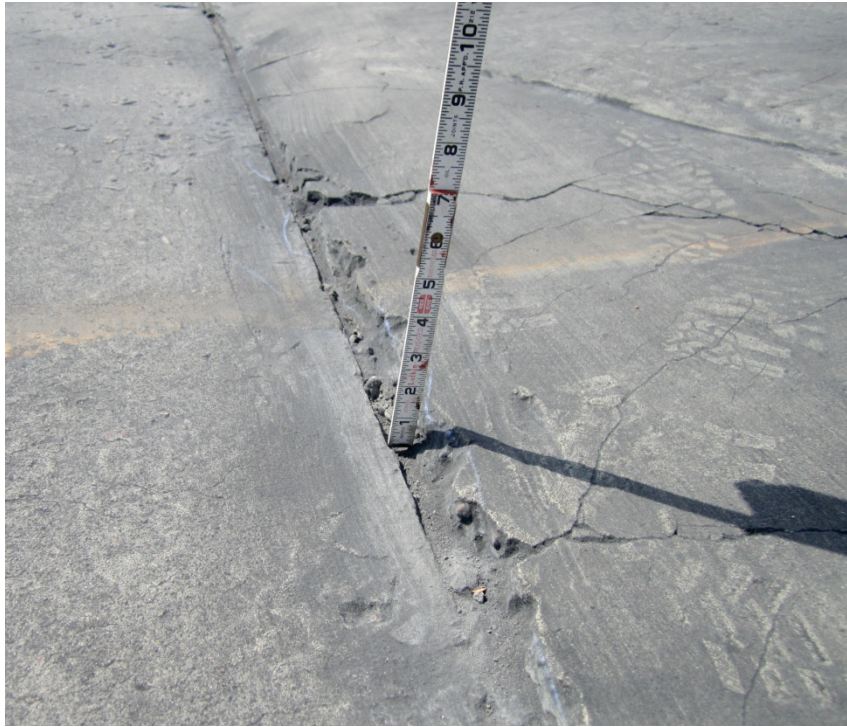
After 1,500 passes, several distresses were observed. Two medium-severity corner breaks were noted near the point where the four quadrants intersect. The joint spall previously mentioned continued to produce a large amount of FOD, and a deep joint spall was observed in the northwest quadrant as shown in Figure 69. Due to signs of structural failure and possible tire hazards, Crater 3 was considered failed at 1,500 passes and trafficking ceased.

Figure 69. Crater 3, 1,500 passes, high-severity joint spall.
