*Airfield Damage Repair Modernization Program*

## **AM2 Mat End Connector Modeling and Performance Validation**

August 2015

Final report

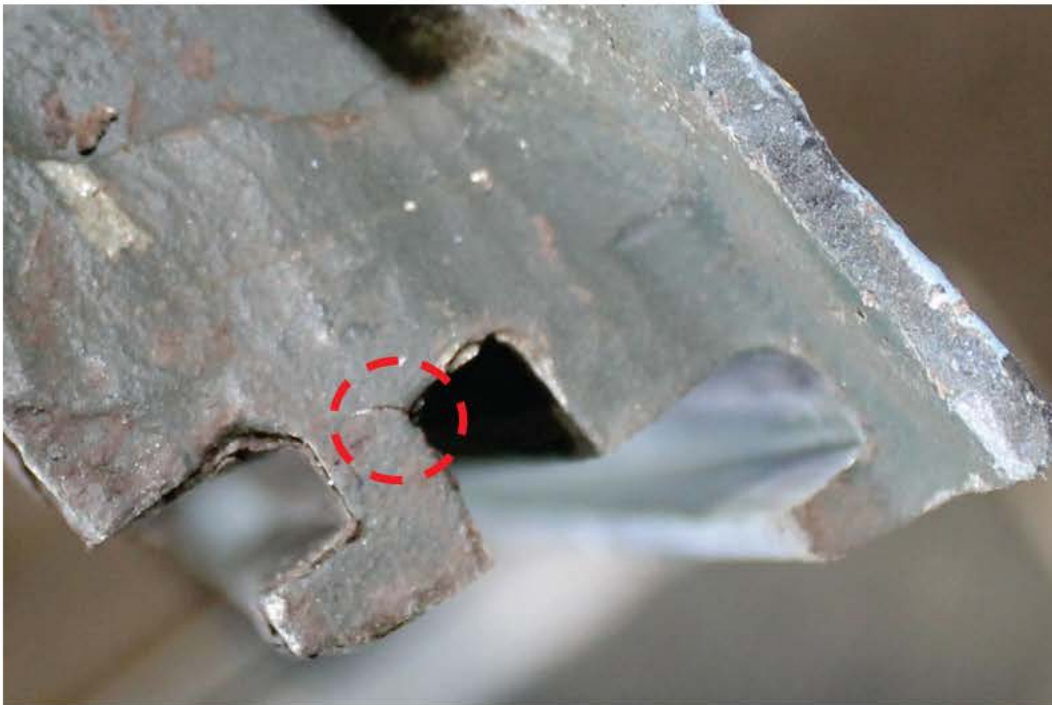
Figure 3. Crack initiation at lower overlap rail.

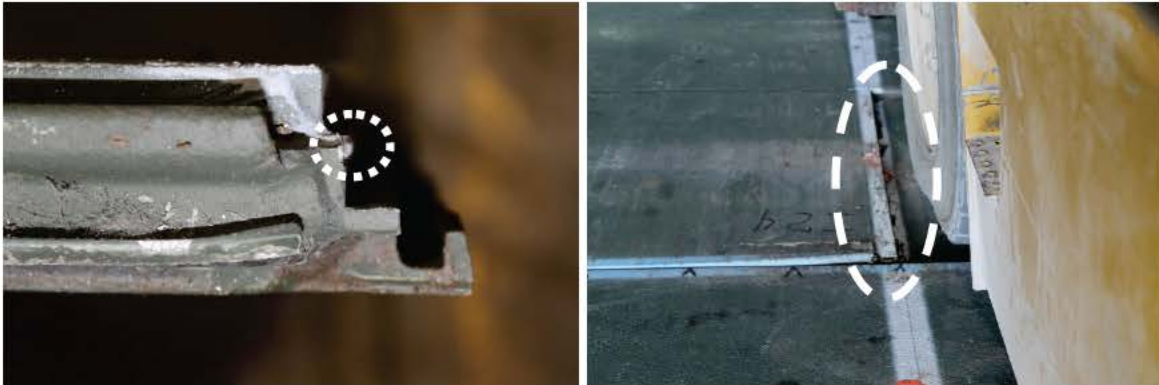
The most common mat breakage was broken upper underlap rails (Figure 27). When a rail failure occurred, separation was noted at the adjoining panels as the load cart passed over the joint. Upper underlap rail failure was confirmed when a crack could be seen at the rail from the

surface. Lower overlap rail failure was also documented. Since the lower overlap rail was not visible from the surface, breakage at this location was confirmed when (1) separation was observed at a joint but the upper underlap rail was noticeably intact or (2) mat panels were removed from the subgrade surface.

Figure 27. Broken upper underlap rail I-79 (left) and I-25 (right).

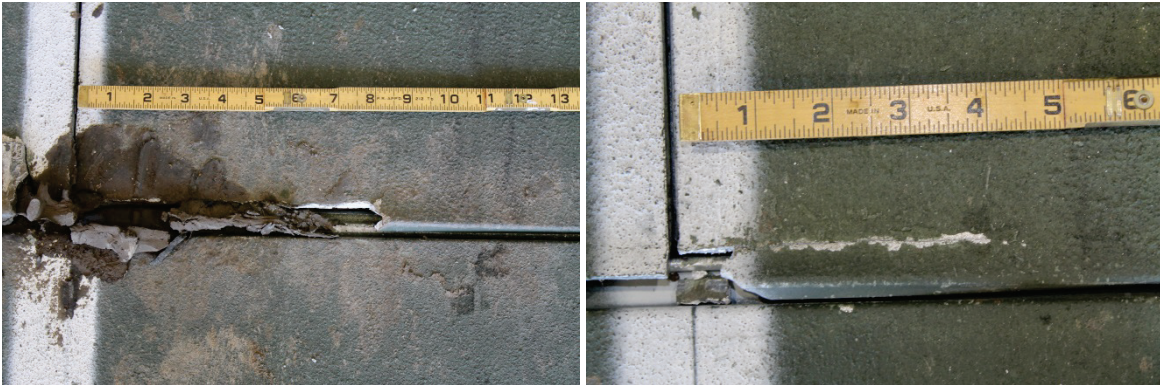
Top skin tears occurred in some panels with their end connector in the traffic area. A top skin tear typically began at (or near) the south edge of the end connector weld and propagated along the top flange of the female hinge. Examples are shown in Figure 28. In two panels, a crack developed along the weld and extended about 2 in. before continuing its propagation parallel to the female hinge. An example is shown in Figure 29 for Panel I-6. Top skin corner curls were also very common. These occurred at the south corner of panels with their end connector along the centerline. They usually occurred before top skin tearing was noted. If a top skin tear reached a point where it was posing a risk to the load cart tire, the loose skin was removed for maintenance. Skin tears greater than 10 in. were difficult to maintain, and traffic had to be stopped frequently for maintenance. Therefore, if the length of a top skin tear reached more than 10 in., the panel was considered failed. Corner curls that also posed a risk to the tire were hammered down. Panels I-69 and I-51 both failed because the end connector along the centerline detached (Figure 30). From the surface, this was obvious from cracking observed along the length of the weld. Panel I-11 failed as a result of skin tearing at the center, near the female hinge. This likely occurred adjacent to one of the core vertical stiffeners (Figure 31).

Figure 28. Top skin tear at I-7 (left) and I-34 (right).

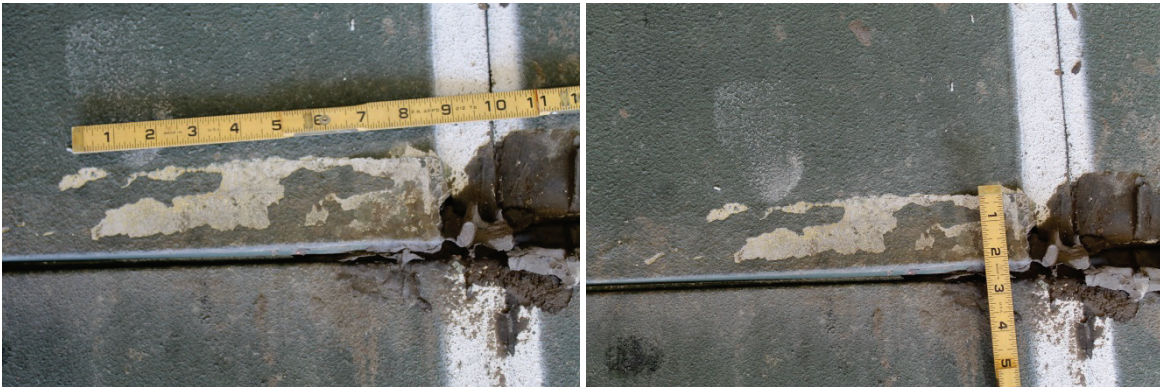
I-11	Crack along face of female hinge, 50 in. long. Crack on bottom skin, 40 in. long, 2.5 in. from edge of bottom flange of female hinge.	-	-	
	I-6	Crack at end connector weld from top surface to bottom surface that extended 3 in. on bottom skin	-	-	
	I-2	Crack along male hinge, 9 in. long	-	-

Figure 29. Top skin tear at I-6.

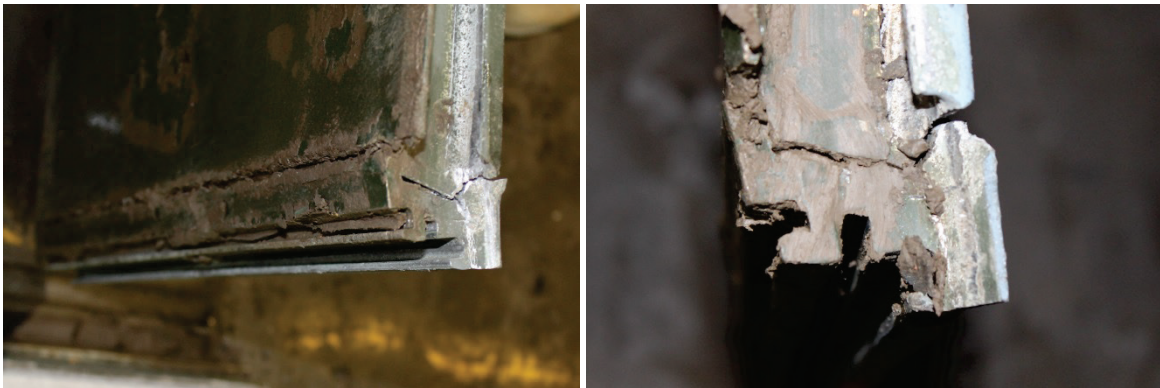
Figure 30. Detached end connector at I-51 (left) and I-69 (right).

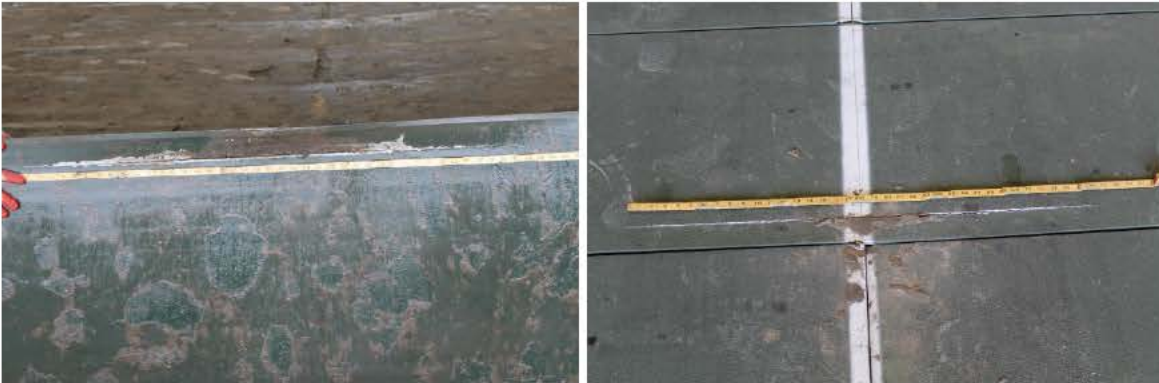
Figure 31. Crack on bottom (left) and top (right) surface of I-11.

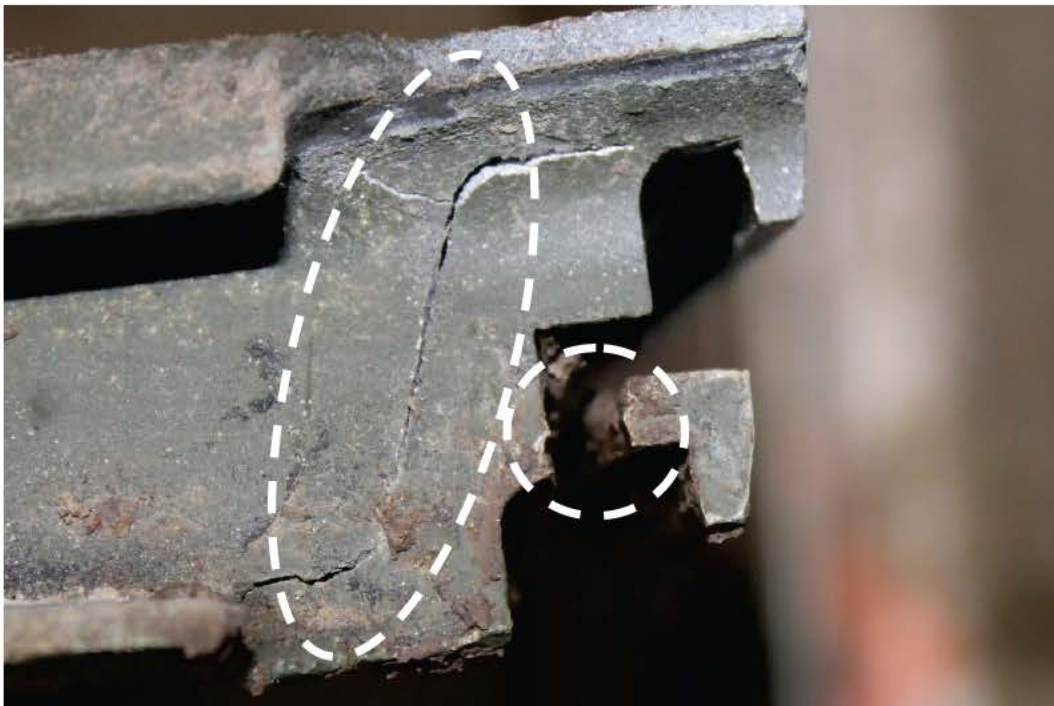
Figure 32. Crack at weld and broken lower overlap rail at I-42.

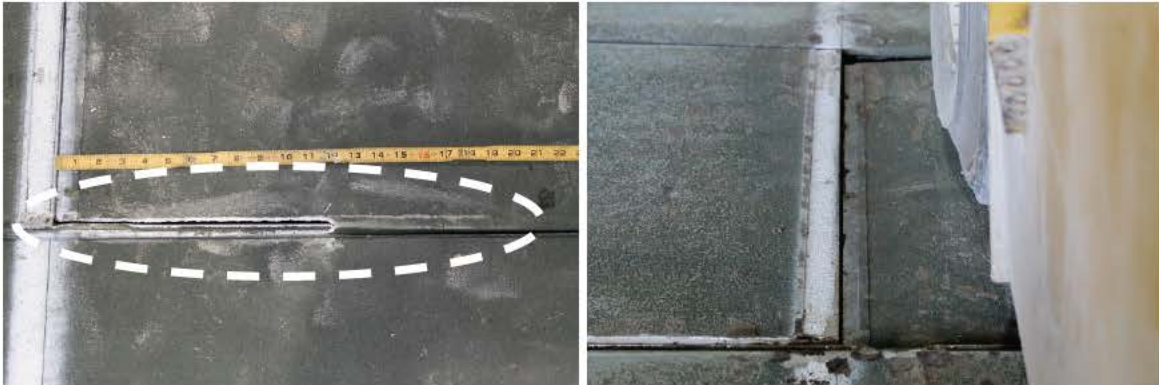
Figure 33. Skin tear and upper underlap rail failure at I-18.

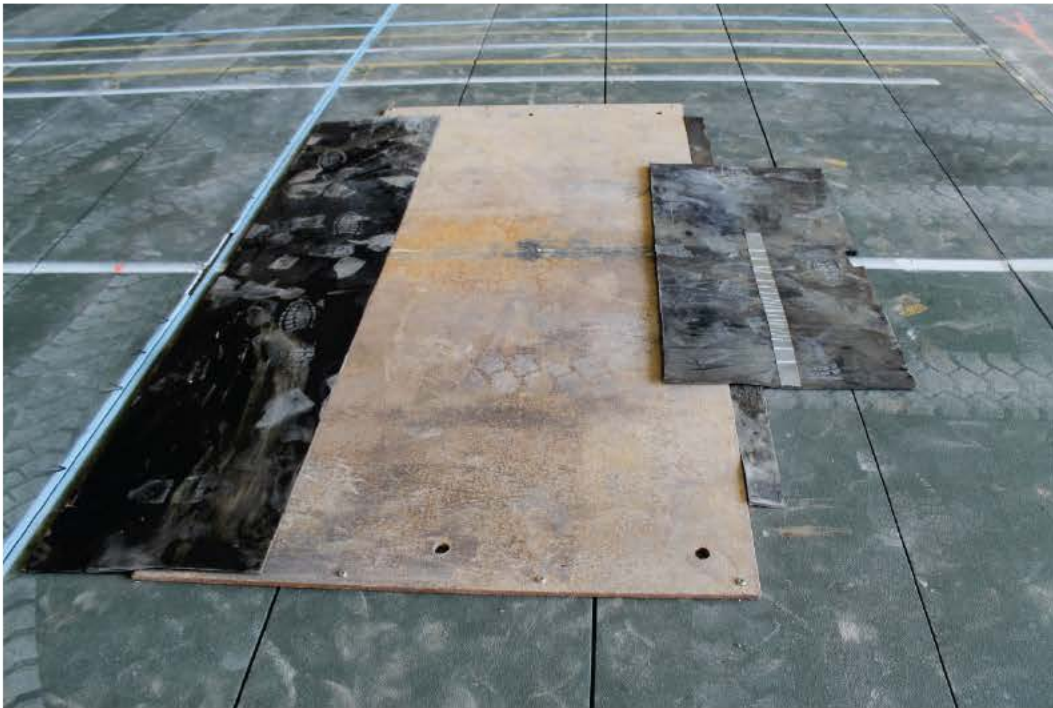
Figure 34. Metal plate placed above I-17 and I-18.

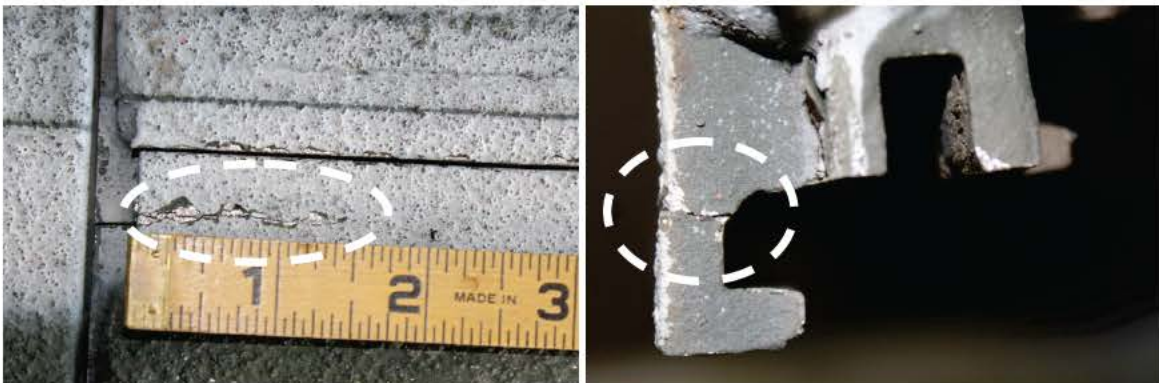
Figure 35. Crack at upper overlap rail of I-62 (left) and I-89 (right).

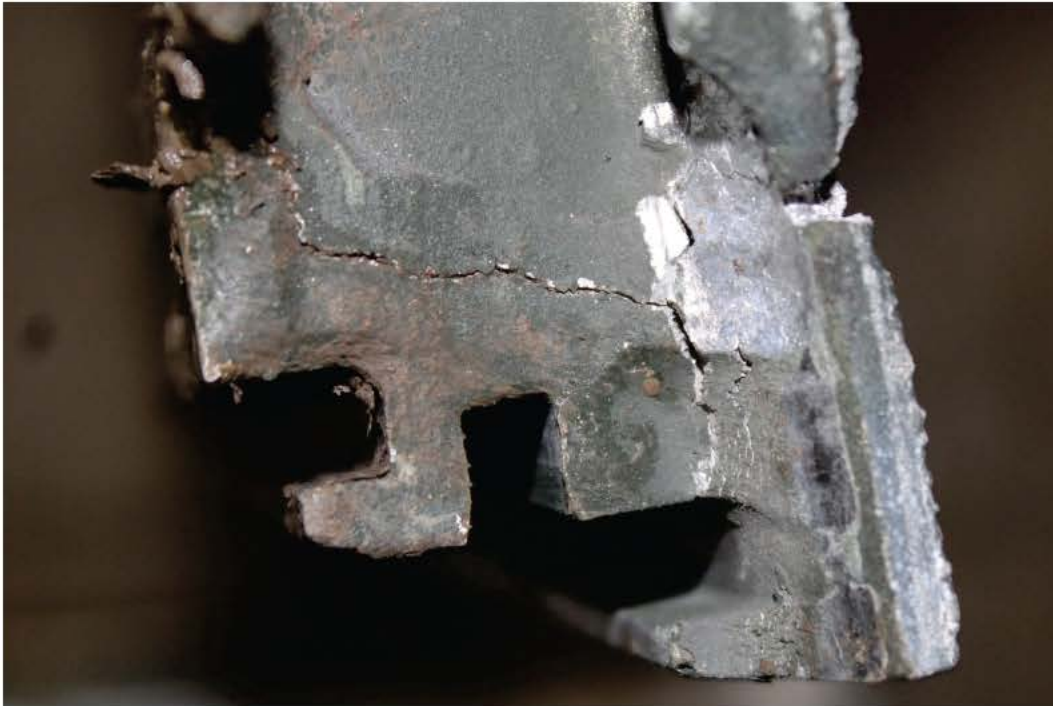
Figure 36. Crack at weld of I-62.

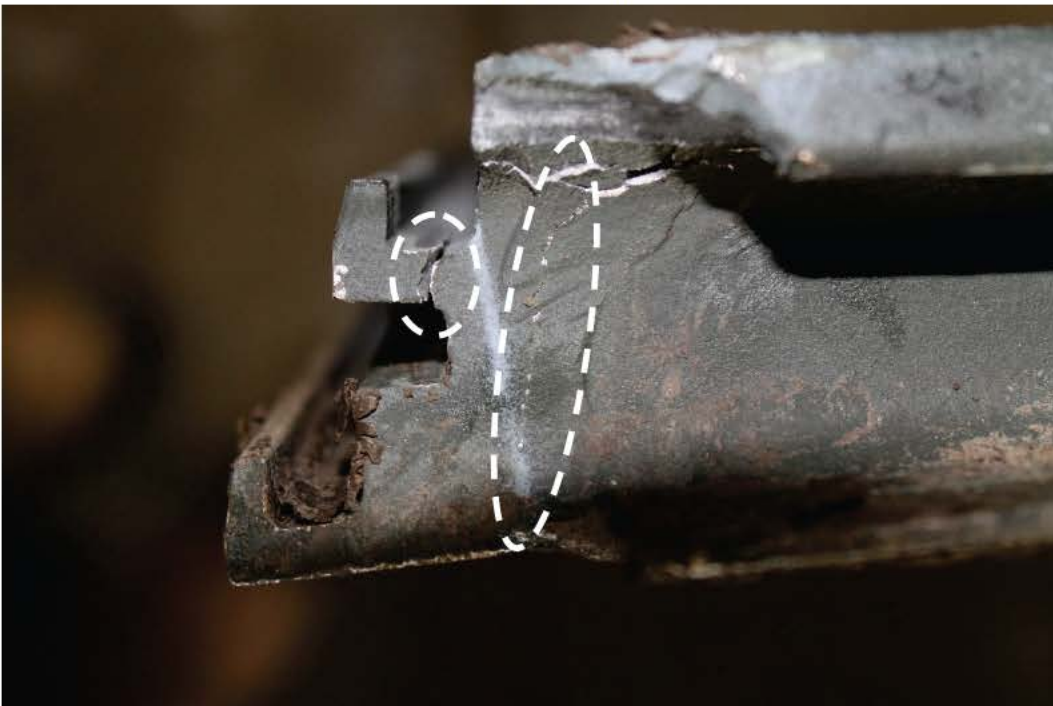
I-58	Crack along face of female hinge, 15.5 in. long	-	-	
	I-54	Upper underlap rail broke length of 3 in., starting at female hinge. Hairline crack at weld.	-	-	
	I-53	Minor cracking at top of weld of end connector	-	-	
	I-44	Crack at weld of end connector from top surface to bottom surface that extended 1.75 in. on bottom skin	-	-

Figure 37. Cracked upper underlap rail and hairline crack at weld of I-54.
