Airfield Damage Repair Modernization Program

AM2 Brickwork Pattern Evaluation with Refurbished Matting

Lyan Garcia, Timothy W. Rushing, and Jeb S. Tingle

August 2015

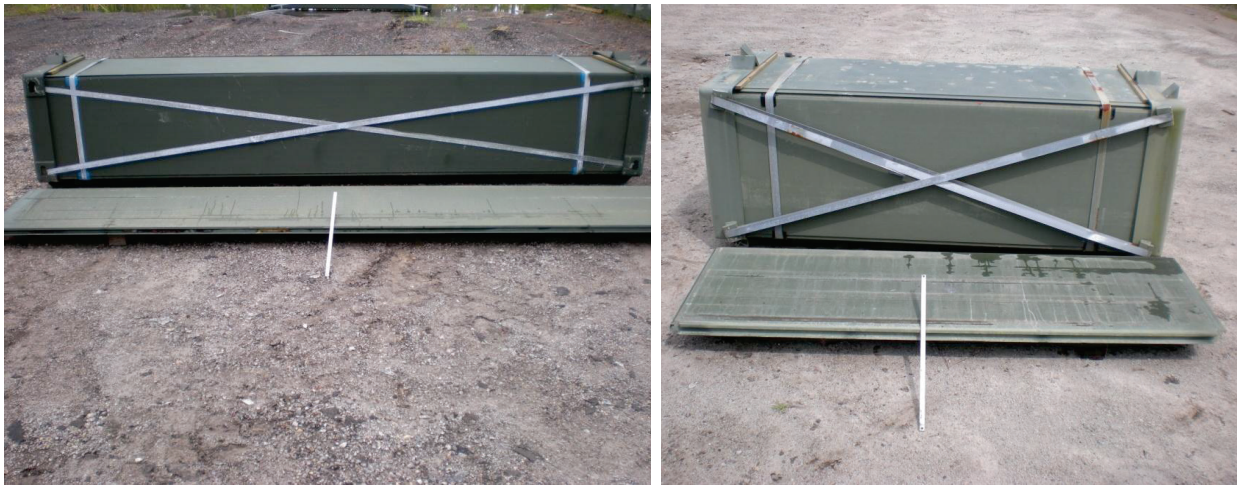
Figure 2. Damage noted on refurbished AM2 panel before applying traffic.

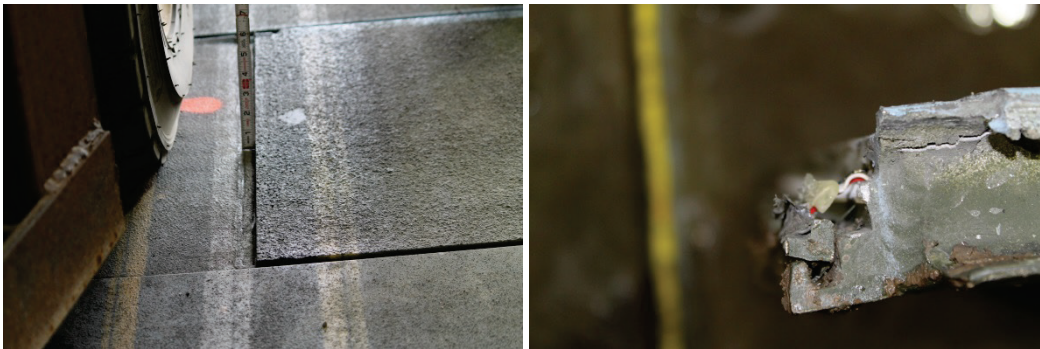
Figure 42. Broken upper under lap rail in Panel B40-1.

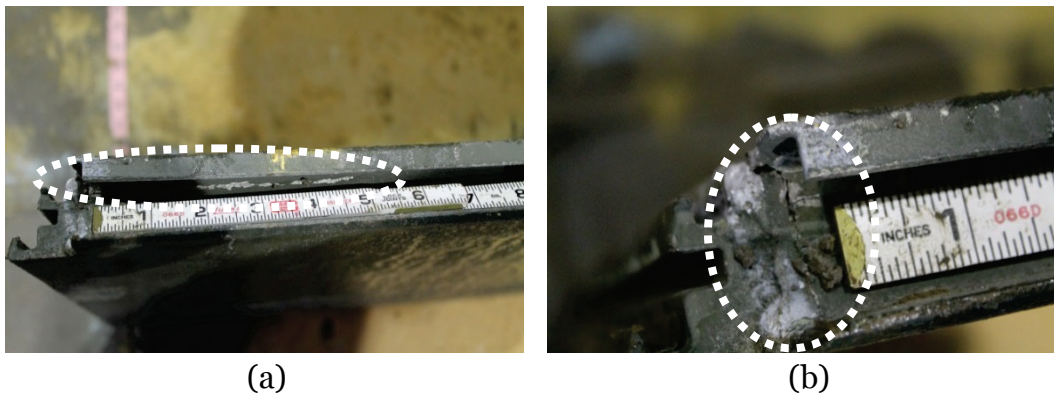
Figure 43. Damage noted in Panel 25 after picking up mats.

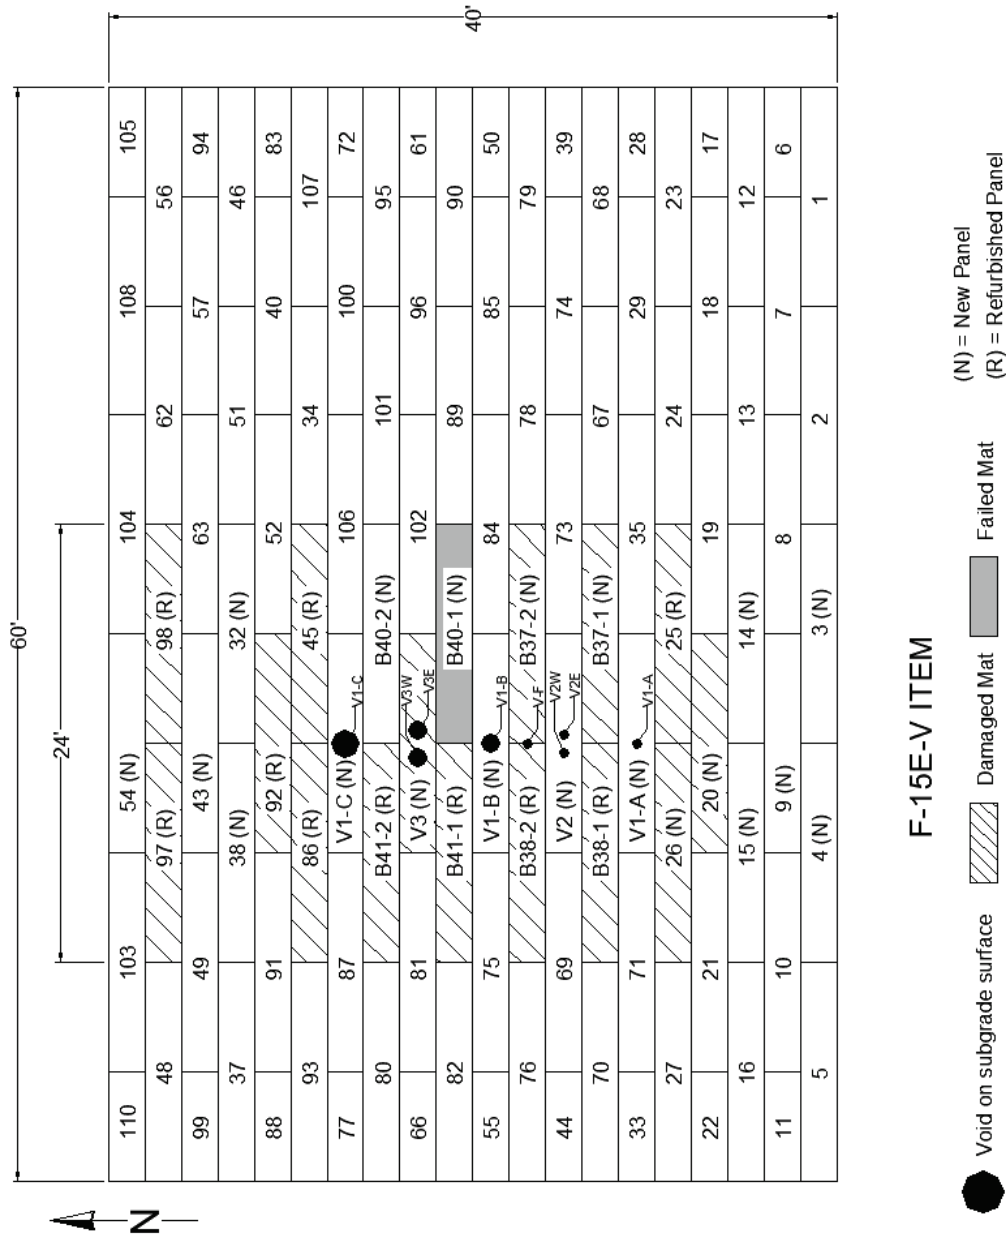
Figure 44. Layout of damaged and failed panels in the F-15E-V item.

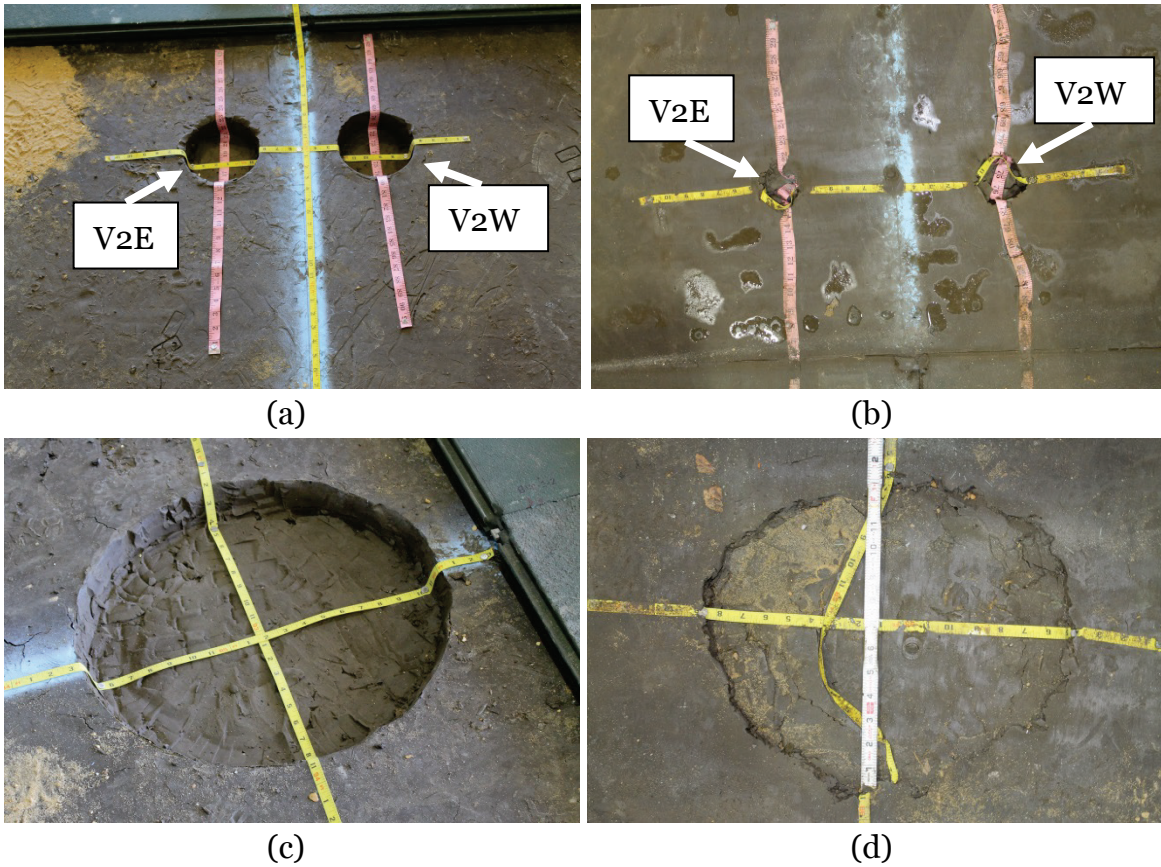
Figure 51. V2W, V2E (a) pretest and (b) posttest and V1-C (c) pretest and (d) posttest.

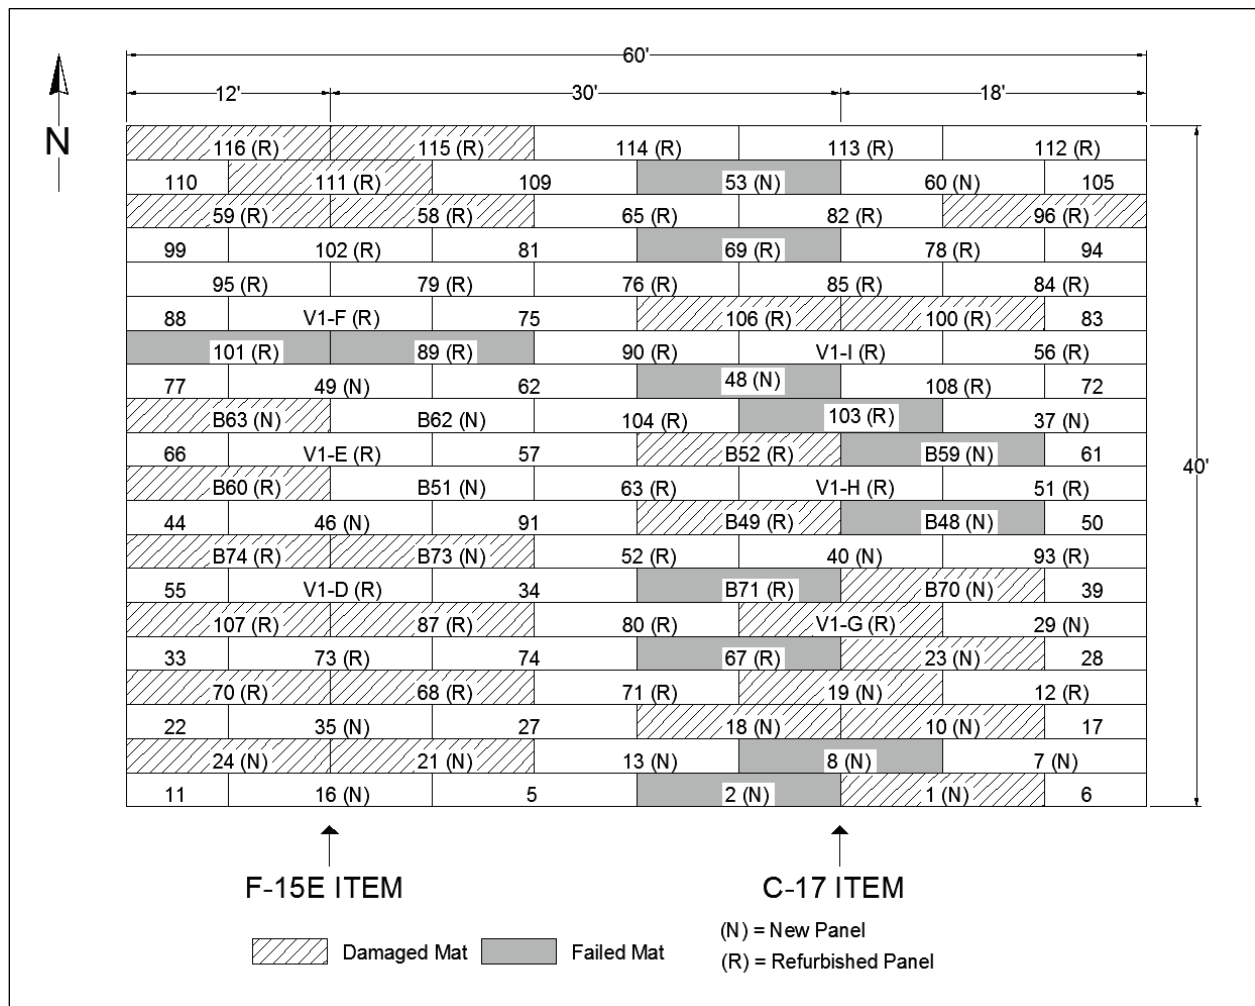
Figure 64. Layout of failed and damaged panels in F-15E and C-17 items.

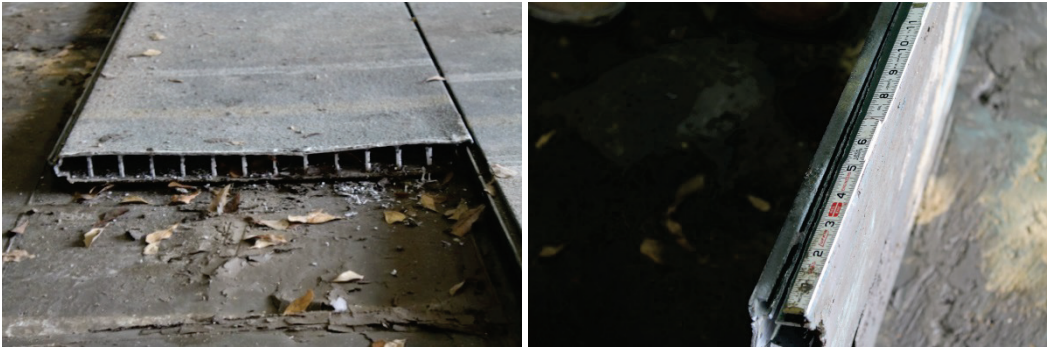
Figure 65. Panel 89 after 430 passes.

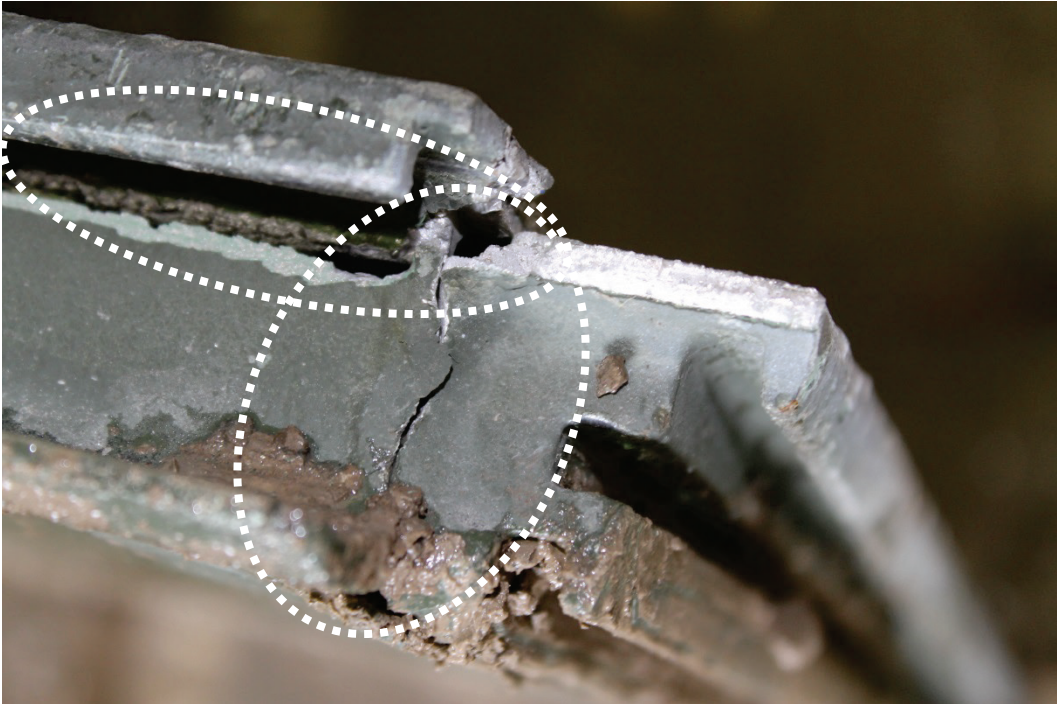
Figure 66. Damage noted in Panel 101 after removing from test section.

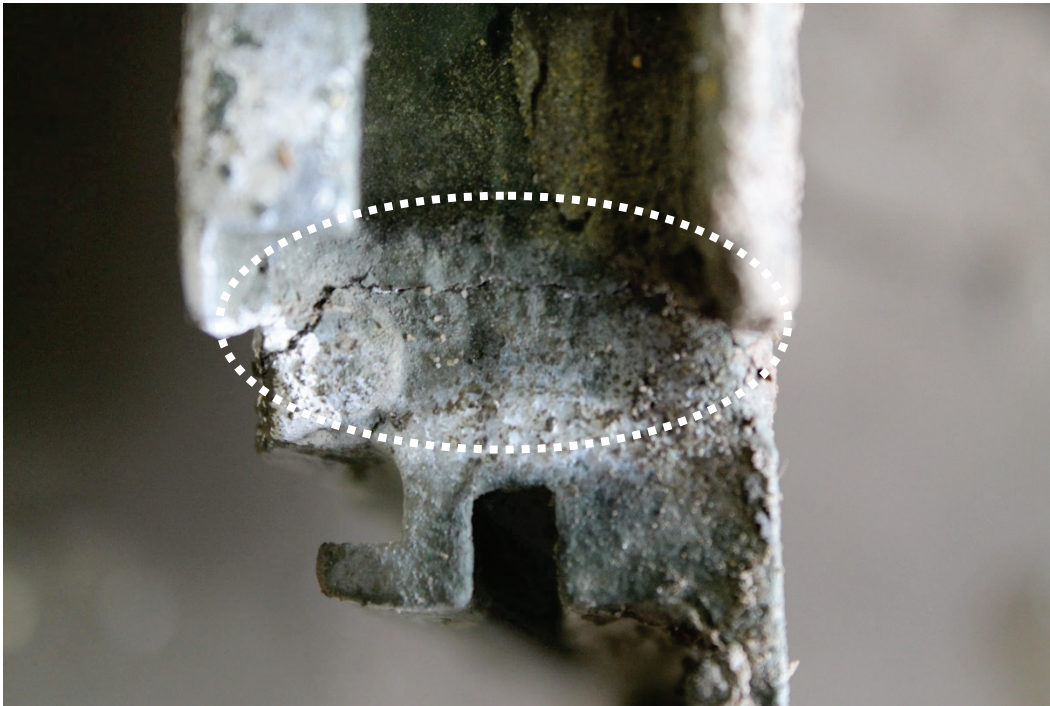
Figure 67. Damage noted in Panel 68 after removing from test section.

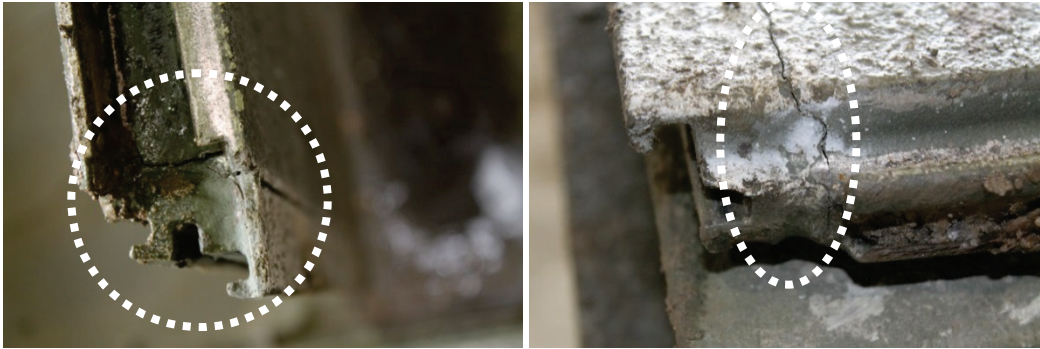
Figure 68. Panel 69 after removing from test section.

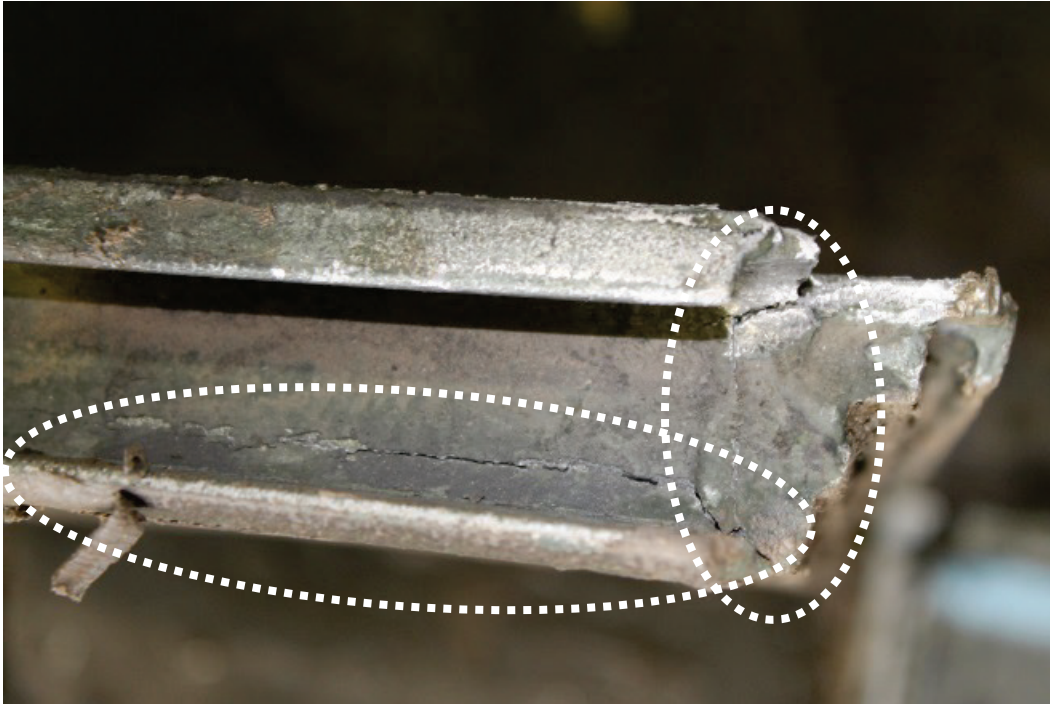
After 1,162 passes, the length of the crack on Panel 103 increased to 40 in. Panels B59 and B70 were noted to have 0.13-in. corner curls on the southeast corner of each panel. Panel B49 had a 1.5-in.-long crack along the weld of the overlap end connector. Panel 67 developed a top skin tear along the top flange of the female hinge that was 1.5 in. long. The corner curls in Panels 67 and 23 increased to 0.19 in.

Figure 69. Panel 67 after 1,308 passes.

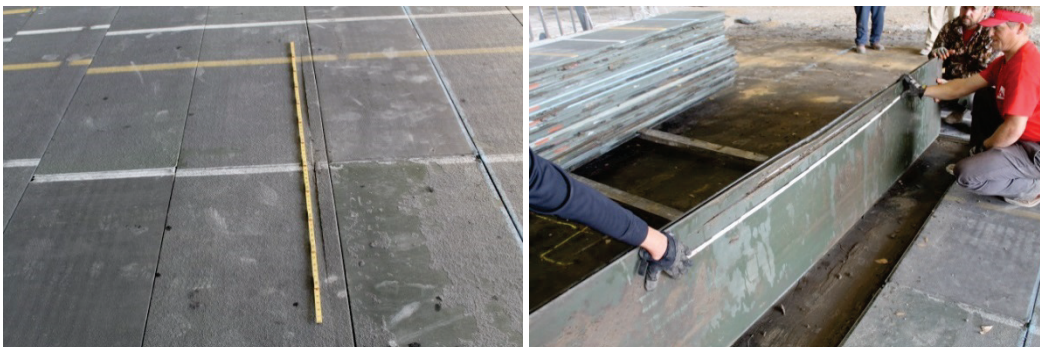
Figure 70. Damage in Panel 103.

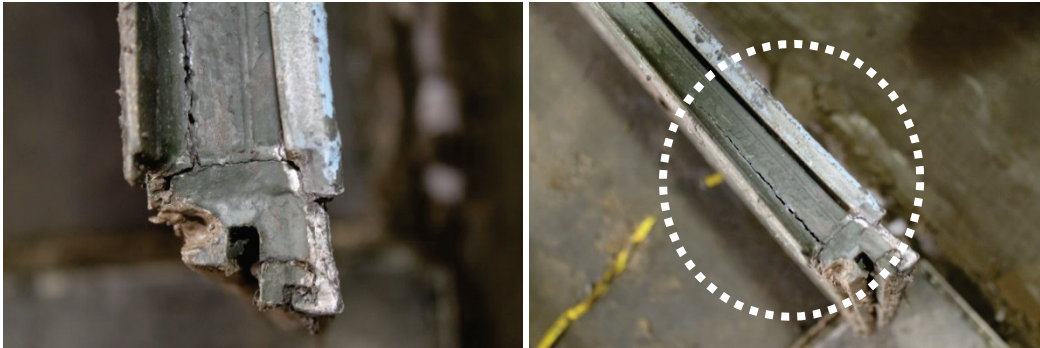
Figure 71. Panel B52 after removing from C-17 test item.
