Airfield Damage Repair Modernization Program

AM2 Modified 2-1 Lay Pattern Evaluation under F-15E Traffic

Final report

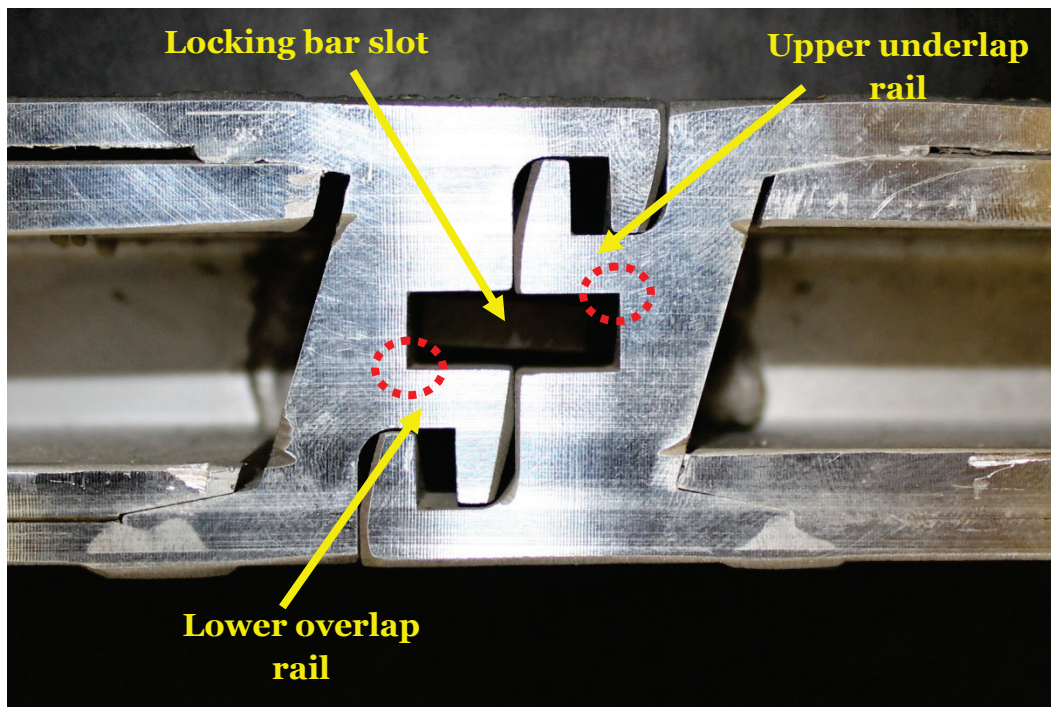
After completion of the test program listed in Table 1, a thorough investigation of both the subgrade and the mat revealed that the manufacturer’s drawing of the extrusion die for the AM2 end connector inadvertently omitted filleted corners in the locking bar channel, at the interface with the smallest cross-sectional area of the rail (Figure 2). Several modeling efforts showed these corners were areas of high stress concentration that eventually caused cracking along the upper underlap or lower overlap rails, which was damage commonly reported by Rushing and Tingle (2007), Rushing and Torres (2007), Rushing et al. (2008), Rushing and Mason (2008), and Garcia and Rushing (2013). An example of crack initiation at one of the corners is shown in Figure 3.

Figure 2. Corners with fillet omitted, as indicated by the dotted circles.

The die was recently corrected after an unknown period of producing the non-filleted design. Researchers questioned whether this fillet omission might have affected the performance of AM2 throughout the NAVAIR and AFCEC test program. Based on modeling results, it was assumed that a filleted corner would reduce stress concentrations at these locations and provide better fatigue life of the rails. Therefore, AFCEC sponsored an evaluation to quantify the difference in performance (if any) between an AM2 production without the filleted corners in the locking bar channel and a production lot with the filleted corners. Each test item was installed in the brickwork pattern. The results showed a significant increase in the performance life with the filleted corners. Further details of this test are reported by Garcia et al. (in preparation).

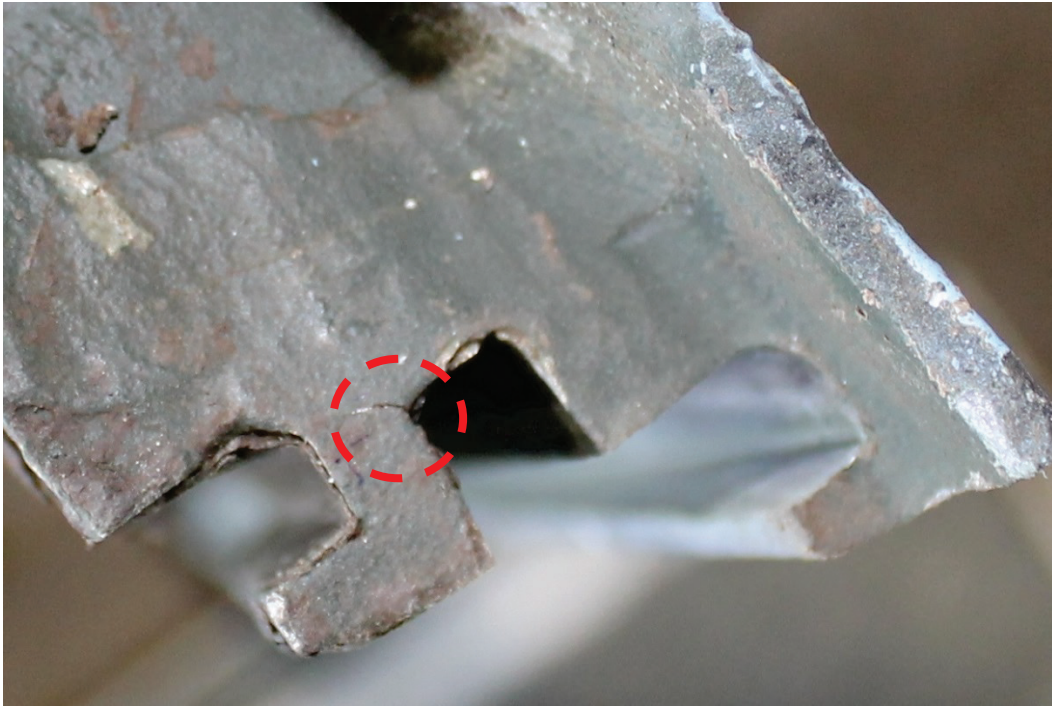
Figure 3. Crack initiation at lower overlap rail.

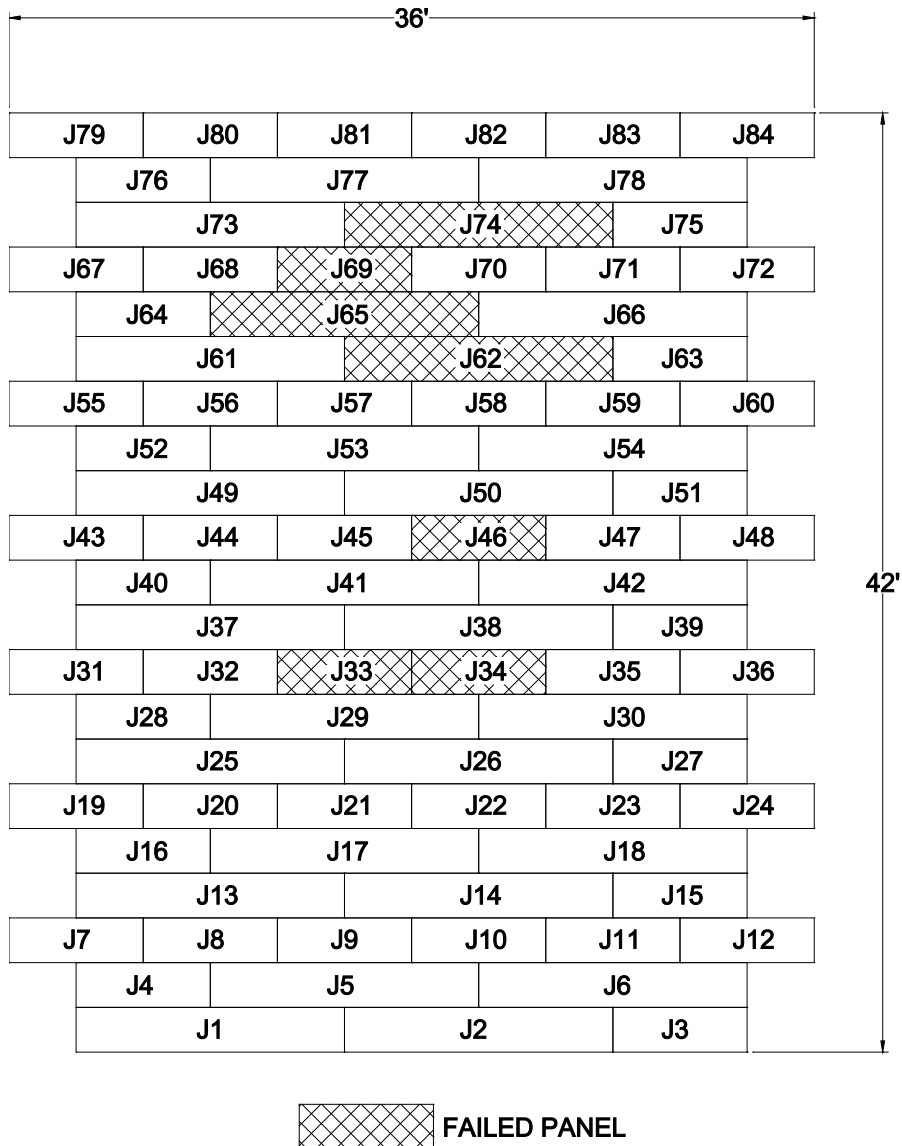
Trafficking began on 27 October 2014. Figure 25 shows the layout of the failed panels as noted by visual observation in the test section. The accumulation of mat damage and mat breakage throughout trafficking and the damage noted after removing panels from the subgrade surface are summarized in Table 8.

Figure 25. Layout of failed panels.

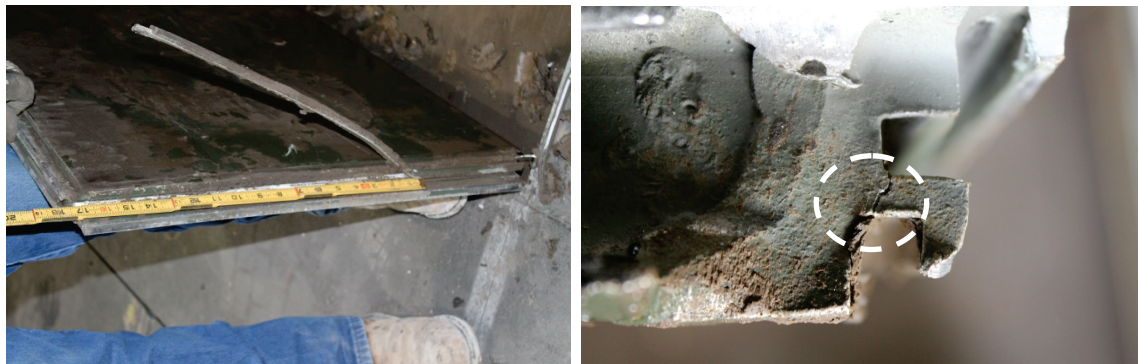
Four panels had breakage at the end connector: two at the upper underlap rail and two at the lower overlap rail. When a rail failure occurred, separation was noted at the adjoining panels as the load cart passed over the joint. Upper underlap rail failure was confirmed when a crack could be seen at the rail from the surface. Examples are shown in Figures 27 and 28. J70 was partially broken at the upper underlap rail, and J9 was partially broken at the lower overlap rail (Figure 28), but the length of breakage in these two panels was 10 in. and 1.5 in., respectively. Since these lengths were less than half the length of the rails, J70 and J9 were not considered failed.

Figure 28. Lower overlap rail breakage at J69 (left) and J9 (right).

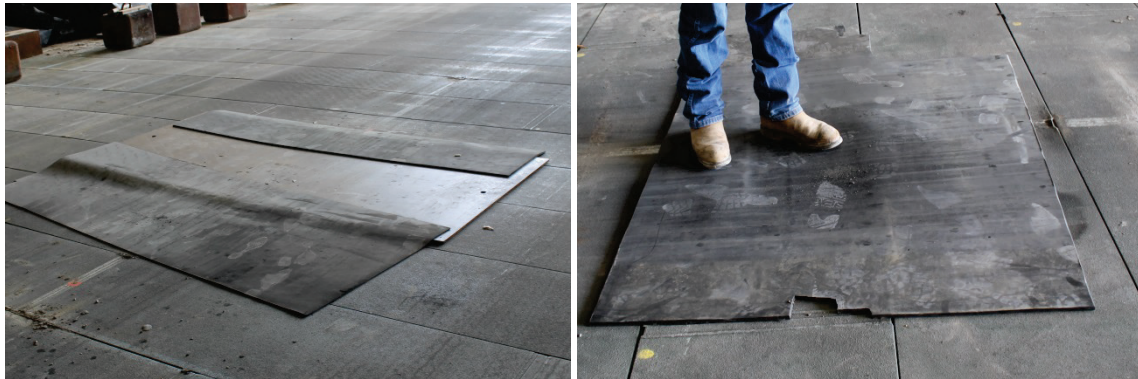
Figure 29. Metal plate placed on J46/J45 (left) and rubber mat placed on J74 (right).

After 1,728 passes, the skin tear and the upper underlap rail failure at J46 were posing serious risks to the load cart tire. Since it was important to continue traffic until mat breakage failure was achieved, a metal plate was placed over J46 and J45 to bridge over the damaged area (Figure 29).

Core crushing was documented in three panels. This failure mechanism is evident through dishing observed on the surface, as shown in Figure 30. Panel J74, which was the first to fail by core crushing, also sheared at the female hinge, creating a severe tire hazard. A rubber mat was placed over the panel (Figure 29) to cover the damaged area and to continue traffic.

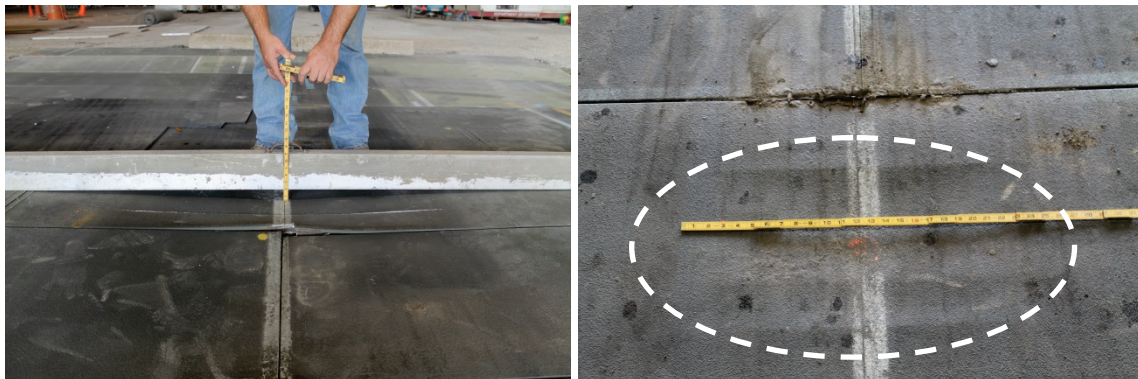
Figure 30. Core crushing in J74 (left) and J62 (right).

Core crushing occurred in three panels due to buckling of the vertical members in the mat core. Rushing and Tingle (2007) reported at least two panels to have failed by core damage in their testing. The initial sign of core crushing was dishing observed on the surface. As the panel structure continued to collapse with increasing load repetitions, the dished area became larger. Top and bottom skin cracking parallel to the vertical stiffeners were characteristics of this failure mechanism. Cracking developed because the skins could no longer accommodate the bending action of the load without the support from the stiffeners.

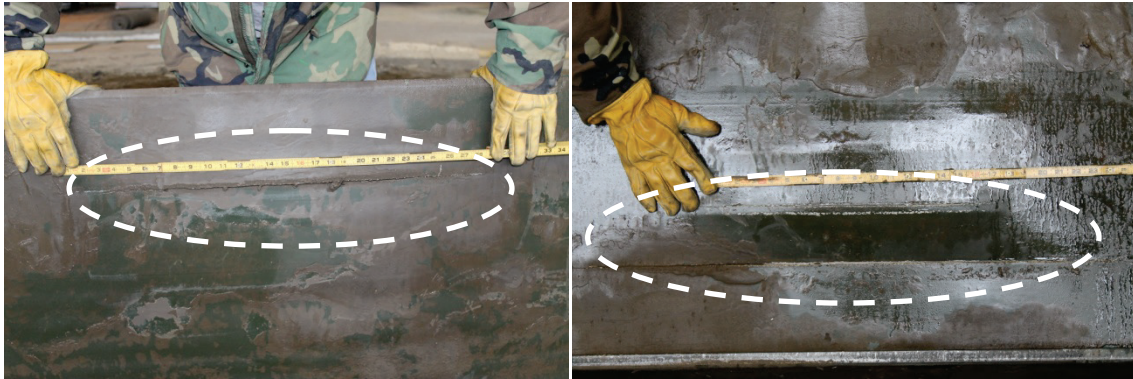
Mat breakage failure was reached after 2,638 passes when 10.7 percent of the test item was documented as failed. Traffic was concluded after 2,850 passes, and the panels were removed from the test subgrade. After the panels were removed from the test section, panels where core crushing had occurred were noted to have cracks on the bottom skin (Figure 31).

Figure 31. Cracks on bottom skin of J65 (left) and J62 (right).
