# FLOOD PROOFING PERFORMANCE

Successes  
&  
Failures

**US Army Corps  
of Engineers®**

**December 1998**

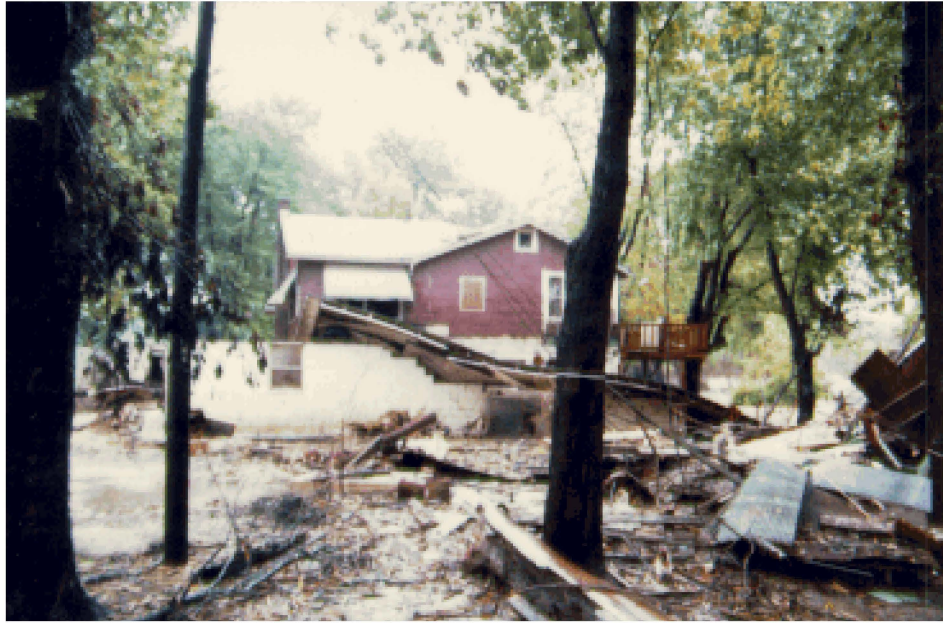
Looking at Structures 52 and 53.

four structures, the extended concrete block wall to support the structure should not have been used in an area close to a major river where high velocity during floodflows could occur. Supports such as columns, posts, or piles embedded sufficiently below grade should have been used, with piles being the preferred choice. Any enclosure of the lower area should have been of minimal strength to easily break under hydodynamic force.

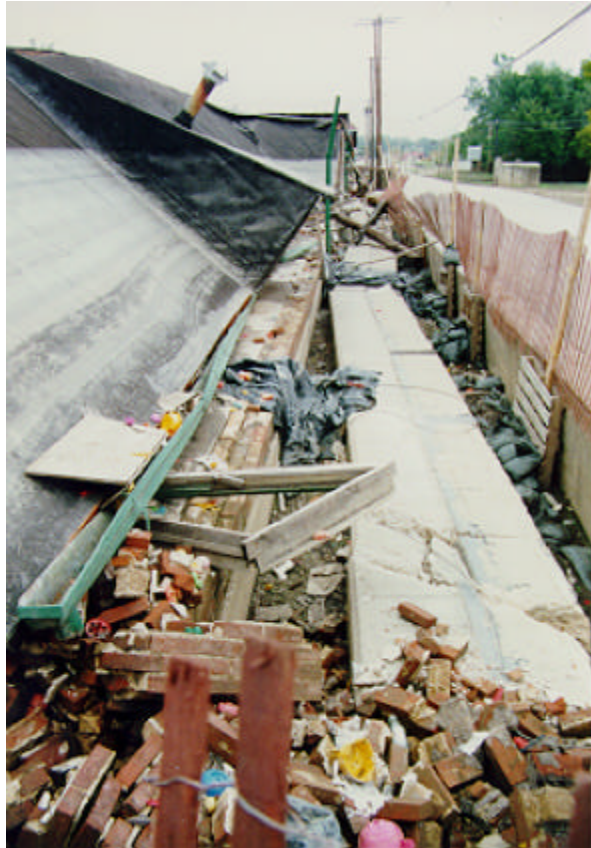
Looking at the collapsed floodwall additions. Note these two additions are still tied together with rebar.

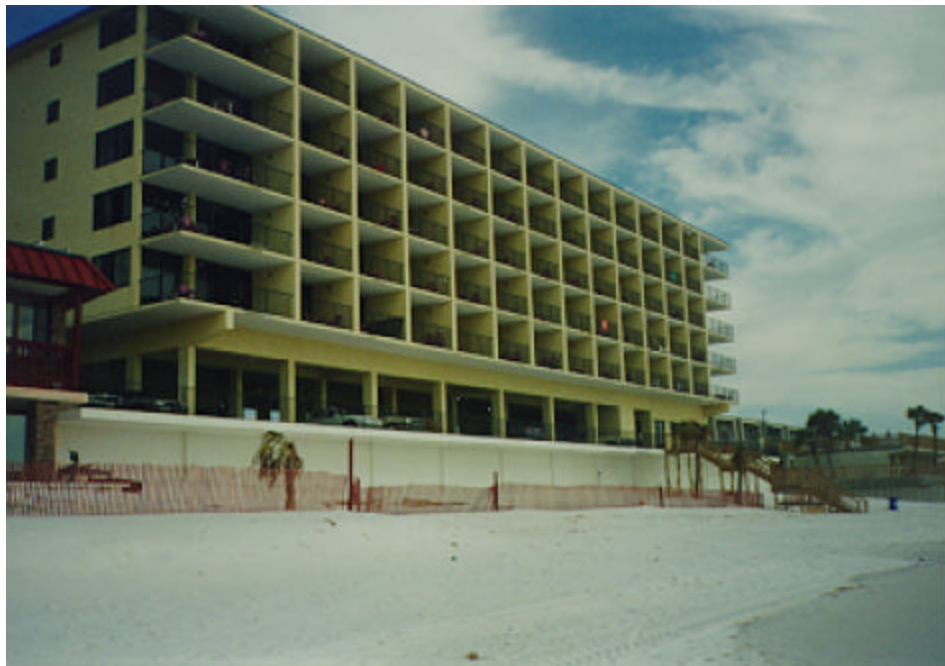
**Lesson.** This structure was successful for two basic reasons. It had both proper elevation and proper scour/erosion protection. The first damageable floor was well above the flood level since it was two floors above the ocean level. The first floor was occupied by automobiles which can easily be moved to a nonhazard area with proper warning time. Scour did not pose a problem because of the wall and the proper column embedment depth.

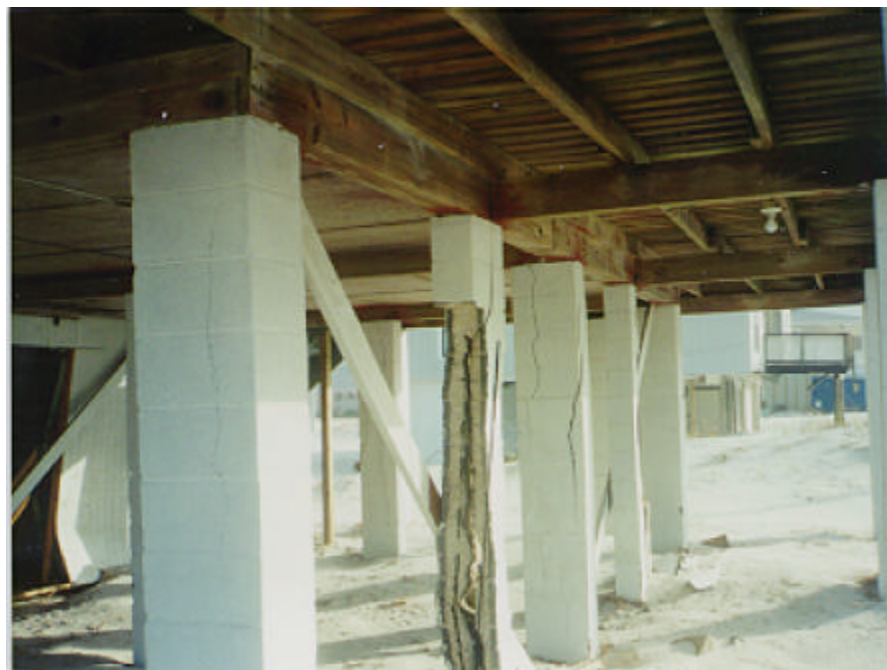
Looking at the column support that was nearing failure.

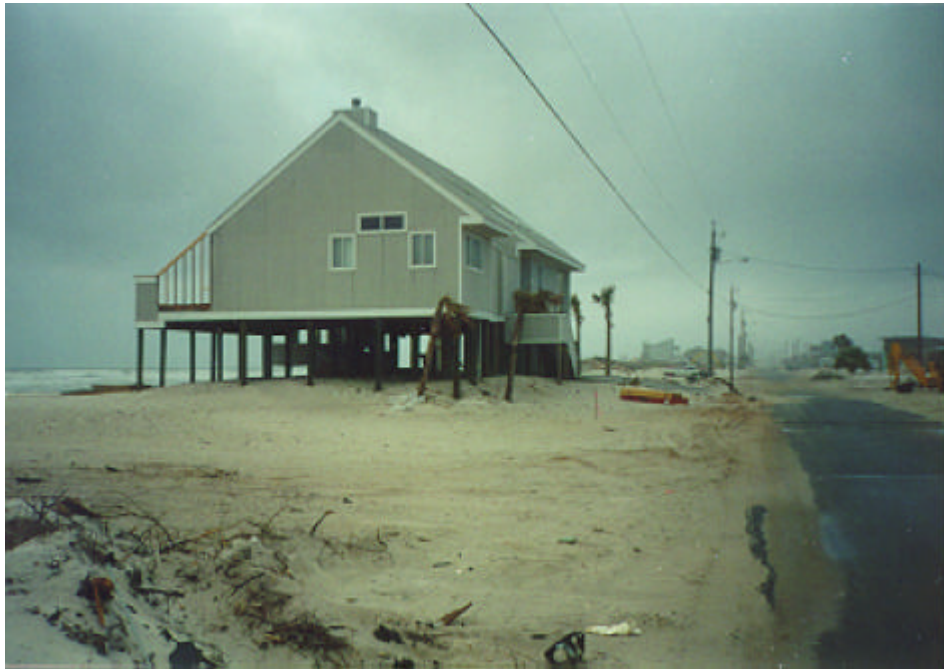
**Lesson.** This structure survived the event well because it incorporated proper design and construction to withstand hurricane force winds, flooding, and hydrodynamic force associated with such a storm.

Looking at the structure. Note the beach at the left. Note also the absence of adjacent structures, which had been destroyed and removed.

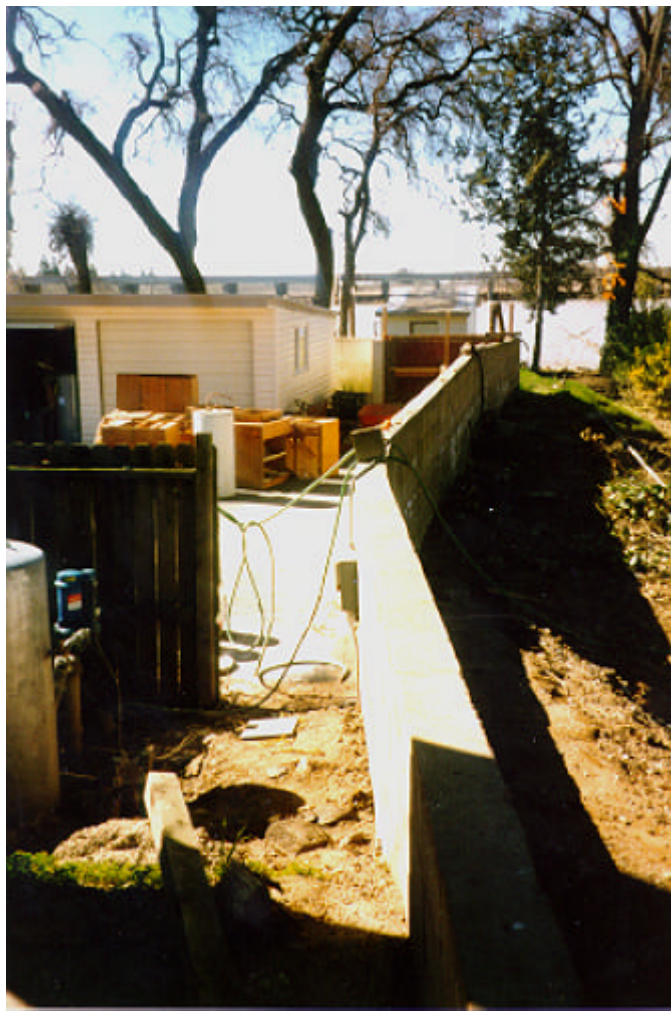
Looking along a portion of the floodwall. The failure under the wall occurred in the immediate foreground. Note the largest closure at the right of the structure. Also note the Sacramento River in the background.

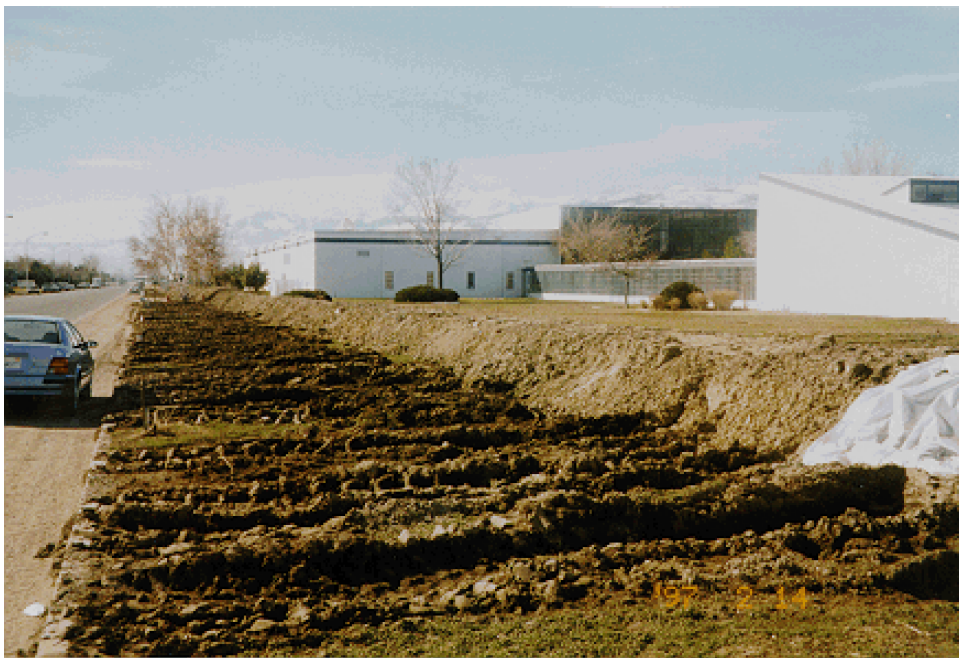
Looking at the recently constructed earthen embankment protecting Structure 95. Note the plastic sheeting at the far right that was placed over the embankment's unprotected side and held in place with sandbags to provide impermeability to the embankment.

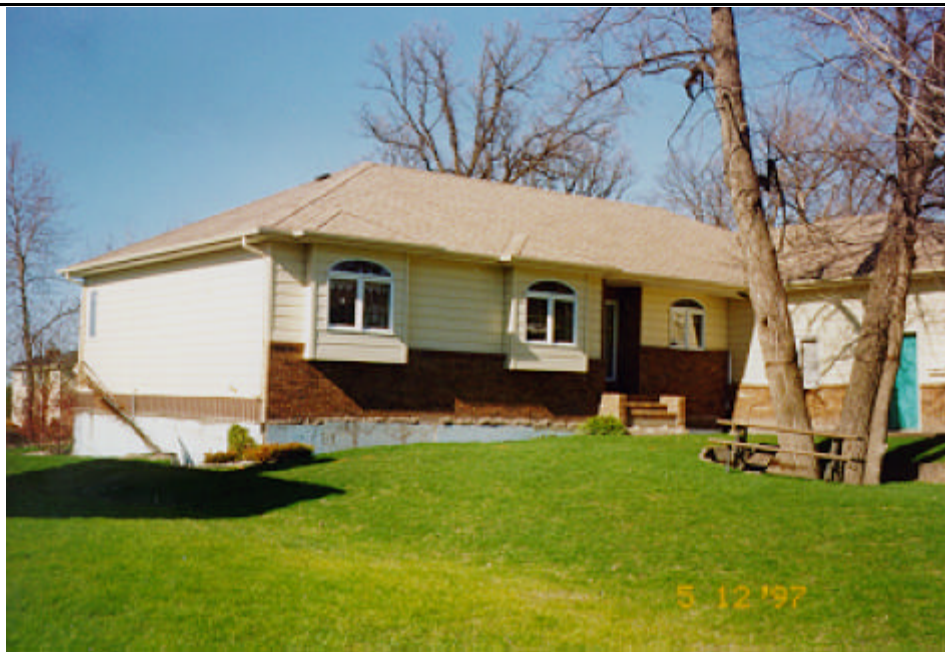
Looking at the structure. Note the garage on the right that held that part of the structure down and the exposed basement wall on the left indicating the amount of lifting that occurred on the west side.
