# FAILURE MODES OF LAMINATE STRUCTURES

L. B. Gordon  
Space Power Institute  
231 Leach Center  
Auburn University, Alabama 36849

R. L. Druce and M. J. Wilson  
Lawrence Livermore National Laboratory  
P.O. Box 808, L-153  
Livermore, California 94550

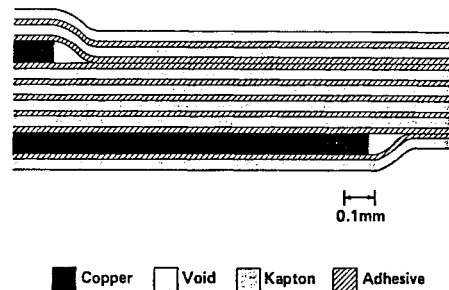
Figure 1. Cross section of cable edge showing laminations and edge voids.

illustrates the gas voids at the edge of the conductors trapped by the laminating process, and the conductor stagger, where the copper edges do not line up but are staggered.

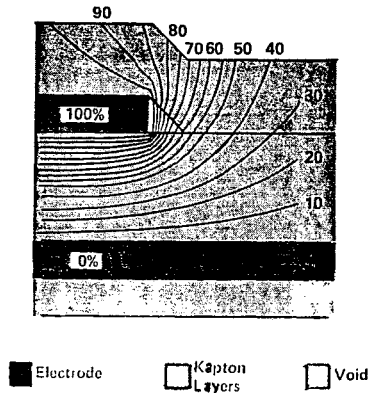
Figure 2. Equipotential contour lines for staggered edge geometry electrodes.

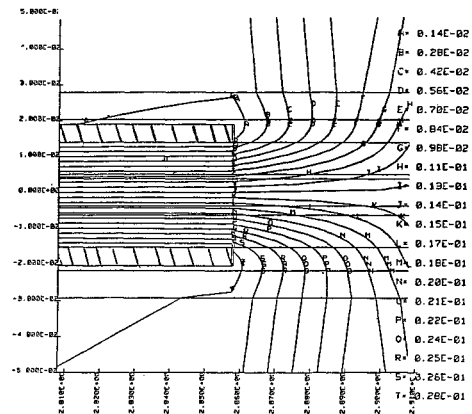
Figure 3. Equipotential contour lines for flush edge geometry electrodes.

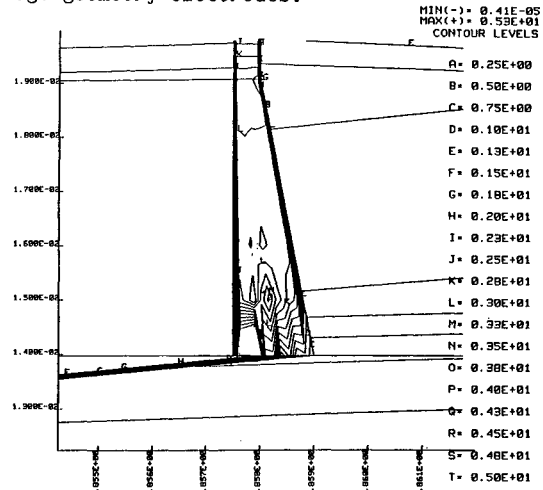
Figure 4. Equipotential contour lines at an electrode edge with a void.

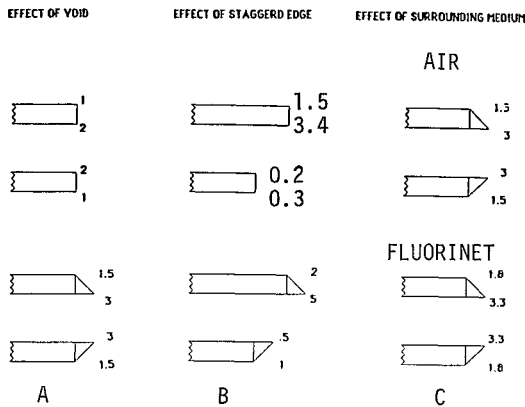
The results from the electric field stress models are summarized in Fig. 5. The electric field strength is normalized to the value of the field in the quasi-uniform region between the two conductors far from the edge. For instance, in Fig. 5a, the normalized electric field strength for two flush edges without voids has a value of 1 at the outside corners and a value of 2 at the

inside corners. Thus, the magnitude of the electric field strength at the outside corners is equal to that found in the uniform field region, while the magnitude of the electric field strength at the inside corners is twice that in the uniform field region.

values), but the stress was increased at the inner corner of the extended edge, Fig. 5b.

- o If fluorinert were used as the surrounding dielectric for the cable instead of air additional flux was "forced" into the void region resulting in increased electric field stress at the edges, Fig. 5c.

Figure 5. Normalized electric field strength for different electrode geometries.

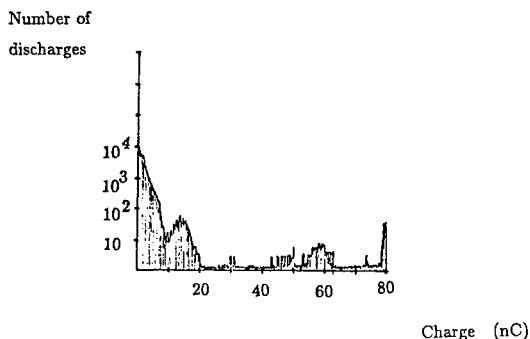
Cables exposed to large numbers of shots exhibited continued change in their PD signatures. In particular, larger and larger PD events would be registered. For example, after 6000 impulses PDs extending to 80,000 pC occurred. These were measured just prior to cable failure and are shown in Fig. 8.

Figure 8. Partial discharge signature changes drastically just prior to cable failure.

After continued aging (under ac, dc, or impulse) cable failure occurred. Under impulse, aging failure occurred after approximately 7000 shots and the mode was by puncture from an extended tree through the central Kapton layer to the upper electrode region. These failures occurred shortly after the appearance of the very large (80,000 pC) partial discharges in the ac monitoring tests.

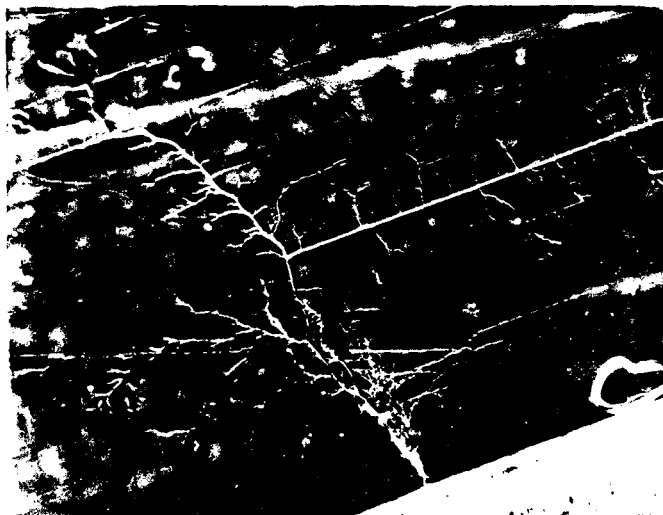
Coincident with major changes in the partial discharge signature there were morphology changes in the dielectric. Electrical trees were observed originating at the conductor edges and propagating in the adhesive region between the Kapton layers. This tree growth was noticeable after 500 impulses. Figure 9 shows a typical tree case through an optical microscope. Tens of these trees were observed along the cable edge and they were typically 1 to 2 mm long.

Figure 9. Impulse tree formation after 500 applied pulses.

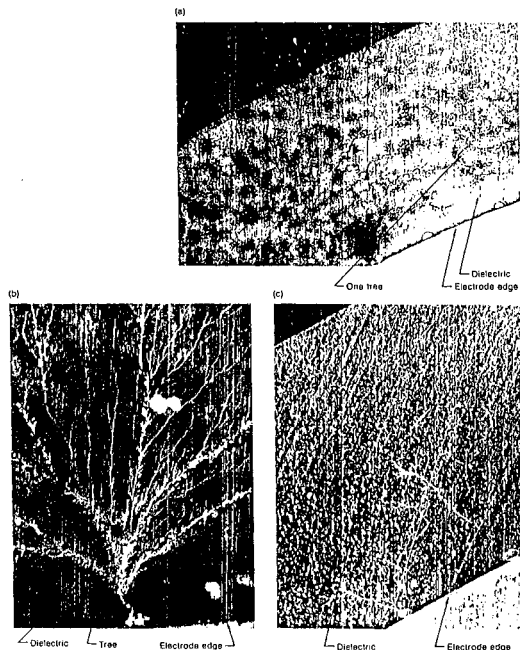
- o Tree development showed differing characteristics under ac, dc, and impulse stresses. Dc and impulse trees (Figure 10) were very similar, but ac (Figure 11) electrical trees were darker and had a larger degree of branching.

Figure 10. Comparison of dielectric degradation caused by three types of high-voltage stresses. We observed that, for two-conductor flat cable, trees form in the dielectric separating the conductors when (a) ac, (b) dc, and (c) impulsive high voltages are applied.
