TECHNICAL REPORT REMR-CS-6

**IN SITU REPAIR OF DETERIORATED  
CONCRETE IN HYDRAULIC STRUCTURES:  
FEASIBILITY STUDIES**

R. P. Webster, L. E. Kukacka

May 1987  
Final Report

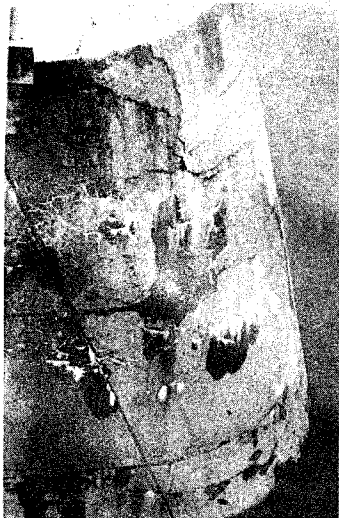
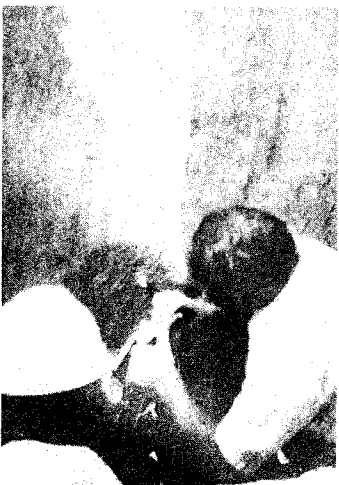
TOP — Deteriorated concrete gate pier, Montgomery Dam

BOTTOM — Pressure injection of concrete cracks, Bloomington Dam Intake

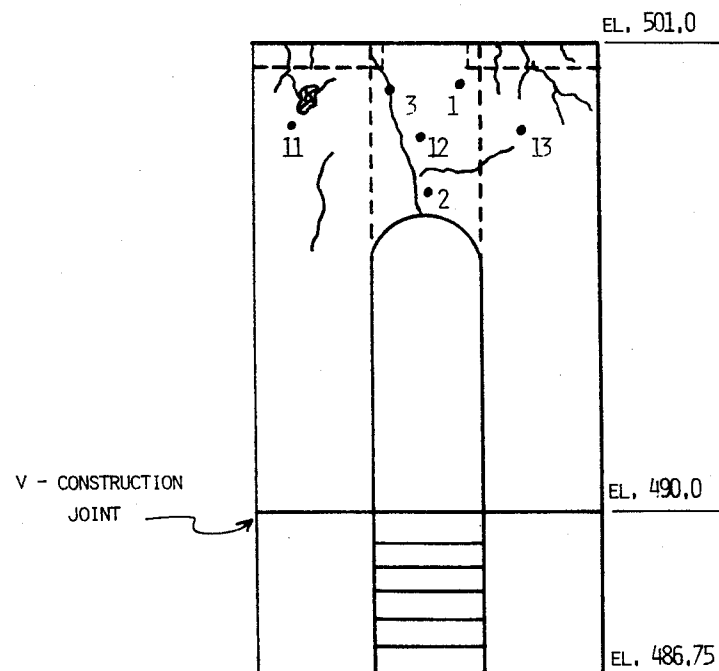
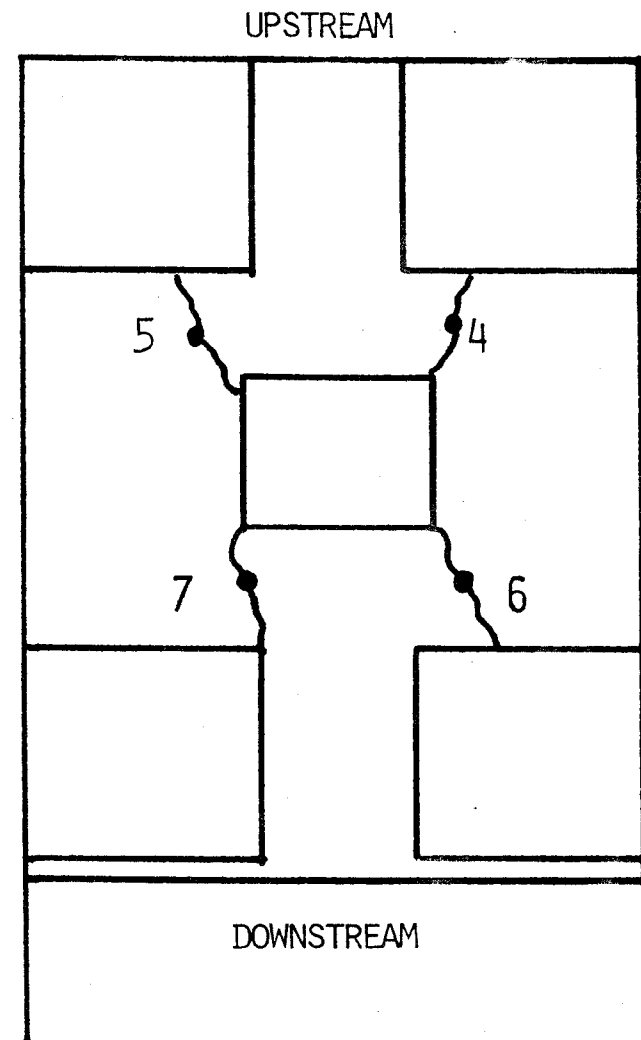
Figure 10. East elevation showing location of injection ports (Flock and Walleaser, 1983).

Figure 11. Downstream view showing major cracks and locations of injection ports (Flock and Walleser, 1983).

Figure 12. Top view showing major cracks and locations of injection ports (Flock and Walleser, 1983).

Epoxy injection was started in the middle of the archway ceiling at Port No. 9 (refer to Figures 10-12). Pumping was continued, while the epoxy reached injection Ports Nos. 2, 3, and 12 on the downstream face. The operation was then moved to the upstream ceiling port (No. 8). The contractor had difficulty maintaining a seal around the injection packer. In addition, leakage of epoxy was noted at the bottom edge of the access manhole and adjacent to the electrical conduits embedded in the archway ceiling. An attempt was made to inject epoxy into Port No. 10; however, it was impossible, even at a pressure of 160 psi.

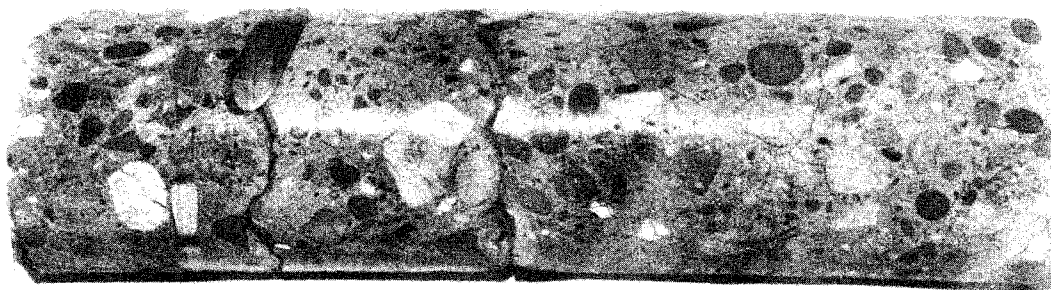
Upon completion of the pulse velocity tests, concrete cores were taken from various locations to further evaluate the effectiveness of the repair. Presented in Figure 13 are photographs of cores taken before and after the pier was repaired. Cores removed from the pier top contained numerous random and crudely parallel diagonal cracks as well as many fractured aggregate particles. Only 5 to 10% of the cracks were filled with epoxy, explaining the difficulty in obtaining pulse velocity readings.

Figure 13. Cores taken from Pier 39 before and after epoxy injection.

The cores taken from the downstream face were not as severely cracked as the core removed from the pier top. The cracks were finer and more randomly distributed throughout the length of the cores. Fifty to ninety-five percent of the cracks were filled with epoxy. Tests for resistance to freezing and thawing subsequently run on two of these cores indicated the epoxy injection was successful in rebonding the concrete and in holding it together under freezing and thawing conditions. Most of the failure observed in these tests resulted from crumbling of the non-air entrained mortar and cracking of the coarse aggregate particles. In general, it was concluded that the epoxy in the fractures tended to hold the concrete together during the freezing and thawing cycles and aided in slowing down the deterioration of the concrete. Based on the tests, the performance of the concrete in the structure cannot be predicted absolutely; however, it is expected that while the exposed concrete surface would be subjected to damage due to freezing and thawing, the deeper interior concrete may be cemented together well enough to form an integral whole and to perform satisfactorily.
