CHARACTERIZATION OF HIGH POWER GAS SWITCH FAILURE MECHANISMS

E. E. NOLTING

Naval Surface Weapons Center
White Oak, Silver Spring, Maryland 20910

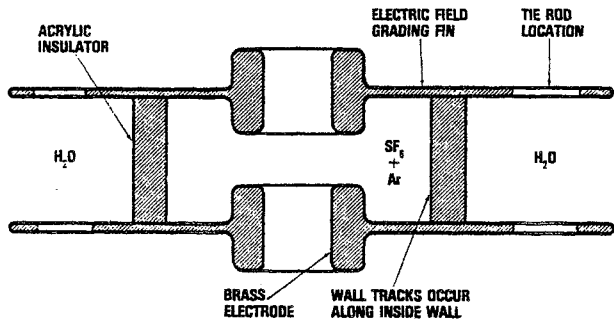
Inspection of the insulator walls showed that faint tracks bridged the length of some of the insulators. Figure 1 indicates location of wall tracks. It was evident that little energy was actually transferred along the insulator wall because of the lack of damage found on either the insulator or the adjacent grading fin. Apparently current passing along the inside wall acts as trigger mechanism for the associated electrodes. Initiation of the main gap closure may occur because of imbalance of the electric field at electrodes due to the surface tracks causing asymmetric field distortion. Another possible mechanism is the generation of ultraviolet radiation at the insulator wall that illuminates the electrode.

Fig. 1. Cross-sectional view of single section of multistage gas switch.

Attempts to stop the sliding sparks by convoluting the inside insulator wall did not have any measurable effect. The surface contours required that the

sliding sparks, starting at grading fin-insulator-gas triple point, would have to reverse direction against the potential gradient. Furthermore, the convolutions were designed so that blast and ultraviolet radiation from the main gap closure were not directly incident at the triple point. Experiments on Casino showed that the tracking still occurred with tracks passing directly across the convolutions.

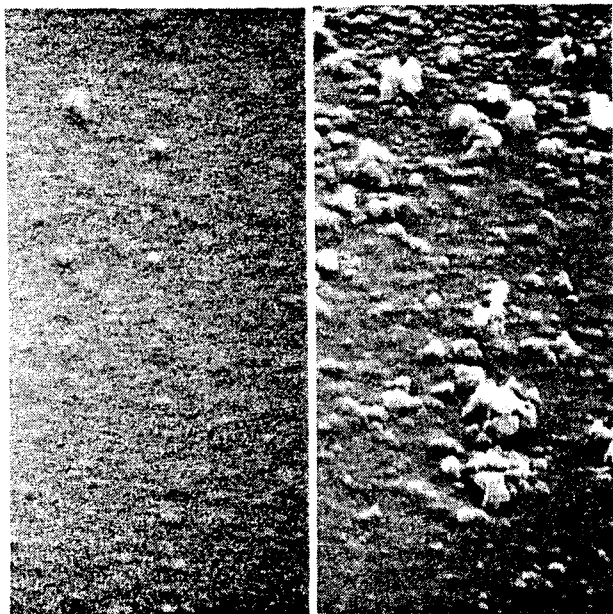
Scanning Electron Microscopy (SEM) was used to show insulator inner wall topography. Figure 3 shows a comparison of the surface of an unused insulator and one exposed to several switch closures. There is an obvious difference in the contamination level between the two insulators.

Fig. 3. SEM micrographs (10,000X) comparing surface contamination of unused plastic (left photo) with insulator exposed to ten switch closures.

Surface analyses comparison of used and unused insulators indicate a substantial plating of electrode material on the insulator. Two approaches are suggested for preventing the metal plating on the insulator: first, a change in the electrode material from brass to a tungsten-copper composite may substantially reduce this effect, second, the use of mechanical shields which do not allow a direct line of sight from the arc gap to the insulator. Designs incorporating both of these features are being readied for testing.
