**CORROSION OF DRAINAGE WELLS  
AT SARDIS DAM, MISSISSIPPI**

**TECHNICAL MEMORANDUM NO. 3-287**

**WATERWAYS EXPERIMENT STATION**

**JUNE 1949**

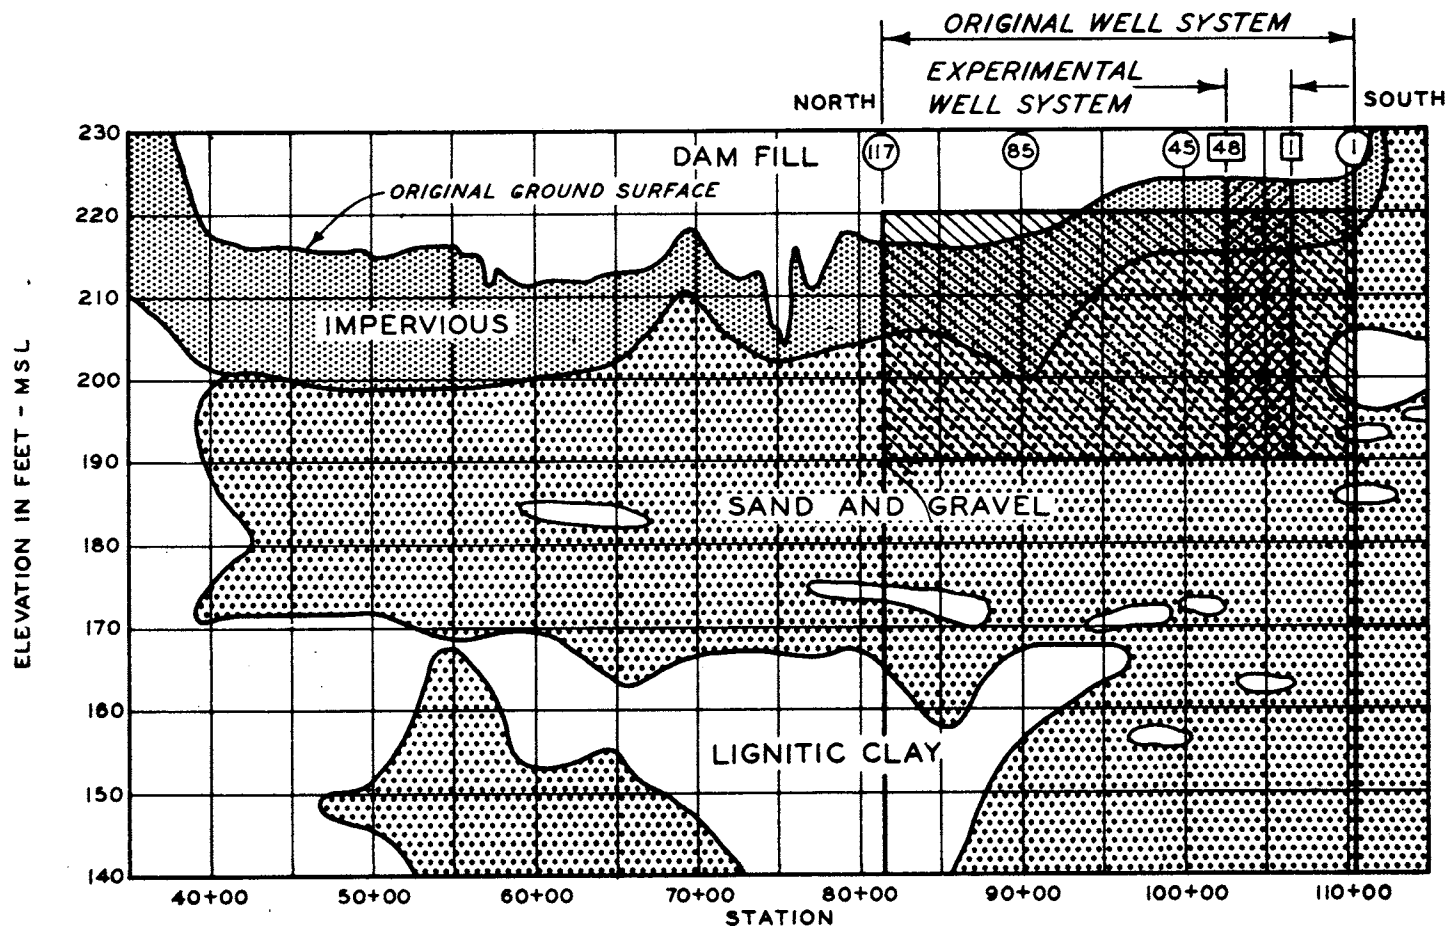
LOCATION OF  
 WELL SYSTEMS

45. The soil profile, shown schematically in plate 1, shows that north of Station 90 a massive lignitic clay formation underlies the well system, while southward, except for a few lenses of the clay, the sand extends more than 100 ft below the wells. The lignitic clay was found to be rich in sulfates and in organic matter, which is a potential source of carbon dioxide. Both of these chemicals, which are important to certain

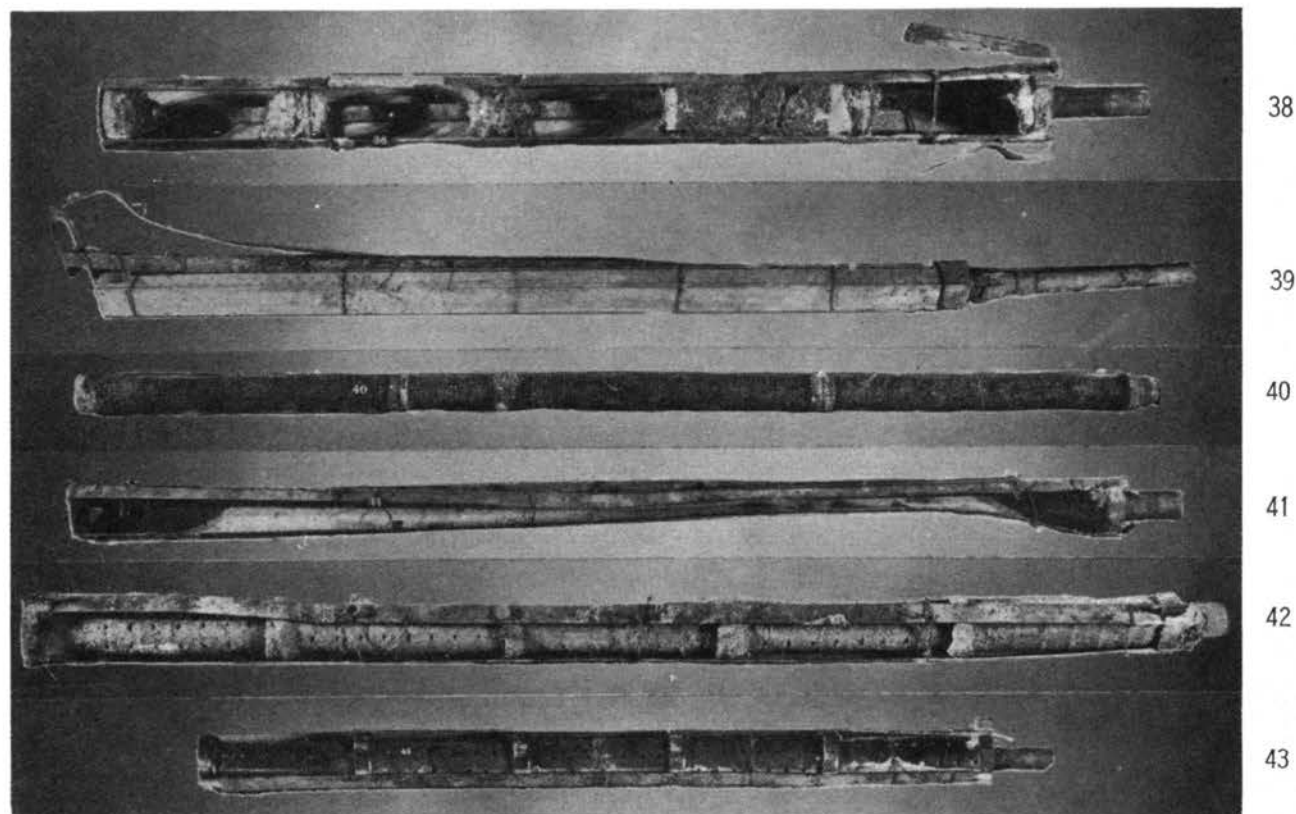
SARDIS DAM EXPERIMENTAL WELL SYSTEM  
NON-METALLIC WELL SCREENS AFTER RECOVERY

19. The effects of exposure of nonmetallic well screens to the corrosive water of the Sardis Dam toe-drain system are illustrated by the photographs of the screen sections of wells 38 through 43 of the

experimental well system on plate 4. The porous concrete in both well 38 and well 41 disintegrated badly. Although some damage probably occurred during removal of the wells, a close examination of the remaining fragments indicated that chemical attack and leaching probably removed much of the cement and weakened the structure critically. The photographs indicate that the porous pipe of well 41 had either disintegrated or was lost nearly completely during removal and that only the nonporous joints of the porous concrete pipe of well 38 remained essentially undamaged in the screen section. The perforated square cypress screen of well 39 and the perforated vitreous clay pipe screen section of well 43 showed less damage than any other used in the experimental system. The gravel-pack well screen of well 40 showed considerable incrustation. Most of the gravel of this well screen was lost as a result of destruction of the cement binder by chemical attack and leaching. The perforated concrete pipe screen section of well 42 remained serviceable. However, the removal of an appreciable quantity of the cement by leaching and chemical attack exposed the aggregate and if continued at the same rate would have rendered the pipe unserviceable in a relatively short time due to enlargement of the perforations and weakening of the pipe walls.

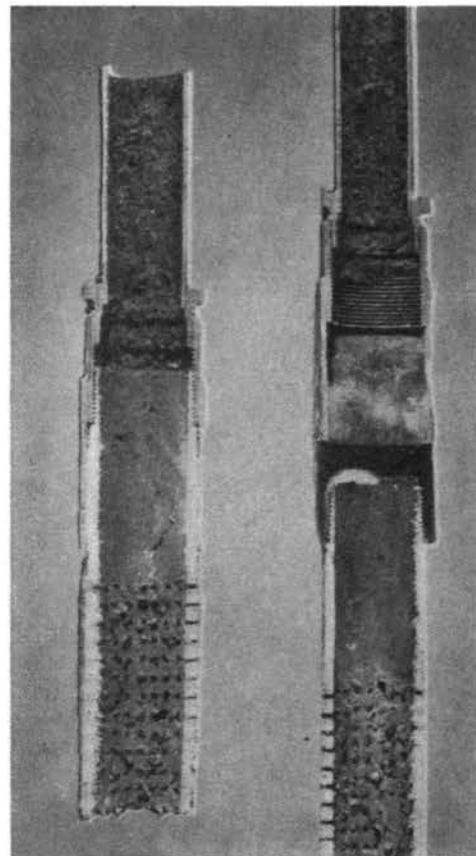
**DISSECTED CORRODED WELL SCREENS**

21. A portion of the slotted brass well screen from well 33 dissected on a diameter is shown in plate 6. There is evidence of some incrustation and deposition of fine-grained soil particles on the interior of this well screen. The important feature of the picture is, however, the evidence of disintegration of the slotted well screen in the vicinity of its connection to the threaded bronze pipe nipple by means of which it was connected to the riser pipe. This condition was relatively common in the wells toward the south (low-numbered) end of the experimental well system. A dissected portion of the cement-asbestos well screen and metal riser pipe coupling of well 37 is also shown on plate 6. This well screen was sheared off less than 1 ft below the coupling during removal from the ground. The break occurred along a circumferential row of perforations which formed a weak zone. There is no evidence of appreciable chemical attack on the recovered portion of the well screen, although some slight attack may be indicated by the presence of asbestos fibres which have been freed from the cement matrix. The interior of this screen was free of incrustation, but showed iron stains. The roughness which is evident in the photograph of the interior is due to chips forced out by the drill during perforation of the cement-asbestos pipe.

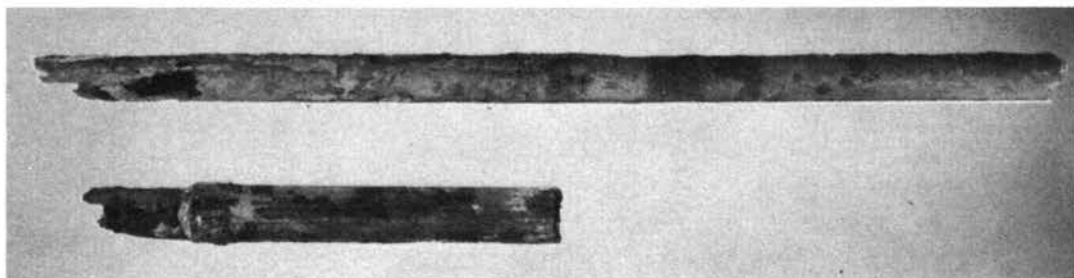
corrosive pitting was evident on the riser pipe in the vicinity of the screen coupling. The photograph of a portion of well 58 at Station 96+80 illustrates the type of corrosive action which was general in the central portion of the original well system. Neither the brass screen nor the galvanized riser pipe shows evidence of serious corrosion. The riser pipes of the wells in this part of the system showed some evidence of corrosion directly below the ground surface, but this had not progressed to a serious degree when the wells were removed. The photograph of well 104 at Station 85+27 shows typical results of corrosive action on the wells at the north end of the system. The brass well screen was incrustated near the riser pipe joint, but otherwise showed no detrimental effects of corrosion. The riser pipe, however, had been subjected to extremely heavy corrosive attack. This attack was heaviest near the brass screen and directly below the ground surface. The corrosion showed that very extensive pitting occurred; many of the riser pipes of wells in this vicinity were perforated to the extent of nearly complete disintegration.

49. Corrosion of the galvanized wrought-iron riser pipes of the wells of the northern part of the system was extremely severe. The attack varied from general deep pitting over the whole exterior of the pipe to concentrated attack several feet above the joint with the screen section and several feet below the concrete ditch lining. In all cases the interior of the riser pipes showed evidence of uniform corrosion. The extent of the attack varied from general heavy incrustation to general perforation and disintegration. In one case, well 99, disintegration was so complete that no trace of the riser pipe could be found in a carefully

WELL 104. NORTH END OF SYSTEM: STATION 85+27

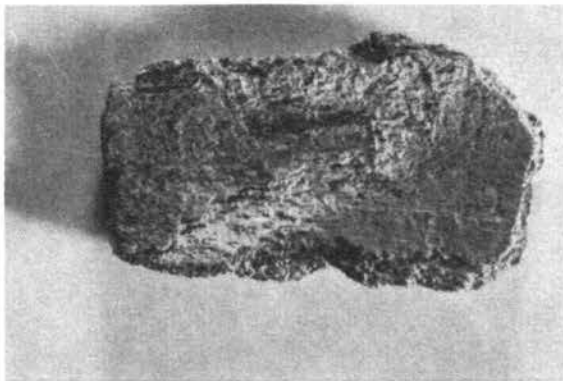
24. A general view of part of well 106 from the north end of the original system at Station 84+75 and details of a section of the perforated riser pipe from that well are shown in plate 9. The nature of the perforation and of the interior incrustation is shown in the photographs. The perforations appear to have resulted almost entirely from pitting of the outer surface of the pipe. Corrosion of the interior of the riser pipe appears to be uniform and to involve incrustation to a thickness of about  $1/8$  in. A portion of the multilayer incrustation which also occurred on the outer surface of the riser pipes in some places is also shown on plate 9.

WELL 104 - STATION 85+27. EXTERIOR INCRUSTATION
