**BANK CAVING INVESTIGATIONS  
MORVILLE REVETMENT, MISSISSIPPI RIVER**

**TECHNICAL MEMORANDUM NO. 3-318**

**CONDUCTED FOR  
THE PRESIDENT, MISSISSIPPI RIVER COMMISSION  
CORPS OF ENGINEERS, U. S. ARMY**

**SEPTEMBER 1950**

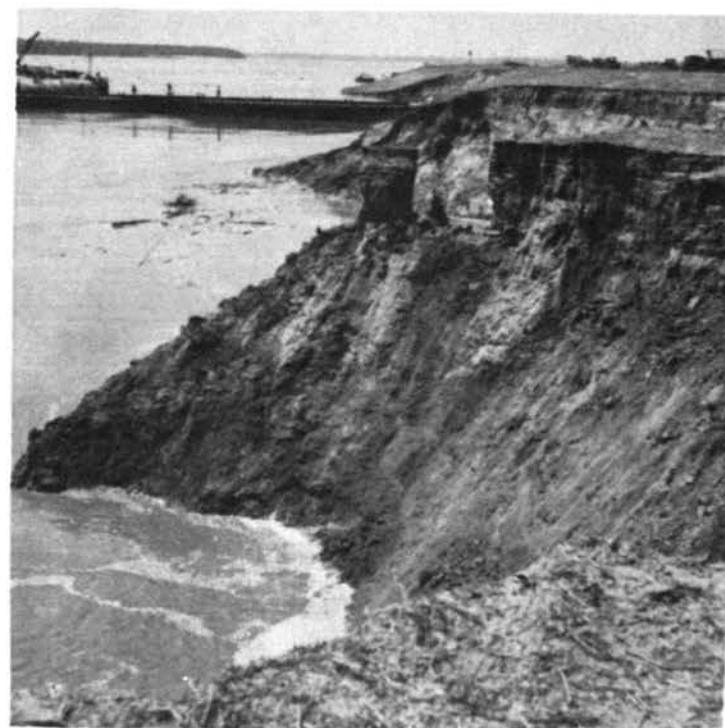
BANK CONDITIONS RANGE 2-D LOOKING DOWNSTREAM

The flat slopes after failure are readily apparent. The bank remained generally unchanged at range 2-D (plate 33) and range 4-D (plate 34) immediately after the first failure. The exposed point caused by the swale filling extended through range 6-D, as evidenced by the peak in the 7 June survey shown on plate 34. Section AA, shown in plan on plate 32 and in section on plate 33 most nearly corresponds to the direction of the axis of the failure. A stability analysis of this section indicates that the most critical surface corresponded to the after-failure surface. The angle of internal friction of the deep sands needed only to have been  $12.7^{\circ}$  to maintain a factor of safety of 1. The analysis of the subsequent failure of the exposed point (assuming that it failed in a direction parallel to the range lines) indicates that an angle of friction of  $23.2^{\circ}$  would be sufficient to maintain stability. The sand in the small failure at range 13-D needed an angle of internal friction of only  $12.9^{\circ}$  to maintain stability.
