# STILLING BASIN MODIFICATIONS BULL SHOALS DAM WHITE RIVER, ARKANSAS

Hydraulic Model Investigation

TECHNICAL REPORT NO. 2-488

U. S. Army Engineer Waterways Experiment Station  
CORPS OF ENGINEERS

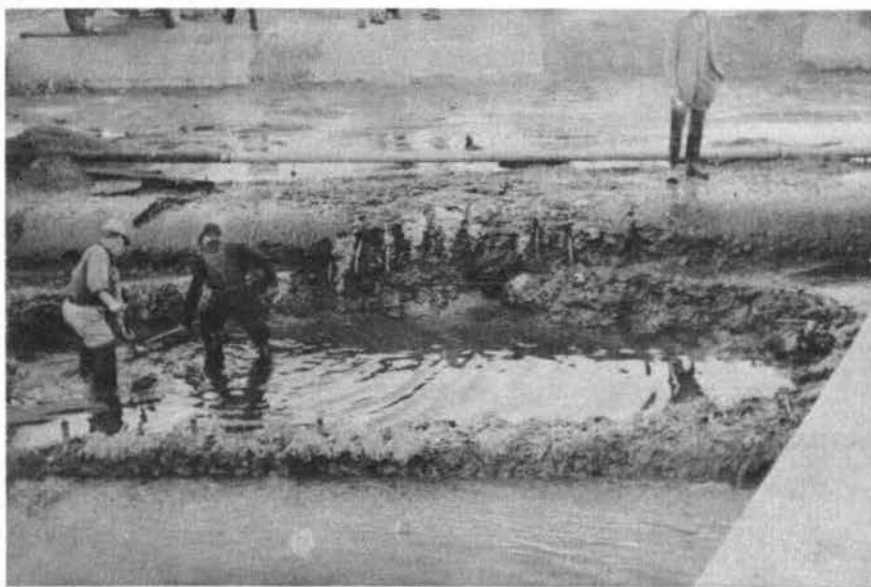
stilling basin, by use of probes and underwater viewing devices, disclosed an appreciable amount of damage to the concrete steps as well as an accumulation of assorted debris. Accordingly, it was decided that a cofferdam should be constructed downstream from the end sill so that the stilling basin could be unwatered for a thorough inspection. This inspection revealed that the floor of the basin had been damaged, to varying degrees, immediately downstream from 12 of the 16 flood-control sluices. The most severe damage had occurred just downstream from the top of the first stilling basin step. Erosion of the concrete, in some cases, reached a maximum depth of 3-1/2 ft (fig. 2). The appearance of the damaged concrete

Fig. 2. Typical damage to stilling basin steps

in certain areas indicated that initial damage had been caused by cavitation at or near the tops of the ellipsoidal steps and that, probably thereafter, a combination of cavitation and abrasive action had caused the damage to progress at an ever-increasing rate.

5. Temporary repairs were made below fourteen of the sixteen conduits by covering the first two steps with an upward-sloping concrete ramp. Downstream from one of the two remaining conduits, all four steps were covered by a sloping ramp. The steps below the remaining conduit were left as originally constructed for test purposes. During these repairs pressure cells were embedded in the concrete for determination of pressures.

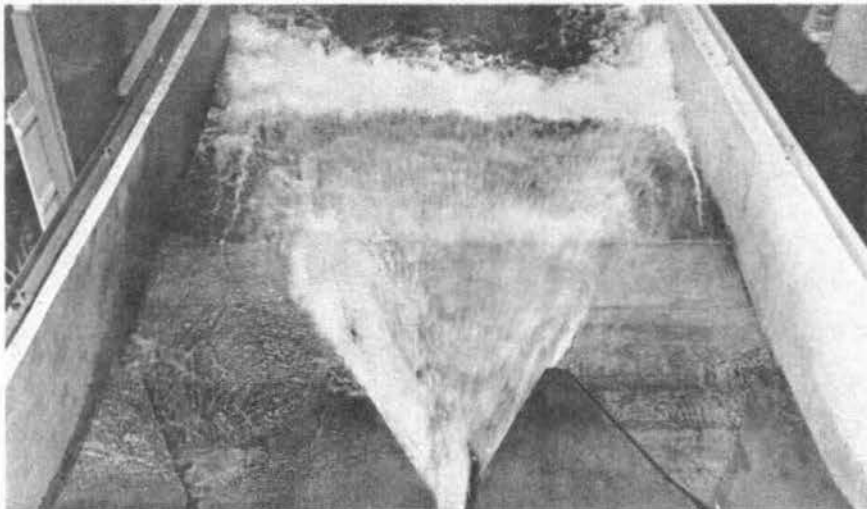
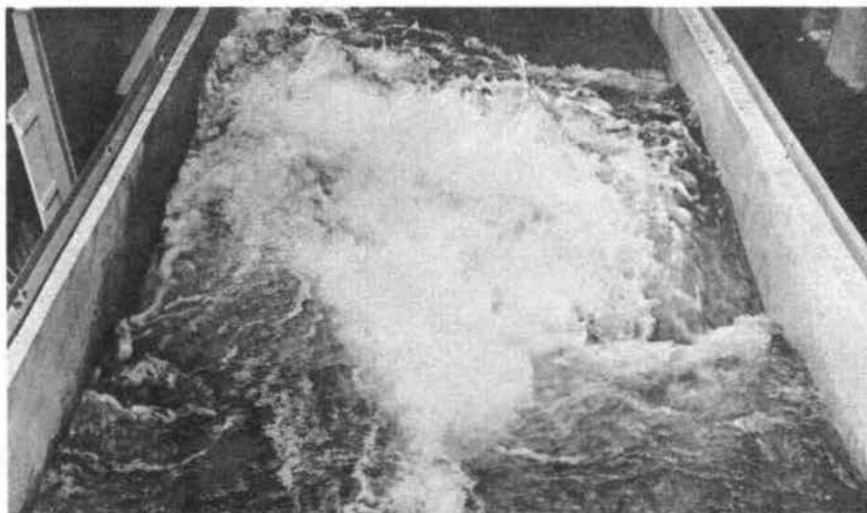
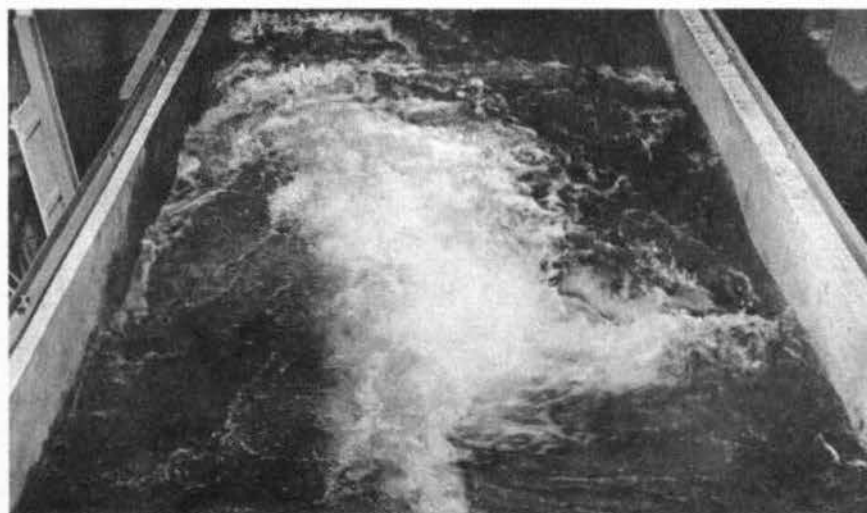
Fig. 3. The high velocity conduit jet (discharge 3500 cfs) impinged directly on 4-ft-high end sill of modification B when tailwater elevation was 452.8, but was contained in stilling basin when tailwater was between 458 and 460

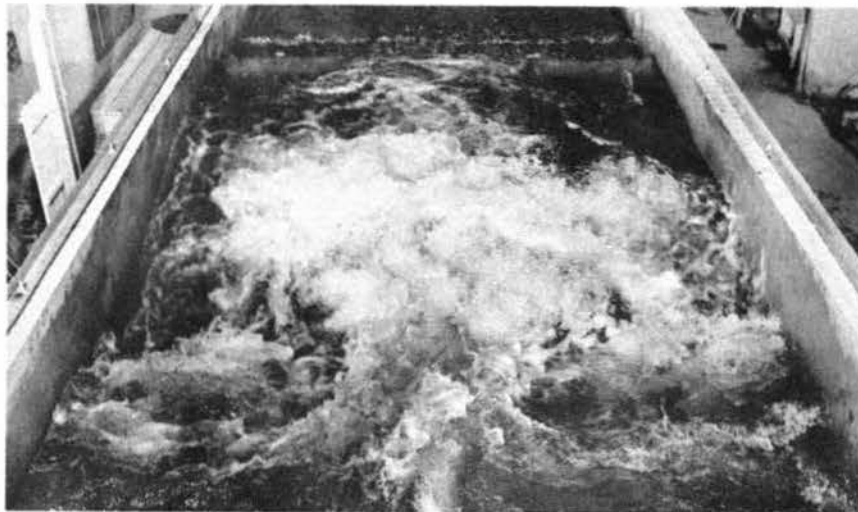
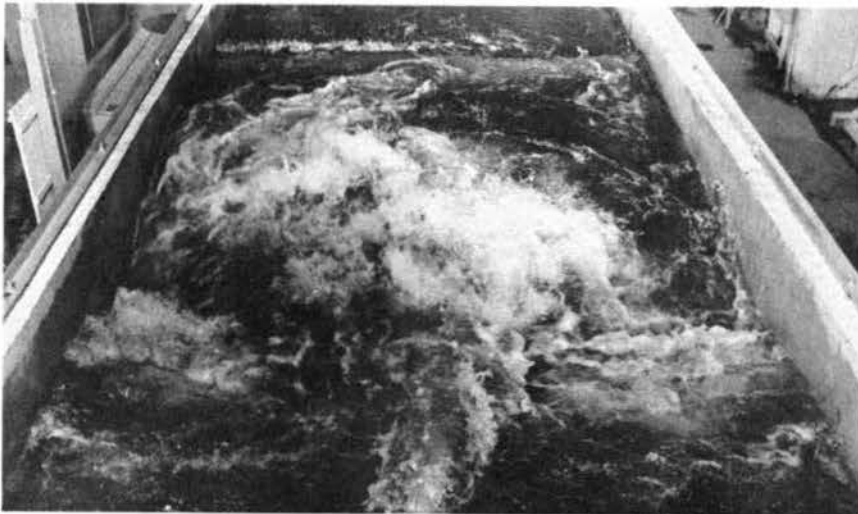
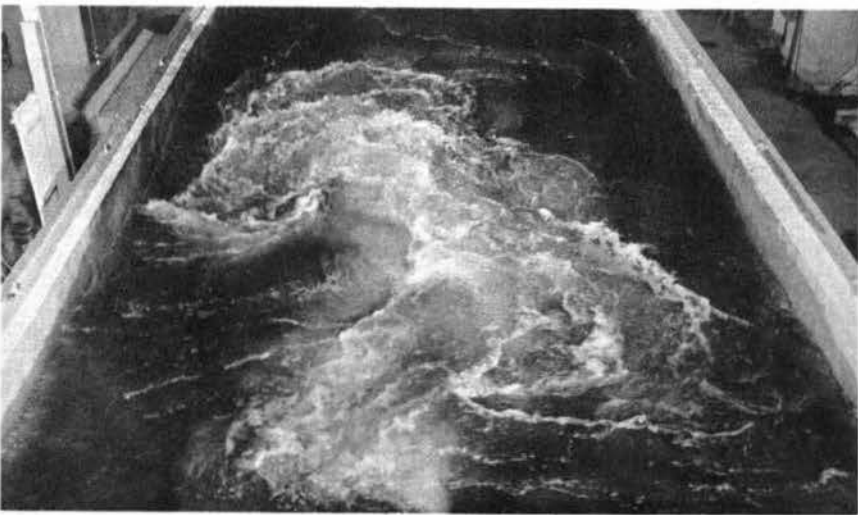
Fig. 4. Ten-foot-high end sill of modification D maintained tailwater depths capable of containing the excess energy of the conduit discharge (3500 cfs) within the stilling basin at all times

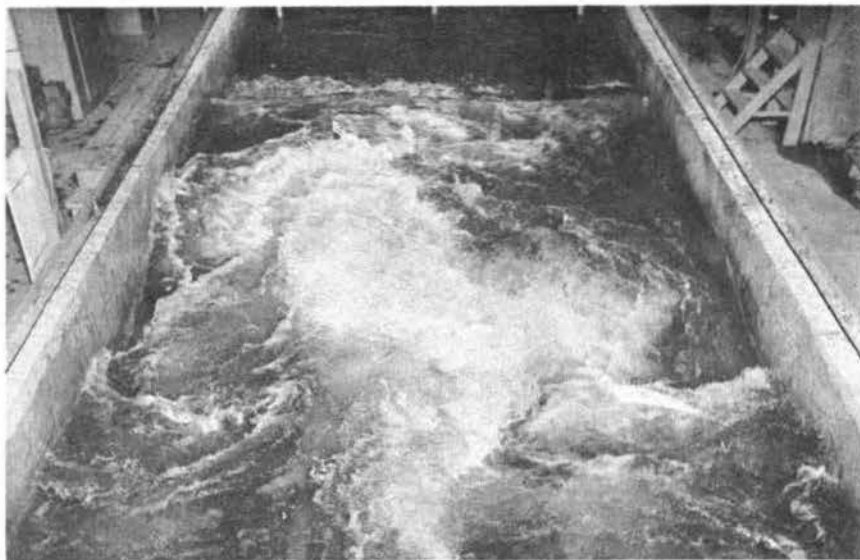
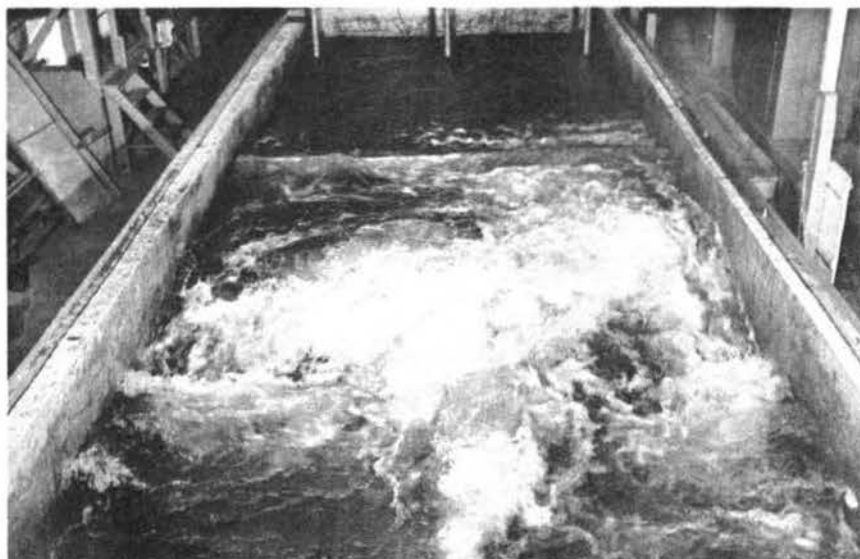
Fig. 5. High velocity jet of conduit discharge (3500 cfs) effectively confined to stilling basin by 12-ft-high end sill of modifications I and M at minimum tailwater elevation of 452.8

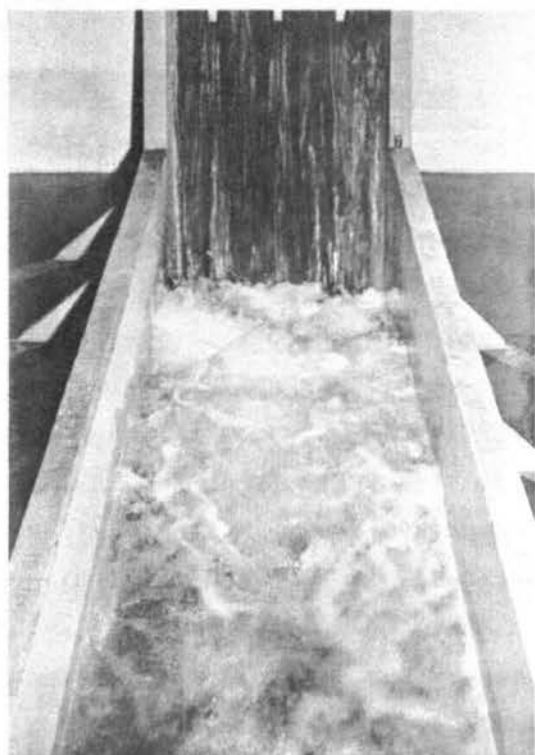
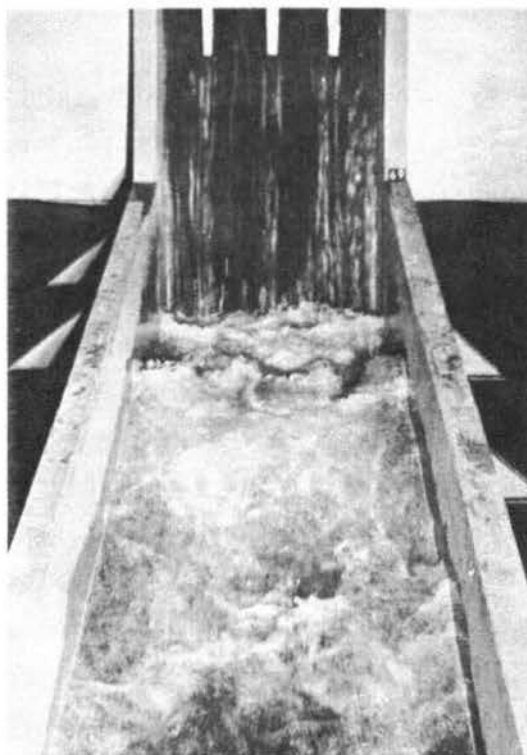
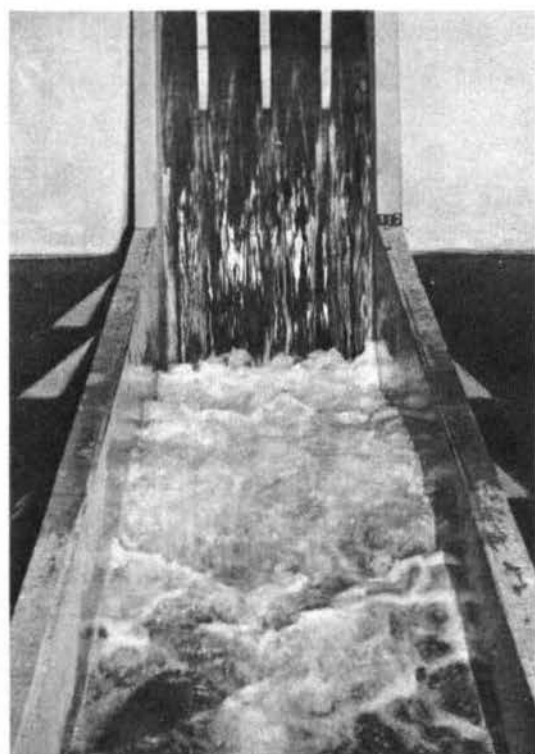
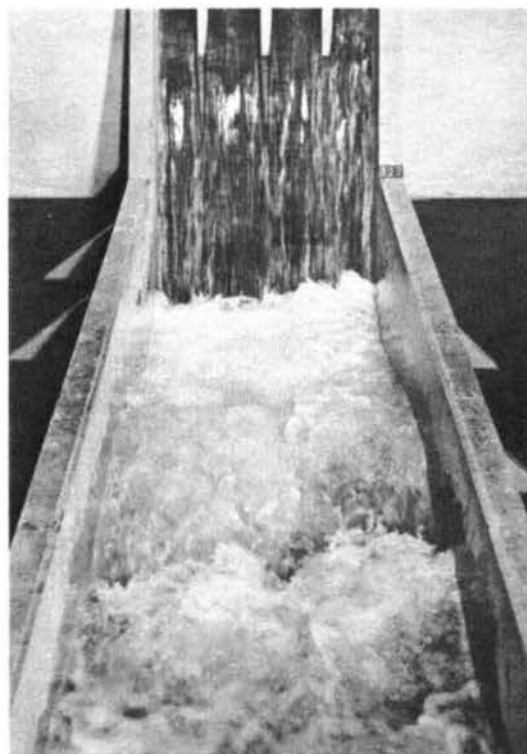
Fig. 6. Hydraulic jump formed in stilling basin of modifications B, D, M, and I at spillway design discharge of 556,000 cfs and tailwater el 514.4
