MADISON RIVER, MONTANA
REPORT ON
*FLOOD EMERGENCY
MADISON RIVER SLIDE*

*VOLUME I
MAIN REPORT*

U. S. ARMY ENGINEER DISTRICT, OMAHA
CORPS OF ENGINEERS
OMAHA, NEBRASKA
SEPTEMBER 1960

U. S. ARMY ENGINEER DISTRICT, GARRISON
CORPS OF ENGINEERS
RIVERDALE, NORTH DAKOTA

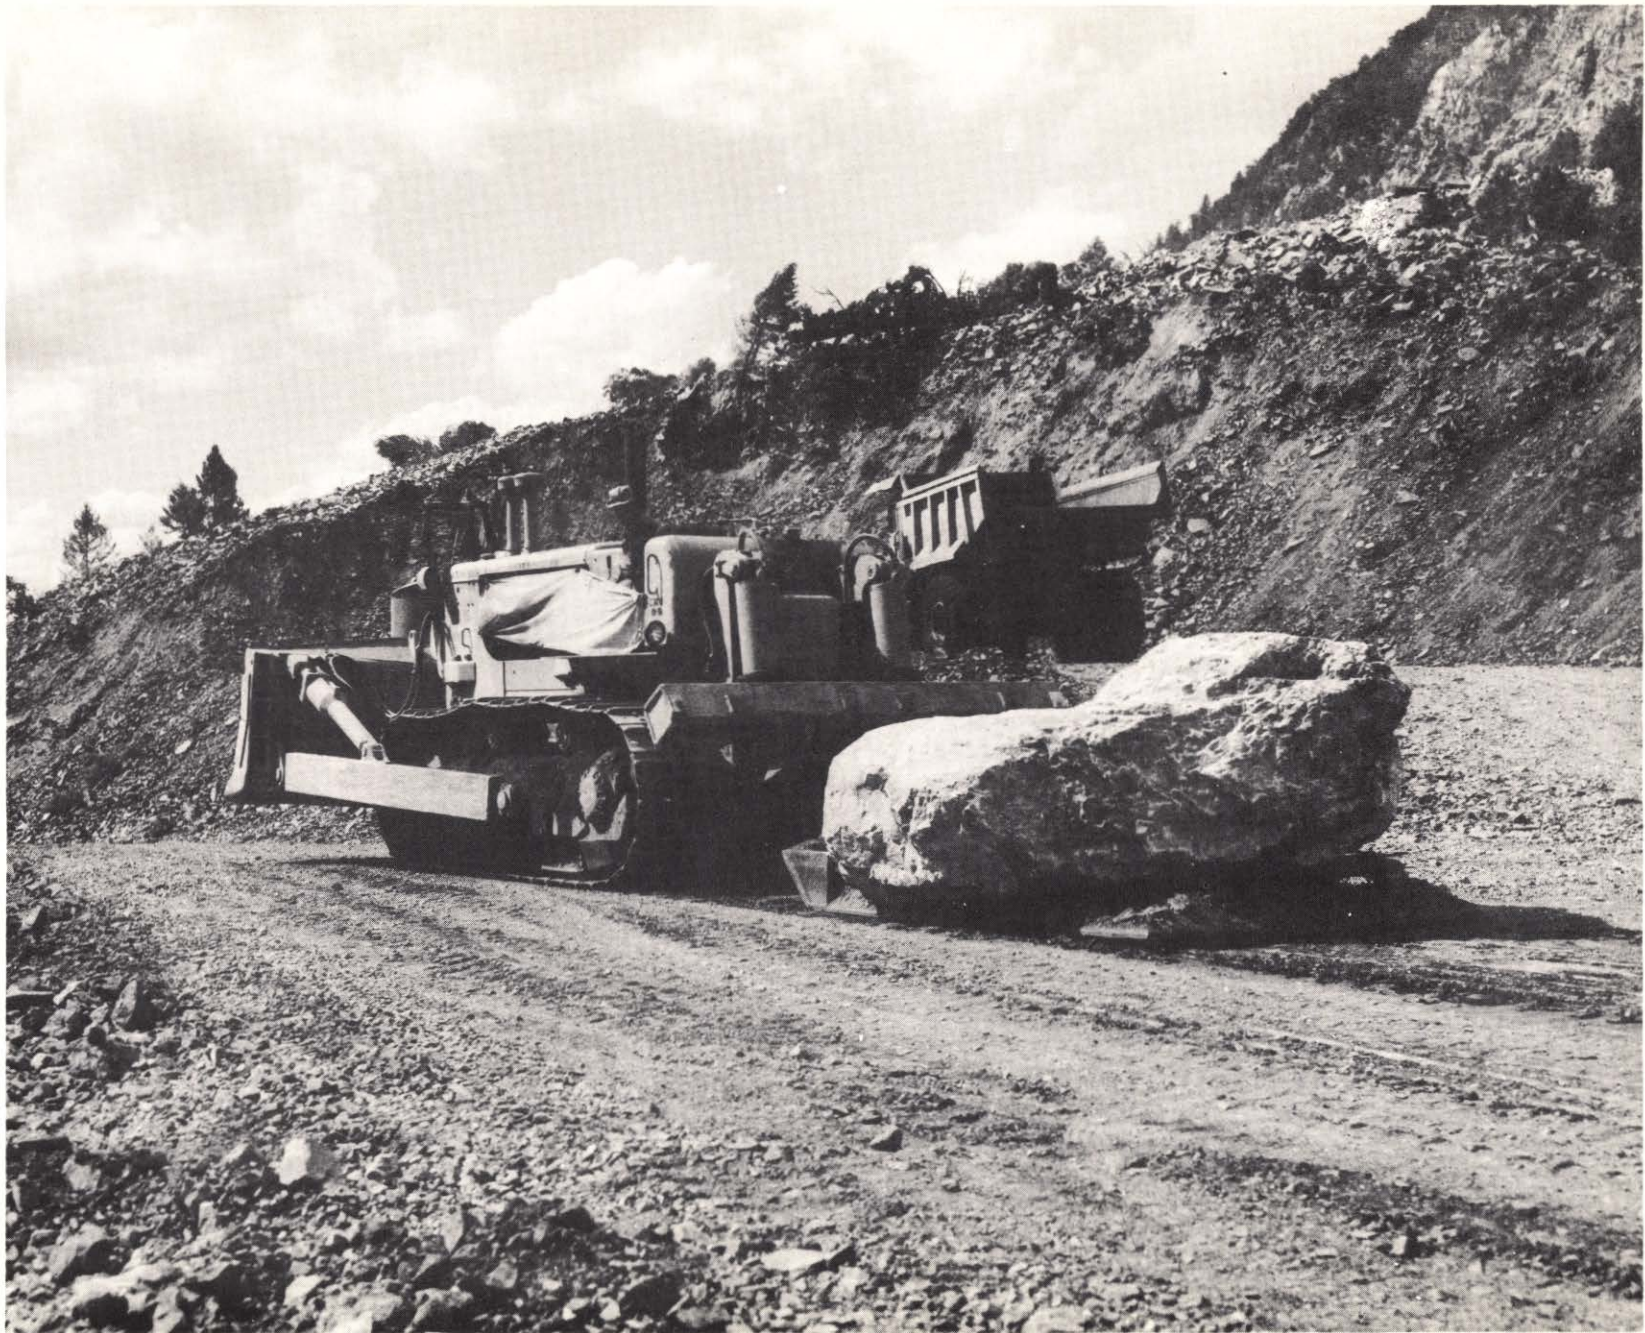
Photo 11. 16 September 1959. Tractor pulling large rock on rock sled.

under the slide. Drilling was started on 3 September, using a churn drill with a drive barrel, so that samples of materials could be recovered. Rock bits were used occasionally, but only when necessary, since their use permitted the recovery of samples only by bailing the mud sludge at the bottom of the holes. In all, six piezometers were installed along the right side of the spillway, though not all were observed concurrently. The locations and observation records of the piezometers are shown on plate 15. Full details of drilling are contained in Appendix X. In general, the observations showed that early conclusions drawn from surface inspections were in error. The earth and rock-floor fines were distributed throughout the major portion of the slide mass. Note material shown in photographs numbers 11 and 17.

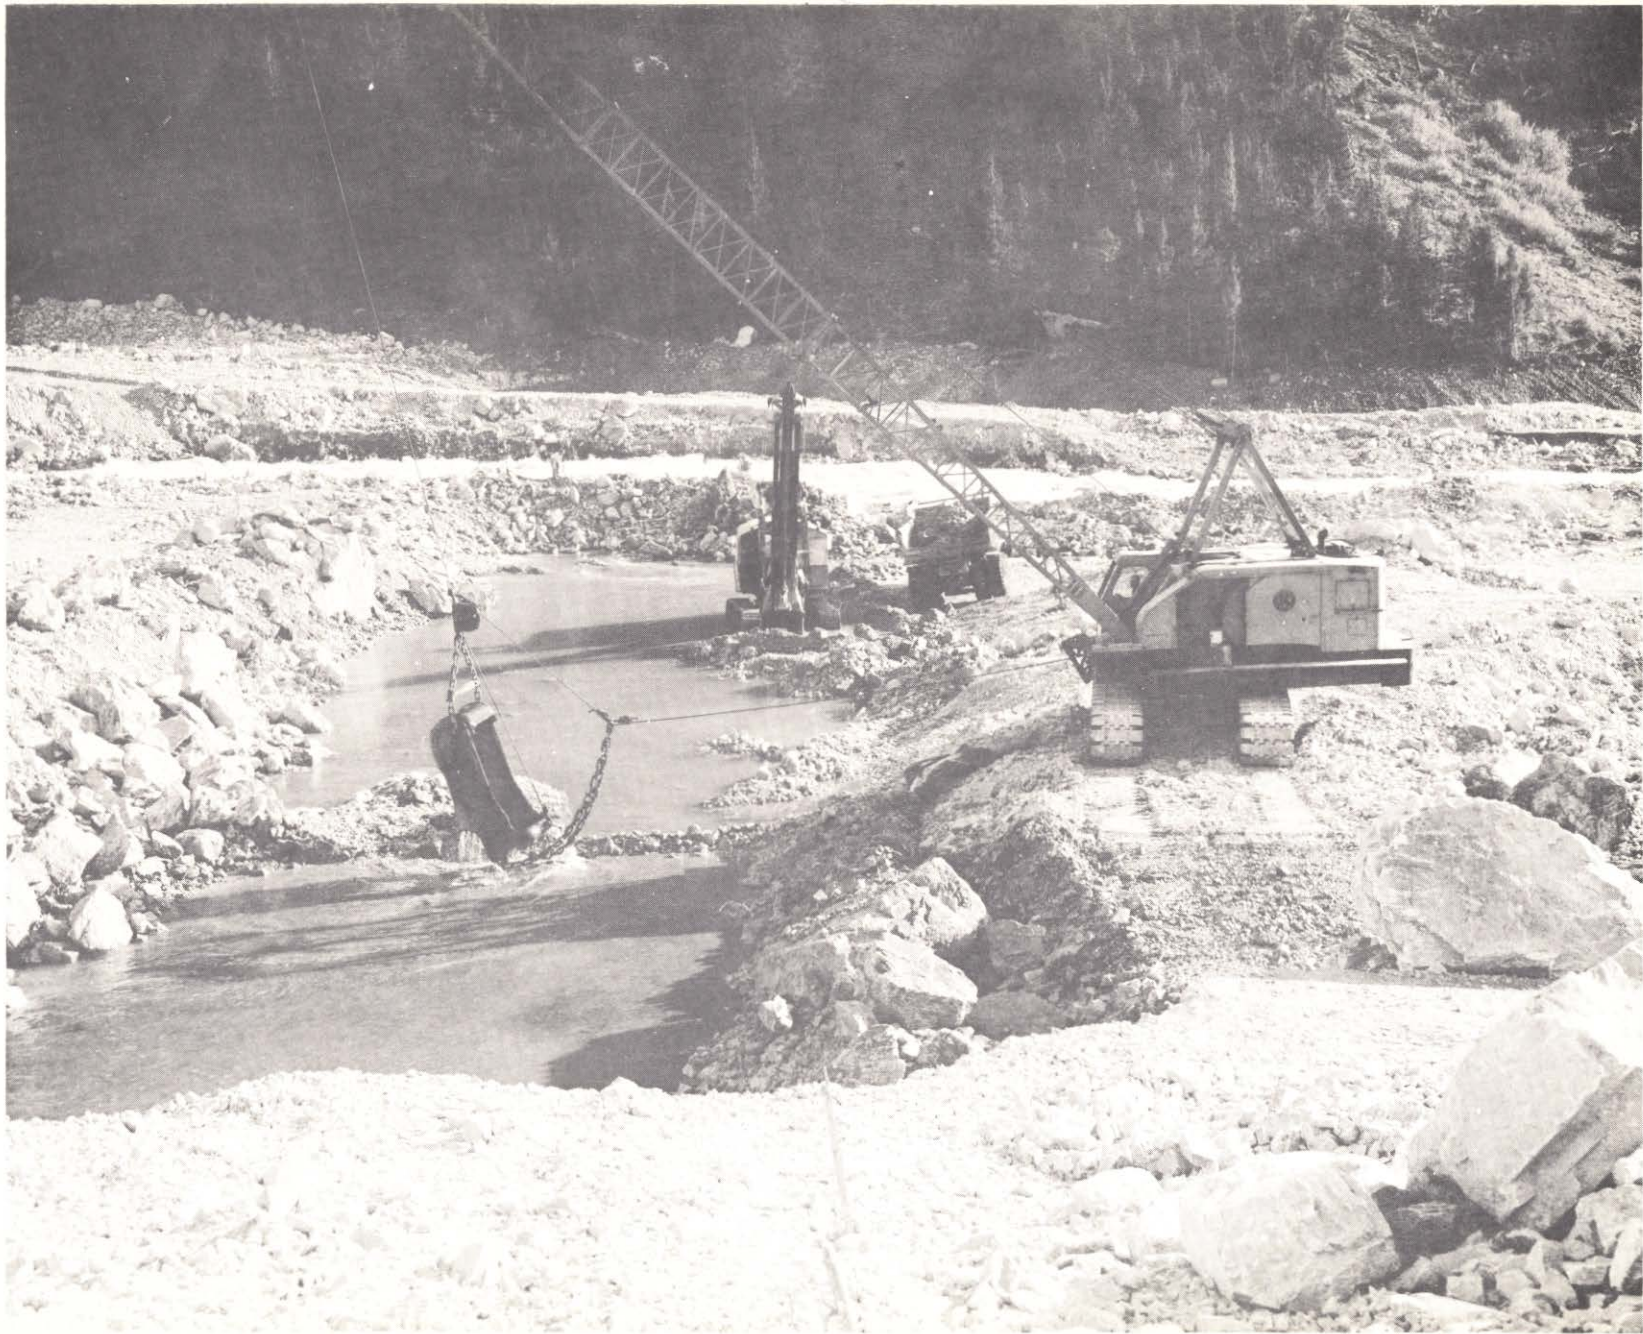
Photo 13. 16 September 1959. Foundation excavation for first rock filled drop structure at about Station 6+00.

49. Serious consideration was given at this time to obtaining durable rock from suitable quarry sites in the mountains nearby, in quantities sufficient to construct two or three permanent rock drop structures, with rock stilling basins, to stop the continued erosion of the spillway, which several times threatened to get out of control. Obviously, such a plan would be both time-consuming and costly, and it was discarded in favor of a plan to lower the spillway and reduce the storage in Earthquake Lake. Foundation excavation for part of the first drop structure is shown in Photo 13.

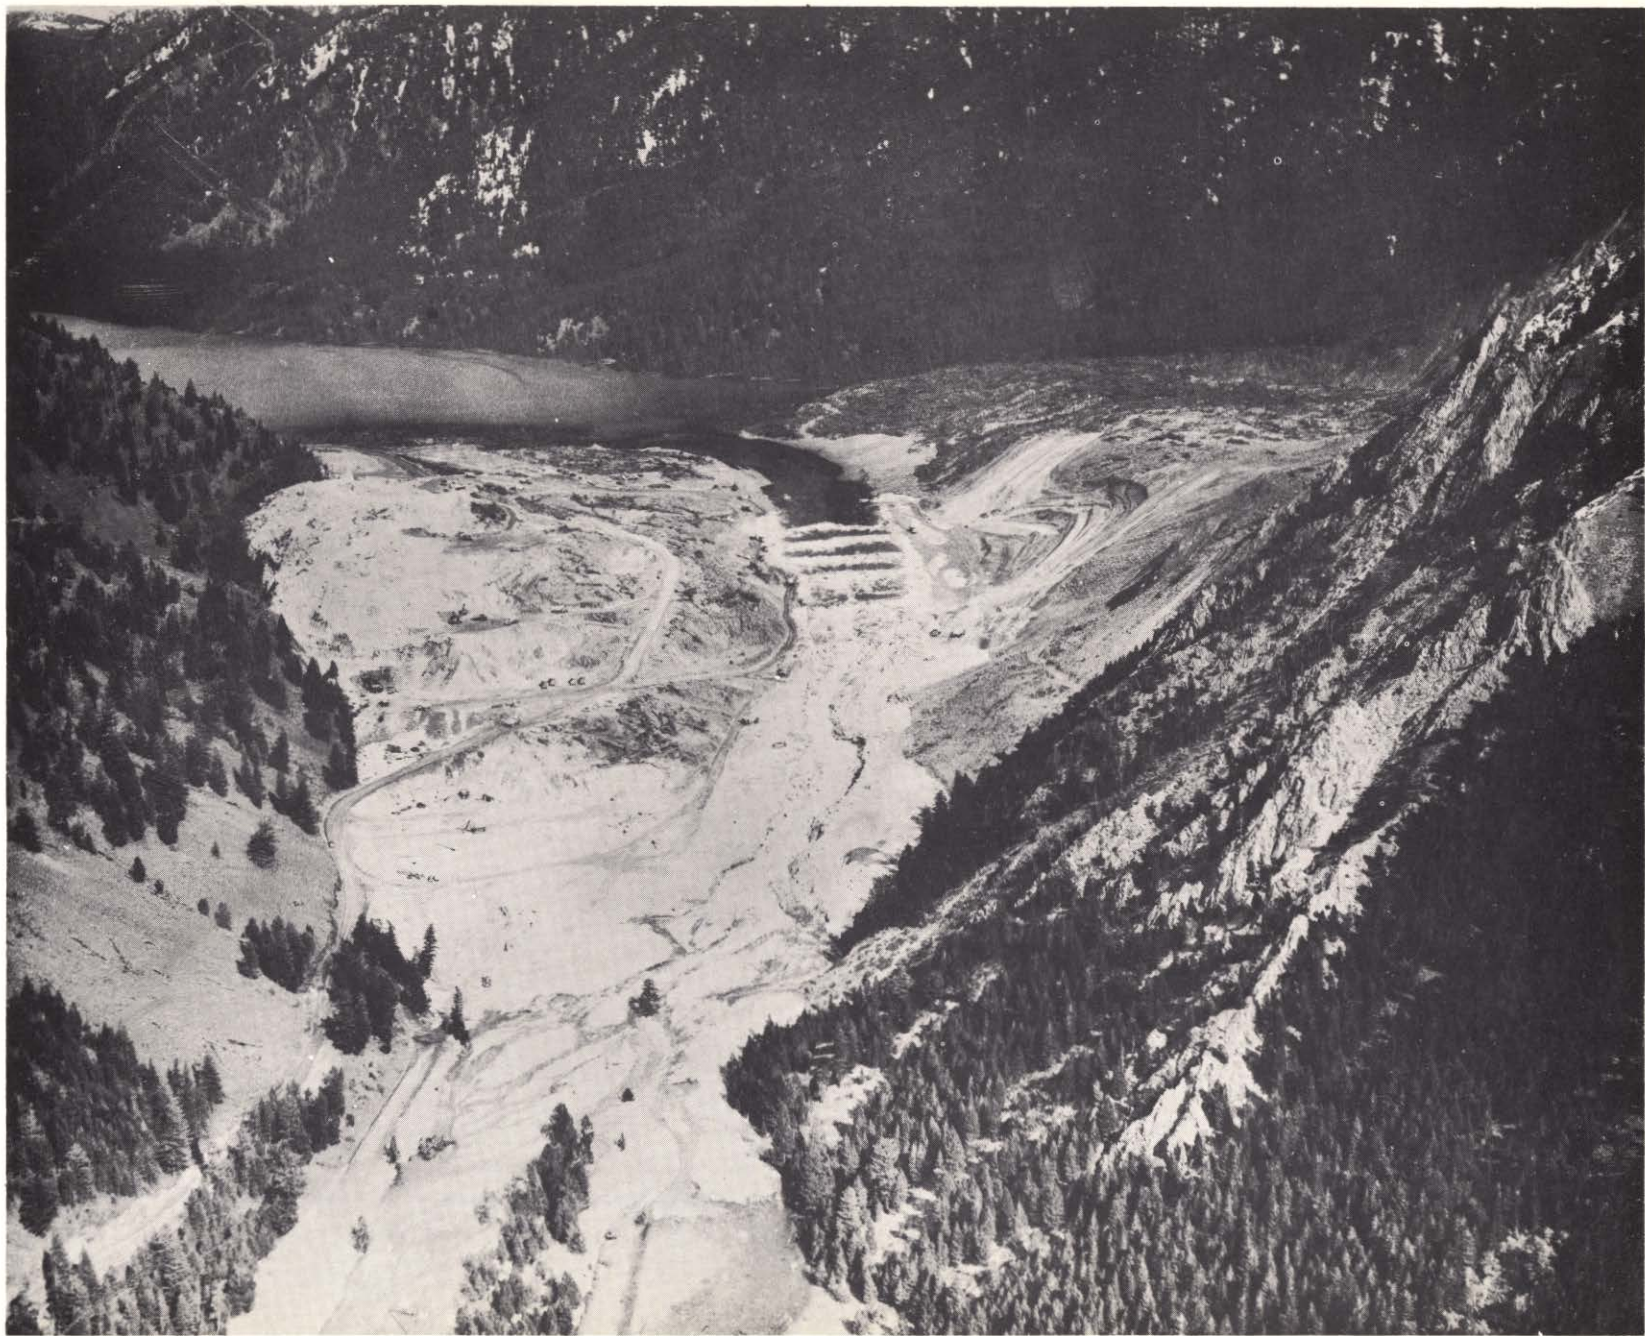
Photo 14. 22 September 1959. Aerial view of slide showing water pouring over rock terraces.

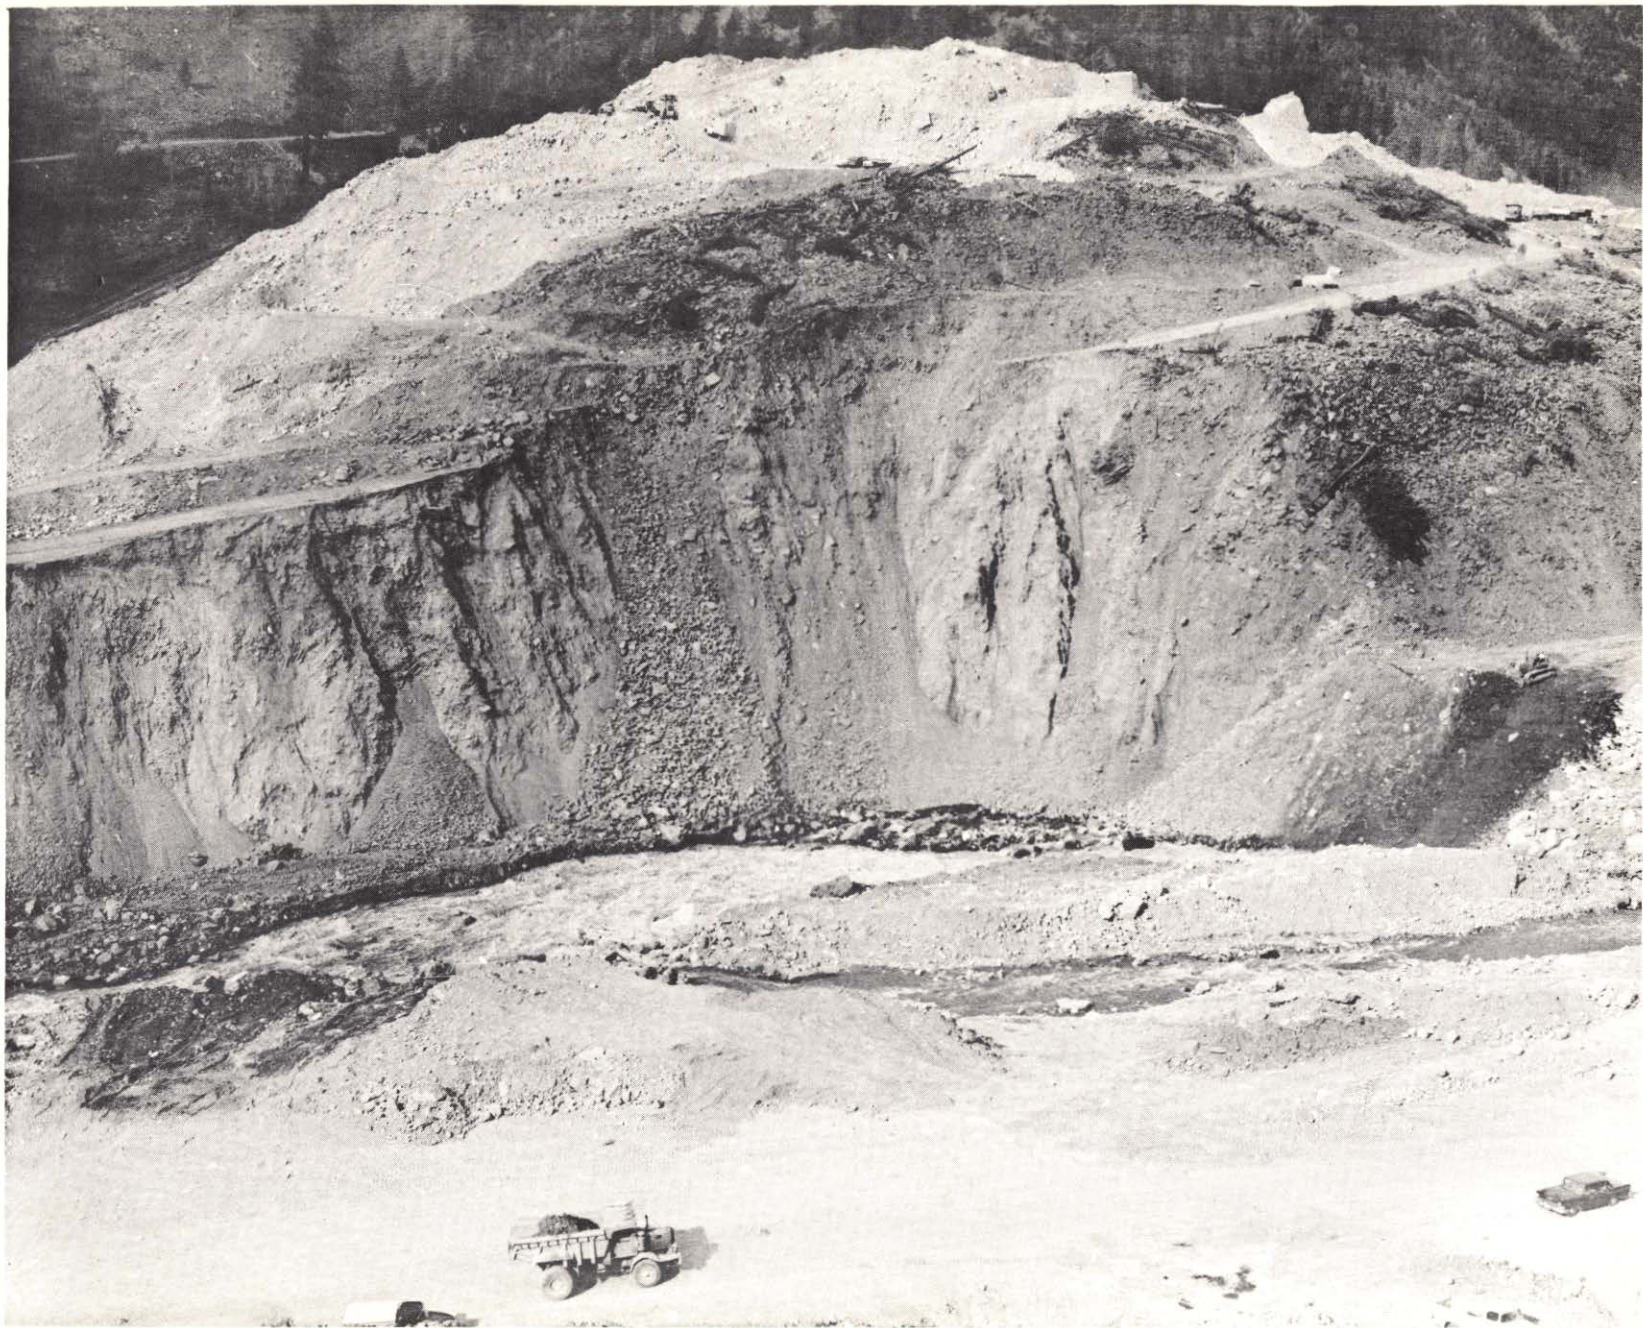
Photo 17. 5 October 1959. Rapid erosion of right bank between Stations 11+00 and 15+00.

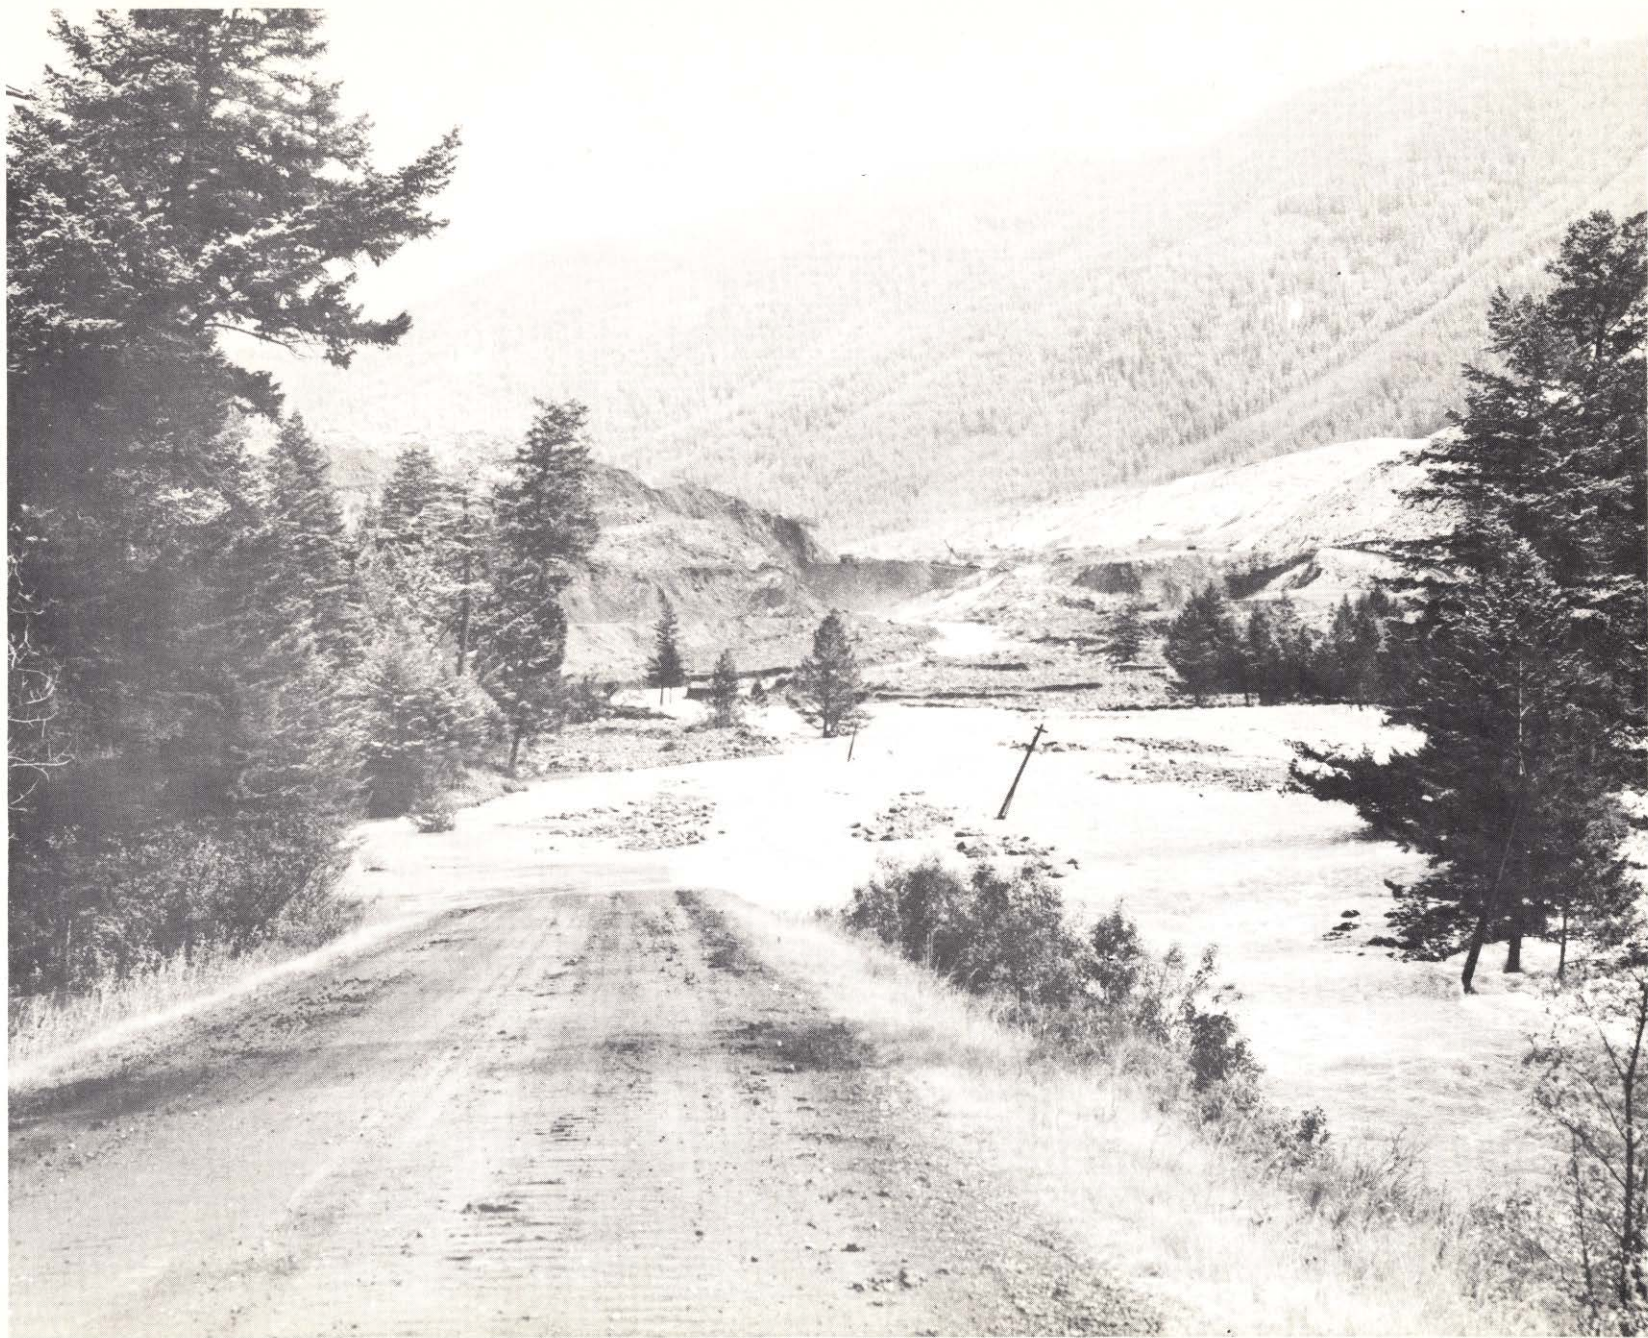
Photo 18. 7 October 1959. First in a series of three photographs showing rapid development of the fan below the slide.

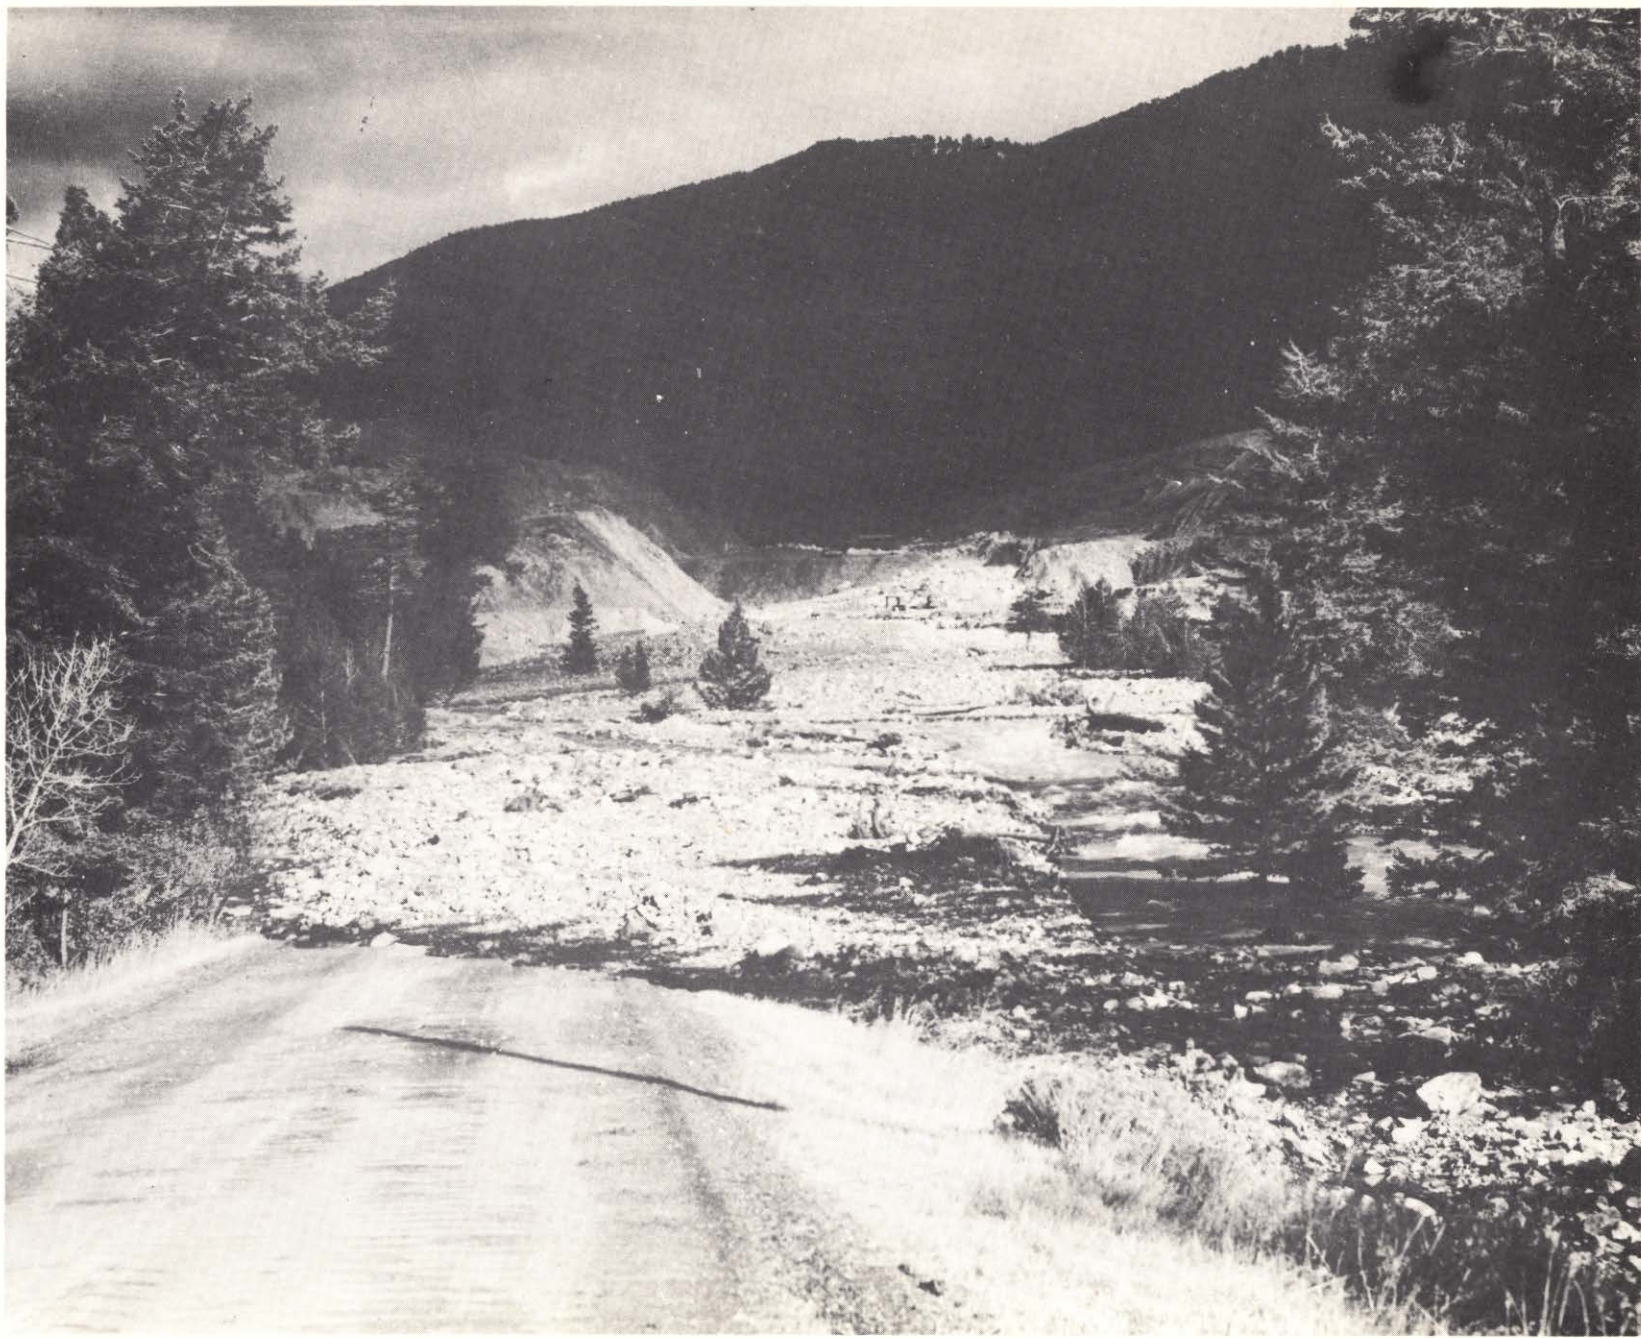
Photo 20. 11 October 1959. View showing rapid development of fan.

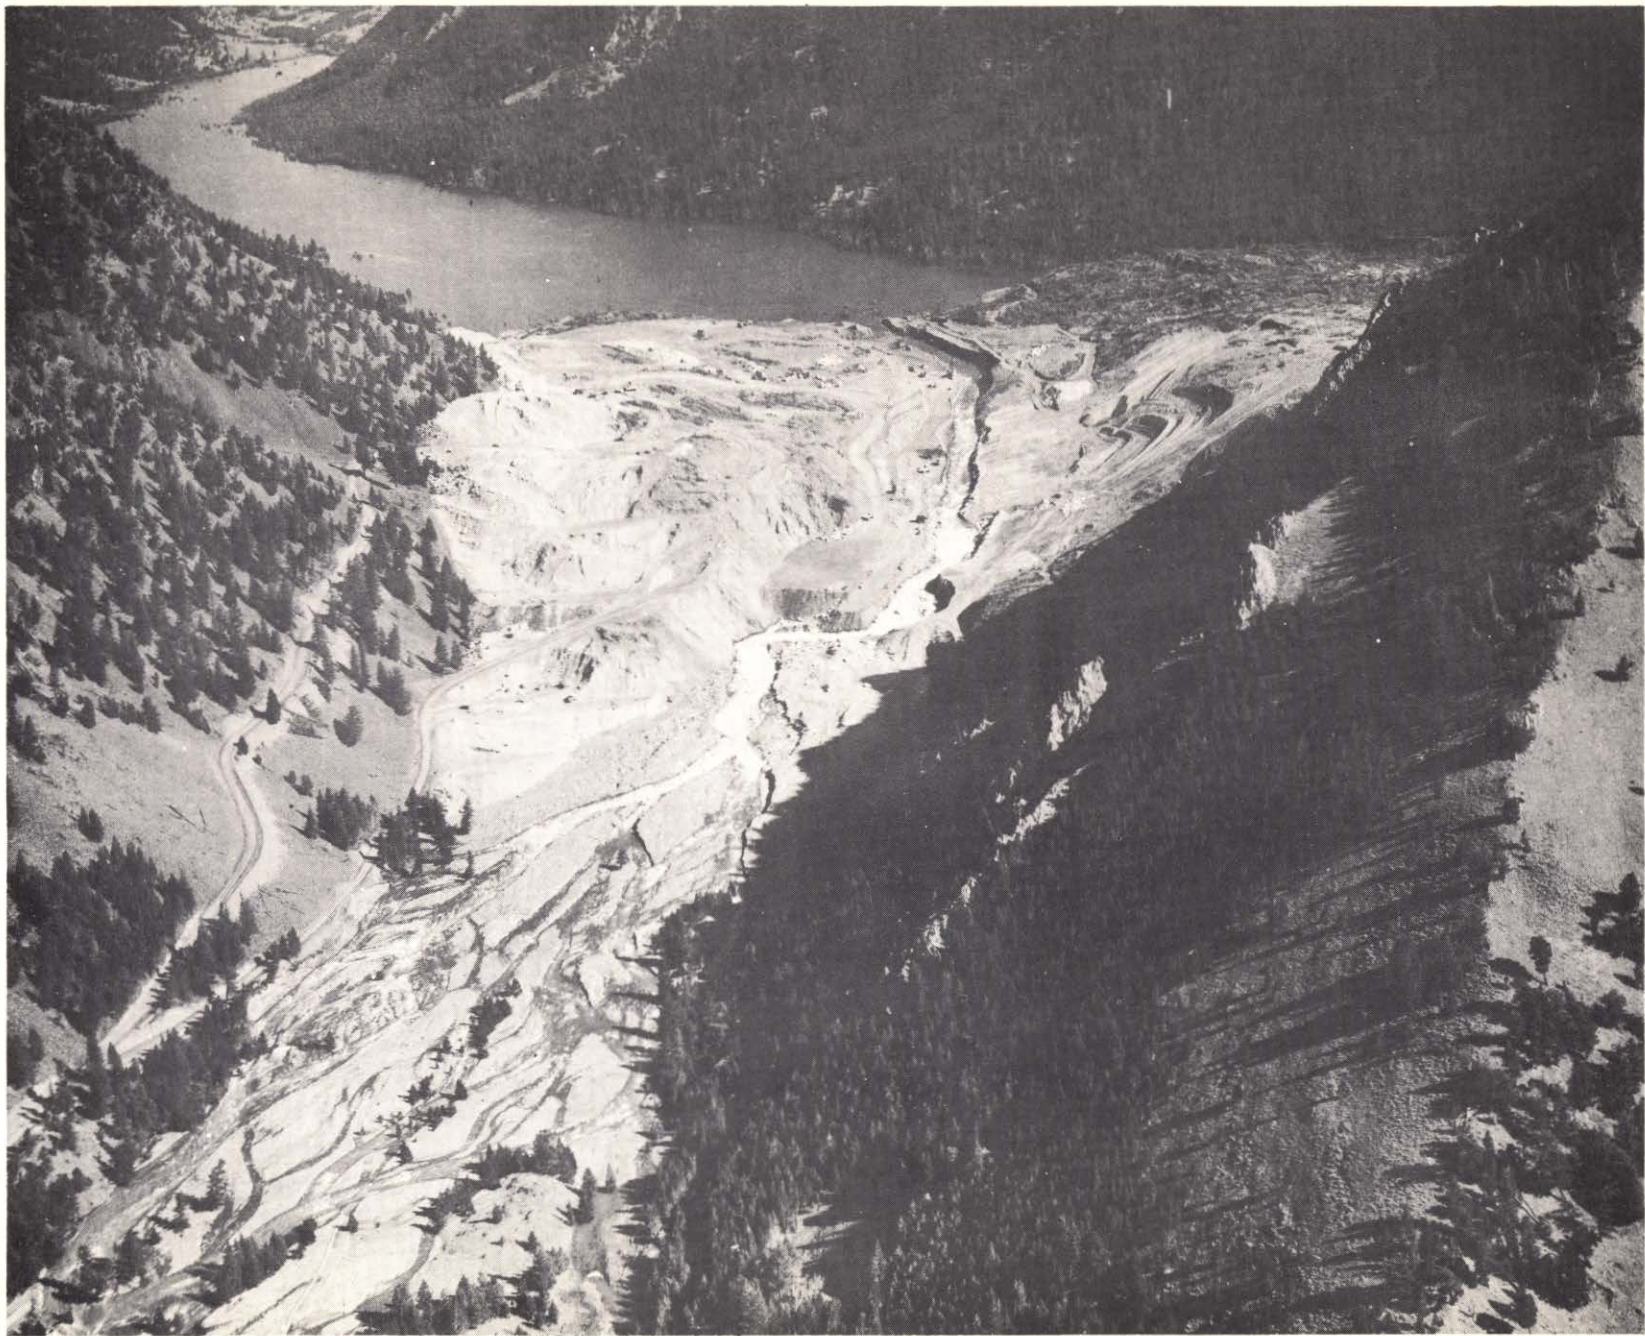
Photo 24. 17 October 1959. Aerial view of slide looking downstream showing spillway channel and buildup of fan below the slide.

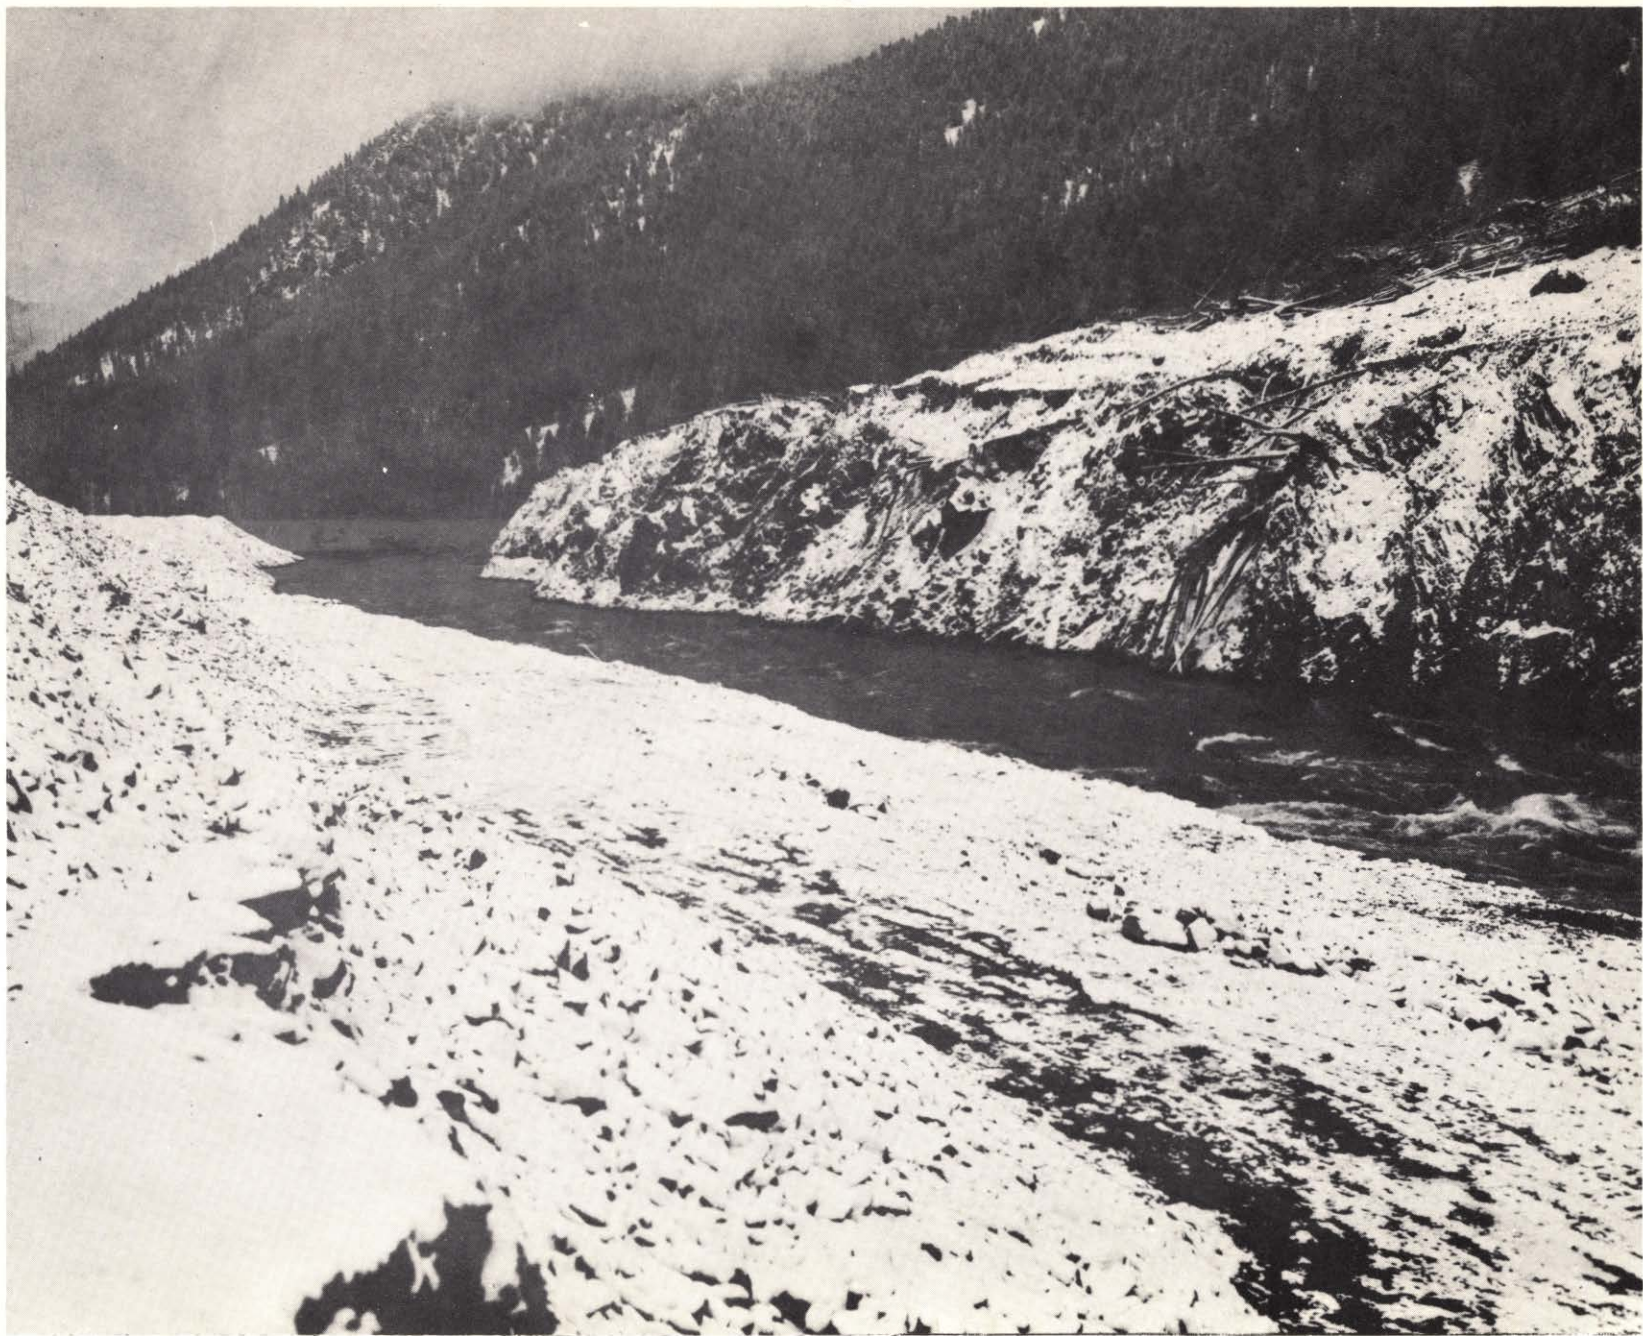
Photo 25. 29 October 1959. Completed spillway entrance looking upstream from about Station 30+00. Note high water line on trees about 50 feet above Earthquake Lake.

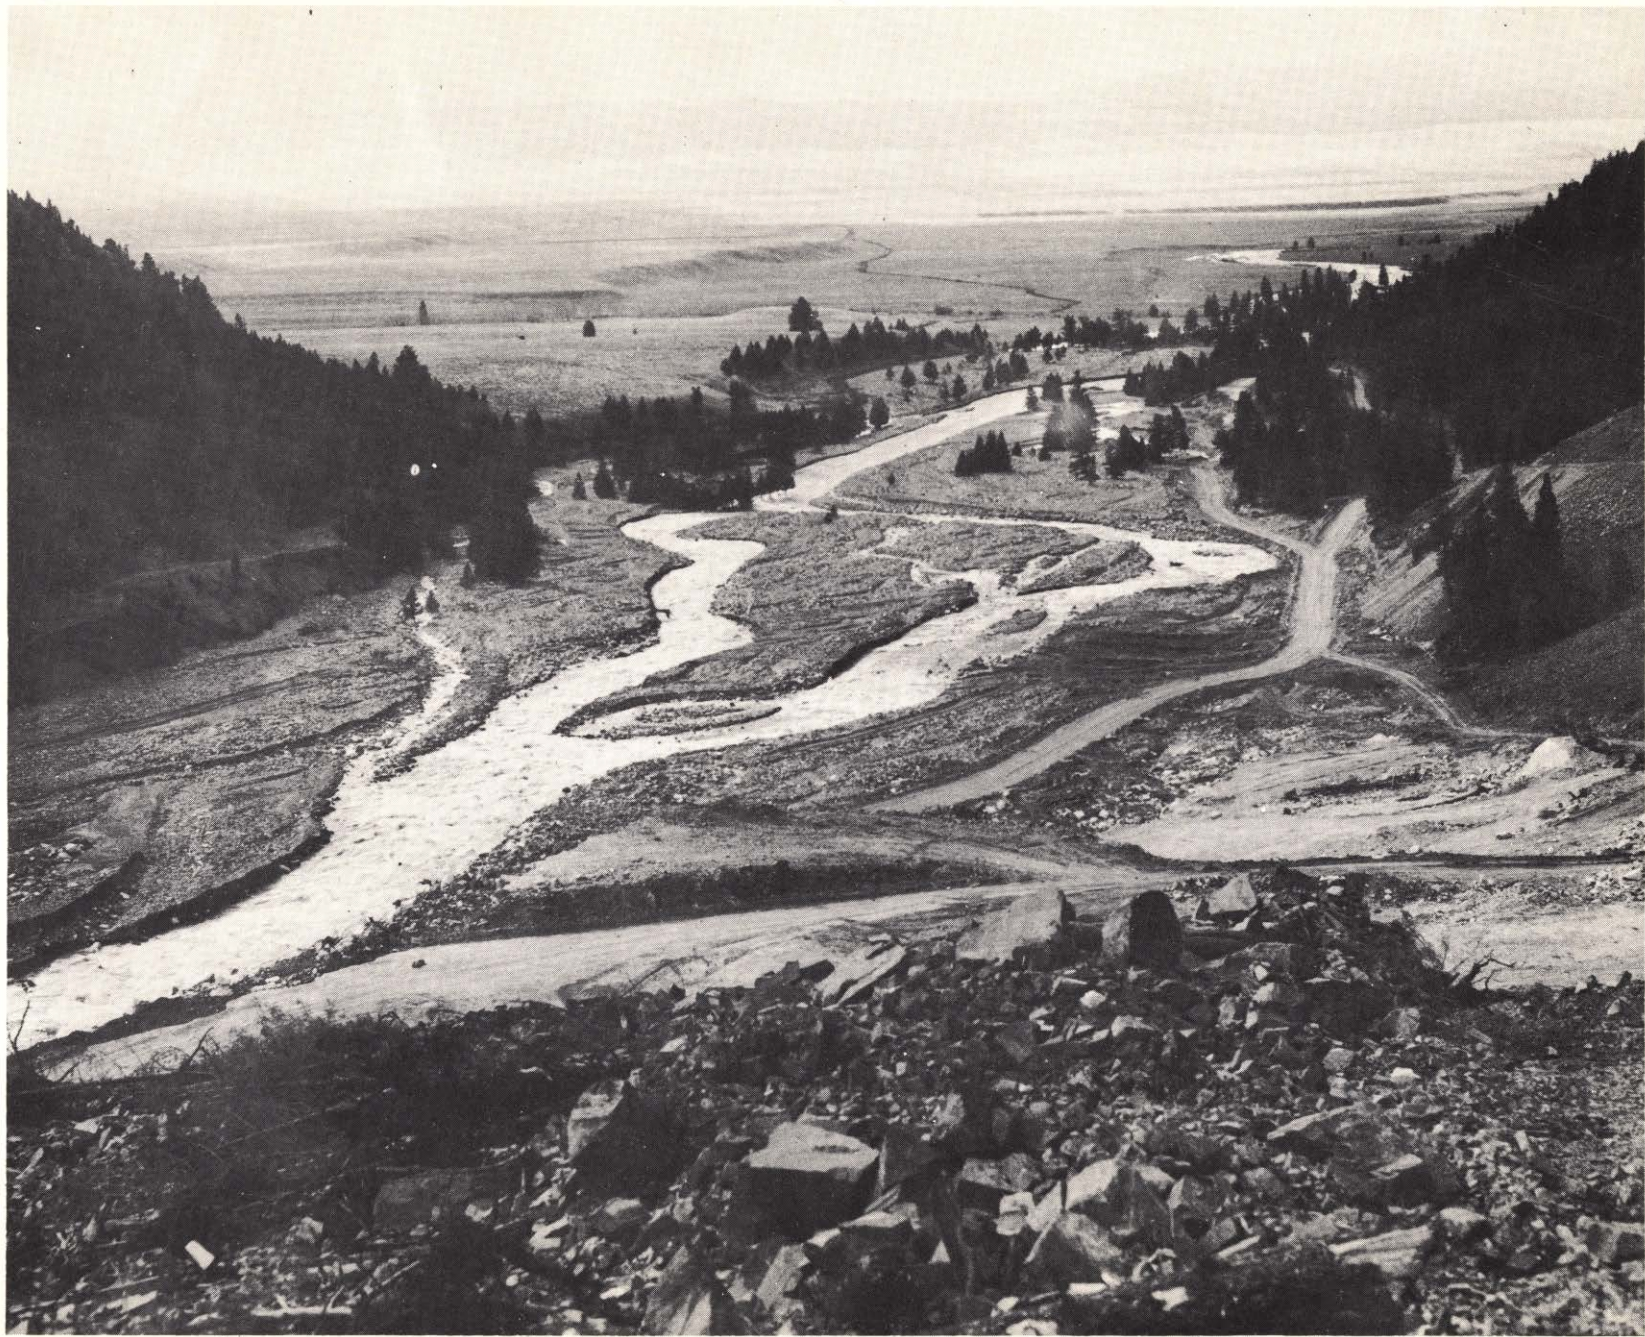
Photo 27. 28 October 1959. View of fan at lower end of slide at end of construction period (for earlier view, see Photo 2).
