## Spark Gap Insulator Wall Survivability

William Wright, Jr.  
US Army Electronics Technology & Devices Laboratory, (ERADCOM)  
Fort Monmouth, NJ 07703

Various insulator materials, including acrylic plastic, fused silica, Transite (an inexpensive asbestos-cement), and Pyrex have been investigated to determine their abilities to survive the hostile environment of a gas-filled spark gap operating at 8 kJ and 0.4C per pulse and 40 kA peak current at repetition frequencies up to a few tens of hertz. Damage mechanisms observed have included mechanical fracture, softening and deformation, ablation, crazing, current tracking, electrode-material deposition, and UV solarization. The acrylic walls failed from softening and ablation, the Transite from current tracking between laminations, and the fused silica from mechanical fracture. The Pyrex walls have darkened from deposits but are still running. Good results have been obtained with Pyrex, a composite wall of acrylic and Transite, and acrylic alone with the electrodes liquid-cooled.

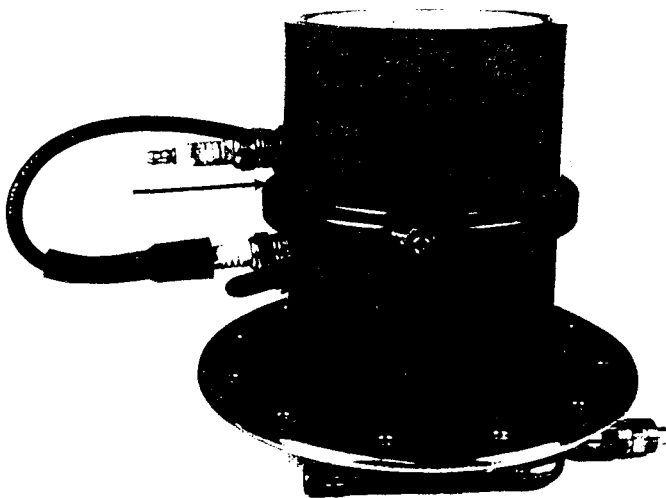
The as-delivered spark gap used cast acrylic walls, 4.0 in. ID and 0.375 in. thick, and an uncooled center electrode. The progression of damage with increasing repetition rate and average power was darkening of the walls, shallow axial crazing in the line-of-sight region, surface melting of the crazed region, and finally softening and gross deformation of the wall edge in contact with the center electrode, as shown in Figure 4, whose temperature reached 133°C, well above the softening temperature for acrylic. At moderate and high average power there was a strong acrylic smell in the exhausted gas, probably from the dissociation of polymers into monomers on the inner wall surface. There was no evidence of electrical tracking over the surface or damage from the acoustic shocking. The wall discoloration was a soft, sooty brown deposit, presumably copper evaporated during the pulse and oxidized before reaching the walls. Any UV solarization of the acrylic was in a very shallow layer at the surface, as would be expected from the high attenuation of UV in acrylic. The walls were easily cleaned with mild abrasive cleanser and water. The arc associated with a prefire fault, during which the capacitor bank dumped and the power supply drove its short-circuit current through the spark gap until the main breaker cleared, was lower current but of much longer duration. This longer time allowed significant arc motion, often leaving a meandering track on the electrode surface up to 0.5 in. long, moving under the influence of magnetic and gas dynamic forces, predominantly away from the current feed. Where the errant arc attached itself to the electrode-wall interface, the result was a heavy deposit of metallic copper, strongly bonded to the wall surface.

Figure 4 Deformed Acrylic Wall

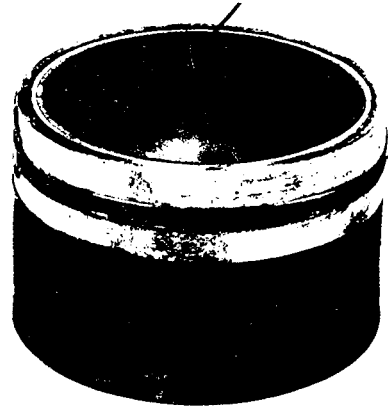
To capitalize on the good electrical properties of acrylic and the thermal properties of Transite, a composite wall was made from a 1.0 in. ring of Transite joined to an acrylic wall with a cylindrical step-joint. The Transite rings needed external metal reinforcing bands to maintain physical integrity because the presence of the holes for the spark plugs reduced the cross section of the ring by over 50 percent. Figure 7 shows these walls after 144,000 pulses at 8 kJ and 0.4 C with a prefire rate of approximately 5x10<sup>-4</sup>, equivalent to the acrylic walls alone. The major damage evident is the crack in the Transite, which occurred before the metal bands were applied, and the wearing away of the Transite around the crack from ablation and the scrubbing action of the gas flow. These walls were still servicable when shut down.

The Transite rings are inherently weak, and the machining necessary to join the materials makes the composite no longer inexpensive, but this wall gave satisfactory results at 0.24 Mw average power for 15 s burst length for hour-long runs.

Figure 7 Transite-Acrylic Composite Wall

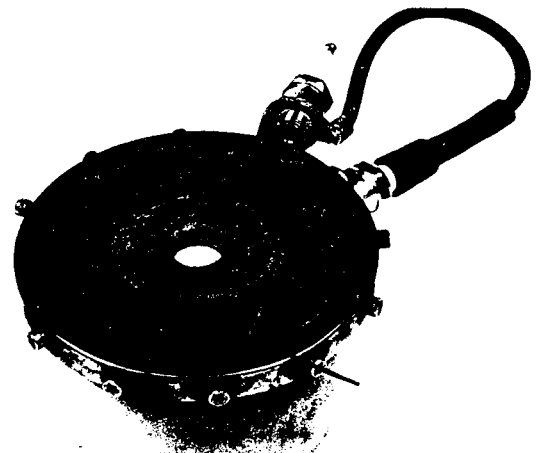
mechanical strength, and UV transmission which allowed placing the pre-ionizing UV source, the spark plugs in this case, outside the gap envelope. With 0.187 in. thick fused silica walls the gap ran for much of one day at 0.32 Mw for many minutes at a stretch, with a total pulse count of 43,000 pulses and a prefire rate of 4x10<sup>-4</sup>. Enough heat was deposited in the center electrode to slightly blue it, but there was no apparent damage to the walls. The next day, however, after a few seconds at low repetition rate and no kick-outs, the upper wall exploded. Autopsy showed no sign of the 45° angular cracking characteristic of fused silica which has been thermally abused, but that some of the knockout arc spots had migrated to the wall-center electrode interface. A little known characteristic of fused silica is its disparity between short-term and long-term mechanical strength<sup>1</sup>, due to the slow propagation of surface microcracking through its volume. The postulated failure mode is that one of the knockout arcs near the wall, see Figure 8, created surface cracking which, over a few hours, propagated through the wall, weakening it sufficiently that the pressure pulses from normal operation the following day broke it. The presence of grinding marks from the fabrication of the walls may have exacerbated the surface problem.

Figure 8 Fused Silica Wall Showing Kickout Arc Spot
