RESTRICTED
NAVY DEPARTMENT
BUREAU OF AERONAUTICS

AERONAUTICAL ENGINE LABORATORY
REPORT ON

MODEL TEST OF PRATT & WHITNEY
AIRCRAFT IN-4360-4 ENGINE

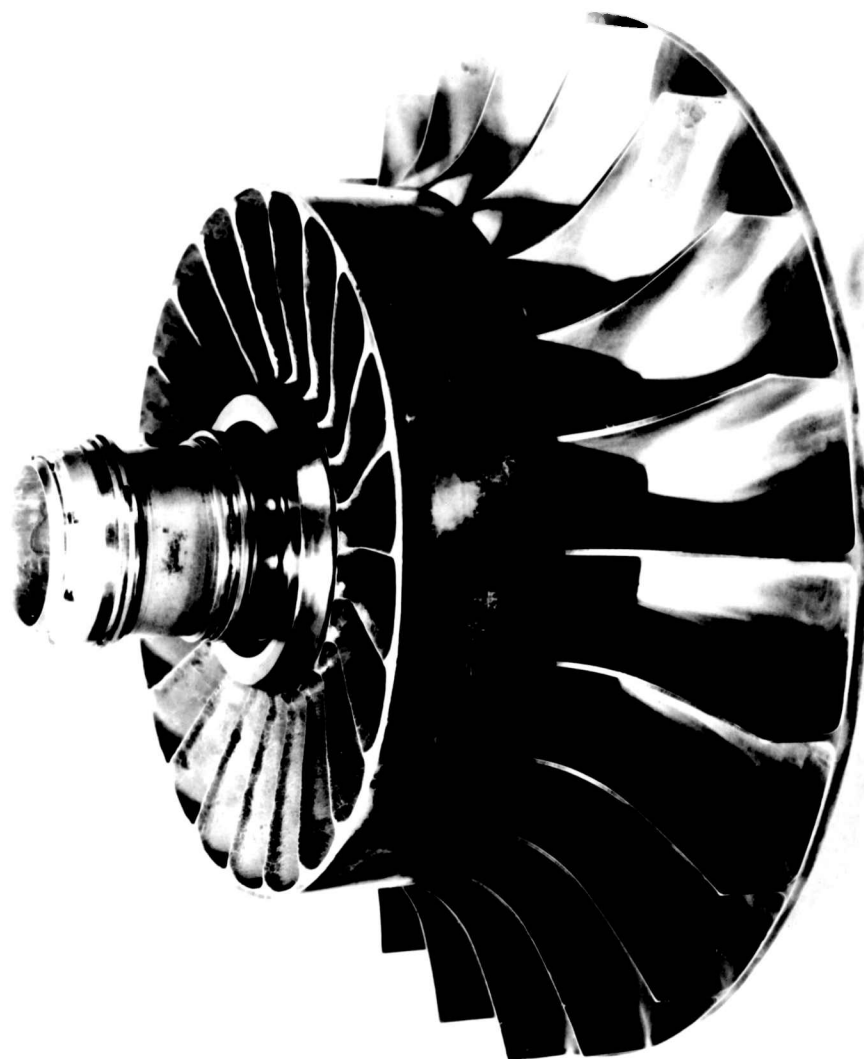
PLATE 13

- (a) Hydraulic supercharger drive couplings - After 77 hours of endurance, failure of the hydraulic coupling pinions occurred during a take-off period of operation (Plates 18 to 23, inclusive). Fixed ratio supercharger drive gears were installed in place of the variable speed hydraulic couplings for the remainder of the endurance test. Similar failures have been experienced during development tests at the manufacturer's plant. The 4360-4 engine, Serial No. P-1, presently undergoing calibration tests at the Naval Air Experimental Station, has experienced two failures of a similar nature, one failure occurring after a total of 48.6 hours operation and the other after 125.7 hours.

IMPELLER AFTER SUPERCHARGER DRIVE FAILURE AT 77 HOURS ENDURANCE
PRATT & WHITNEY XR-4360-4 ENGINE

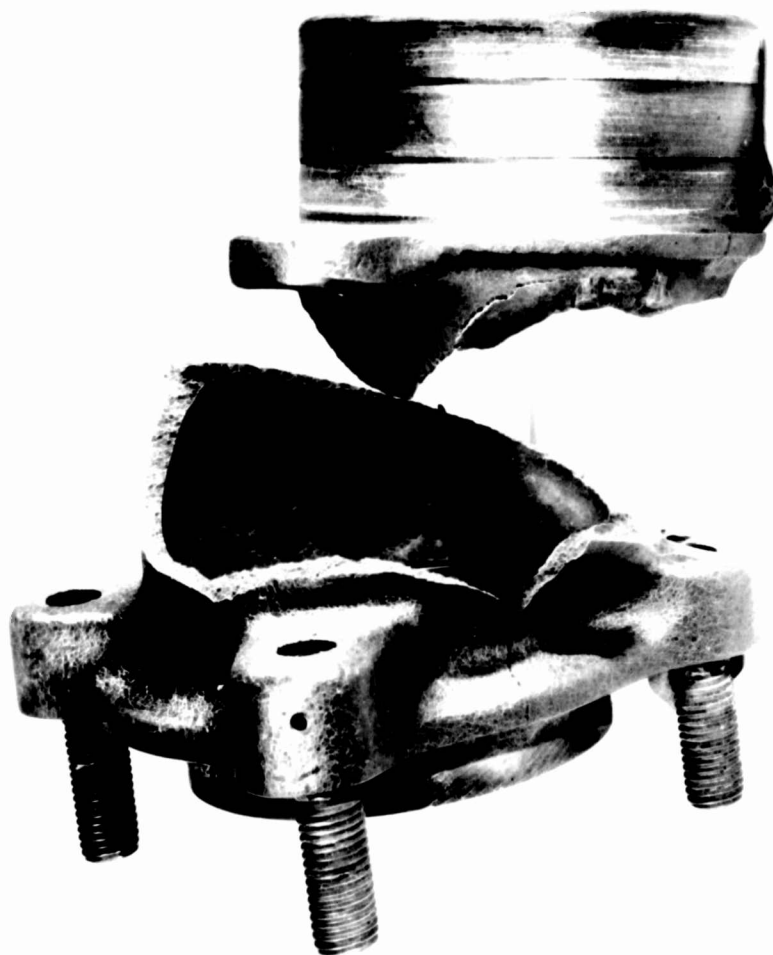
PLATE 14

- (e) Exhaust Port Adapter Elbows - Failure of exhaust port adapter elbows occurred several times throughout the test (Plate 14). The exhaust system consisted of individual flanged stacks approximately 10 inches long. At 81-3/4 hours endurance, the exhaust system was modified to permit the use of short stacks approximately 5 inches long. This appeared to materially reduce the number of adapter elbow failures. Failure of the adapters is believed to have resulted from excessive weight of the exhaust stack combined with a relatively poor adapter design. During preliminary runs on the P-1 engine a similar failure was experienced while employing the same type of stacks (10 inch). However, since the installation of an exhaust collector on one further trouble has been experienced. It is believed that airplane installations employing individual or siamese stacks will encounter similar exhaust port adapter elbow failures.

"A"-3 EXHAUST PORT INSERT
AFTER 2-1/2 HOURS ENDURANCE
PRATT & WHITNEY XR-4360-4 ENGINE

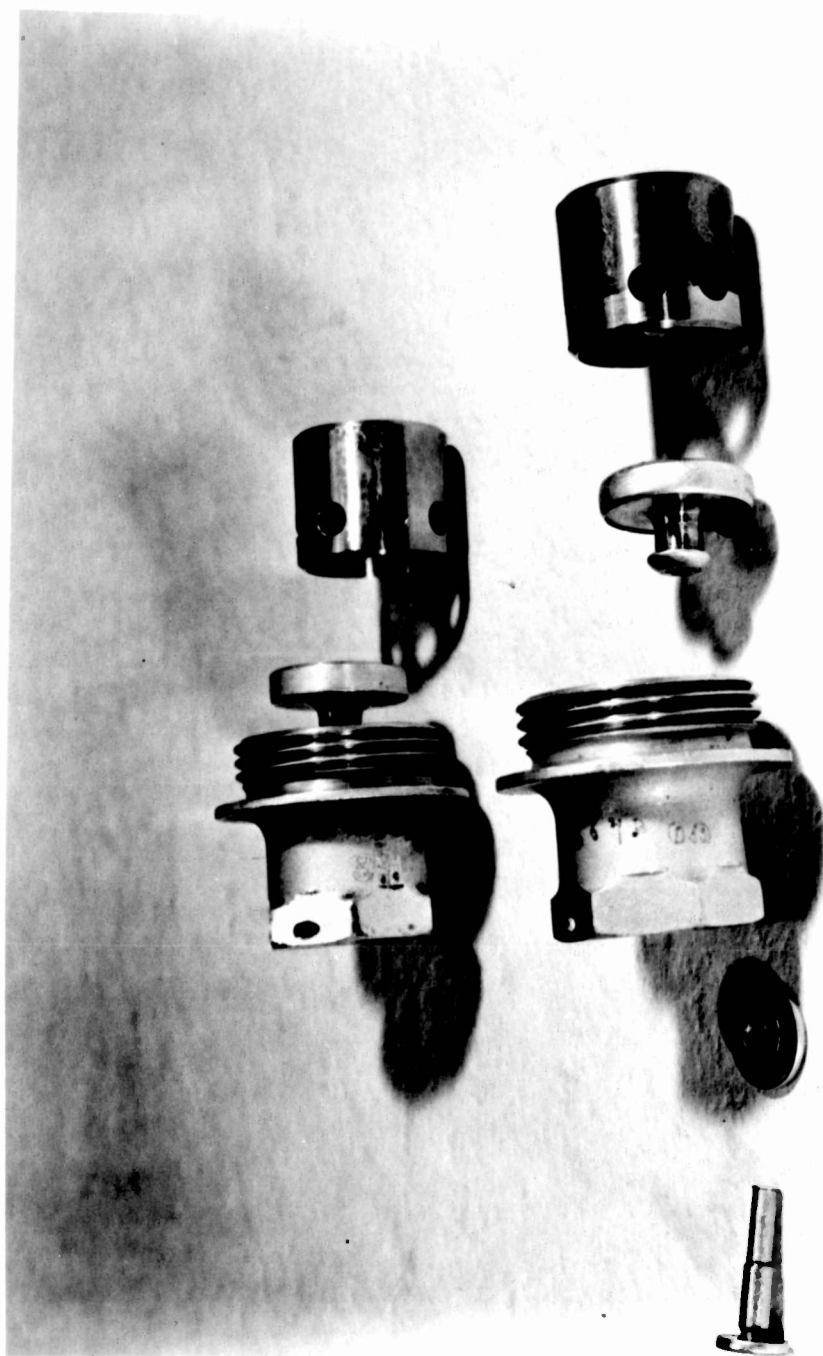
- (m) Intake Pipe Drain Valves - After 77 hours endurance, the intake pipe drain valves on Nos. 3, 4, and 5 banks were all replaced because of mechanical failure of two of the valves (Plate 16). Pratt and Whitney aircraft are familiar with the unsatisfactory operational life of these valves (reference (f)), and at present are developing a unit designed to give more satisfactory operation.

INTAKE PIPE FUEL DRAIN VALVES
AFTER 77 HOURS ENDURANCE
PRATT & WHITNEY XR-4360-4 ENGINE

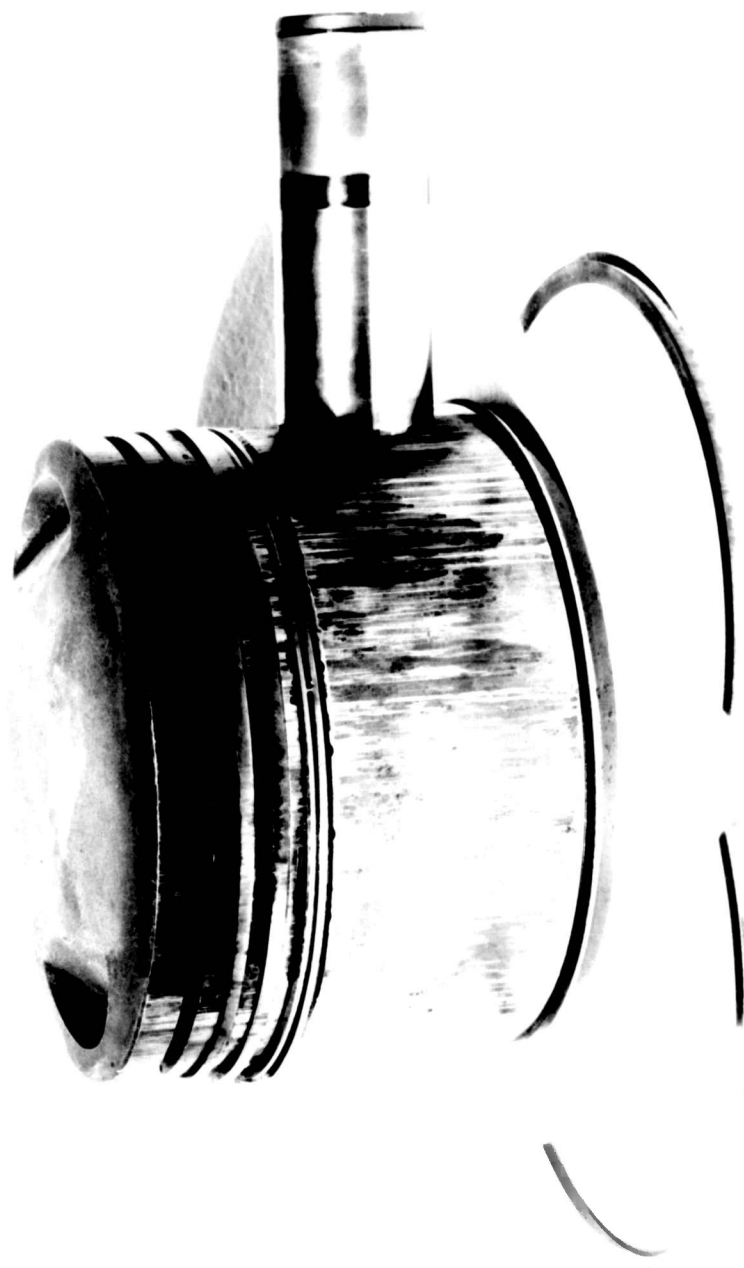
- (b) Piston Scuffing - Failure of B-3 cylinder after 98-3/4 hours endurance required installation of a new cylinder, piston, and set of rings (Plate 17). Upon examination of the damaged cylinder, (discovered by excessive flange temperatures) the top ring on the piston was found broken and collapsed in the groove. The cylinder walls and piston faces were severely scuffed. After 61.2 hours of operation on the No. P-1 calibration engine, both B-2 and B-3 cylinders were replaced because of scuffing of the cylinder and piston. These failures were probably aggravated by a detonation condition noticed in the two cylinders as a result of oil leakage at the impeller shaft. Another replacement of B-3 cylinder was necessary on the No. P-1 engine at 88.8 hours. The failures were very similar to those experienced on the No. P-17 engine, although no ring failures occurred. During the last five hours of endurance at rated power and 110 per cent rated speed, a progressively greater amount of cooling air was required to cool the "B" row of cylinders. The B-2 cylinder flange temperature was critical, eventually climbing to an excessive temperature prohibiting operation at this condition during the last 1/4 hour of the endurance test. An examination of the B-2 cylinder upon disassembly of the engine disclosed Nos. 1, 2, and 4 piston rings broken (Plate 39). A portion of the top edge of the top land of the piston was feathered by pieces of the broken ring spreading the groove open and distorting the top land. In view of the localized failure of cylinders on the "B" row, it is believed that a marginal lubrication condition exists on this bank. Relative leanness of the Nos. 2 and 3 banks of cylinders tends to aggravate this condition. See reference (f) for a discussion of failures of a similar nature.

"B"-3 PISTON
AFTER 90-3/4 HOURS ENDURANCE
PRATT & WHITNEY XR-4300-A ENGINE

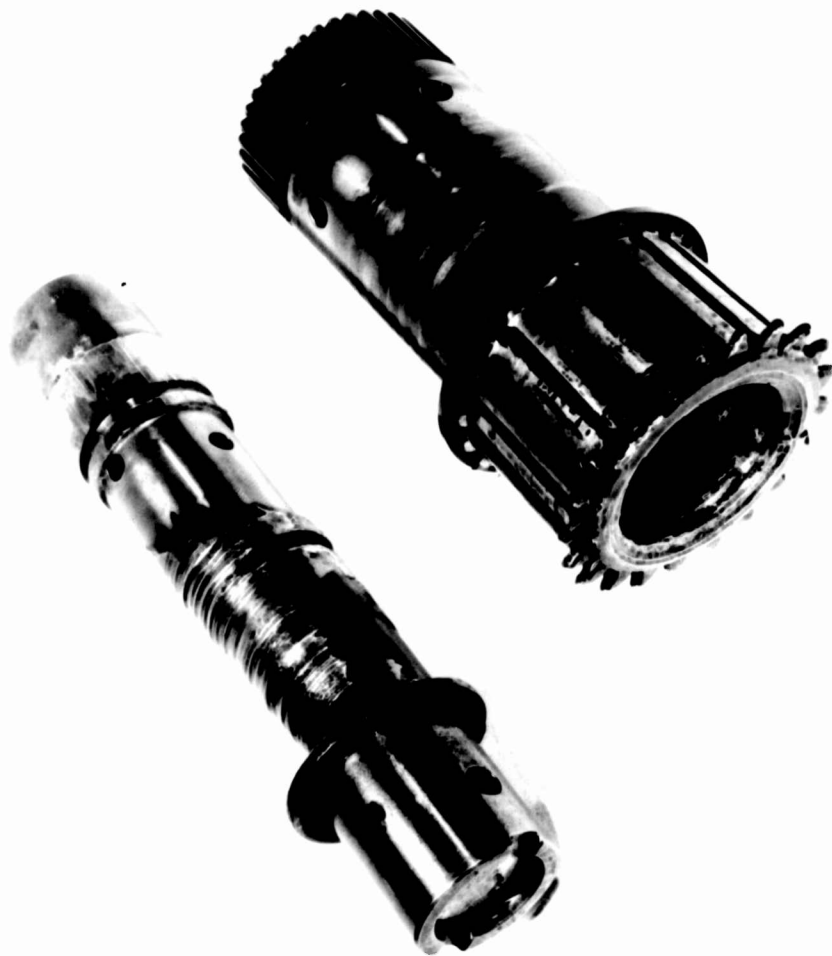
PLATE 18

PRIMARY STEP-UP PINION, RIGHT SHAFT
AFTER 77 HOURS ENDURANCE
PRATT & WHITNEY XR-4360-4 ENGINE

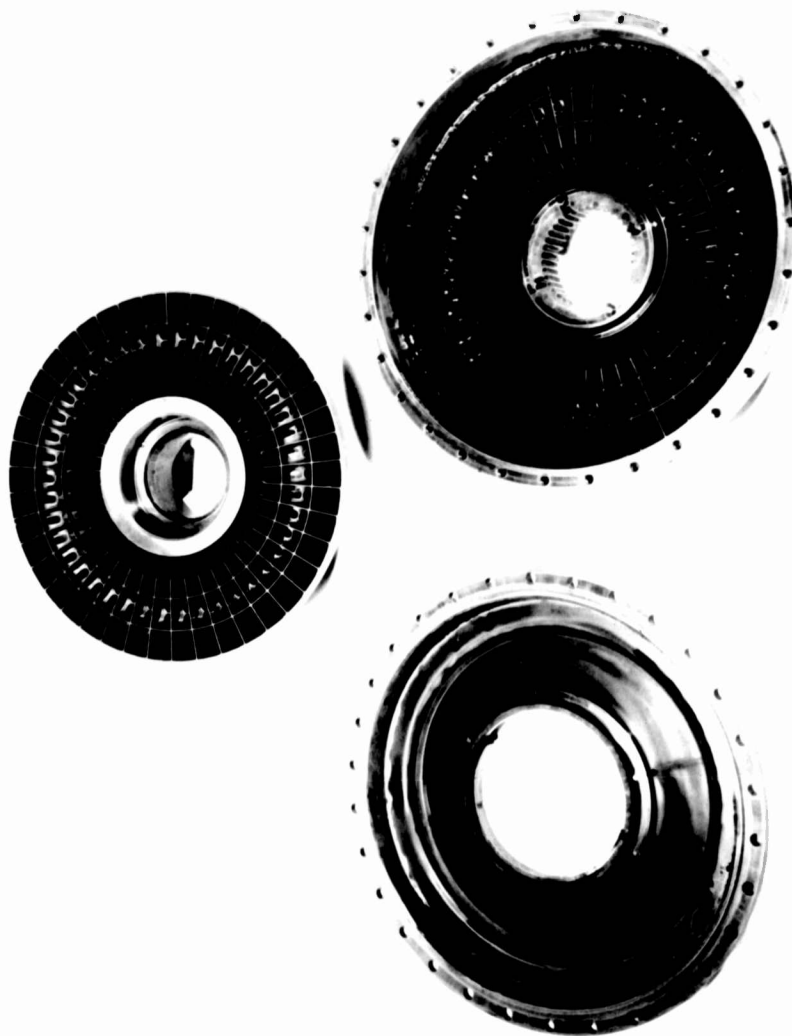
PLATE 19

RIGHT COUPLING - VARIABLE SPEED DRIVE
AFTER 77 HOURS ENDURANCE
PRATT & WHITNEY XR-4360-4 ENGINE

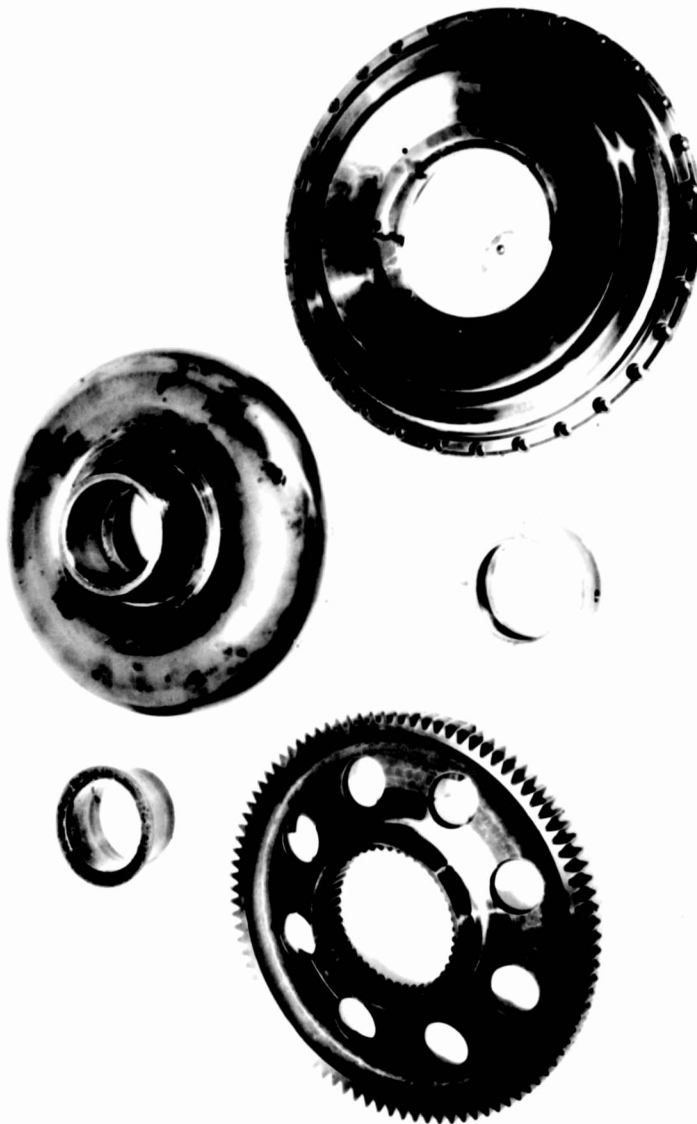
PLATE 20

RIGHT COUPLING - VARIABLE SPEED DRIVE
AFTER 77 HOURS ENDURANCE
PRATT & WHITNEY XR-4360-4 ENGINE

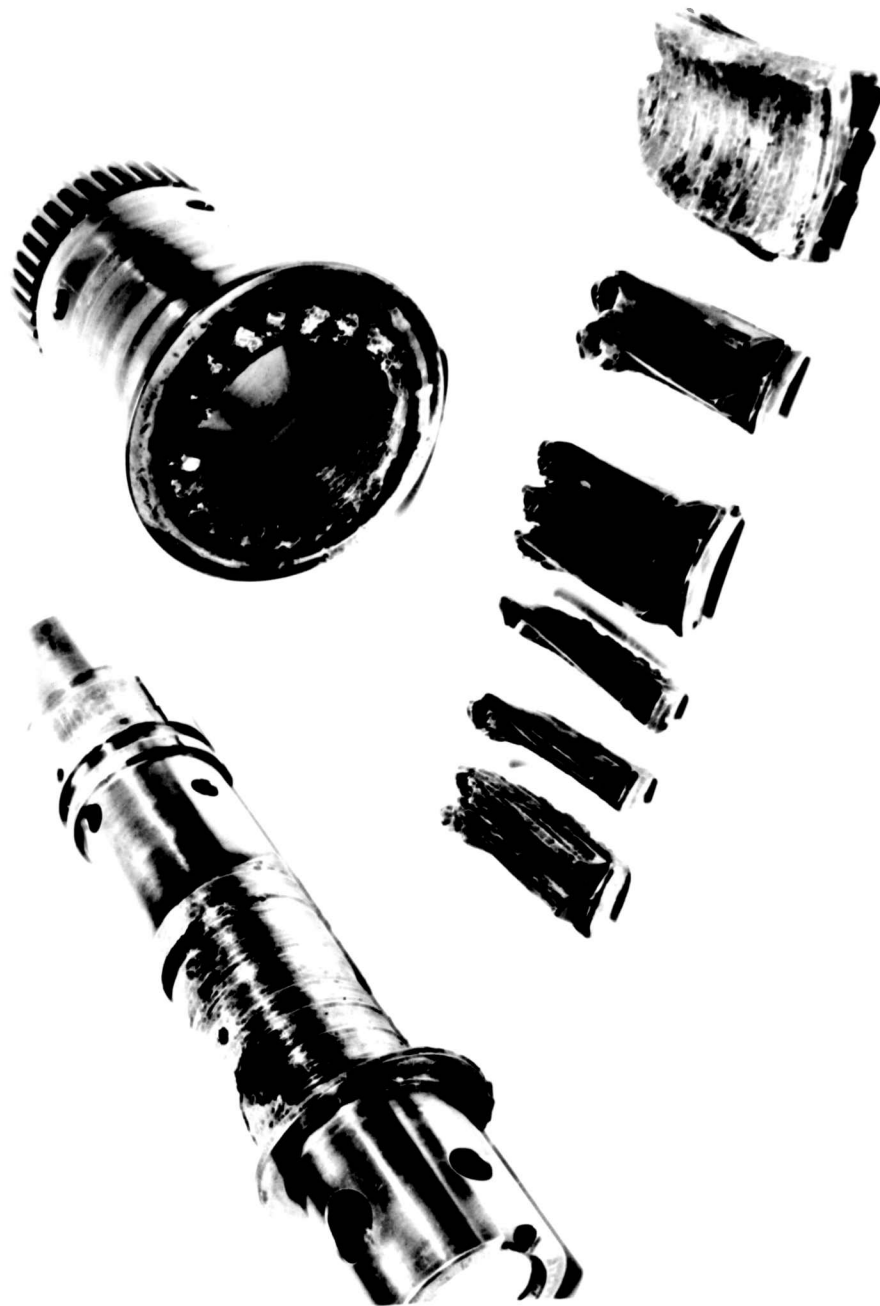
PLATE 21

PRIMARY STEP-UP PINION, LEFT SHAFT
AFTER 77 HOURS ENDURANCE
PRATT & WHITNEY XR-4360-4 ENGINE

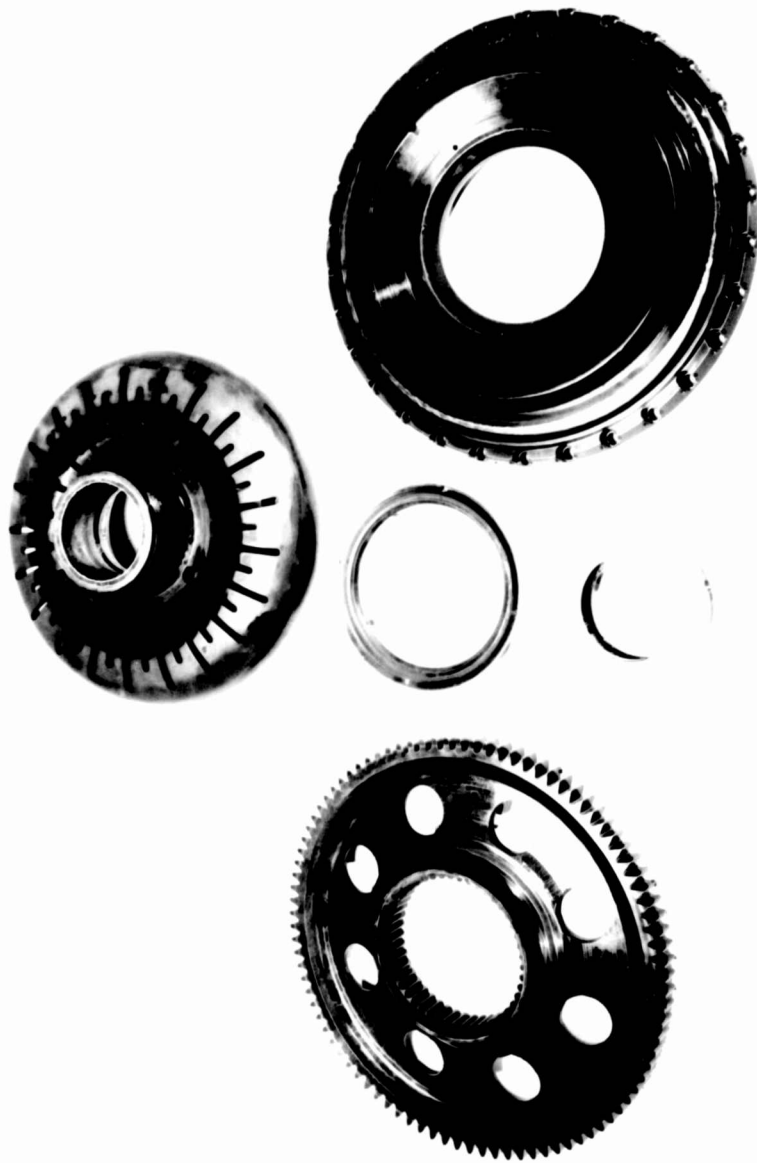
LEFT COUPLING - VARIABLE SPEED DRIVE
AFTER 77 HOURS ENDURANCE
PRATT & WHITNEY XR-4360-4 ENGINE

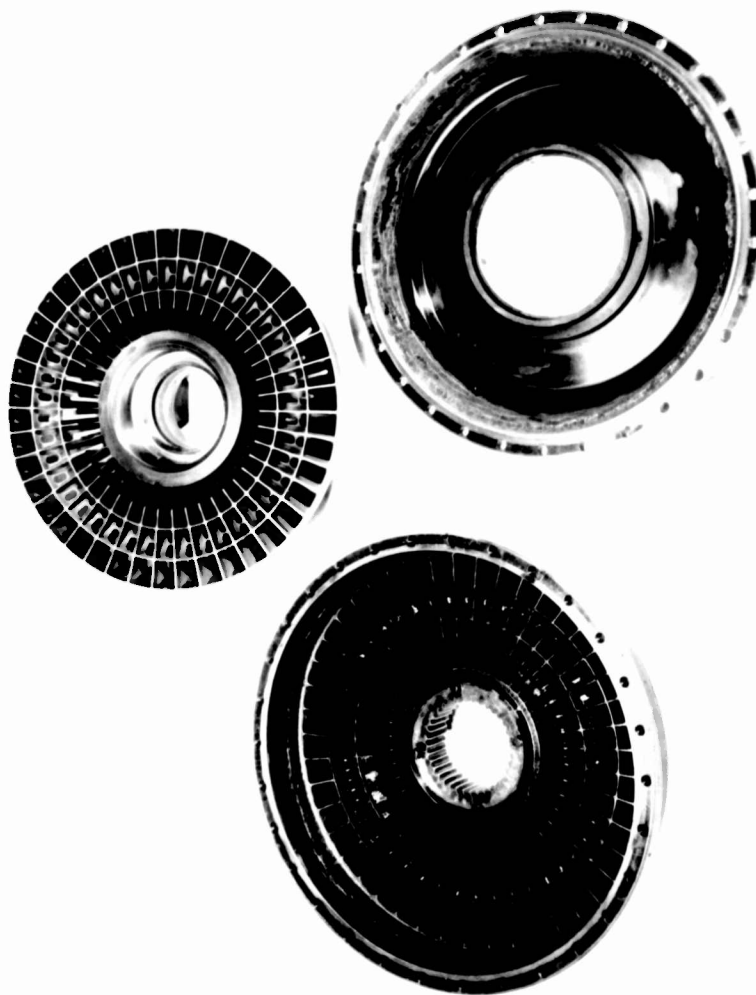
PLATE 23

LEFT COUPLING - VARIABLE SPEED DRIVE
AFTER 77 HOURS ENDURANCE
PRATT & WHITNEY XR-4360-A ENGINE

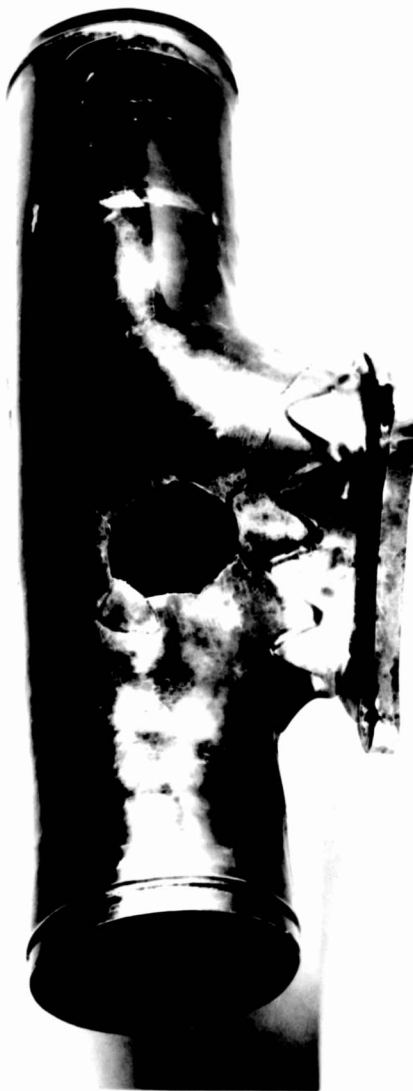
PLATE 24

- (d) Intake Pipes - Several intake pipe failures occurred during the tests. The B-1 intake pipe was found cracked at 96 hours and repaired by brazing. The B-2 intake pipe failed after 98-3/4 hours (Plate 24). At 116 hours endurance, further failures on the B-1 intake pipe occurred (Plate 25). At 121-1/2 hours endurance, the B-7 intake pipe failed by cracking. At 145 hours endurance, a broken intake pipe hose connection between the C-5 and D-5 cylinders was replaced (Plate 42). Cracking of the intake pipes appears to have resulted from relative vibration of adjacent cylinders which was probably accentuated by some engine backfiring. Intake pipe failure of the C-4 and D-1 intake pipes on the No. P-1 engine after 81.7 and 40.3 hours, respectively, further substantiates the weakness of the present design. Since one manifold supplies combustible mixture to one bank, a broken intake pipe adversely affects the firing of four cylinders. See reference (f) for further discussion of this type failure and remedy effected for the test of reference (g).

"B"-2 INTAKE PIPE
AFTER 98-3/4 HOURS ENDURANCE
PRATT & WHITNEY XR-4360-4 ENGINE

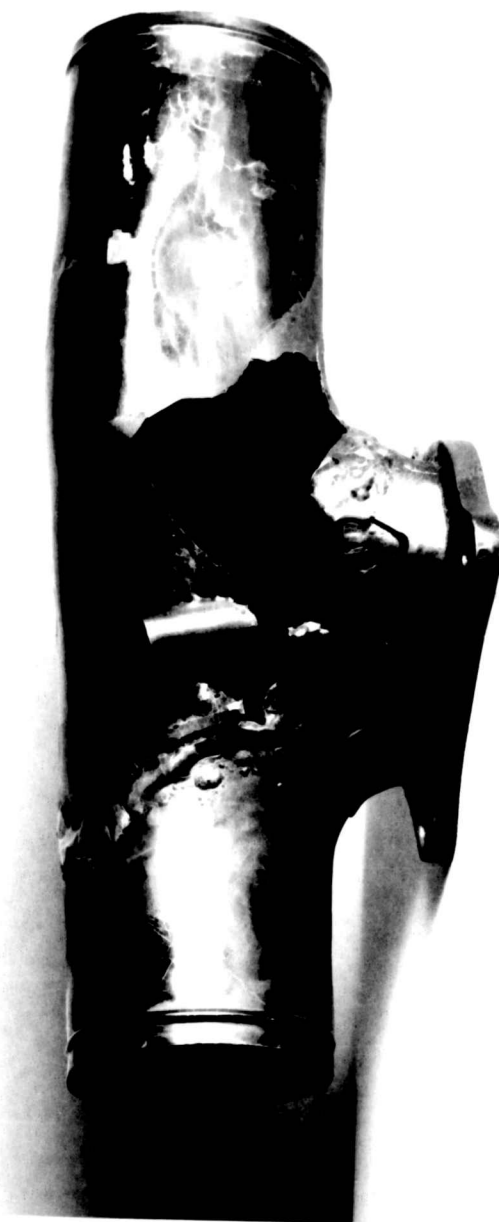
PLATE 25

"B"-1 INTAKE PIPE
AFTER 116 HOURS ENDURANCE
PRATT & WHITNEY XR-4300-4 ENGINE

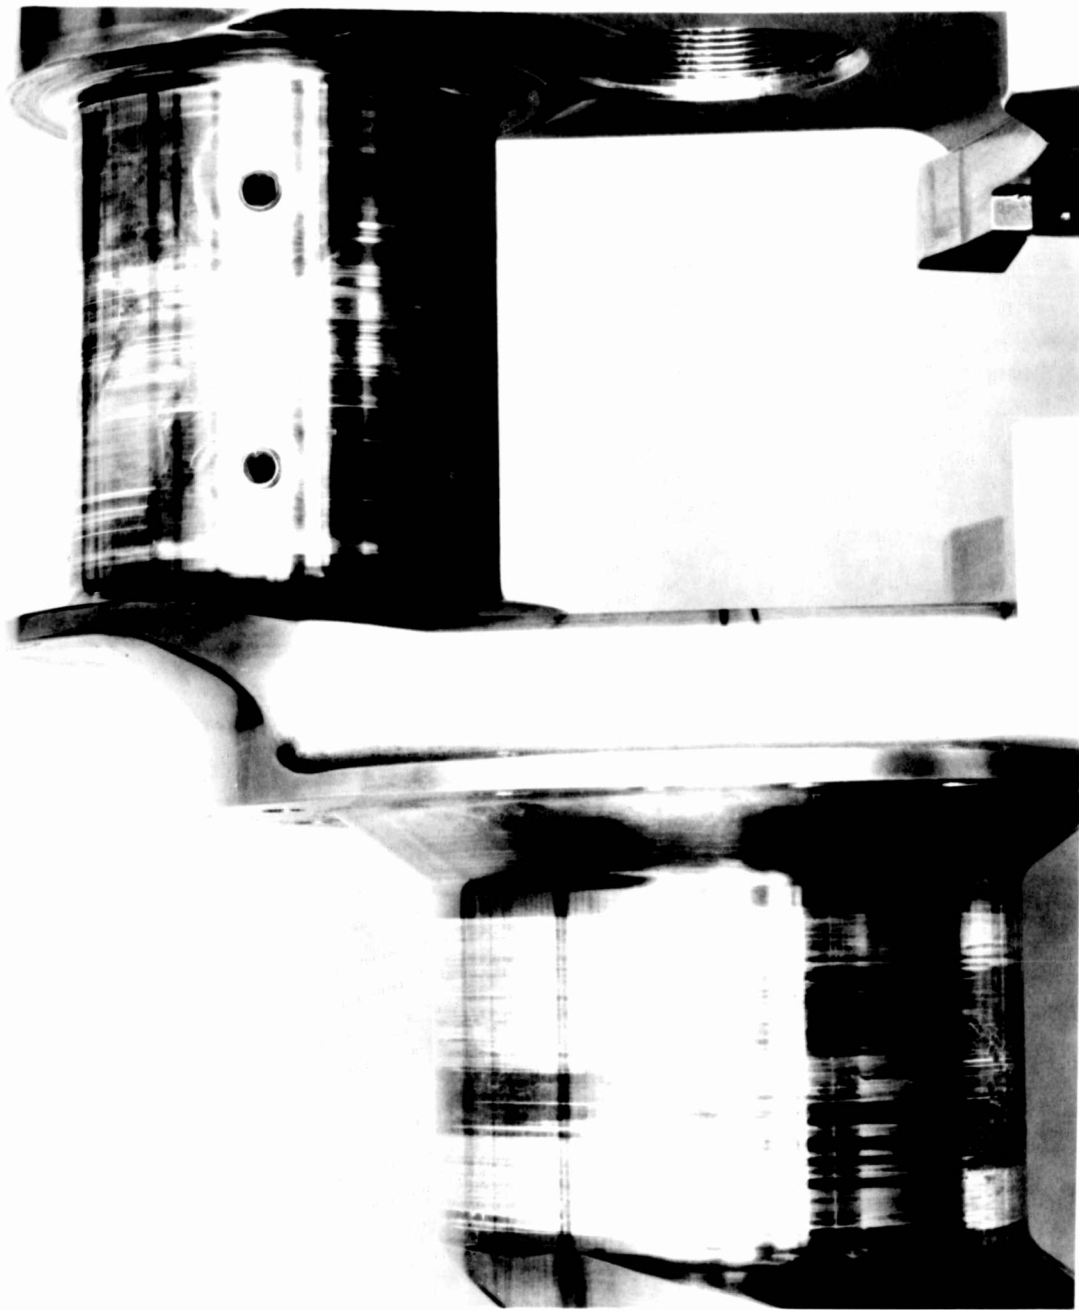
PLATE 27

REAR INTERMEDIATE MAIN BEARING & "A" ROW CRANKPIN
AFTER 150 HOURS ENDURANCE
PRATT & WHITNEY XR-4360-4 ENGINE

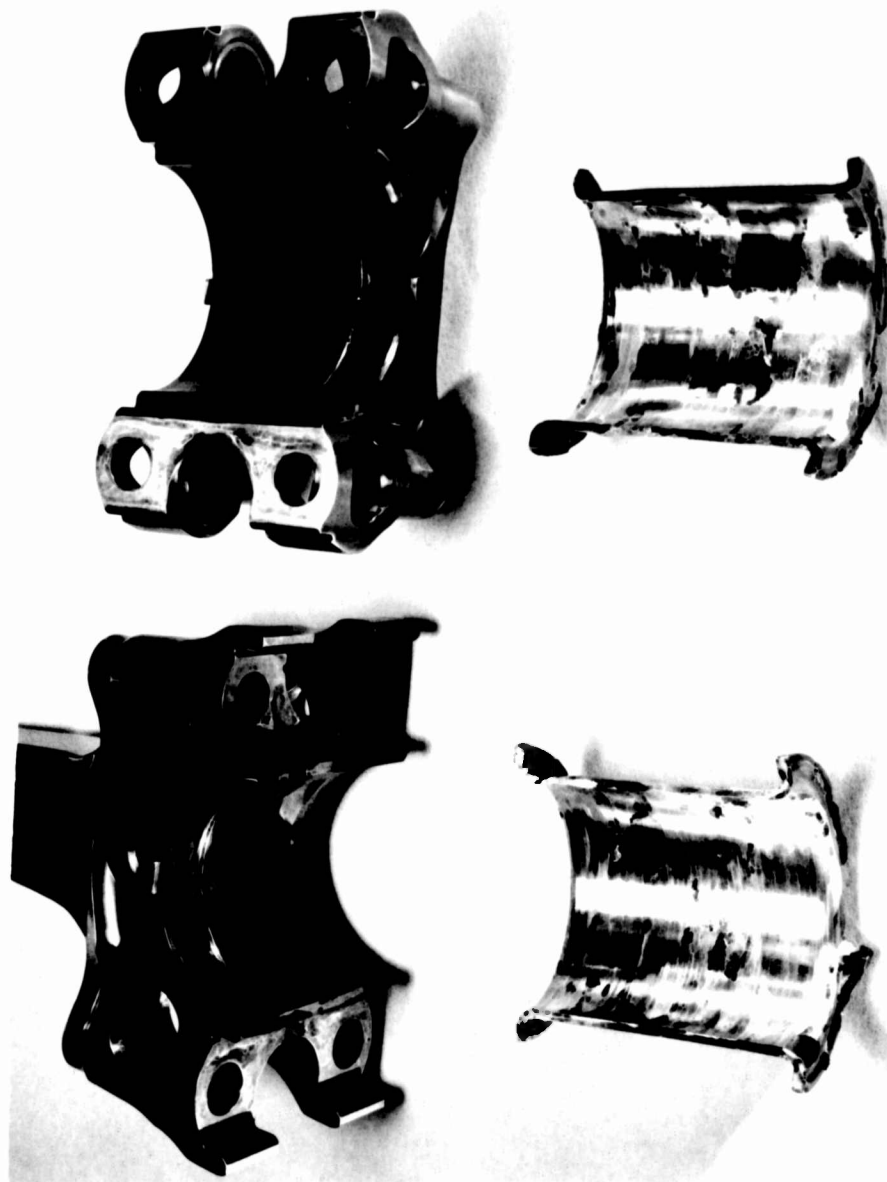
(2) Rear Row "A" Master Rod Bearing Failure - The condition of the master rod bearing on the "A" row was similar to that of the rear intermediate main bearing, the bearing material being badly scored and burned (Plate 28). The yoke section of the master rod and the lower half of the rod were distorted as a result of the intense heat and pounding to which it was subjected between the time of engine failure and stopping of the engine. The "A" row crankpin was severely scored on the bottom side indicating the failure to have probably occurred during dive (inertia load) operation (Plate 27). It is believed that this failure can also be attributed to inadequate lubrication rather than local chipping of the silver as discussed in references (f) and (g).

"A" ROW MASTER ROD & BEARING
AFTER 150 HOURS ENDURANCE
PRATT & WHITNEY XR-4360-4 ENGINE

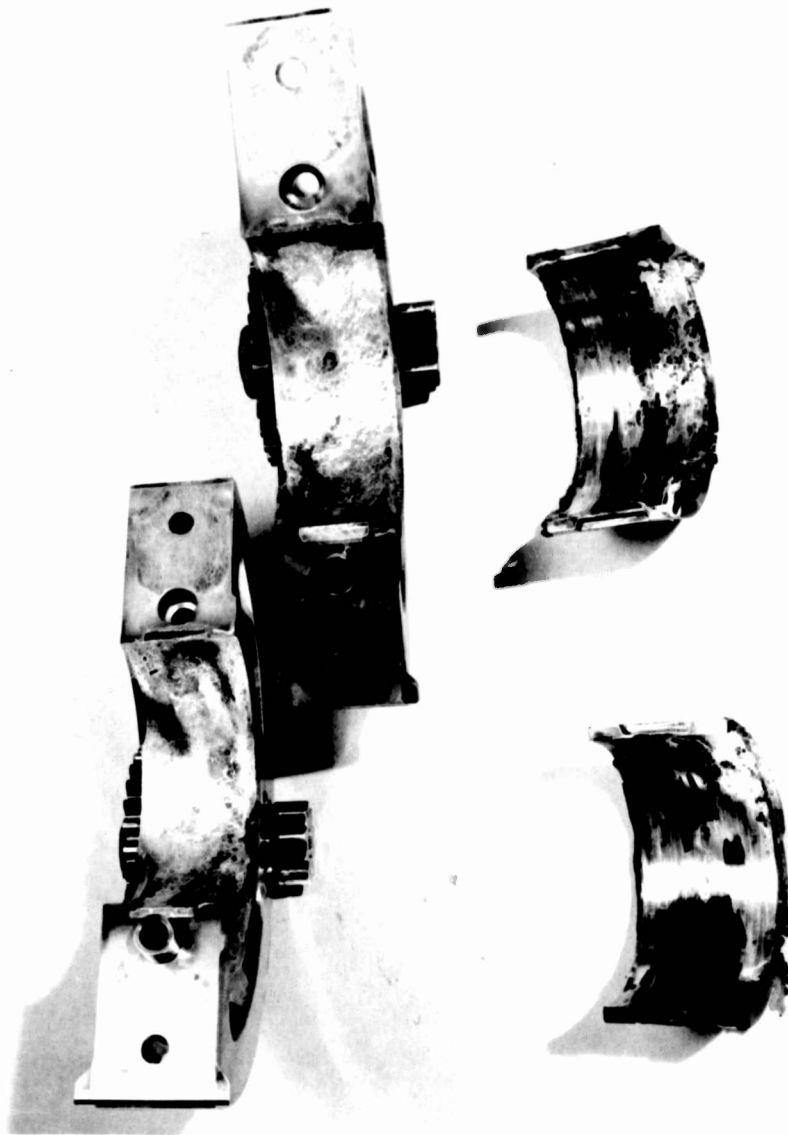
This bearing was severely scored and burned. The main bearing support was also damaged by the pounding action of the crankshaft (Plates 29 and 31). It is believed that this failure caused the rear intermediate crankcase to crack at the cam bearing support (Plate 38). An inspection of the rear intermediate journal showed scoring and grooves on the side adjacent to the counterweight. Failure of this bearing is believed to result from inadequate lubrication aggravated by unequal load distribution over the bearing width (as caused by crankshaft deflection). For a discussion by Pratt and Whitney Aircraft relative to this type failure see reference (g).

REAR INTERMEDIATE MAIN BEARING
AFTER 150 HOURS ENDURANCE
PRATT & WHITNEY XR-4360-4 ENGINE

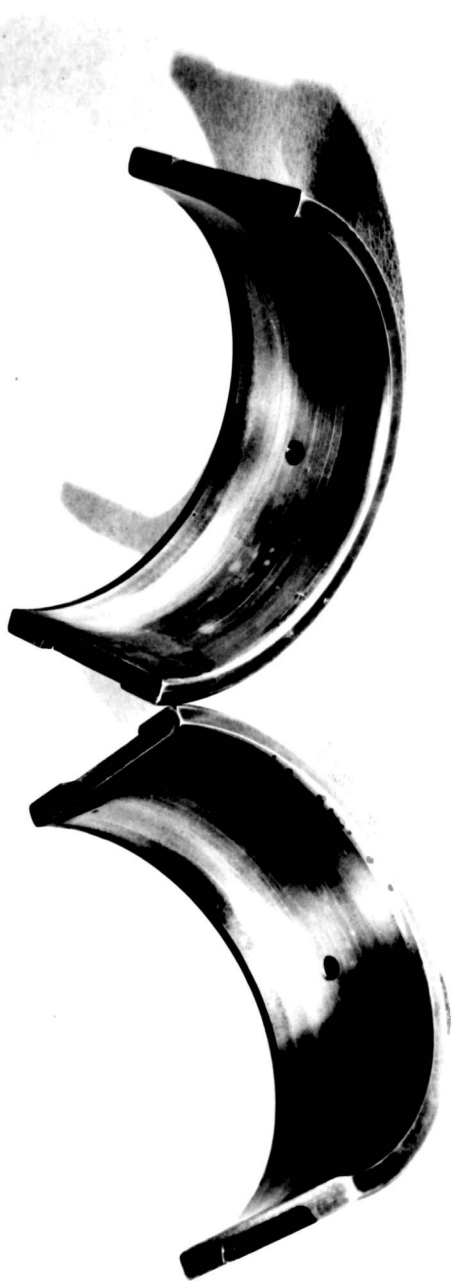
- (6) Bearings - In general, the condition of the main and master rod bearings was unsatisfactory (Plates 26 to 32, inclusive). The top half of the "B" master rod bearing had a crack about 1/2 inch long starting at the cut-out in the side of the bearing half used to position the bearing in the master rod. This crack probably resulted from the sharp corner left in the cut-out. The front main bearing had several deep grooves cut into it while the rear main bearing had a series of fine grooves. This scoring condition is probably the result of foreign material in the lubrication system. The front intermediate main bearing had approximately 50 per cent of the lead washed out. The lead facing on other bearings was also appreciably washed in varying amounts. In general, inspection indicated many local high pressure areas which probably resulted from a combination of crankshaft deflection, improper bearing (clearance) relief, and inadequate lubrication. For a discussion of failures attributed to local chipping of the silver see references (f) and (g).

FRONT INTERMEDIATE MAIN BEARING
AFTER 150 HOURS ENDURANCE
PRATT & WHITNEY XR-4360-4 ENGINE

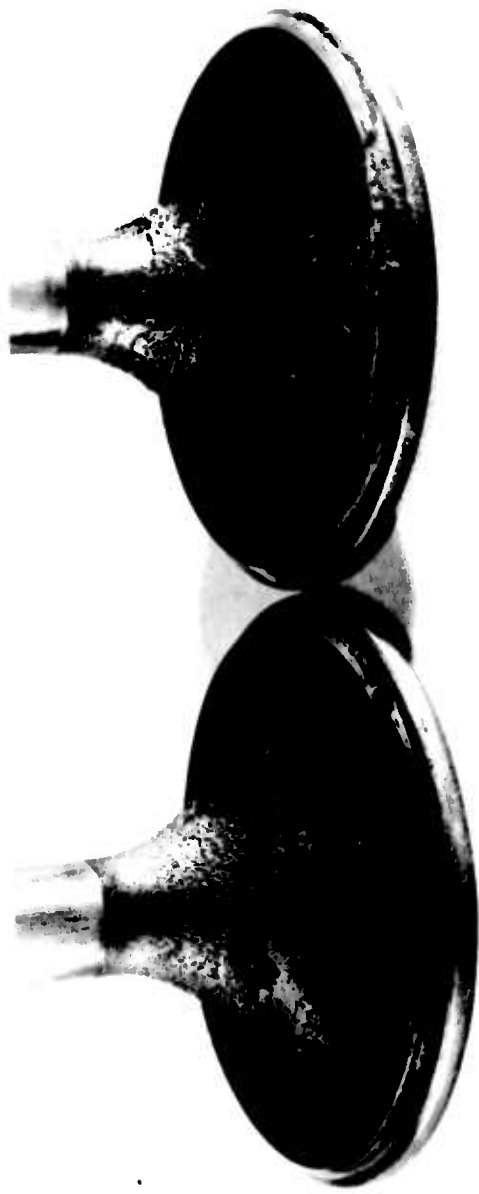
- (10) Valves - One intake valve had a burned area of approximately one inch on the seat while a second intake valve had a fine circumferential groove, 1/16 inch wide pounded into the center of the valve seat (Plate 33). Three exhaust valves had slight guttered notches and burned areas on the top edge of the seat (Plate 34). Slight indications of erosion were also noted on the heads near the edges of several exhaust valves.

INTAKE VALVES
AFTER 150 HOURS ENDURANCE
PRATT & WHITNEY XR-4360-4 ENGINE

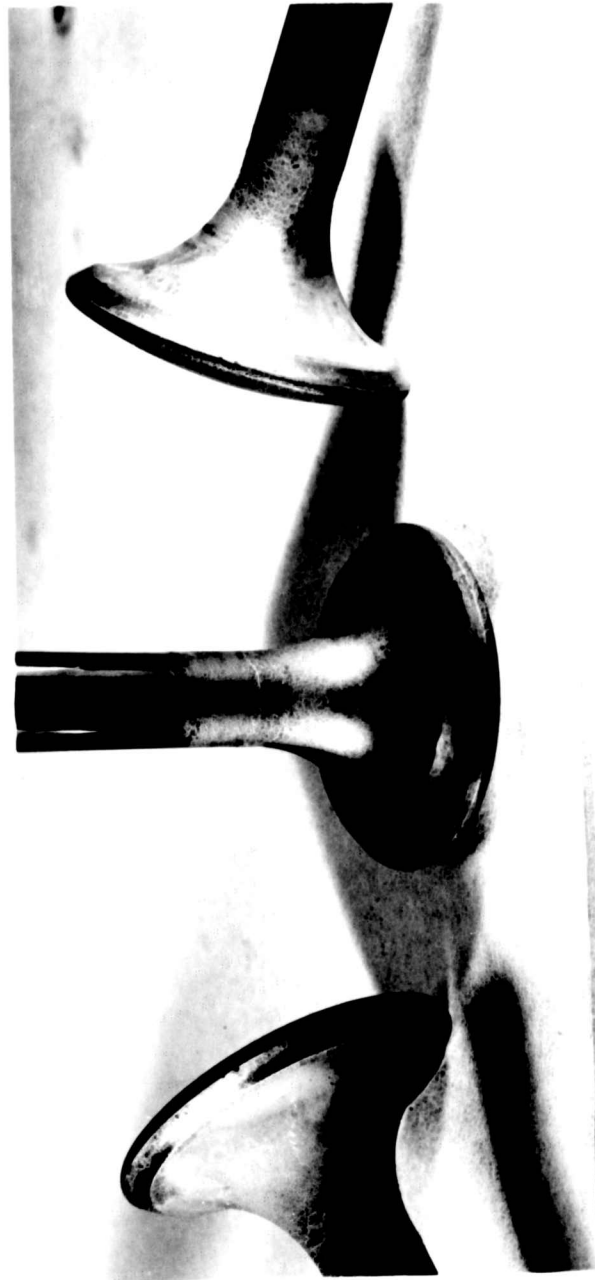
PLATE 34

EXHAUST VALVES
AFTER 150 HOURS ENDURANCE
PRATT & WHITNEY XR-4360-4 ENGINE

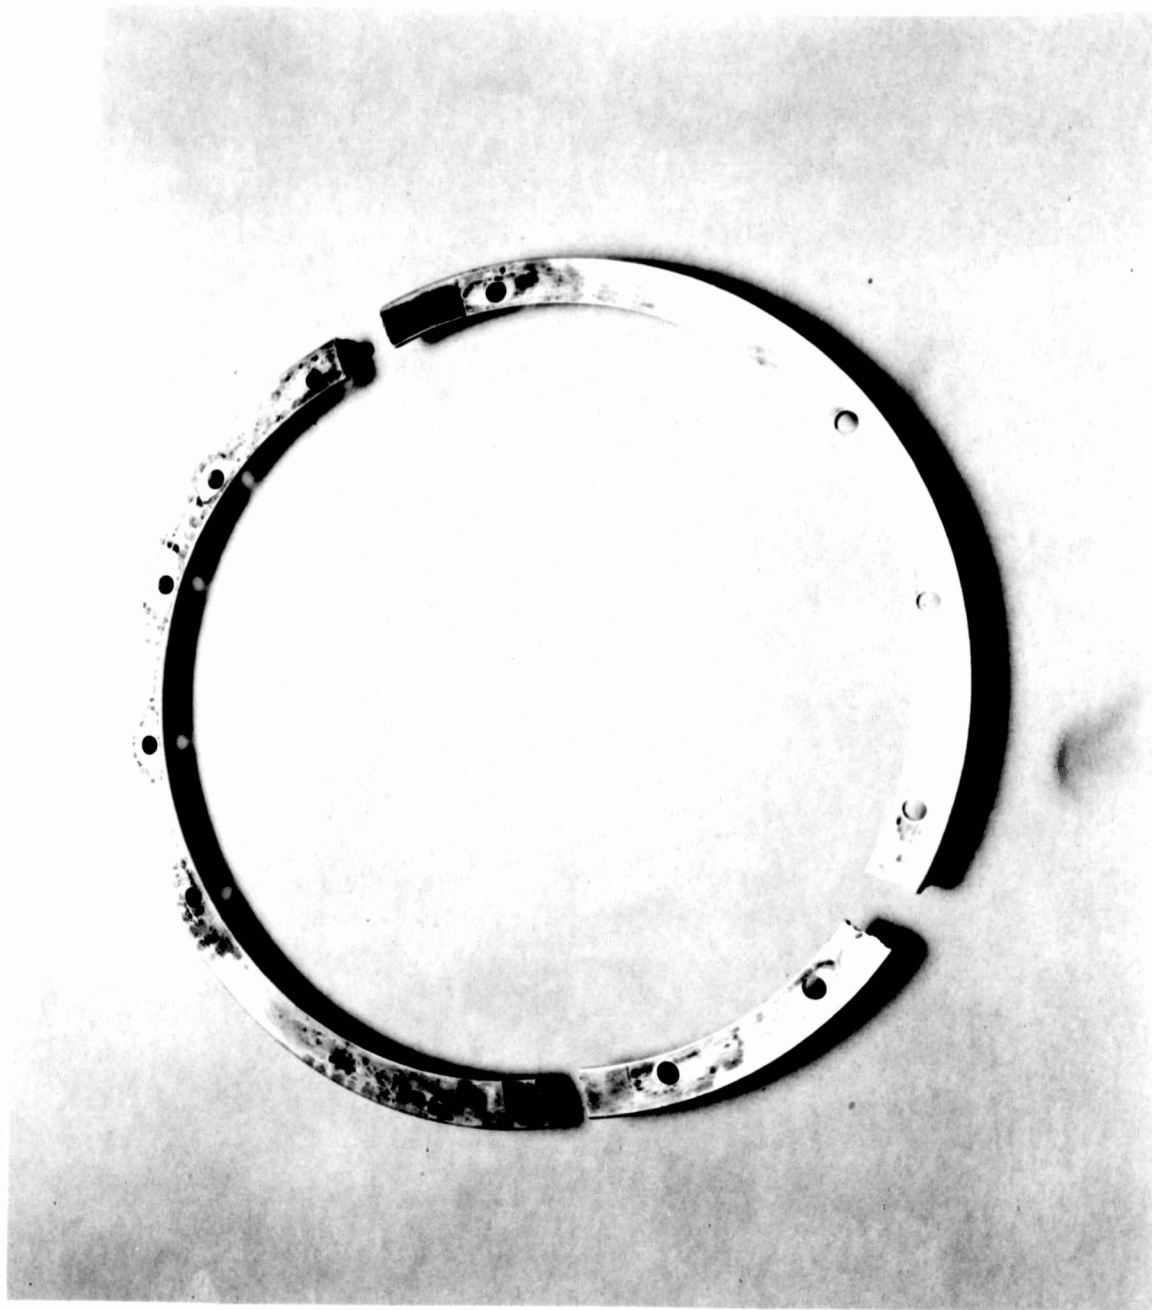
PLATE 37

(3) Cam Bearings - The rear intermediate cam bearing (A-B row) was cracked in two places while the front intermediate cam bearing (C-D row) was cracked in one place (Plate 37). These cracks did not appear to affect the cam operation in any way. Failure of the rear cam bearing might have been caused by the cracked cam bearing support but no similar reason can be given for the crack in the front bearing. For a discussion of other failures see references (f) and (g).

NEAR INTERMEDIATE CAM BEARING
AFTER 150 HOURS ENDURANCE
PRATT & WHITNEY XR-4360-4 ENGINE

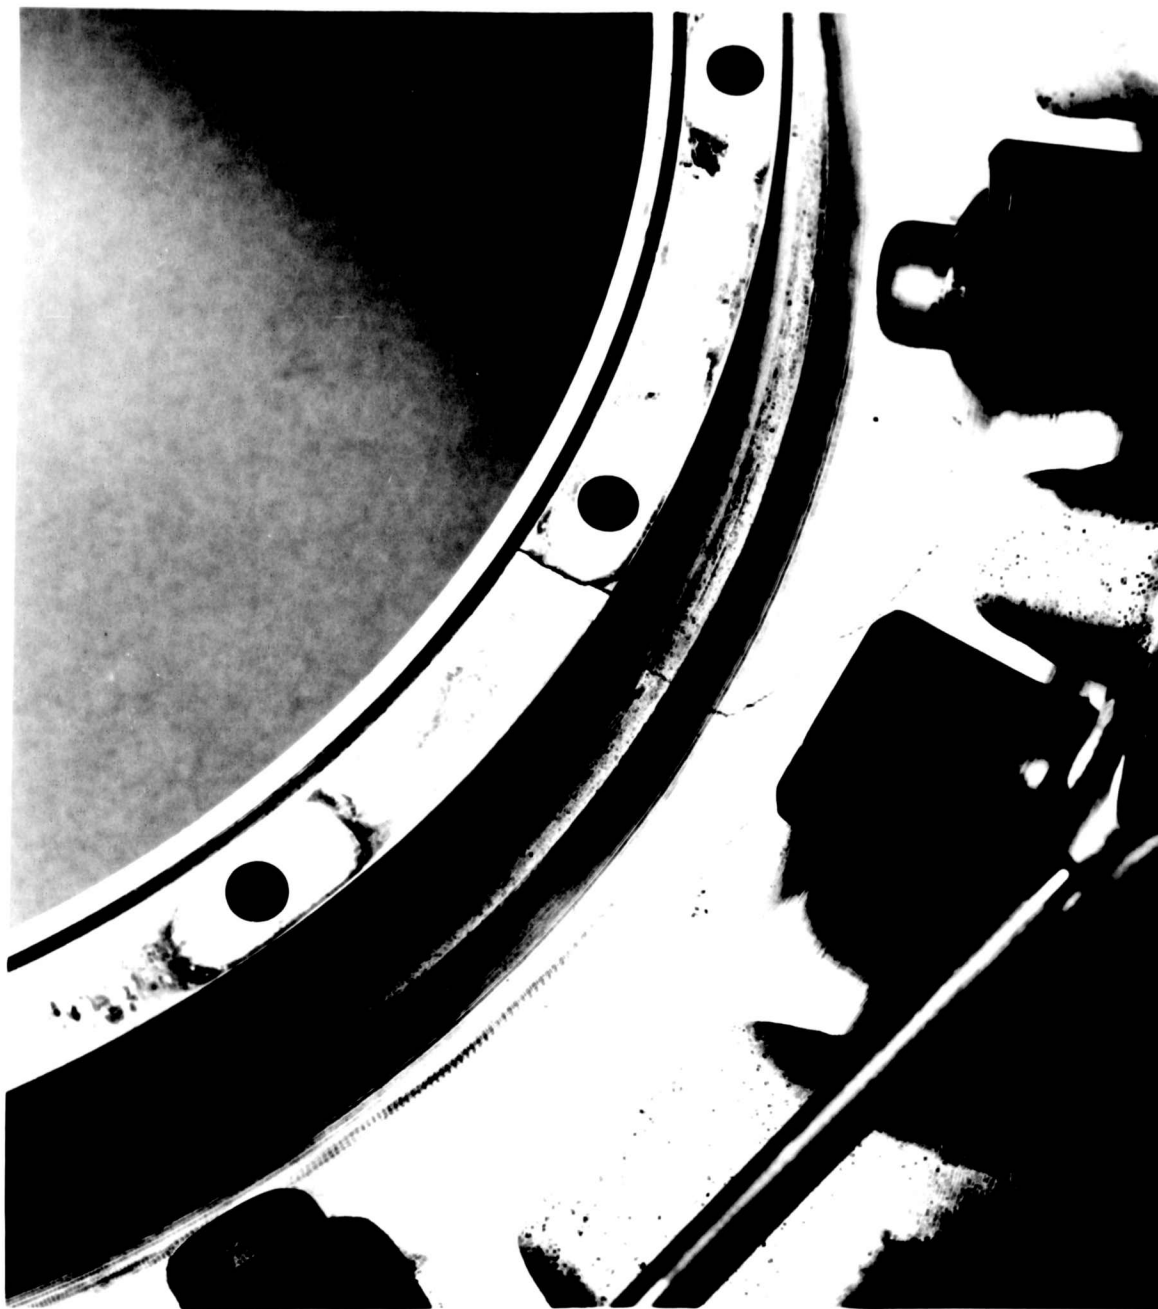
REAR INTERMEDIATE CRANKCASE
AFTER 190 HOURS OF SERVICE
PART. # MILNEY WH-4360-1. E. I. I. S.

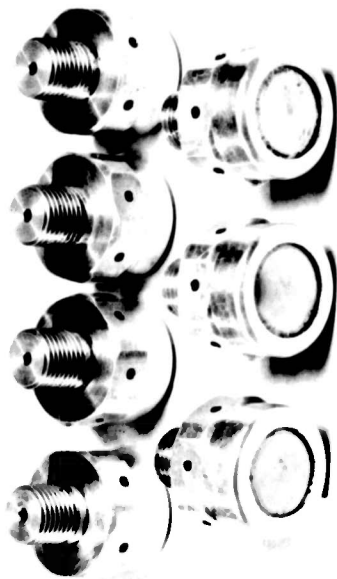
- (j) Magneto Pressure Pump and Altitude Vent Valves - At 31-1/2 hours of endurance, failure of the magneto pressure pump occurred. Inspection indicated that several of the altitude vent valves were found closed and the fibre key locking the pump rotor to the shaft was found sheared (Plate 40). The sheared key resulted from an overload condition imposed on the pump by reason of the failure of the altitude vent valves. A second set of altitude valves installed after repair of the pump also failed after a short period of operation. Further details on the magneto pressure pump and altitude valve will be reported under Project TED No. NAM-04170 which covers testing of these items.

ALTITUDE VENT VALVES AND MAGNETO
SUPERCHARGER PUMP WOODRUFF PINS KEY
AFTER 24 HOURS ENDURANCE
PRATT & WHITNEY XR-4360-4 ENGINE

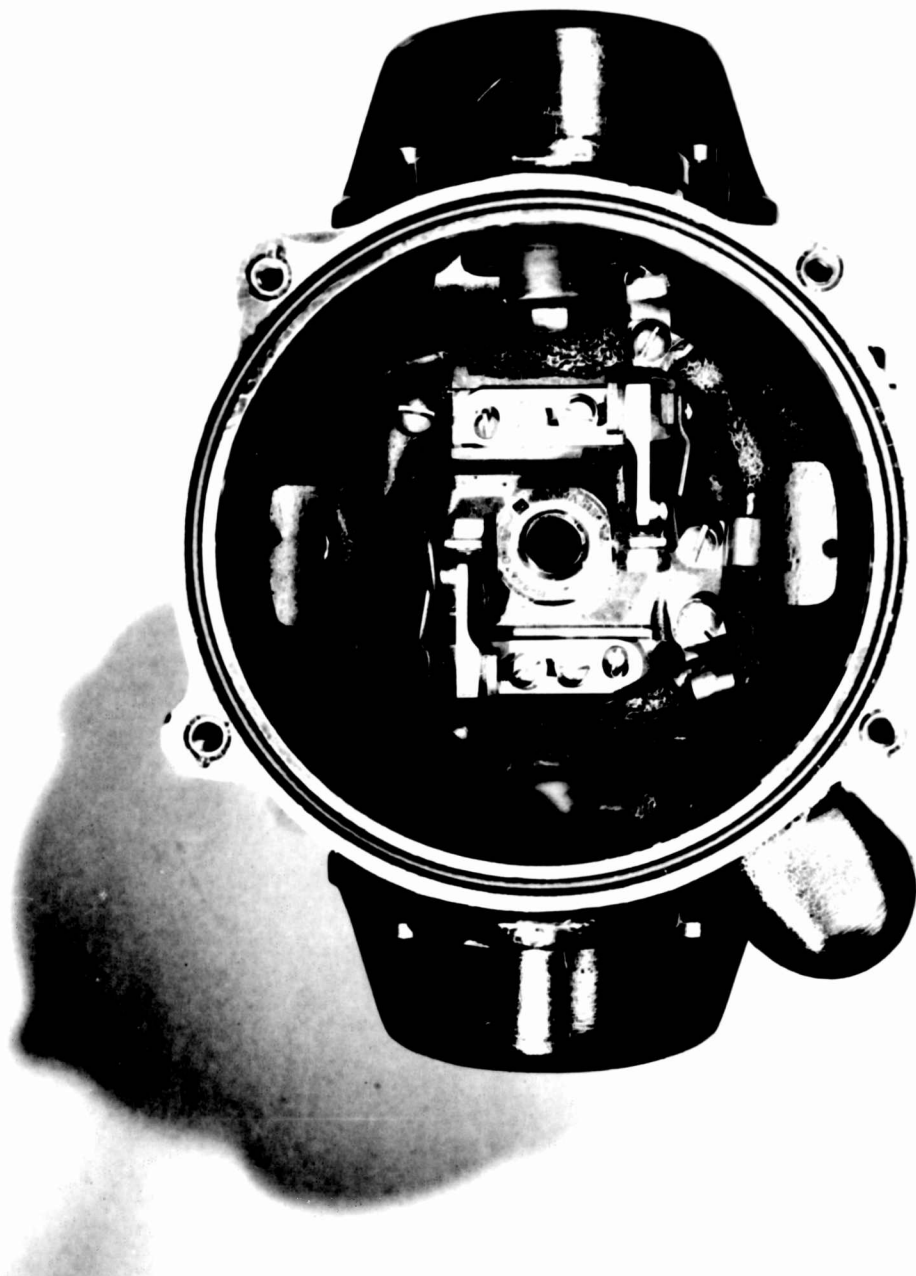
- (i) Magneto - At 145 hours of endurance, failure of the No. 1 bank to fire satisfactorily on the left magneto was investigated. Inspection showed that the magneto housing was cracked three-quarters around at a point approximately 2 inches from the flange (Plate 42). Upon disassembly of the engine after 150 hours of endurance, a fine crack was noticed in a similar location on No. 2 magneto (Plate 43). It appears that Type I magneto and harness system used during the endurance tests is not able to withstand the vibration accompanying normal engine operation. Modified versions of the magneto and harness system have since been manufactured and are presently undergoing tests at Pratt and Whitney Aircraft.

TOP VIEW - NO. 1 MAGNETO
AFTER 1145 HOURS ENDURANCE
PRATT & WHITNEY XR-4360-4 ENGINE
