RESTRICTED
NAVY DEPARTMENT
BUREAU OF AERONAUTICS

AERONAUTICAL ENGINE LABORATORY
REPORT ON

MODEL TEST OF PRATT & WHITNEY
AIRCRAFT IN-4360-4 ENGINE

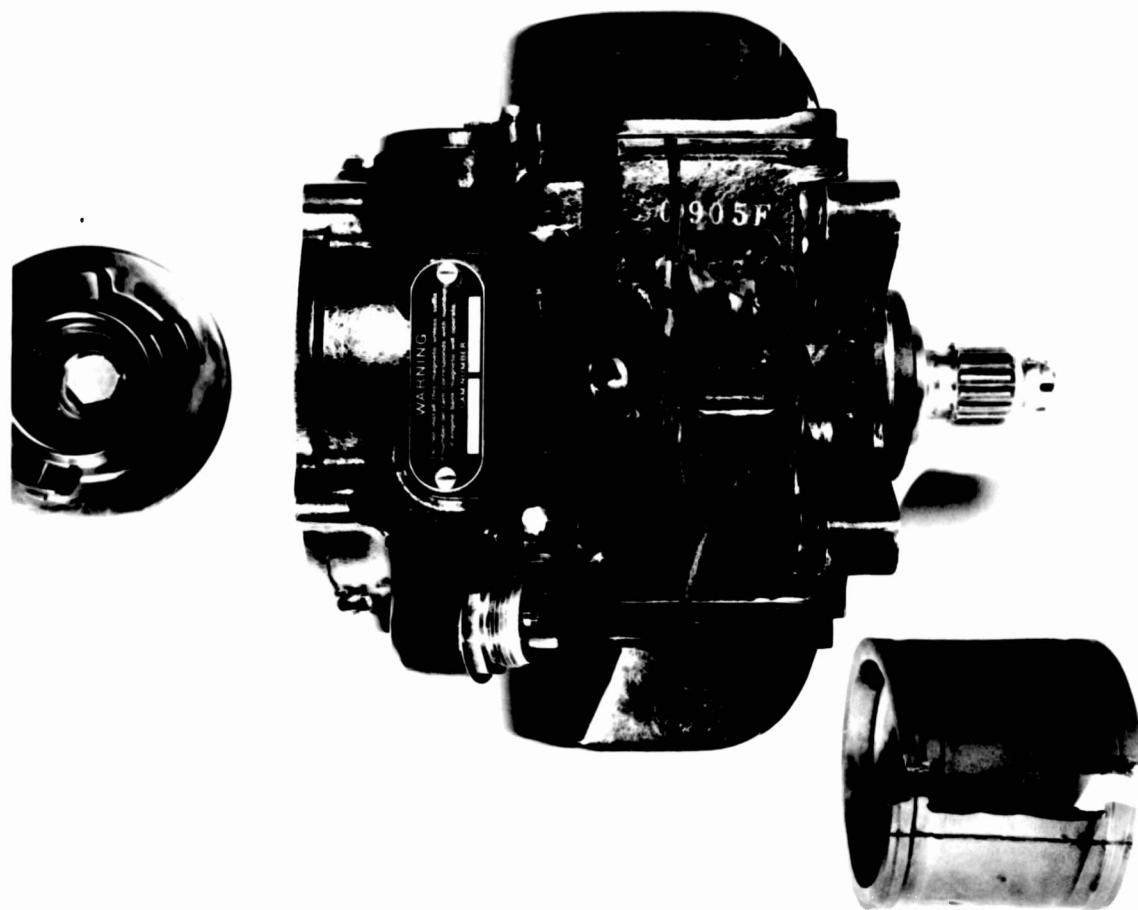
NO. 1 BANK MAGNETO & INTAKE MANIFOLD COUPLING
AFTER 145 HOURS ENDURANCE
PRATT & WHITNEY XR-4360-4 ENGINE

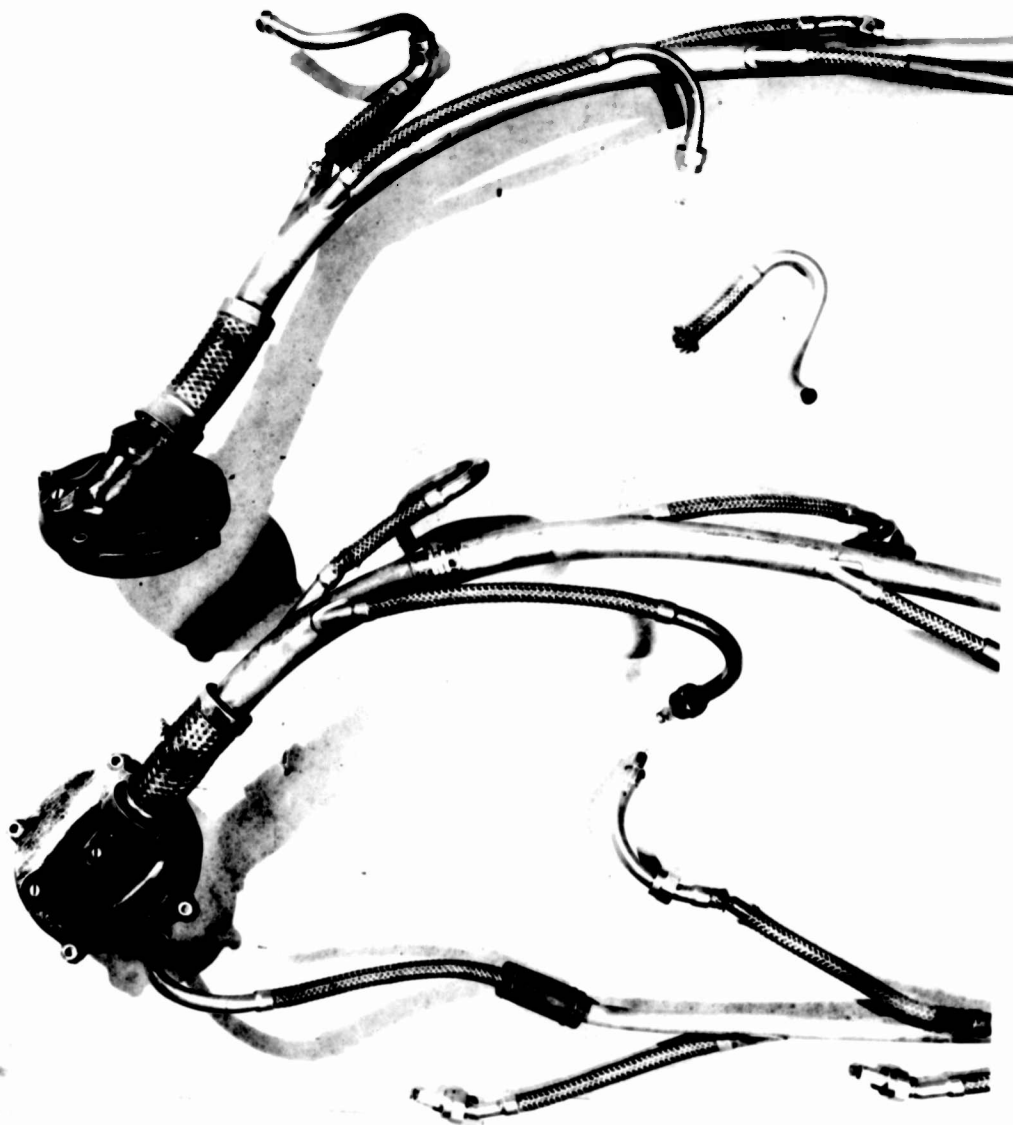
PLATE 44

- (h) Ignition Harness - During the 150-hour endurance test, it was necessary to replace all of the seven ignition harnesses because of shielding conduit failures (Plate 44). The flexible conduit failures occur near the soldered end connections of the spark plug conduit and the middle of the short length of magneto conduit. Failure of the spark plug elbow tube body also occurs near the coupling nut. The failures appear to result from vibration. With the present design, the ignition harness is not supported to the engine at any place along the entire length of the manifold. The only means of holding it in place is by the spark plug elbows and the attachment at the magneto distributor cover. The design of the solid "U" tubing used for spark plug elbows on the "D" row is conducive to failure. As this harness does not employ detachable or rewirable leads, failure of one lead necessitates replacement of a complete harness assembly. Similar harness failures have occurred on the No. P-1 engine which employs the same installation.
