FLIGHT MEASUREMENTS OF THE EFFECT ON ELEVATOR STICK FORCES

OF STABILIZER INCIDENCE AND ELEVATOR RIB SPACING

ON THE P-63A-1-BE SERIES AIRPLANE

MEMORANDUM REPORT

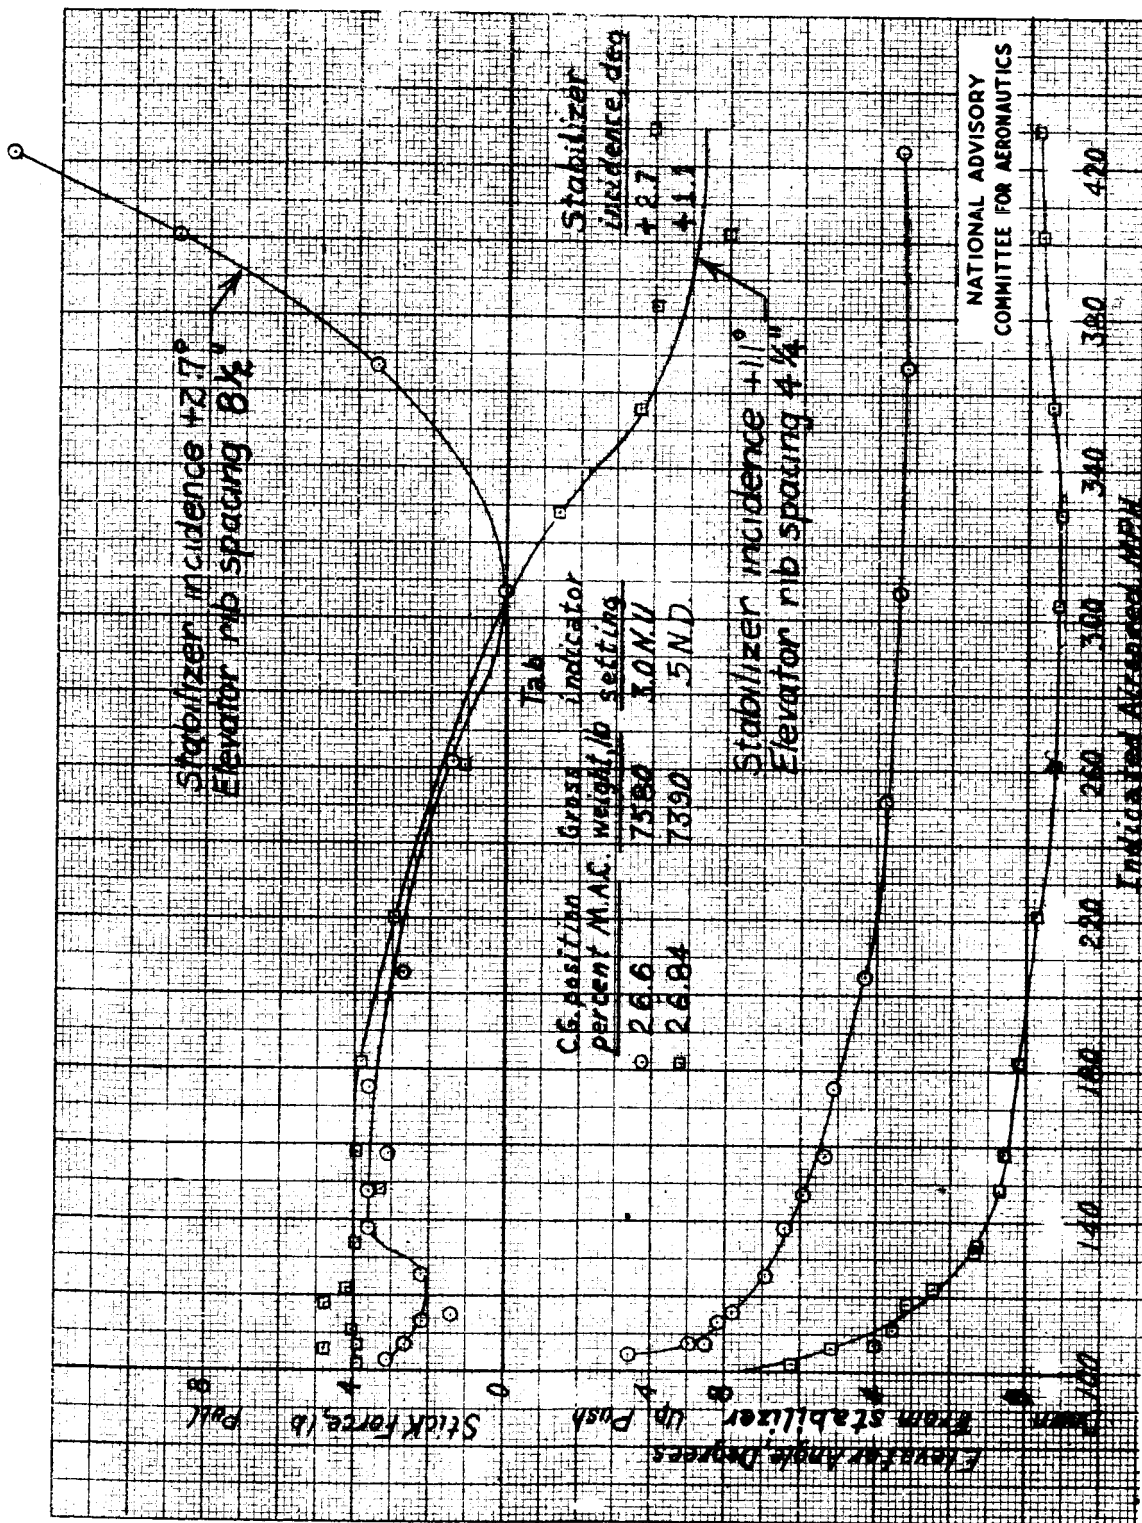
Figure 10. - Data showing the effect of stabilizer incidence setting and elevator rib spacing on the static longitudinal stability characteristics of the P-63A-1 airplane. Clean condition, engine idling, altitude range 5-10,000 feet.

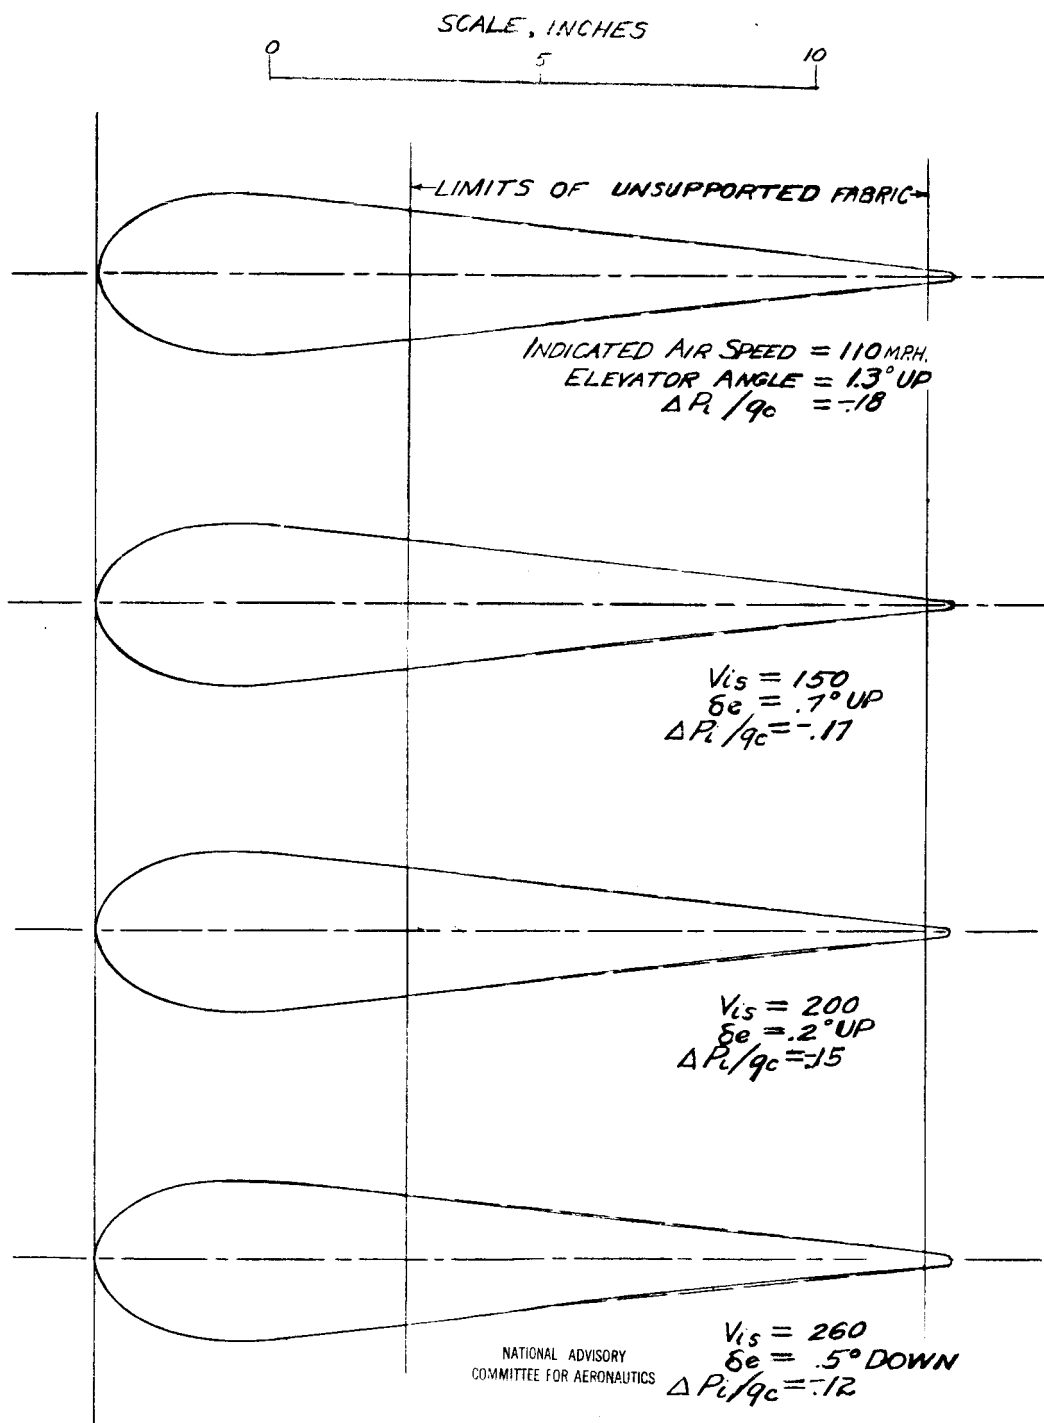
Figure 12 shows the distortion characteristics through the speed range of the  $\frac{1}{4}$ -inch rib-spaced elevators with the low stabilizer incidence of  $1.1^\circ$  up from the thrust axis. The internal pressure for this elevator was about 11 percent of the free-stream impact pressure

below free-stream static pressure at high speeds. Examination of the maximum fabric deflection which occurred with these elevators at high speeds (fig. 15) shows that at the highest speed for which comparable data are available ( $V_{is} = 360$  mph) the deflection was only about one-fourth as great as it was for the original  $8\frac{1}{2}$ -inch rib-spaced elevators. This large reduction in fabric distortion is to be expected because theory indicates that for constant pressure differential the maximum fabric deflection in a panel should vary approximately as the square of the unsupported gap distance. Warping of the mean camber line of the  $4\frac{1}{4}$ -inch rib-spaced elevators at high speed was scarcely discernible so that the elevator mean camber lines are omitted in figure 12. The absence of curvature of the mean camber line would be expected because the elevator air load at high speed should be small when the elevator is approximately aligned with the stabilizer for straight flight trim.

FIGURE 12.- ELEVATOR SECTIONS AT CENTER OF PANEL NUMBER 7 (FIGURE 4) SHOWING THE VARIATION OF FABRIC DEFLECTION WITH INDICATED AIRSPEED IN STRAIGHT FLIGHT. ELEVATOR ANGLES ARE GIVEN WITH RESPECT TO STABILIZER. STABILIZER INCIDENCE  $+1.1^\circ$ . ELEVATOR INTERNAL PRESSURE MEASURED AT PANEL NUMBER 7 IS GIVEN AS FRACTION OF CORRECT IMPACT PRESSURE BELOW CORRECT STATIC PRESSURE. ELEVATOR RIB SPACING  $4\frac{1}{4}$  INCHES.
