February 1944 as  
Advance Restricted Report 4B02

FLIGHT TESTS OF THE THERMAL ICE-PREVENTION  
EQUIPMENT ON THE B-17F AIRPLANE

By Bonne C. Look

Ames Aeronautical Laboratory  
Moffett Field, California

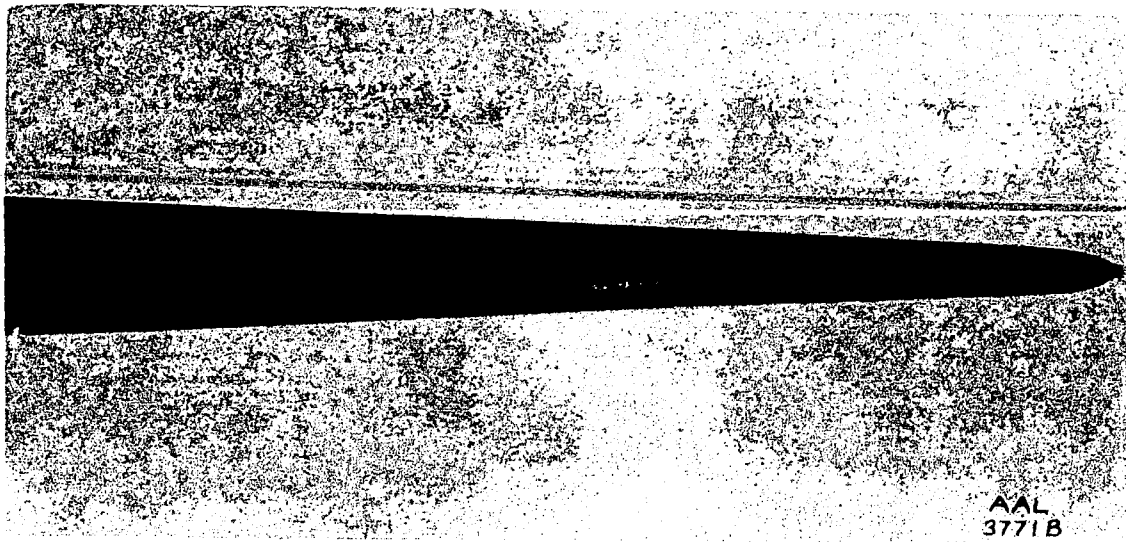
During all the icing flights the heating system prevented the accumulation of ice on the major portion of the heated region. The areas of the leading edge which were not adequately protected to prevent the accumulation of ice during all conditions were at the tip, at midspan, and about 10 inches of the leading edge at the junction of the horizontal stabilizer and fuselage. The extent to which the horizontal stabilizer accumulated ice is shown in figures 22, 23, and 24. In the most severe icing conditions (tests 4 and 5) ice was observed to form on the aft region of the heated double-skin and on the upper and lower surfaces of the horizontal stabilizer aft of the heated leading edge (figs. 23, 24, and 25).

Figure 24.- Ice formation on the left horizontal stabilizer accumulated during tests 4 and 5.

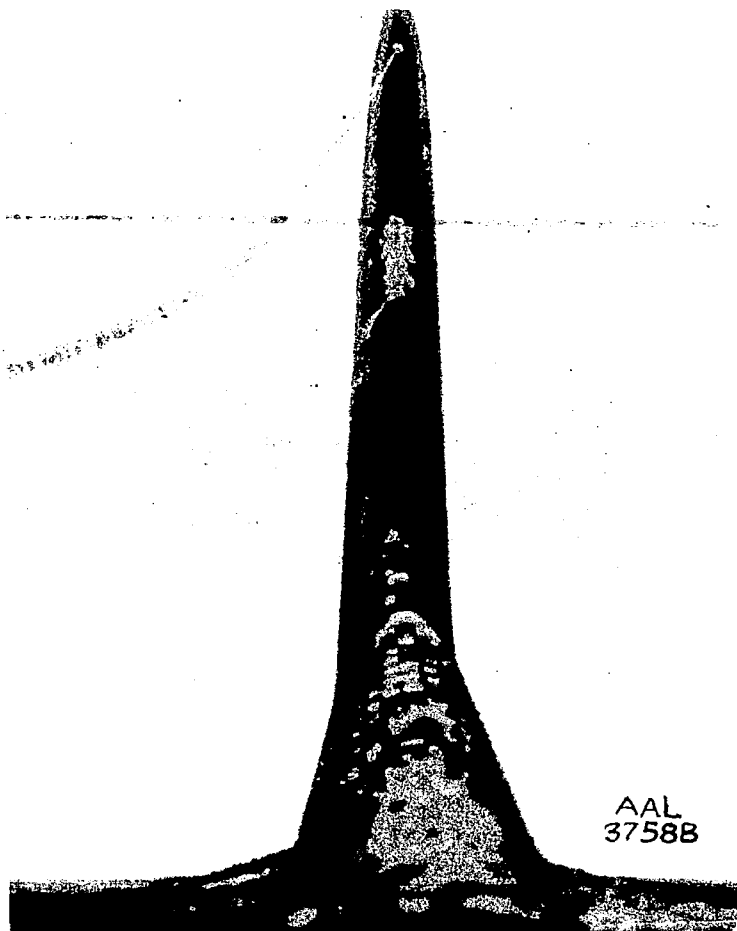
In the preliminary dry-air tests of the ice-prevention equipment, reported in reference 3, it was found that the heating of the vertical stabilizer was below the design value, but not to a serious degree. The results of the flight tests in icing indicate that three small areas of the leading edge were not sufficiently heated. The unsatisfactorily protected regions of the vertical stabilizer are shown in figures 28, 29, and 30, which were obtained during icing flights of tests 4, 5, and 7. The ice on the leading edge at a point approximately midway between the base and the top of the vertical stabilizer is in the vicinity of the dorsal and fin junction. Ice formations aft of the heated leading edge, which are visible on both sides of the vertical stabilizer in figures 28 and 29, were observed only during the most severe icing conditions of tests 4 and 5. The increase in engine power for test 5 did not produce any apparent change in the degree of protection afforded by the ice-prevention system for the vertical stabilizer.

Figure 28.- The vertical stabilizer showing ice accumulation on the heated leading edge in the region of the dorsal and fin joint, and on the unheated forward portion of the dorsal during tests 4 and 5.

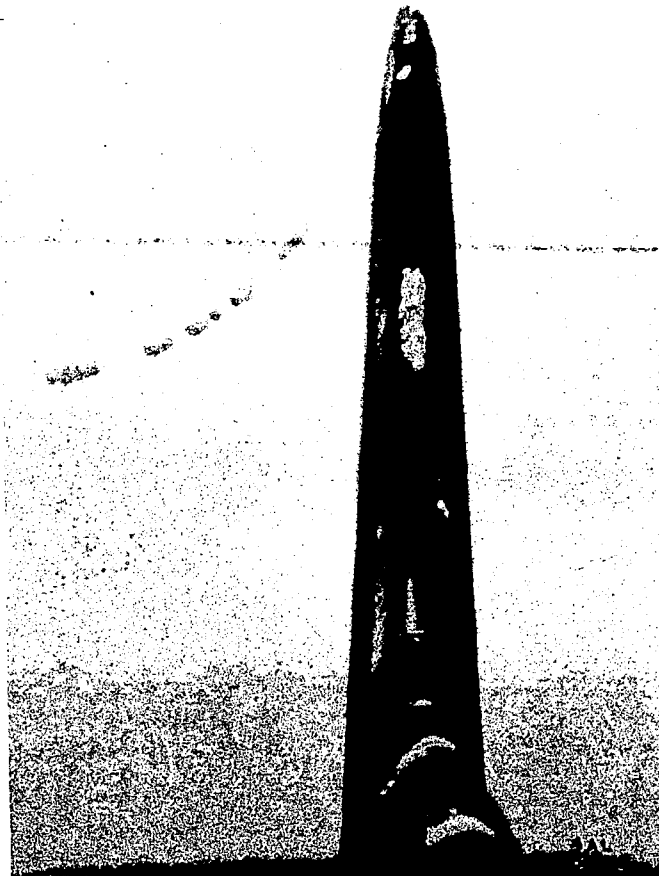
Figure 30.- Rime-ice formation on the heated leading edge of the vertical stabilizer at the junction of the dorsal and fin, at the tip of the fin, and on the running lights on the forward portion of the dorsal during test 7.

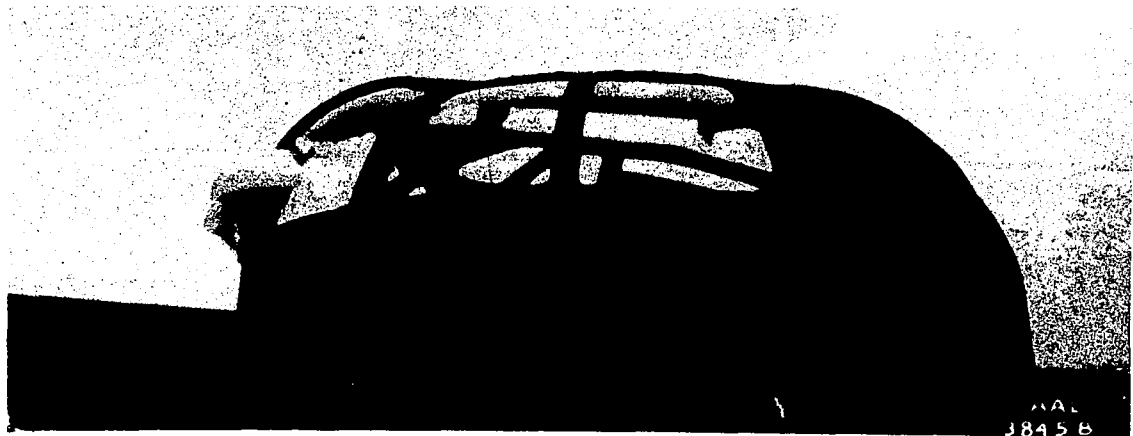
Photographs of the ice remaining on the upper gun turret, on the ball turret, and on the front of the fuselage, after landing from flight test 7, are presented in figures 35, 36, and 37, respectively. During flight, the ice extended over a greater area of the regions than is shown in the figures, but some of the ice was lost after leaving the icing condition. The results of these observations indicated that protection should be provided for the windows used by the gunners, the bombardier, and the pilot if the airplane is to be successfully flown in inclement weather.

Figure 35.- Rime-ice formation on the forward side of the upper gun turret accumulated during test 7.  
(Photograph taken after landing.)

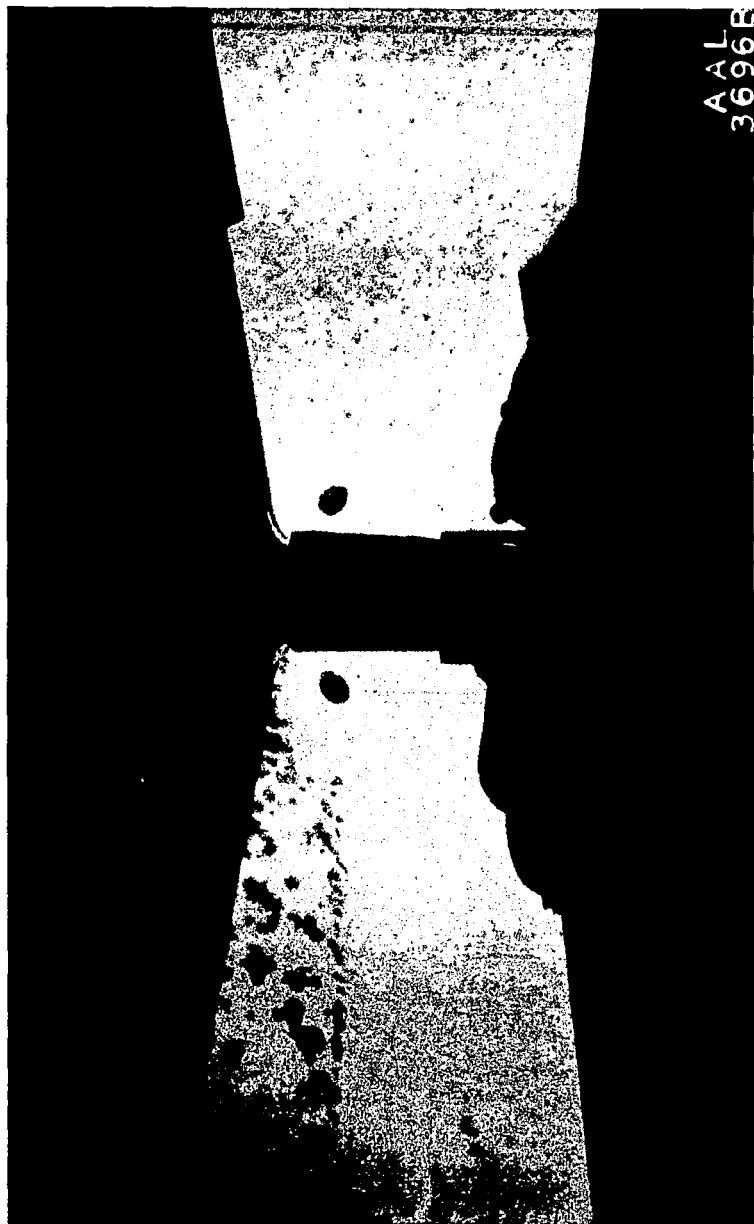
The pilot's heated windshield, adapted from the service windshield and defrosting system, was protected from ice accumulations on the lower portion, as shown in figures 31 and 32. Figure 33 is a view of the windshield exterior, obtained from the aft top window of the bombardier's compartment during test 3, and illustrates the susceptibility of the windshield to icing. Although the pilot's windshield was not completely protected during flight in icing conditions, it was observed to clear more rapidly than did the unheated copilot's windshield when the airplane was flown out of the icing conditions, as shown in figure 34.

Figure 31.-- Icing of pilot's (left) and copilot's (right) windshields during flight of February 23, 1943. The photograph shows the partial protection afforded the heated pilot's windshield.

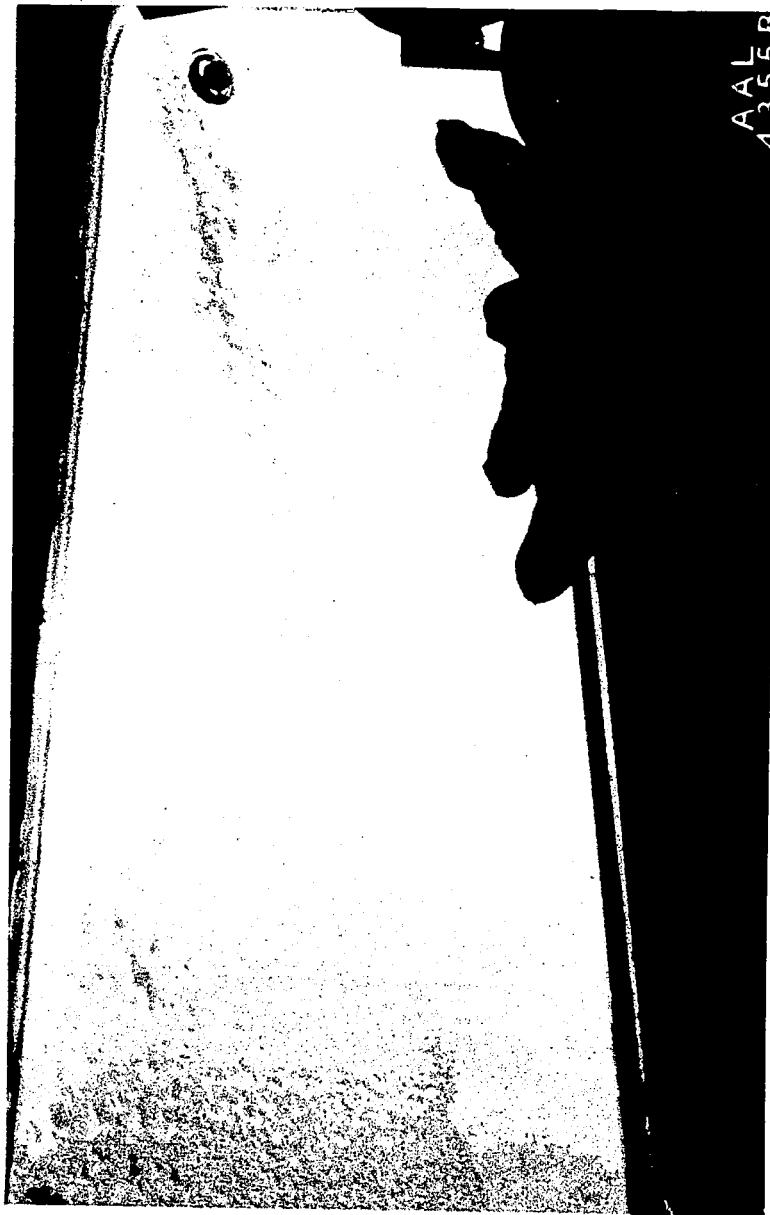
Figure 32.- Ice accumulation on the pilot's heated windshield during flight in icing, test 3.

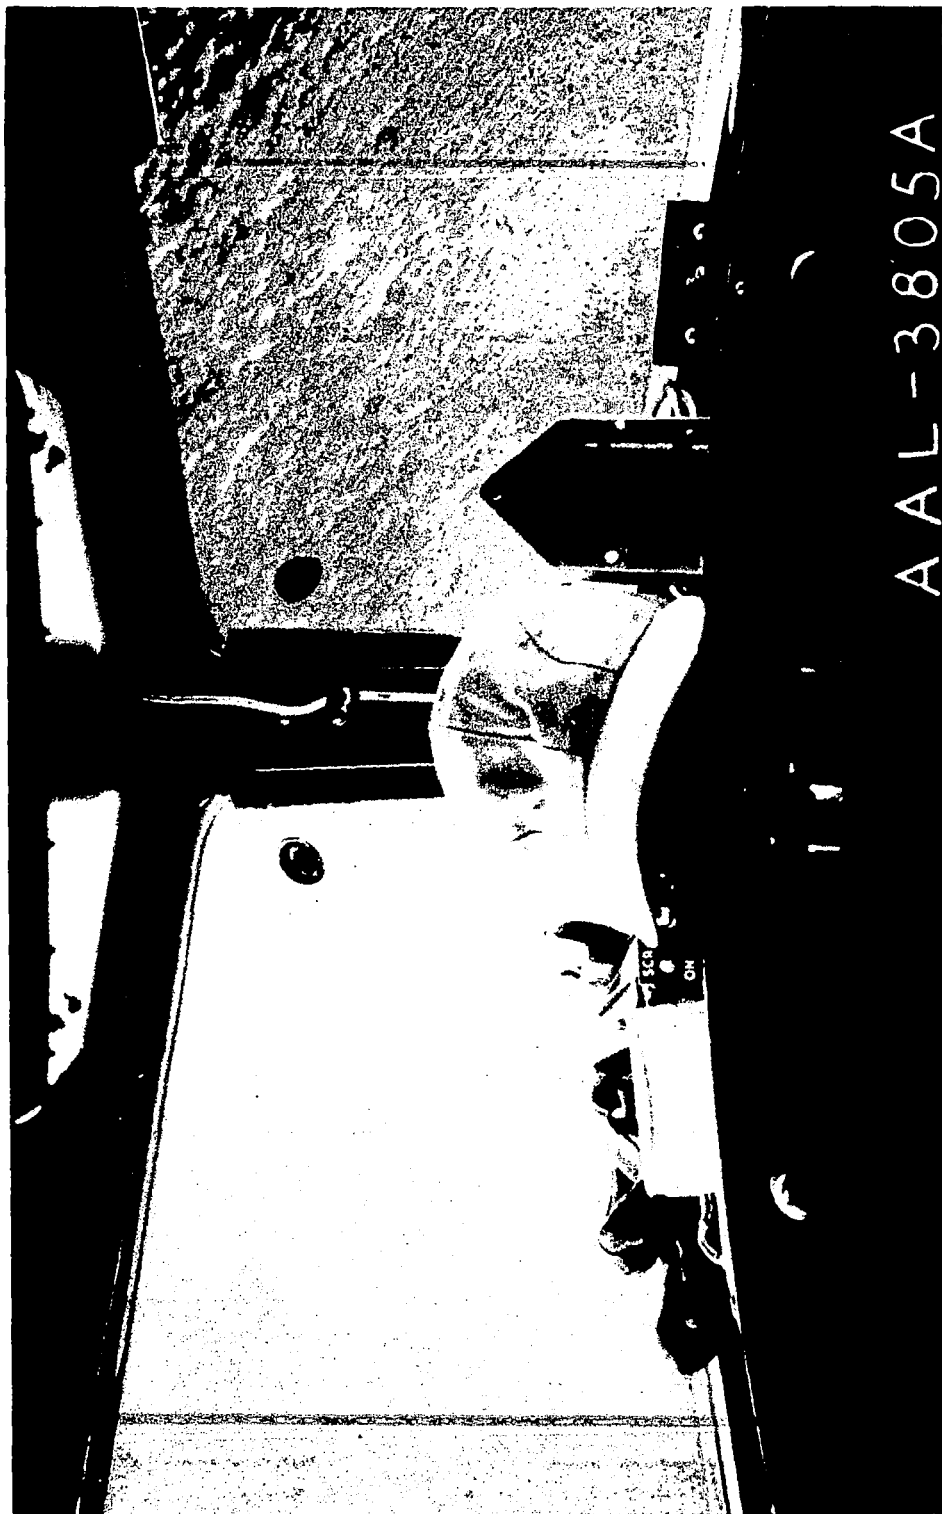
Figure 34.- The pilot's (left) and copilot's (right) windshields during tests 4 and 5, after leaving the icing region. The heated pilot's windshield is clear of ice.

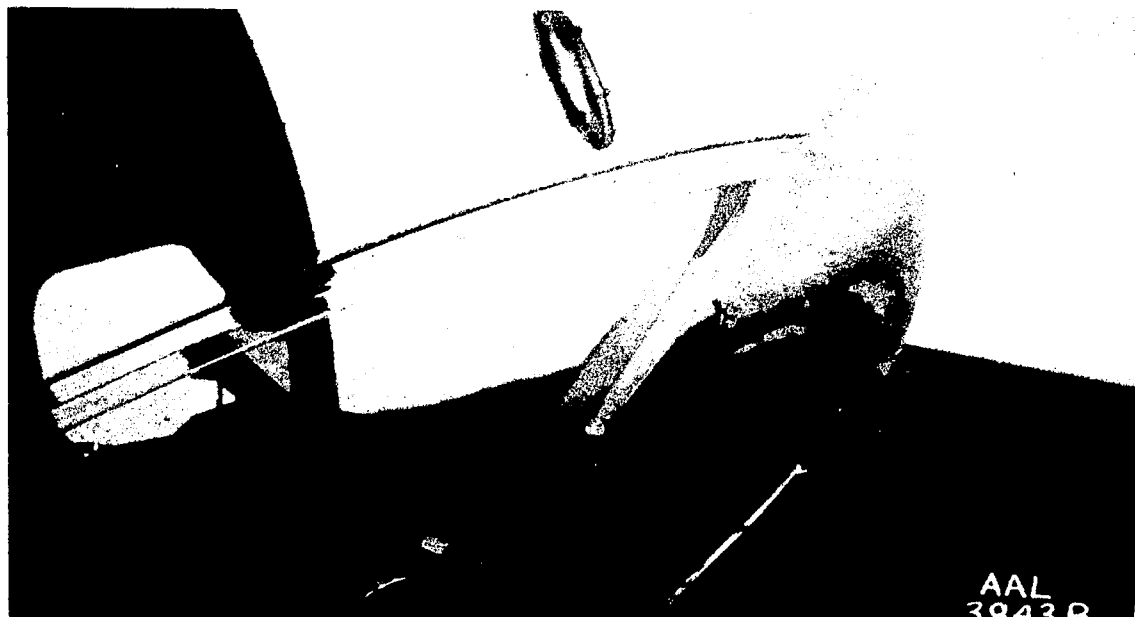
Figure 37.- Rime-ice accumulation on the front of the fuselage during test 7. (Photograph taken after landing.)

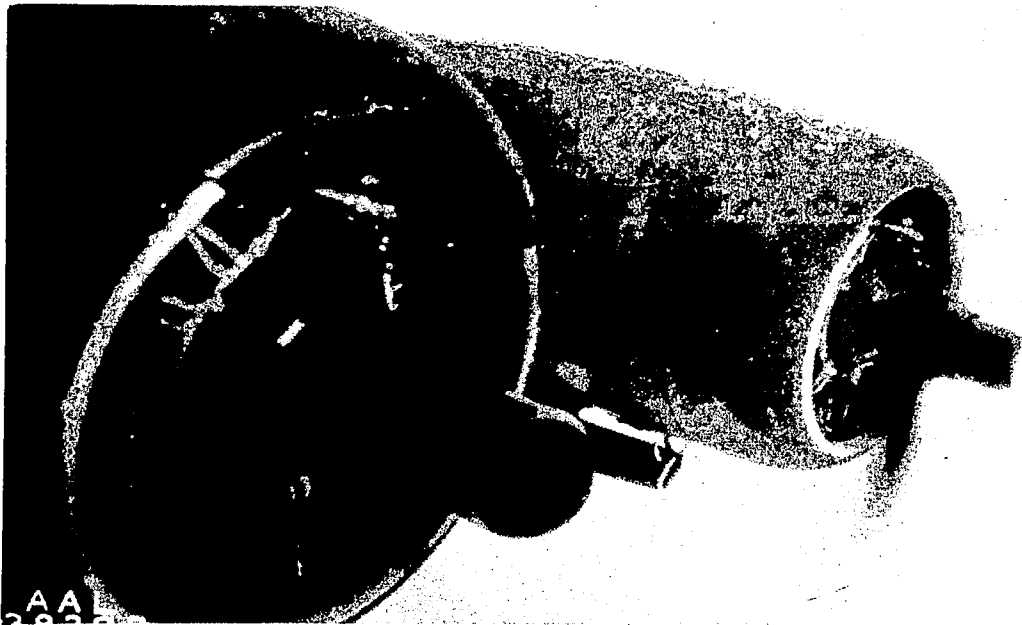
Figure 40.- The left engine nacelles showing ice accumulations on the leading edge of the cowls, and on the lip of the air inlet for the heat exchanger in the outboard nacelle (beneath the right nacelle) during test 7.

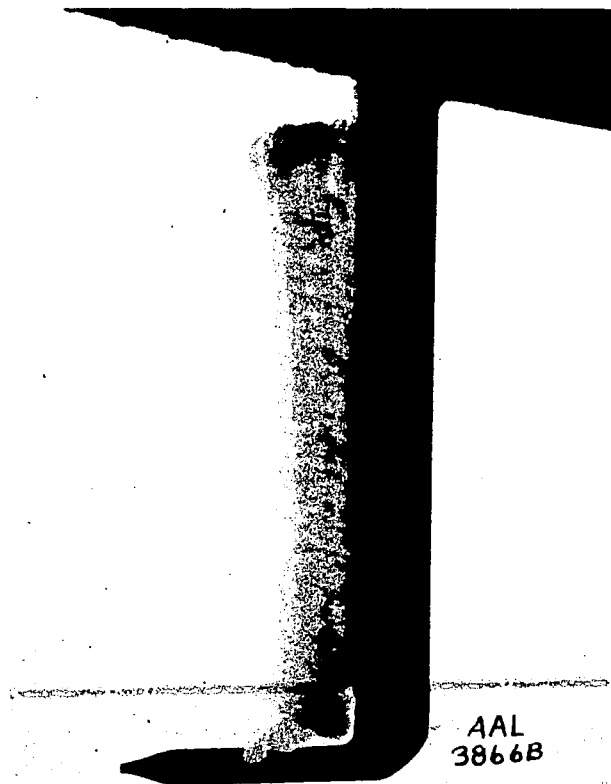
AAL  
3866B

The severity of icing on the airspeed-head support mast is shown in figure 44. This figure is a photograph of the right airspeed-head mast taken at the same time figure 43 was obtained. The static-pressure openings in the airspeed head are located about  $2\frac{1}{2}$  inches forward of the support-mast leading edge. The ice accumulation shown in the figure extended to within  $1/8$  of an inch from the static openings, and is an example of the ice formation accumulated during many of the flights. An accumulation of this magnitude was found to affect the airspeed reading as much as 20 miles per hour at cruising-power conditions.

Figure 44.- Ice accumulation on the right airspeed mast during test 7. (Photograph taken after landing.)

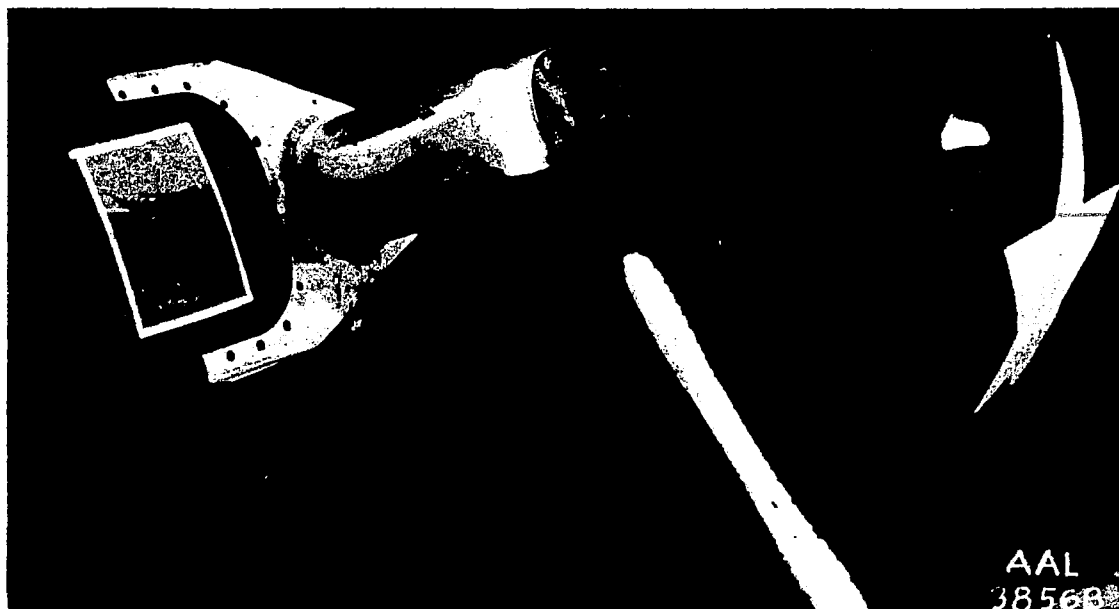
Figure 45 shows the ice-indicating strut which was mounted on the left side of the fuselage at the aft edge of the radio-compartment window. The ice formation on the strut leading edge was accumulated during test 7. Another illustration of icing on the strut is shown in figure 46. The ice formations shown on the strut illustrate the amount of ice which may accumulate on unprotected surfaces during flight in icing conditions. The variation in thickness of the ice on the strut probably was due to interference of the fuselage.

Figure 45.- Ice accumulations on the ice-indicating strut and on the lead-in antenna wire of the liaison radio. Photograph was taken after landing from test 7.
