ACCELERATIONS AND BOTTOM PRESSURES MEASURED ON A
B-24D AIRPLANE IN A DITCHING TEST

By Margaret F. Steiner

Langley Memorial Aeronautical Laboratory
Langley Field, Va.

MEMORANDUM REPORT

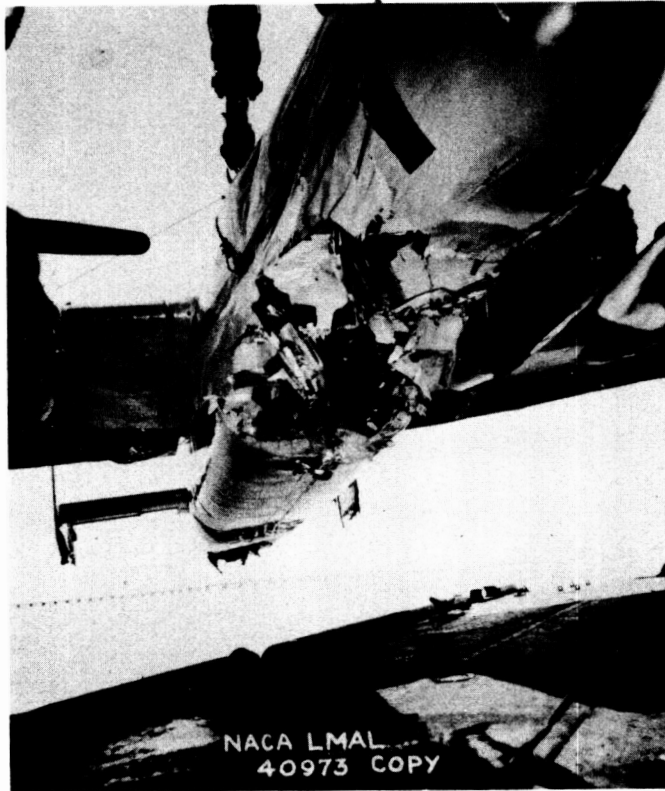
The pressure distribution holds for this reinforced airplane with its specific damage. The distribution would be different for a normal airplane in a ditching or for an airplane which remained undamaged. Figure 16 is a photograph of the B-24D fuselage bottom taken just after the airplane was retrieved from the James River. Note the damage in the nose-wheel area, the dent in the rear bomb doors, and the hole near bottom turret. Rudders were slightly damaged and the skin was indented over the lower half of the fuselage in a strip just in front of the empennage.

Immediately after first contact the area just aft the $\frac{1}{8}$ -inch steel plating was forced inward, the skin was crushed at a section of the fuselage tail near the rudder hinge line, and the rudders were damaged.

the airplane rocked forward with the port wing low. These high pressures failed the bottom area just in front of the walkway. As the nose plowed through the water the steel reinforcement over the bombardier's sighting window was dented at which time the maximum decelerations also occurred. The damage around the nose-wheel door section apparently weakened the structure to such an extent that the nose section was almost broken away from the rest of the airplane.

Figure 16.- Photograph of B-24D fuselage bottom taken after airplane was removed from James River. Note damage in nose-wheel door area, dent in rear bomb door, hole near bottom turret, and damage to rudders. The skin was indented over lower half of fuselage in a strip just in front of the tail empennage.
